WADD TECHNICAL NOTE 60-296

F-102 HIGH-ALTITUDE FLAMEOUTS IN AND AROUND THUNDERSTORMS

JANUARY 1961

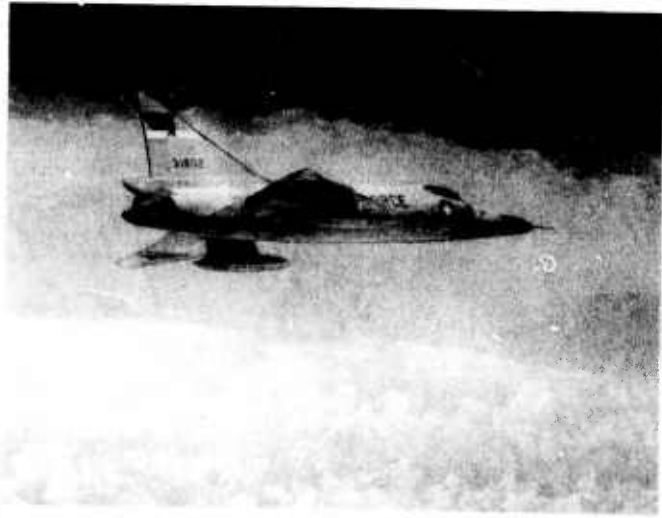
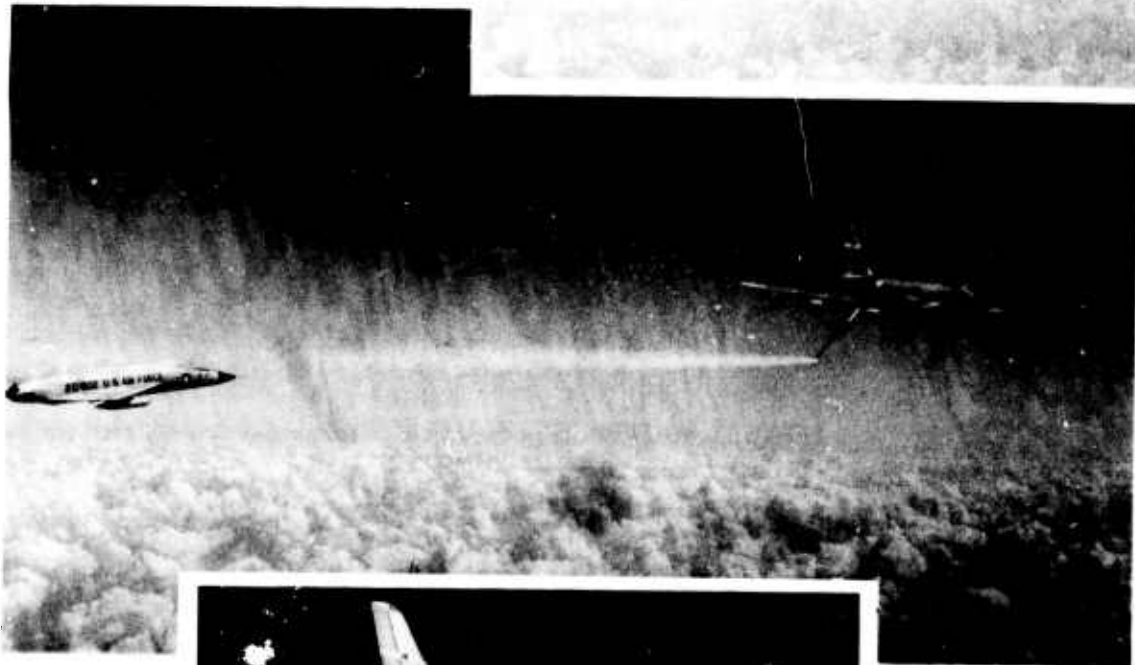
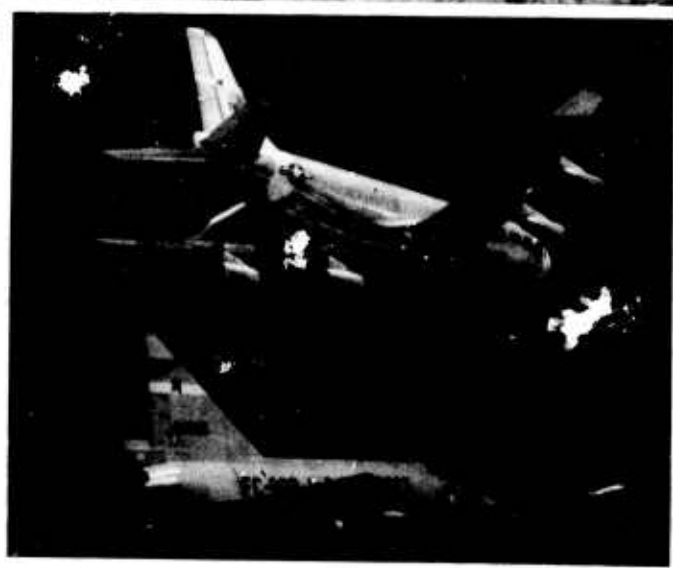
Figure A1. F-102A flight into the simulated ice-crystal environment created by a KC-135 aircraft in south-central Ohio.

ALTITUDE WAS 40,000 FEET;
AIRSPEED WAS MACH .85.
ICE-CRYSTAL CONCENTRATION
FOR THIS FLIGHT WAS 2.0
GM/CUBIC METER. THE F-102A
WAS 750 FEET BEHIND THE
KC-135.

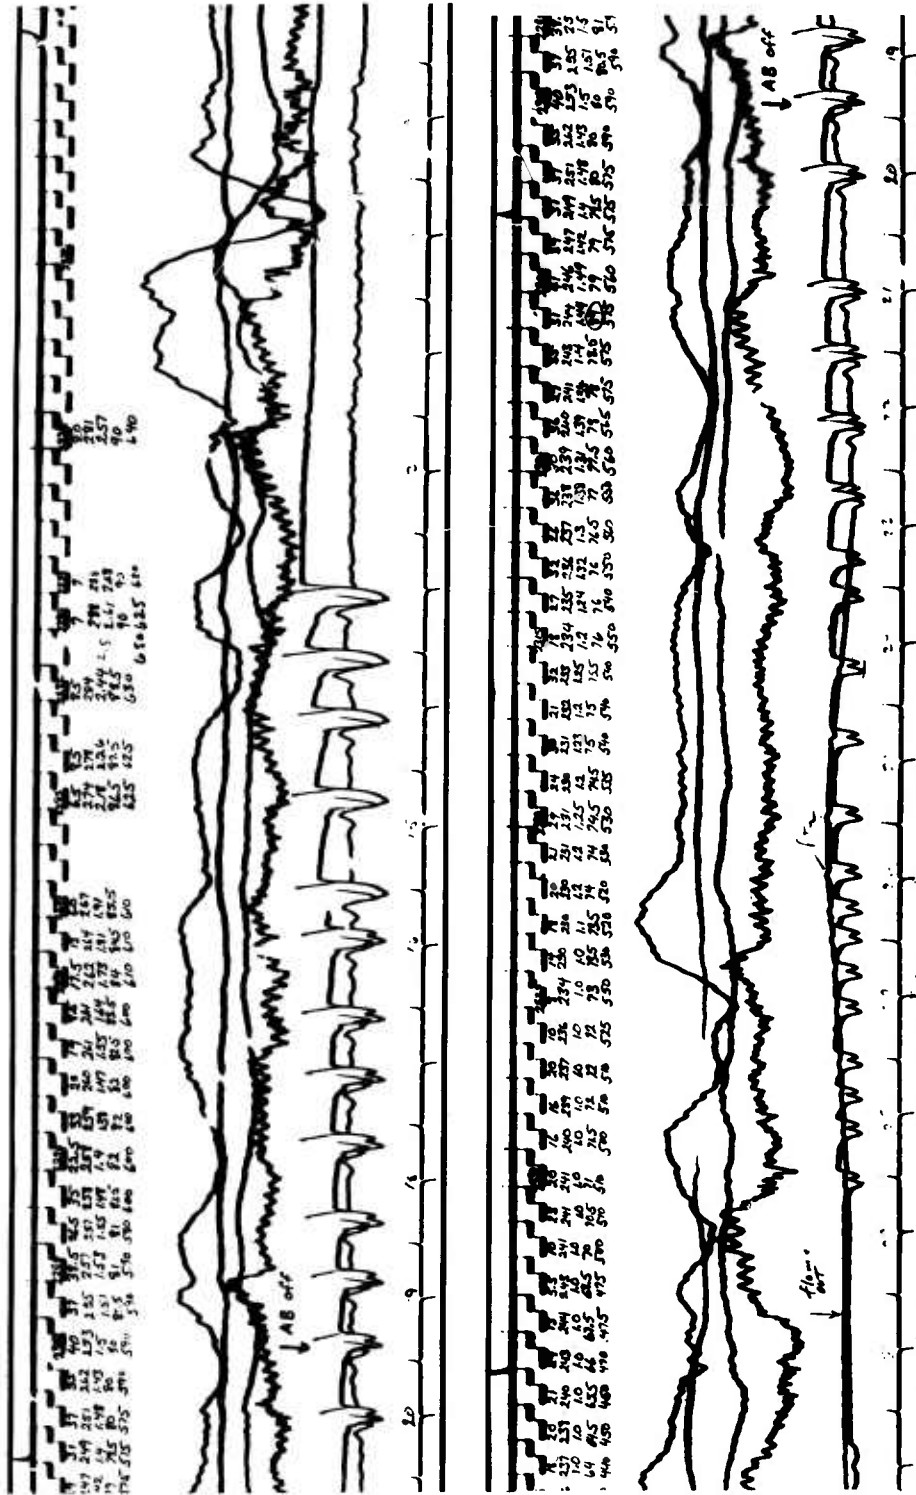
Figure B4. Oscillograph recordings of compressor stalls experienced during Pass Nr 8 of Flight Nr 12, Project "Rough Rider," 27 May 1960.

35. The flight handbook 220 KIAS best glide and best engine restart speed which is also recommended in the flight safety supplement was well proved in the tests. On Flight Nr 12, Pass Nr 8, after the flameout, in order to clear the storm center quickly, the pilot maintained the airspeed at least 20 knots above the recommended 220 KIAS, and at times, was as high as 300 KTS. He was unable to restart the engine until he brought the airspeed down to 220 KTS. By this time he had tried three restarts and was close to 31,000 feet altitude.

"On the last pass, I had the burner going, and with the speed brakes out to keep from going supersonic. In fact, I was playing with the speed brakes to try to maintain around .9 to .92 Mach number. Very shortly after entering the storm, through heavy clouds, the engine started stalling just as it had before with 'military' power. I was in turbulence and had experienced probably a half-dozen stalls or more when I pulled the throttle out of AB into military power. Shortly thereafter, the thing just flamed out. I continued on heading. When the RPM wound down to below 70 percent, I knew the thing had quit, so I pulled the throttle back to idle and then, while still in the storm, selected dual ignition rather than single, and just set up a glide to continue on out of the storm. Broke out about 36,500, as I recall, and the fire never did start again by using the continuous ignition switches. However, I feel sure this was due to the fact that the RPM was still a little bit too high. When the RPM finally stabilized between 25 and 30 percent, I 'stop-cocked' the throttle and turned the ignition off for a few seconds; then made a normal air start using the ignition button on the throttle. The first time I attempted this at about 34,000, it didn't work, so I shut it off again. The second time, it fired at about 31,000. I feel quite sure it would have been impossible to 'deadstick' the thing due to the canopy's and windshield's icing over, which it does on every flight; so it was fortunate that we got the thing started."

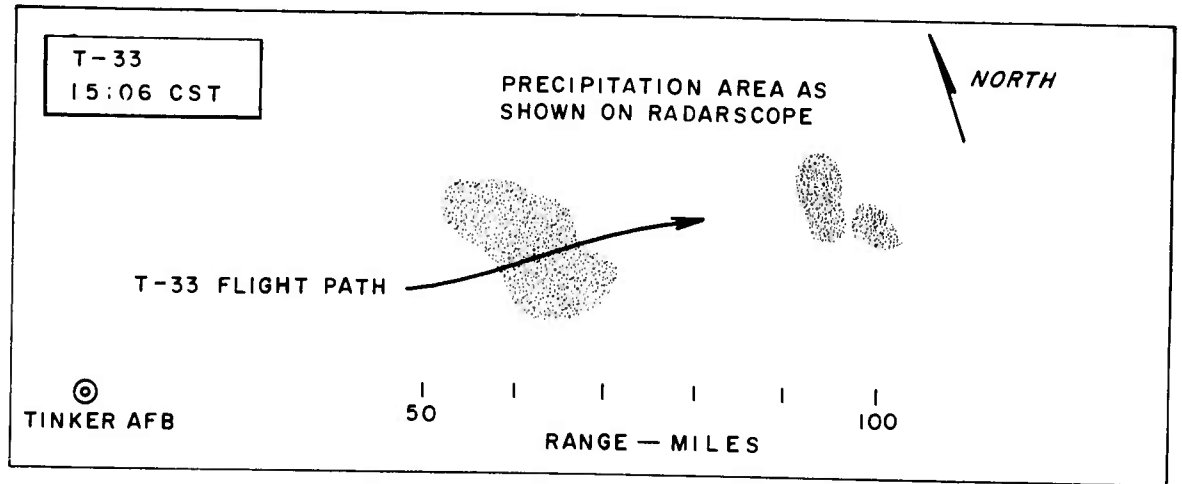
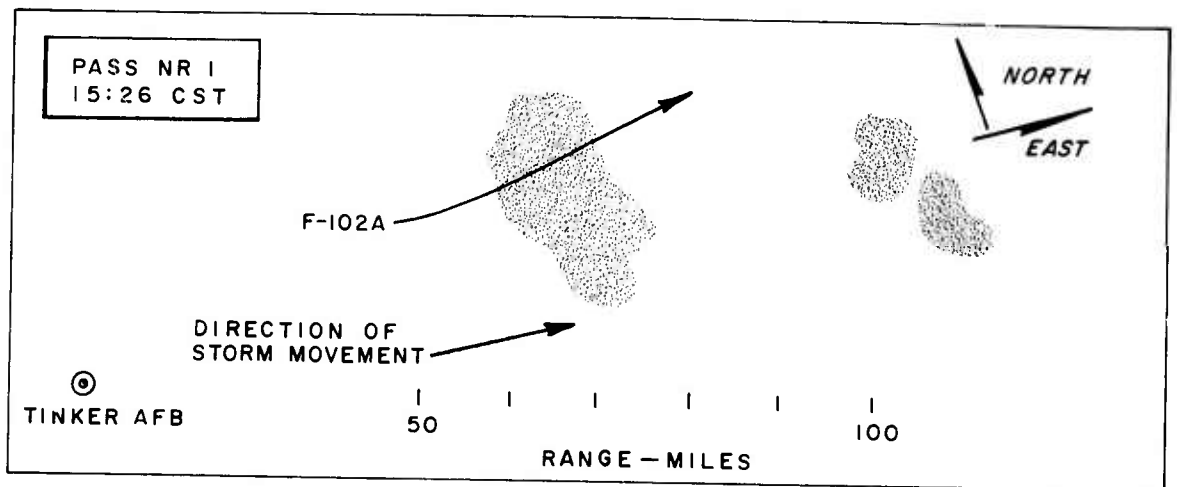
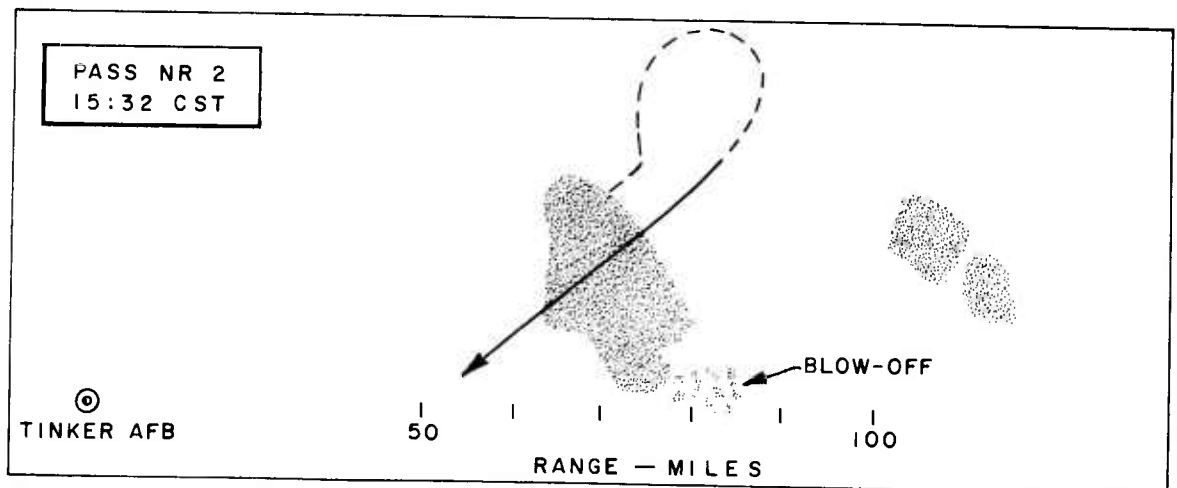
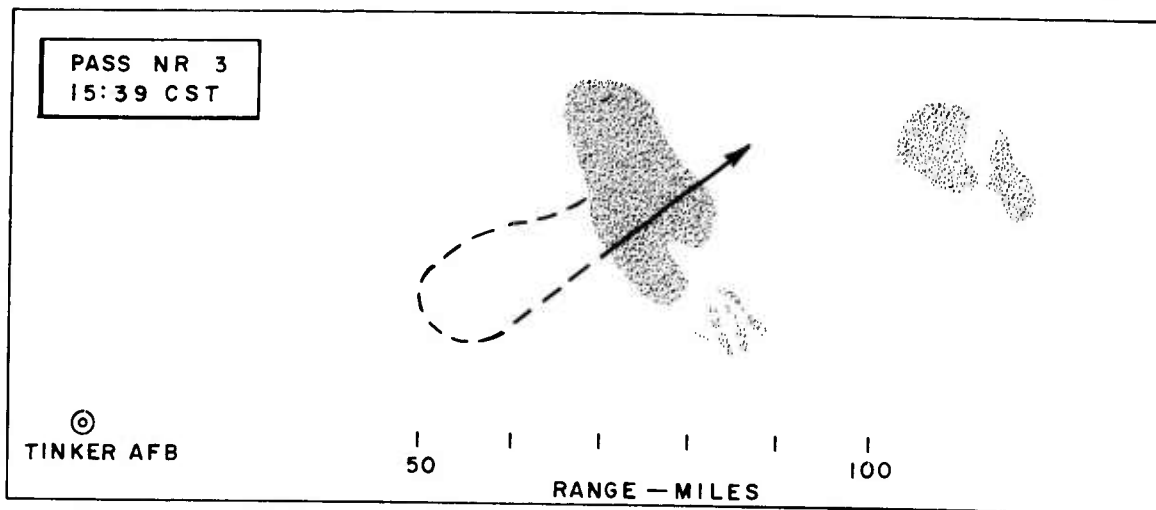
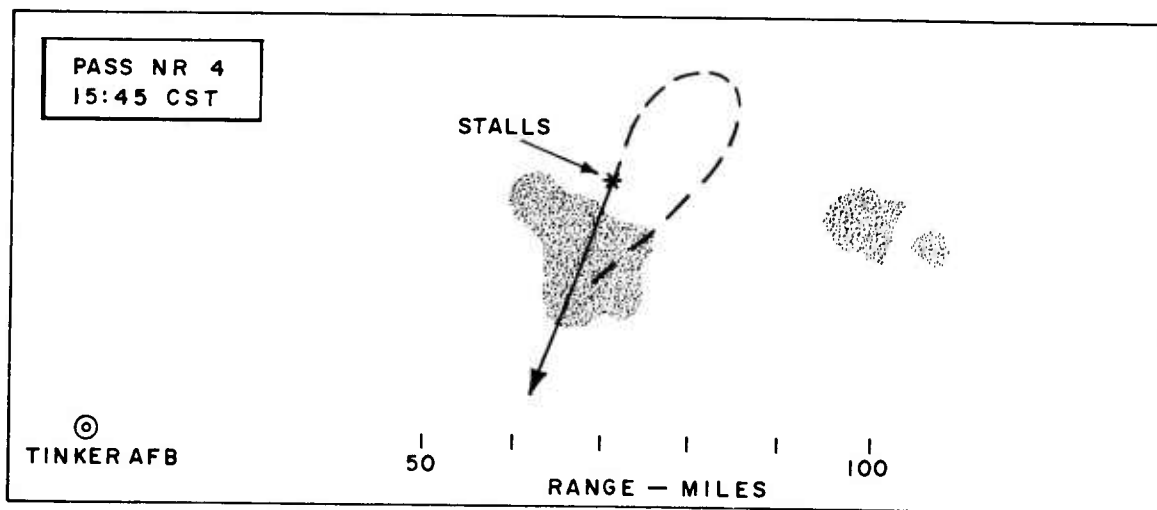
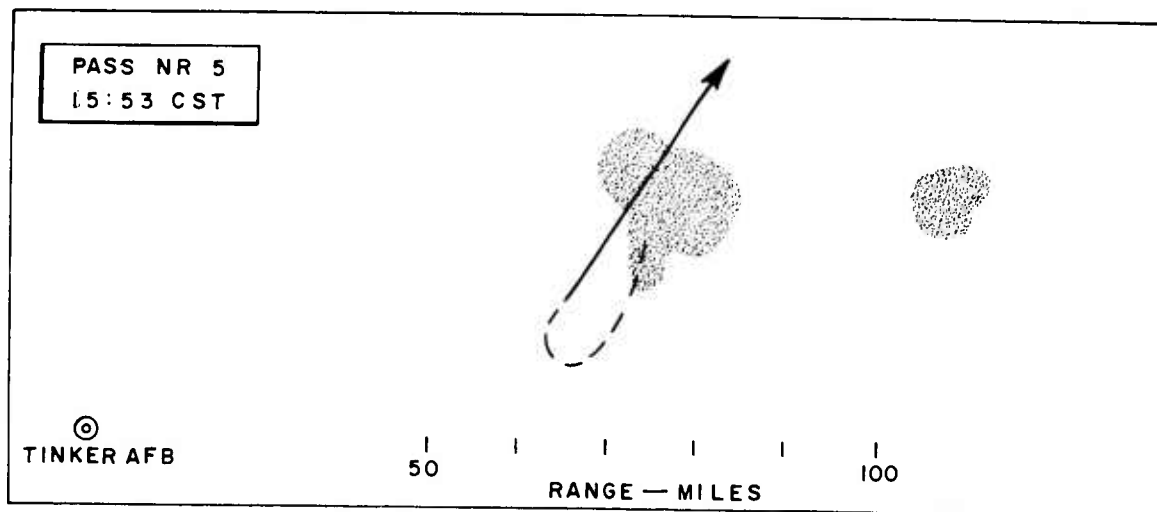
Figure B5. Graphic presentation of F-102A thunderstorm penetrations, Project "Rough Rider," 27 May 1960. (The first illustration shows storm penetration by the NASA T-33 prior to penetrations by the F-102A. If hail had been encountered, the F-102A would not have entered this particular storm.)

PASS NR	ACFT PENETRATION TIME	HEADING (degrees)	ALTITUDE (ft)	CLOUD TOPS (ft)	TURBULENCE	MOISTURE	HAIL	ENGINE STALLS
1	15:26	070	38,000	41,000	light to-heavy (briefly)			none
2	15:32	230	35,000		heavy	some	none	none
3	15:39	050	36,000		light	none	none	none
4	15:45	210	38,000		moderate	some		23
5	15:53	030	37,000		moderate	none		none
6	15:59	250	35,000		very little	none		none
7	16:06	020	40,000		heavy	heavy with lightning		as many as 8 or 10 in 2 seconds
8	16:12 (FLAMEOUT)	250	40,000	44,000	heavy	heavy		as many as 8 or 10 in 2 seconds

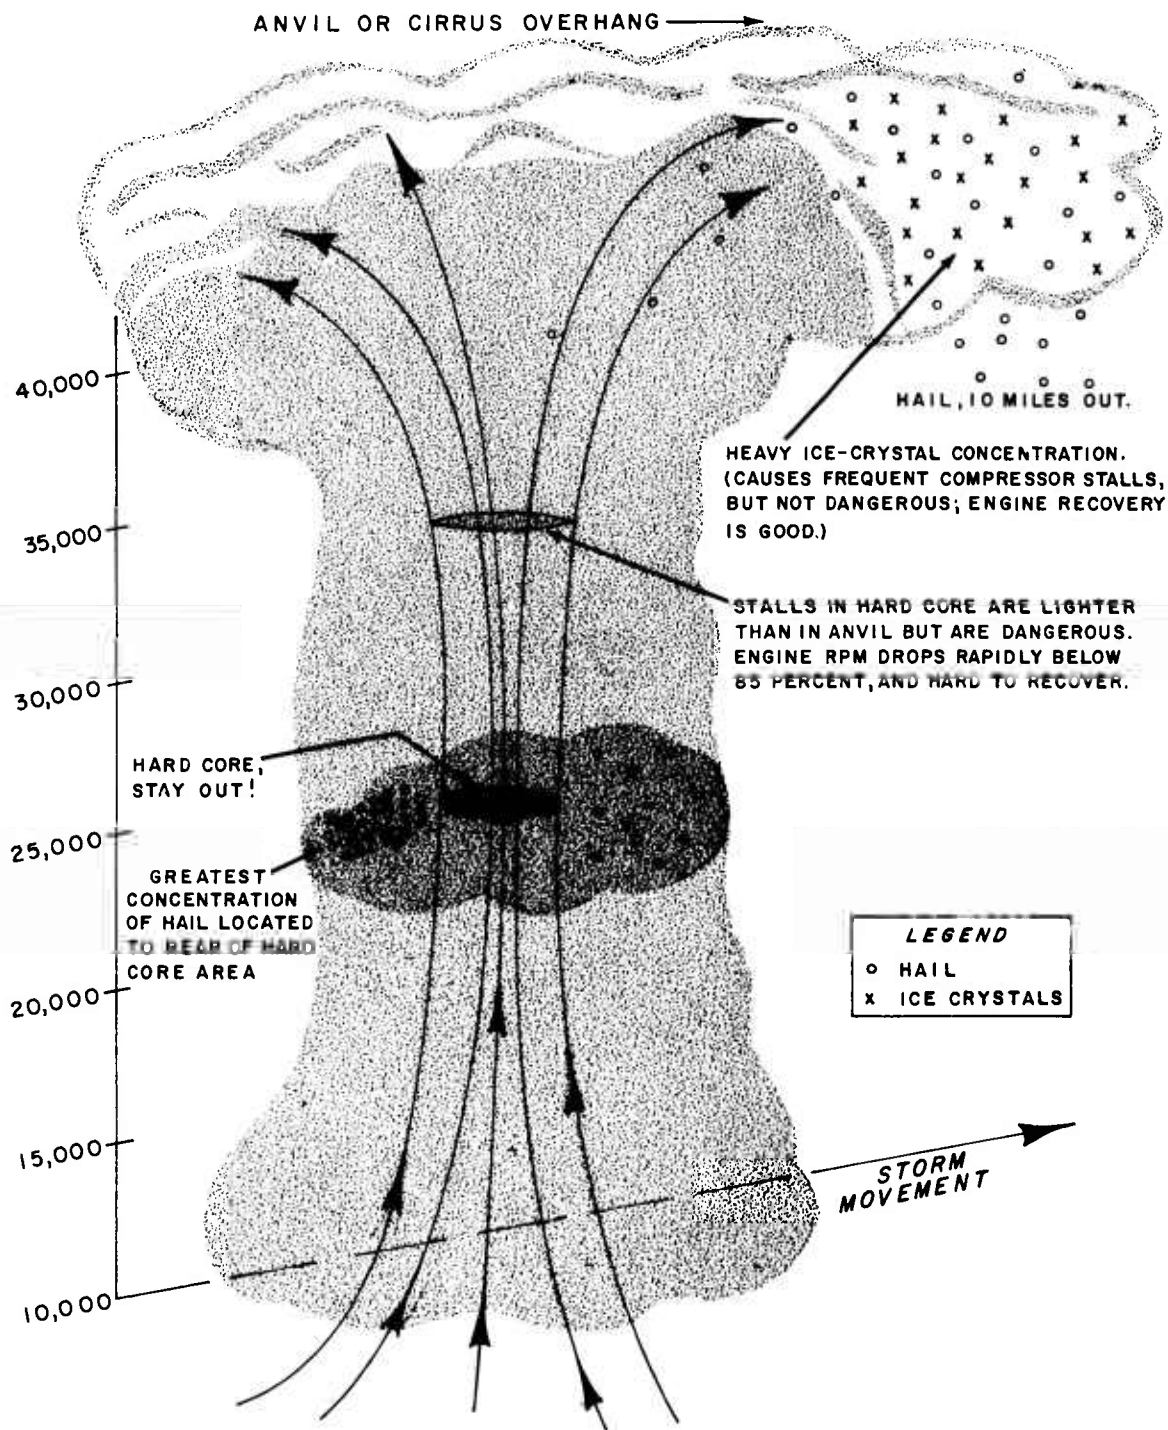
Figure B7. Thunderstorm cross-section, Project "Rough Rider," 27 May 1960.

27. Experience has shown that most thunderstorms have a horizontal cross-section as shown in Figure 6. The greatest turbulence in these storms was found in the core (or area of greatest precipitation). Project pilots could only describe the precipitation in this area as "slushy moisture." It was probably a mixture of ice crystals, light rain or freezing rain, and soft hail. Hail was encountered mostly in the core, but was found many times downwind of the core. (During one penetration, radar returns indicated development of a tornado about 10 miles from the flight path of the aircraft. Tornadoes were quite common during this season of the year and every precaution was taken to avoid them.)
