MINISTRY OF AVIATION

TROPICAL TESTING ESTABLISHMENT
PORT HARGOURT, NIGERIA

THE BEHAVIOUR OF PAINTS
IN THE TROPICS

November, 1961

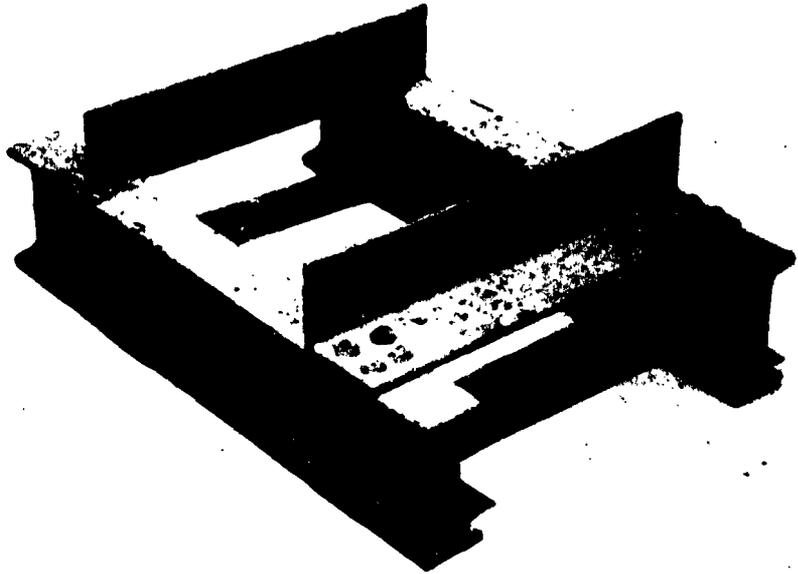
Fig.48 Priming Schemes for Metallic Coatings (Trial sponsored by the British Iron & Steel Research Association). System A13-19 after 19 months exposure at the marine site showing severe corrosion of the metal coating and breakdown of the paint system.

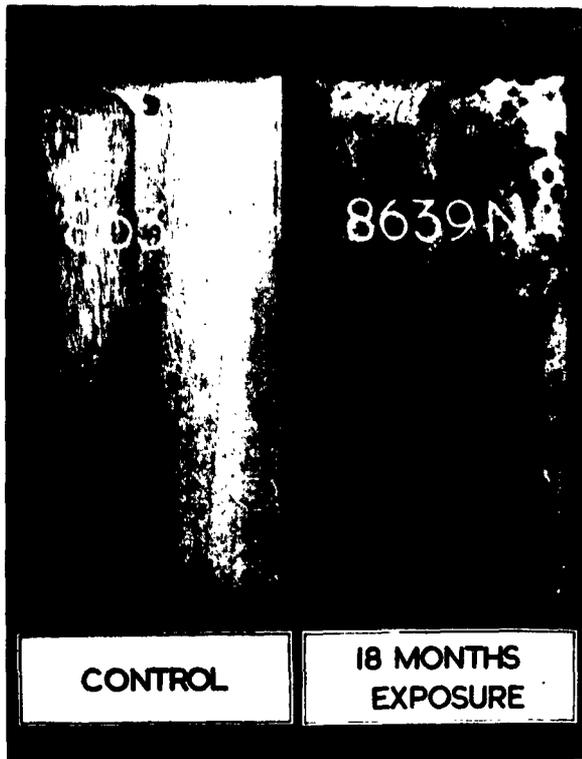
Fig.62 Commercial Varnishes (International Paints, Ltd.). E1-1 after 18 months exposure at town site, showing extensive checking and cracking.
