Technical Note N-467

CELLULAR GLASS INSULATION FOR UNDERGROUND HOT LINES

15 October 1962

U. S. NAVAL CIVIL ENGINEERING LABORATORY  
Port Hueneme, California

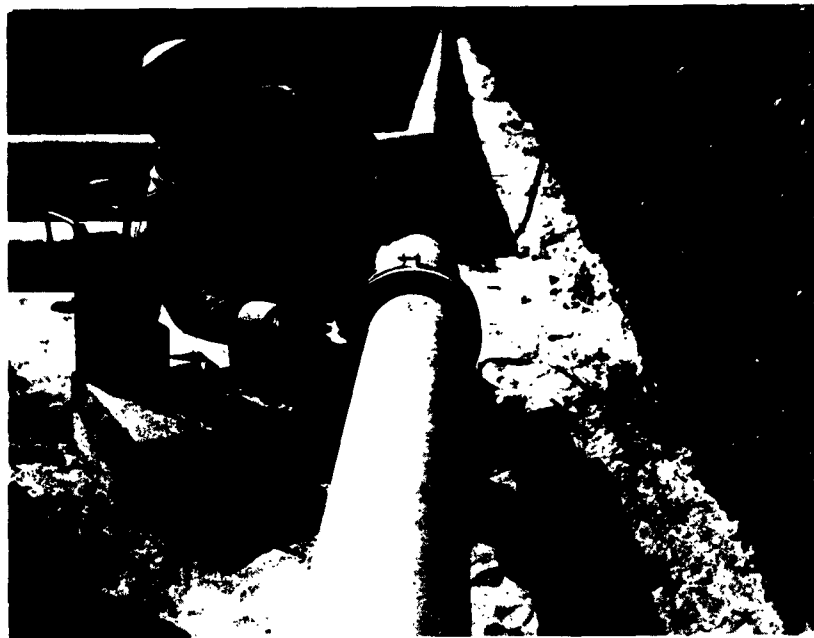
The water cut-off collars can be eliminated if there is assurance that there would be no leak resulting from internal corrosion. The galvanizing burns off when the half-sections of the collar are welded together and then to the pipe. The collars can be given a coating of zinc chromate primer but this treatment adds to the cost of the job. Without galvanizing or primer the collars would quickly rust if there were leaks. Internal corrosion is usually a problem only with condensate pipes, steam pipes generally are not affected.

Figure 3. Workman welding sheet metal collars onto pipe.

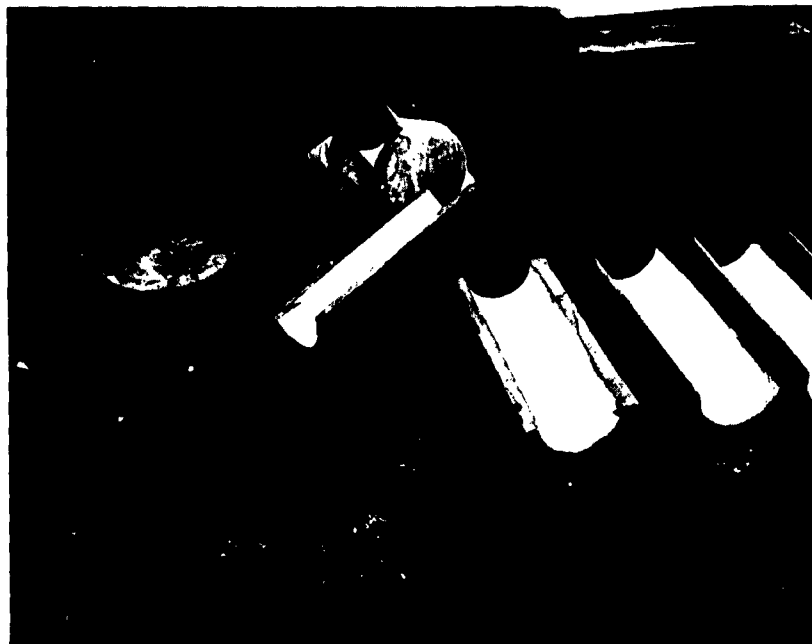
Figure 4. Coating the core and buttering the joints of Foamglas insulation.

A coating is considered necessary only if the pipe is subjected to vibration.

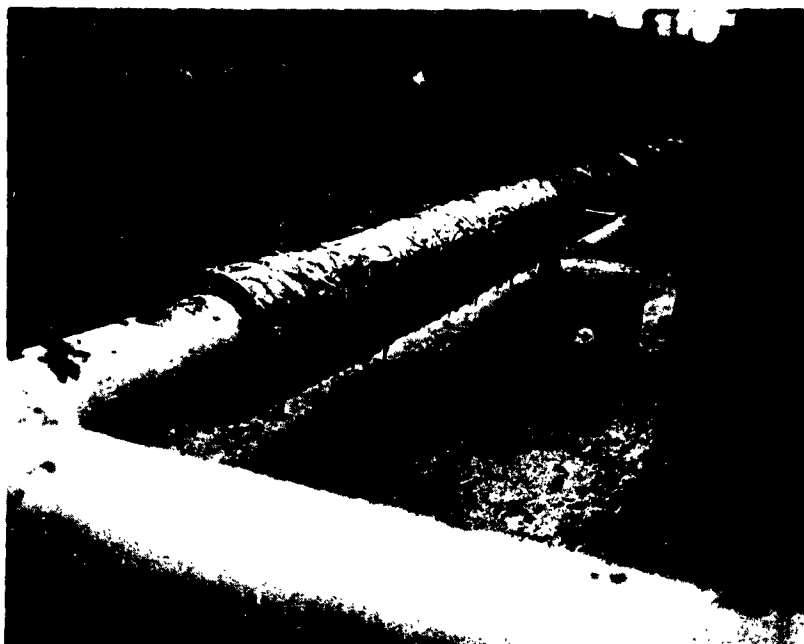
Figure 12. Final coating of Bitumastic 50. Note flow from vertical surfaces and streamers from bottom.
