# FINAL REPORT

## TESTS ABLE and BAKER

BUREAU OF AERONAUTICS  
GROUP

DIRECTOR OF SHIP MATERIAL  
JOINT TASK FORCE ONE

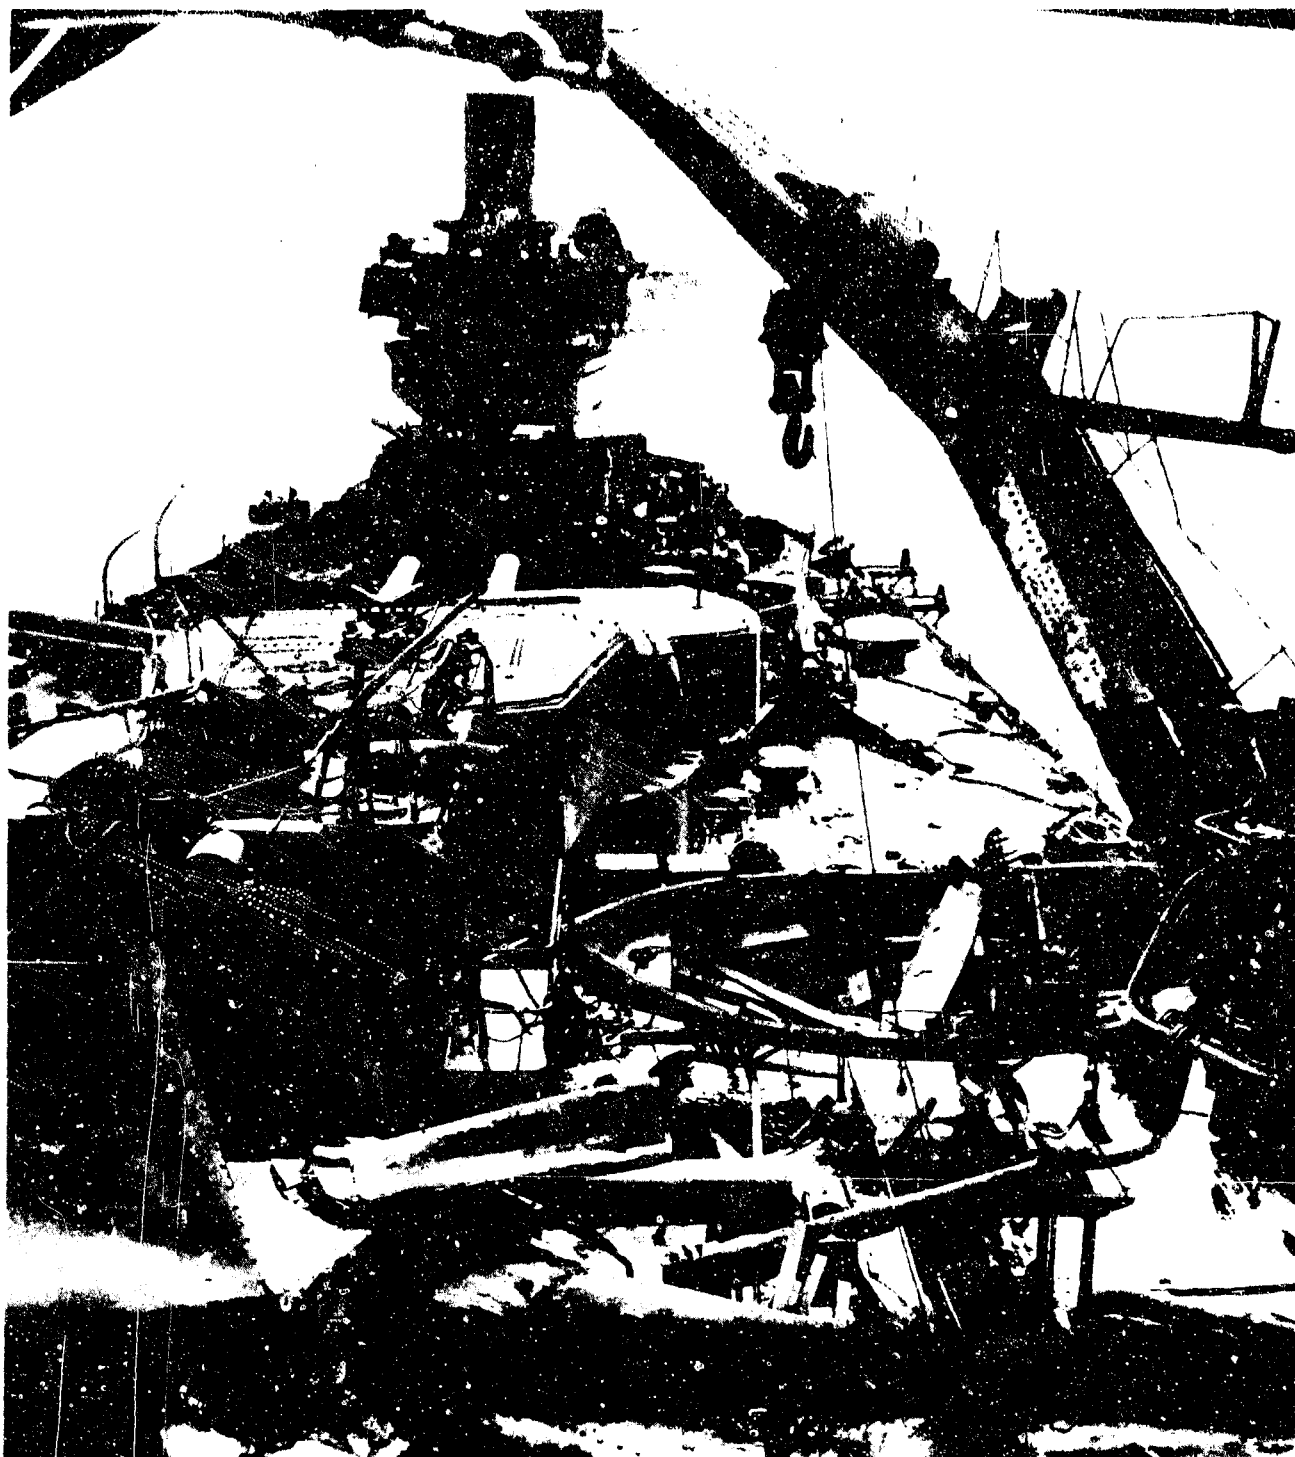
General view of USS ARKANSAS after Test ABLE. OS2U-3 secured to cradle welded atop the turret, visible to the left of center in photograph, was blown over the side with no trace of the airplane remaining.

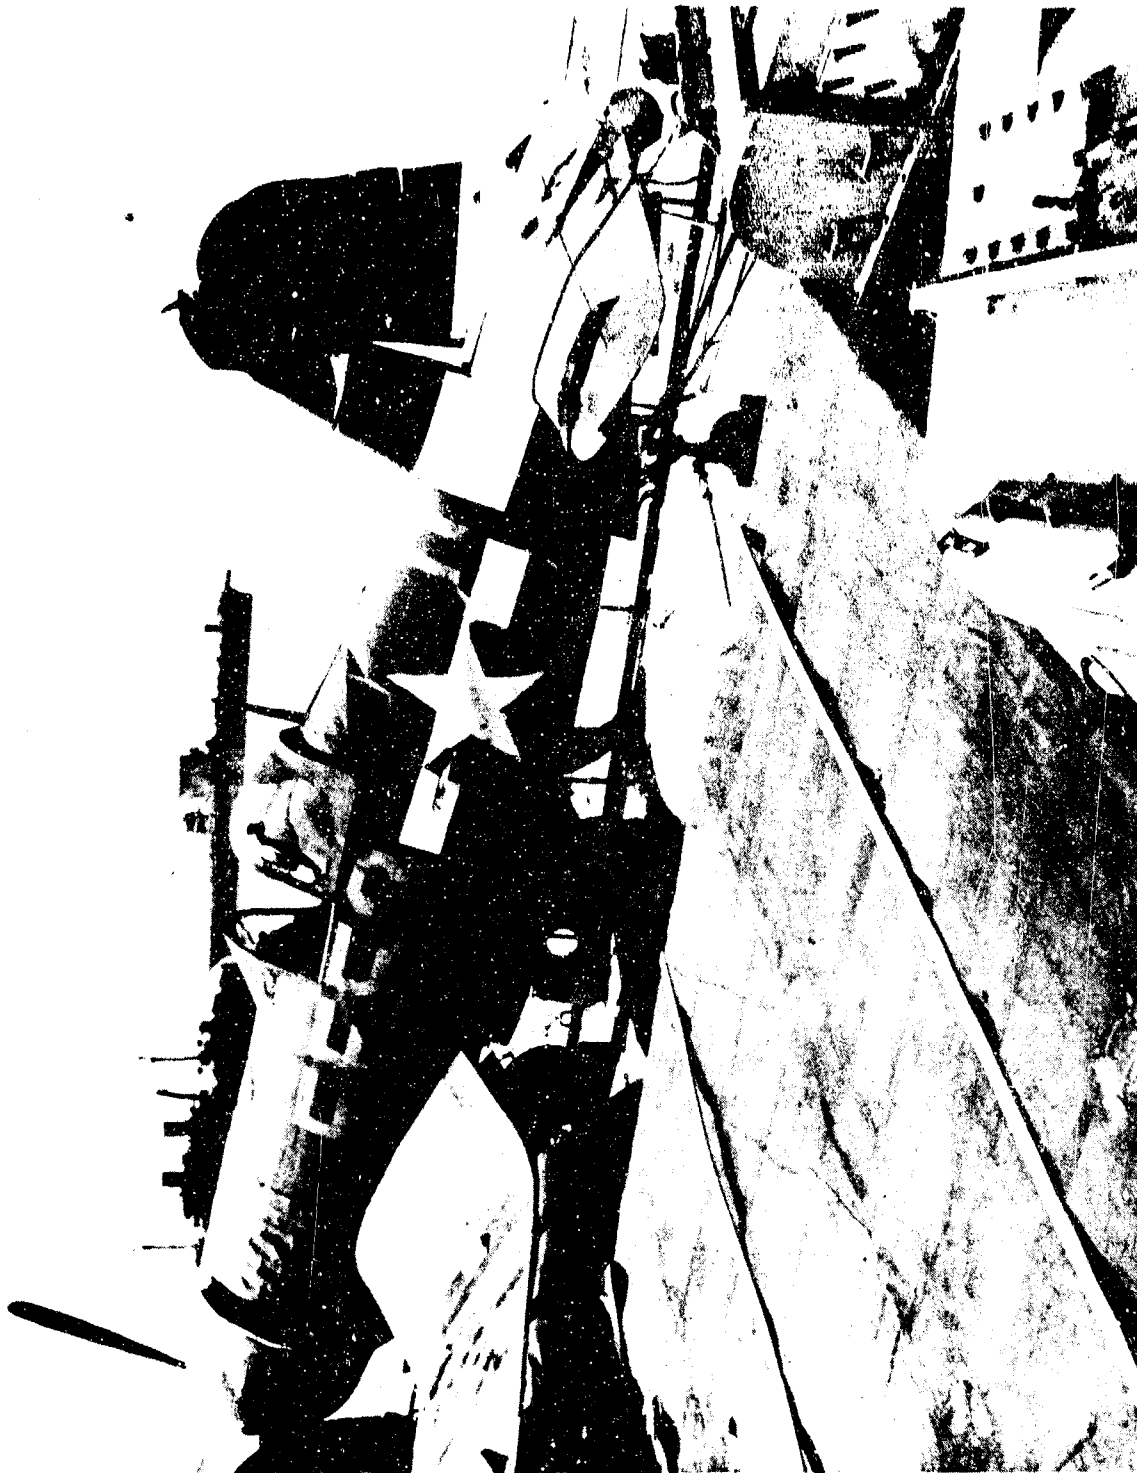
Model FG-1D on main deck of USS FALLON APA-81 after exposure to Able blast. The FALLON was approximately 1300 yards from actual blast center. This airplane sustained damage typical throughout the intermediate zone of 1300 to 2200 yards from the blast center.

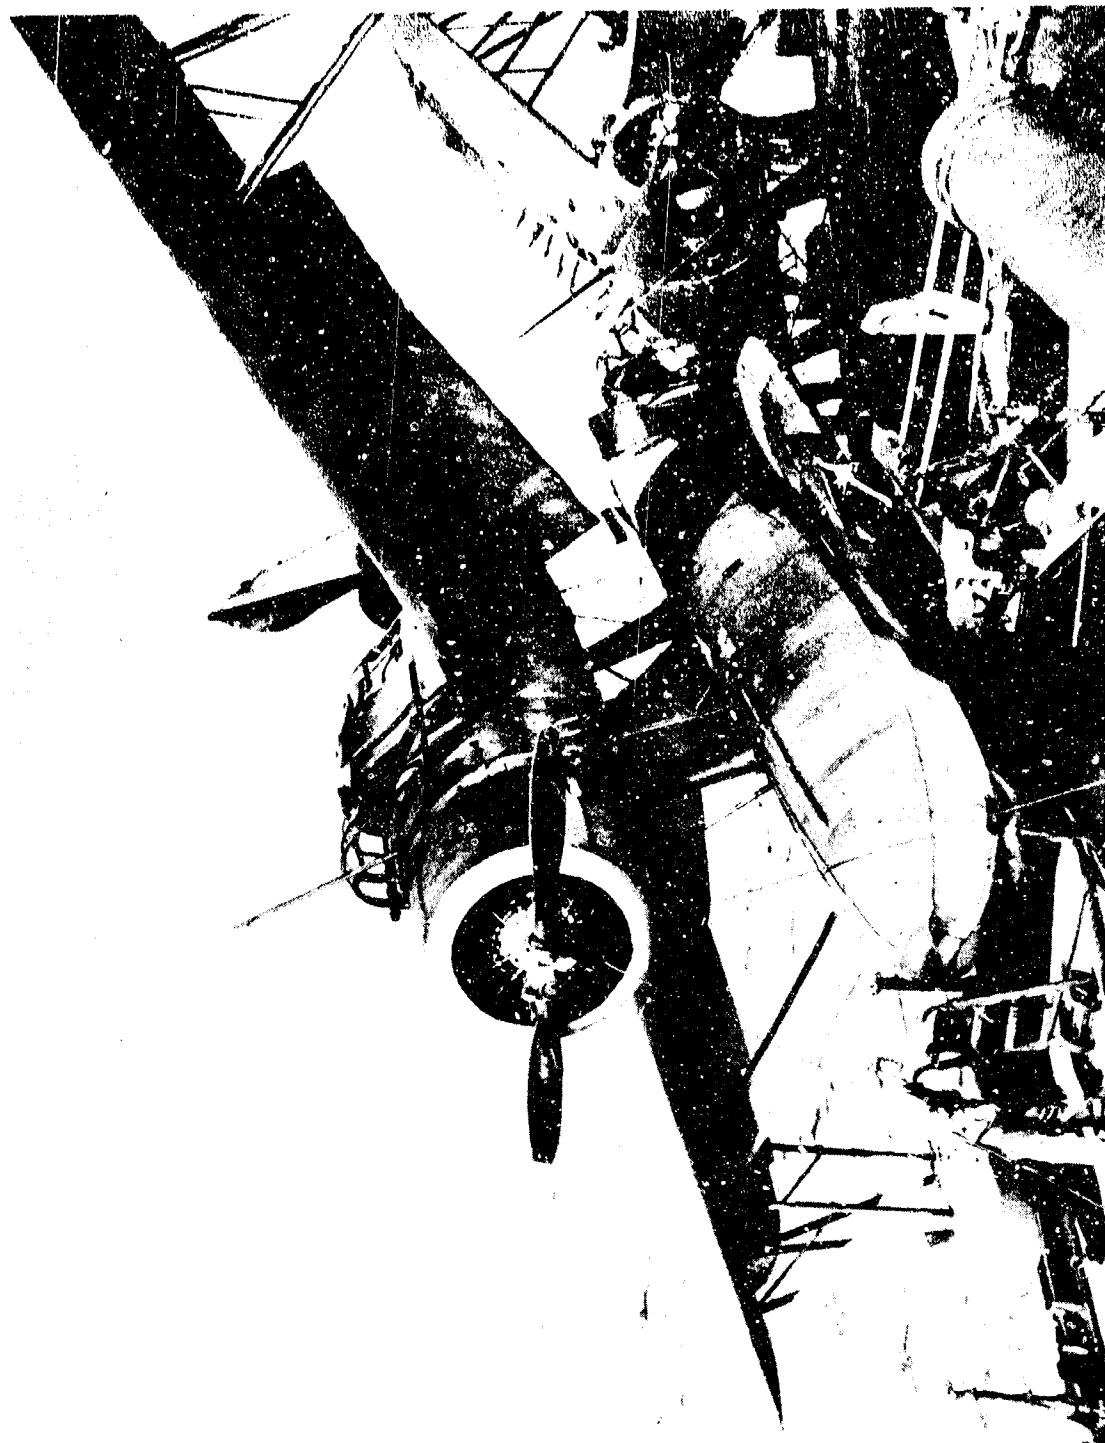
Model OS2U-3 airplane on board USS PENNSYLVANIA after Test ABLE. Float type aircraft exhibited less resistance to overturn as compared to wheel type aircraft, and consequently may be more affected by secondary damage due to falling to deck. Note blast damage to control surfaces and cockpit panels.

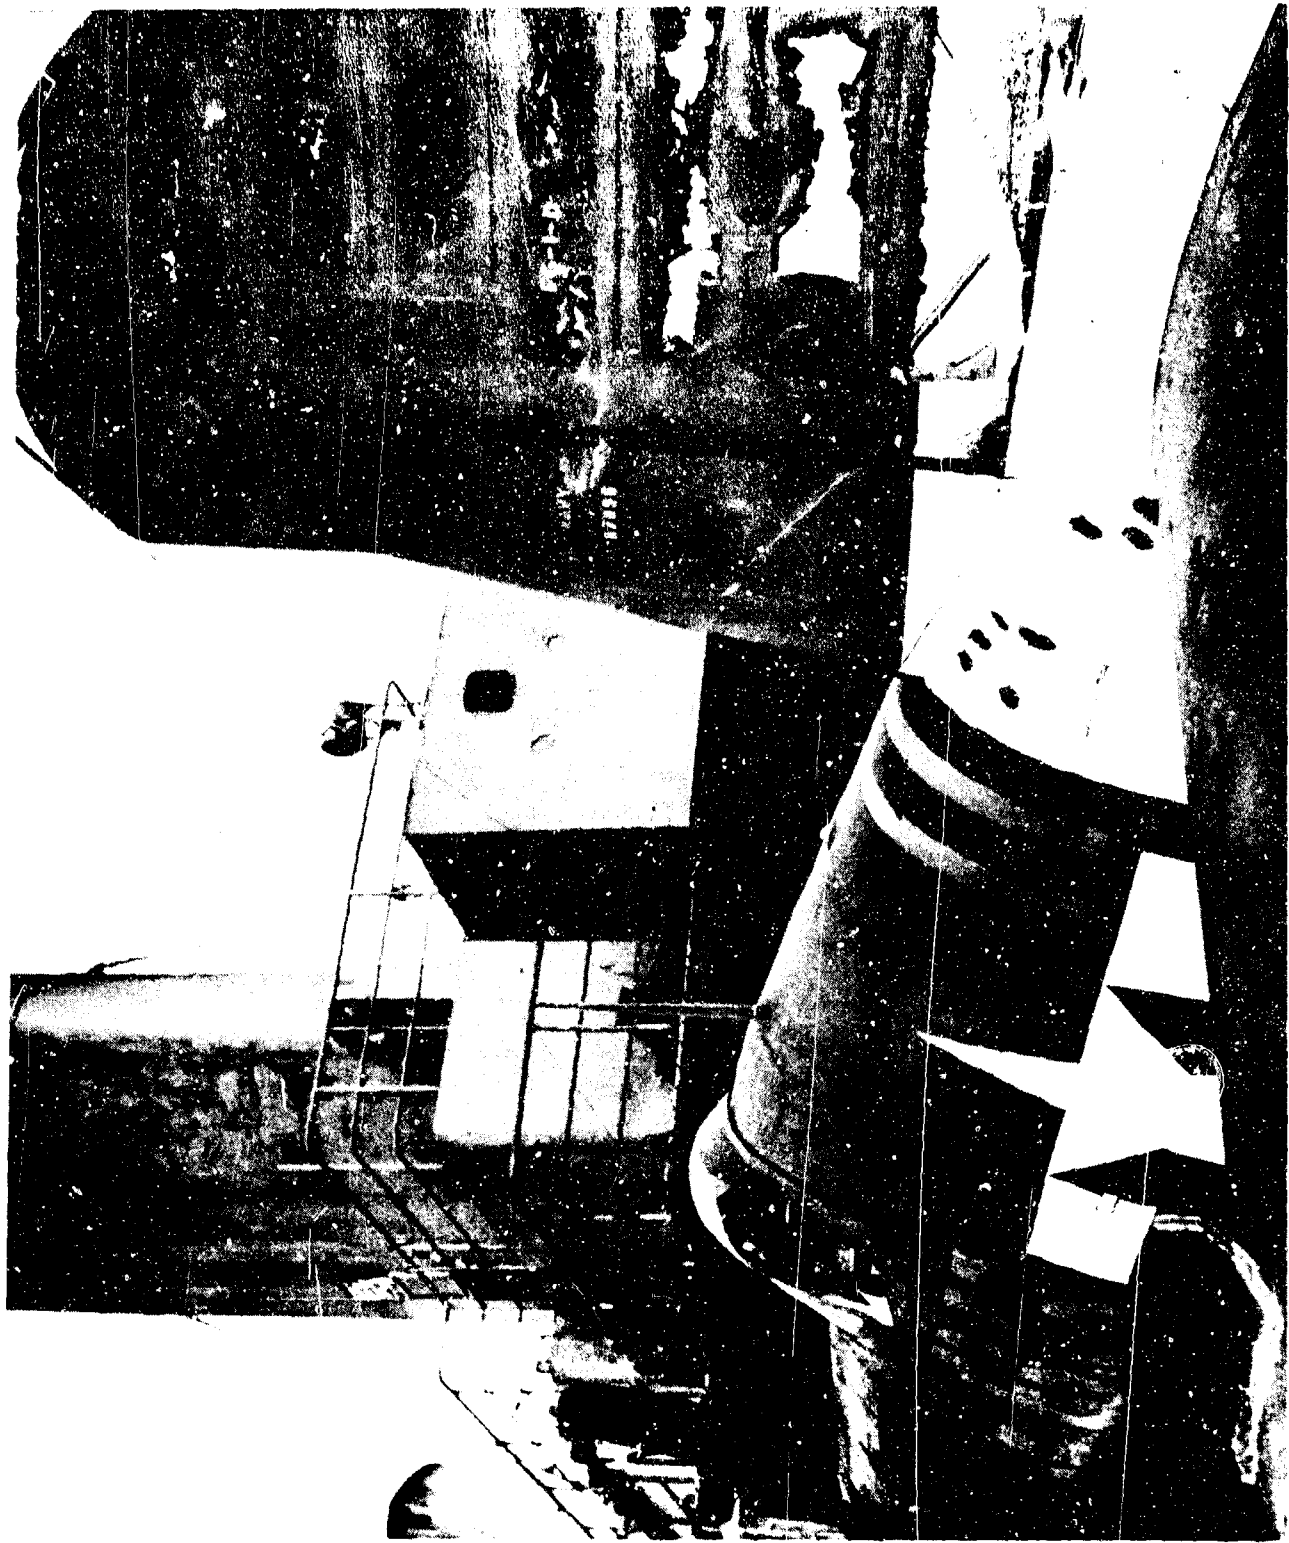
Model FG-1D airplane on main deck of USS BLADEN after Test ABLE. Scorching of fabric and damage to plexiglass is typical of the minor damage sustained by airplanes in the outer zone.

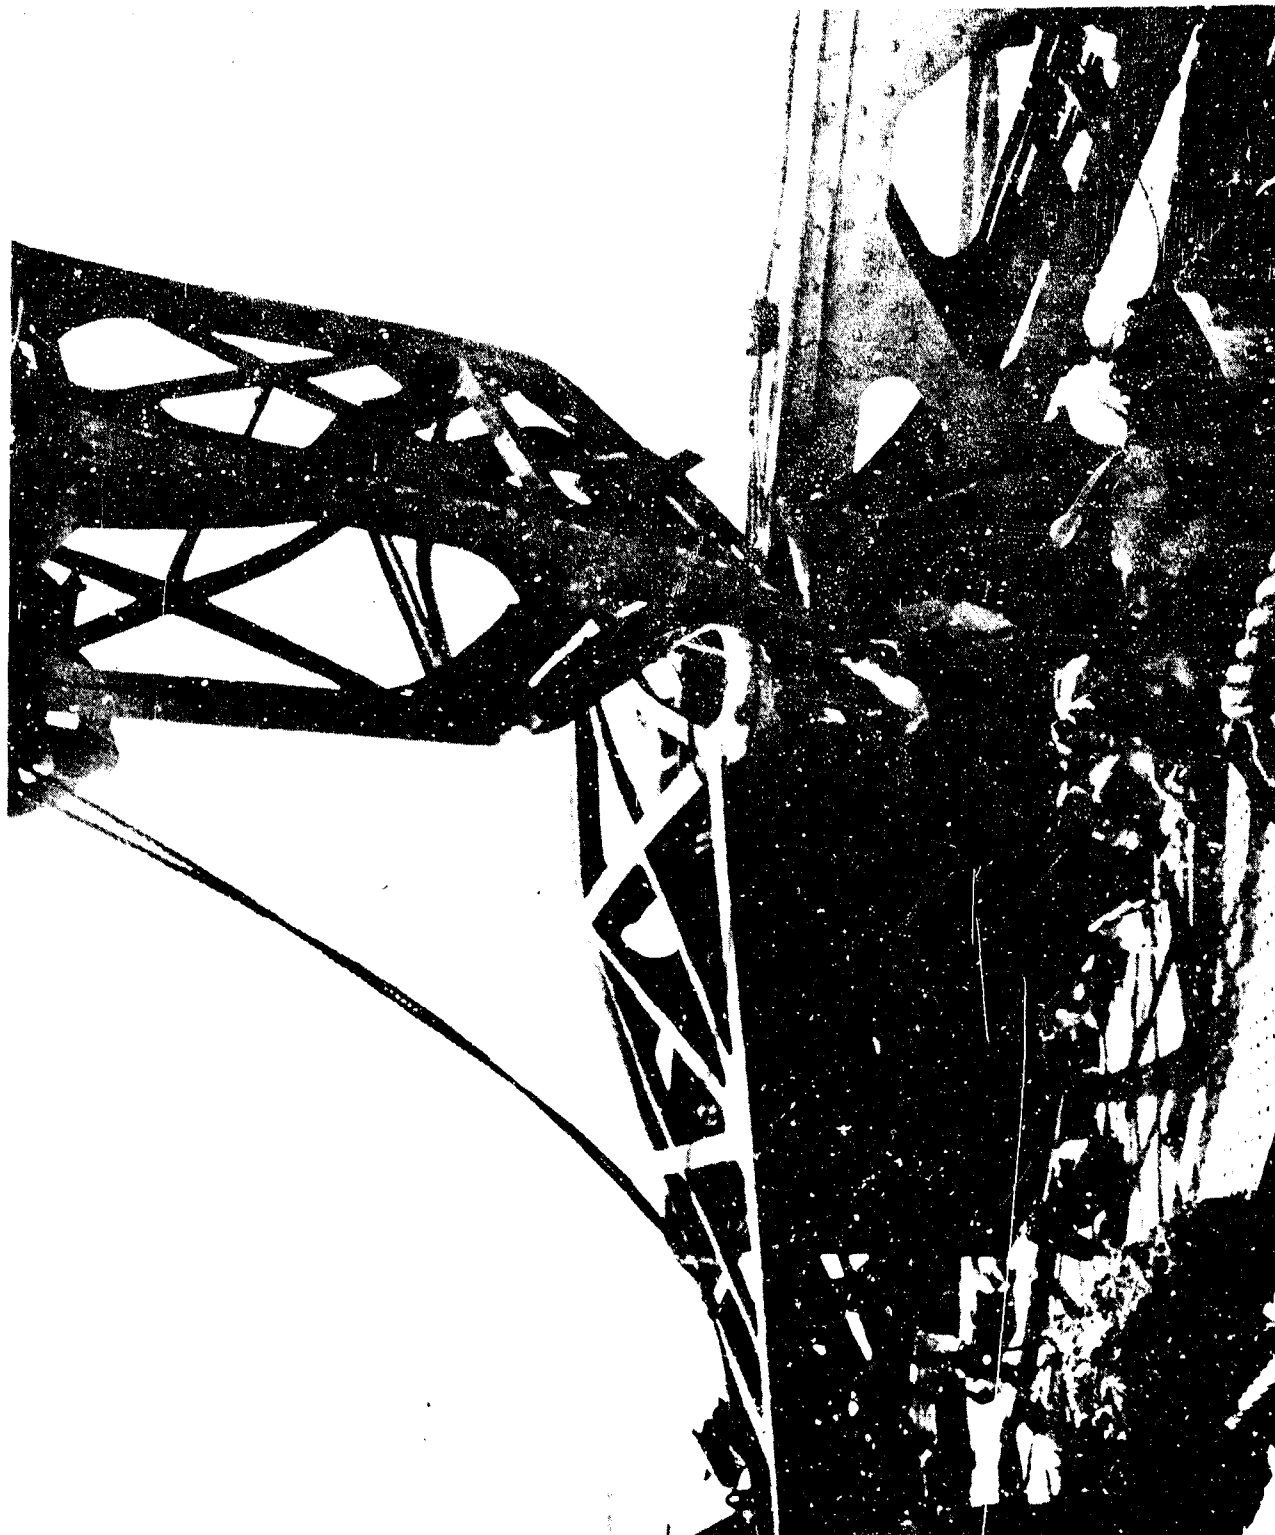
Airplane crane, USS NEVADA after Test VBLE. Lower leg of the crane bent over the stern of the catapult starboard side.

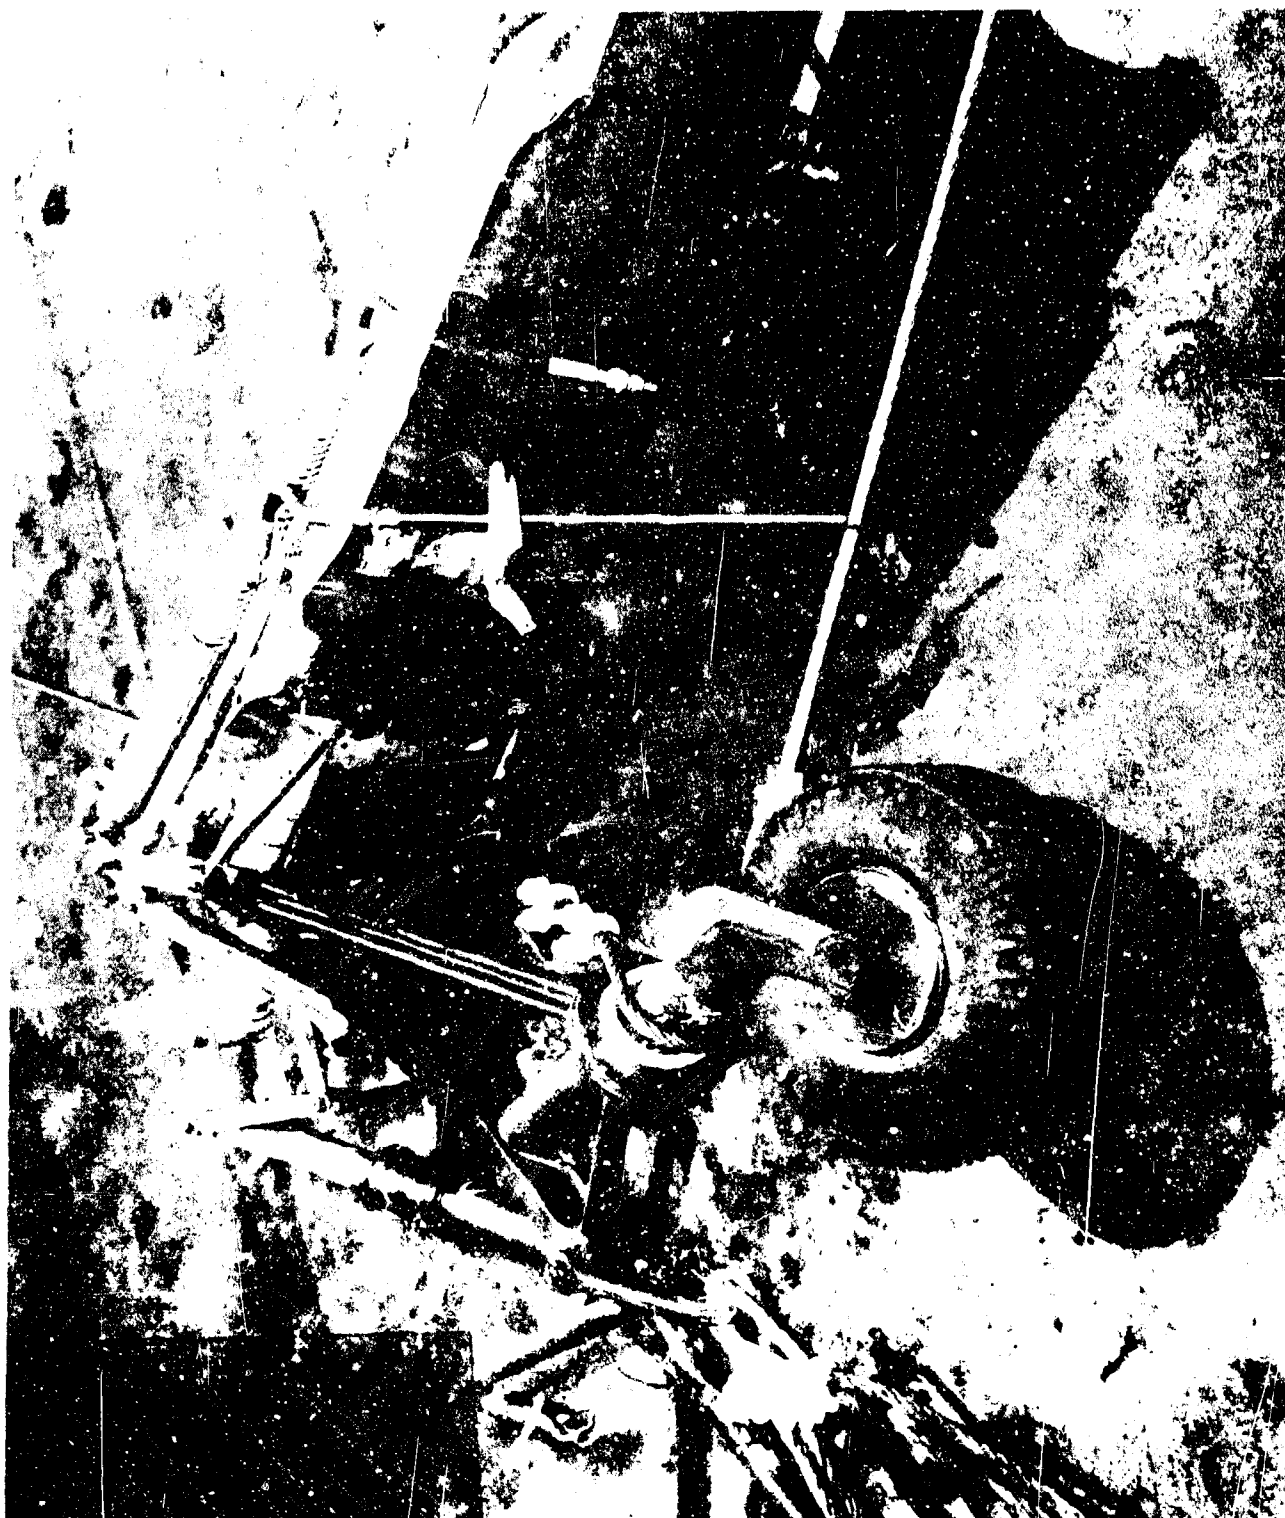
Model FG-1D airplane on main deck of FALLON at approximately 500 yards from burst was blown or washed overboard. The only remaining trace of the airplane was that portion of the tail wheel assembly shown on photograph.

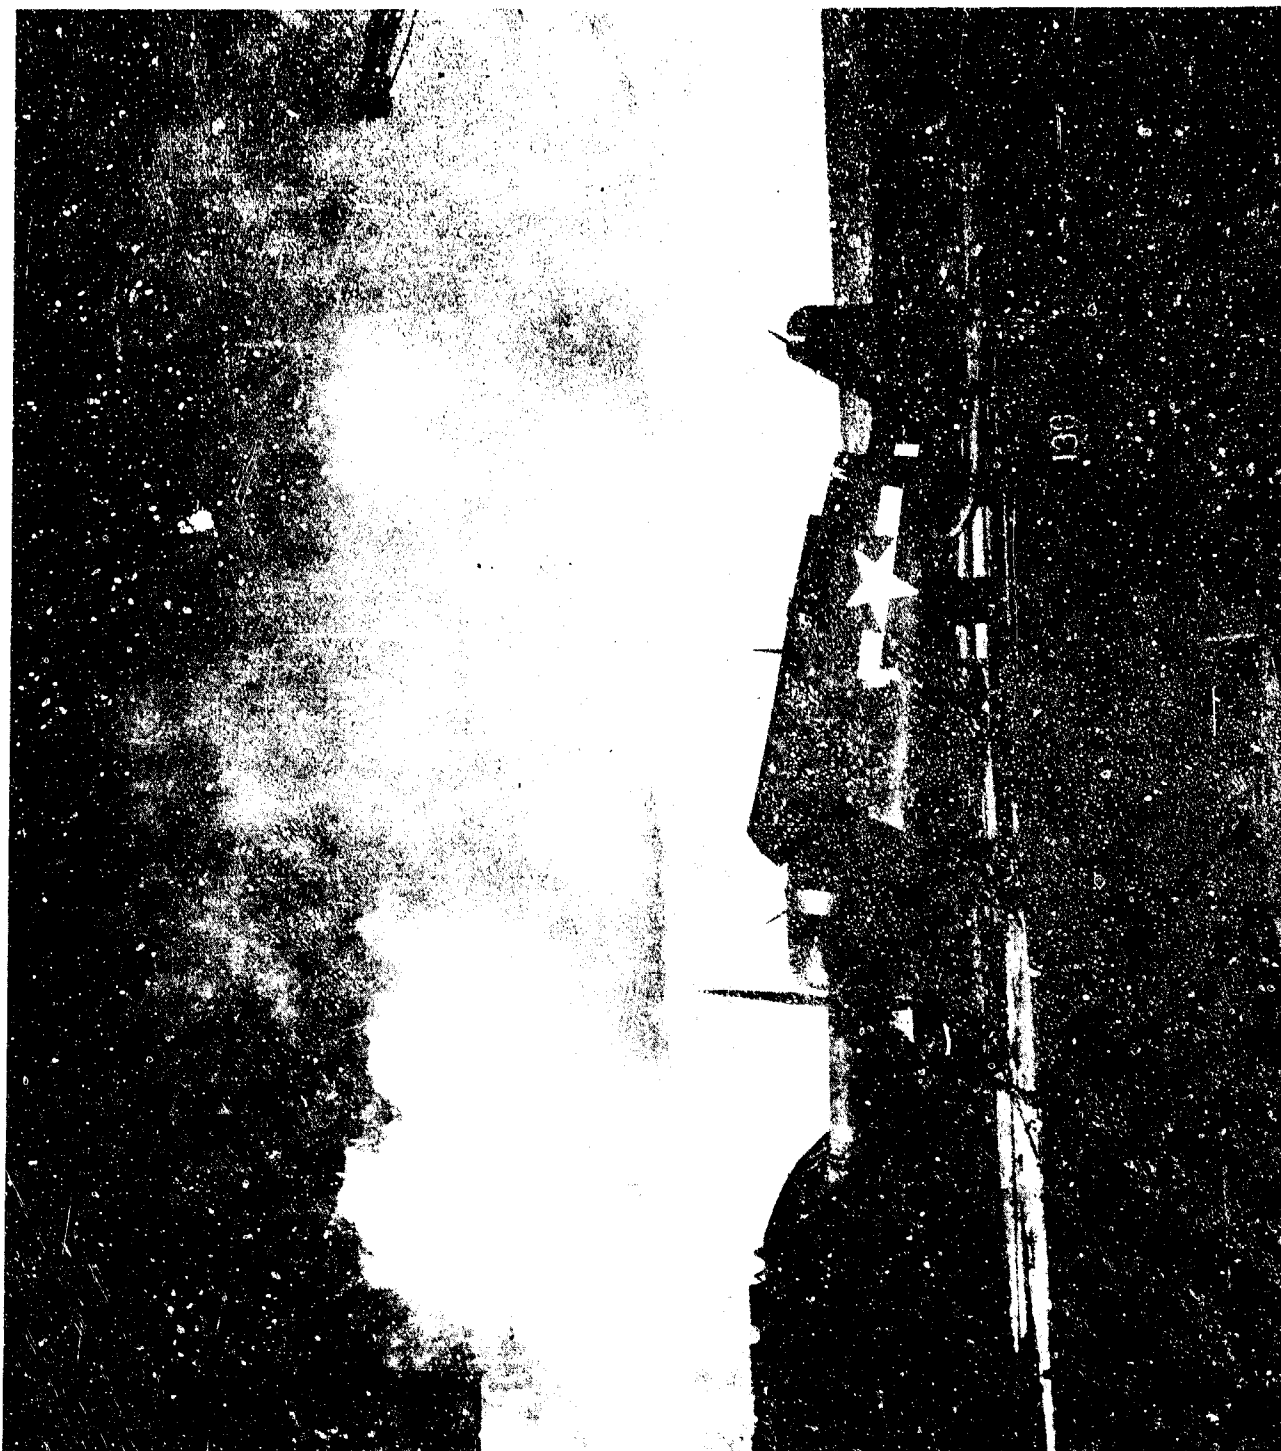
Model F6F-5N airplane aboard PENNSYLVANIA at approximately 1200 yards from burst. This airplane was essentially undamaged by Test BAKER, however extreme radiological contamination would prevent routine maintenance or operation.

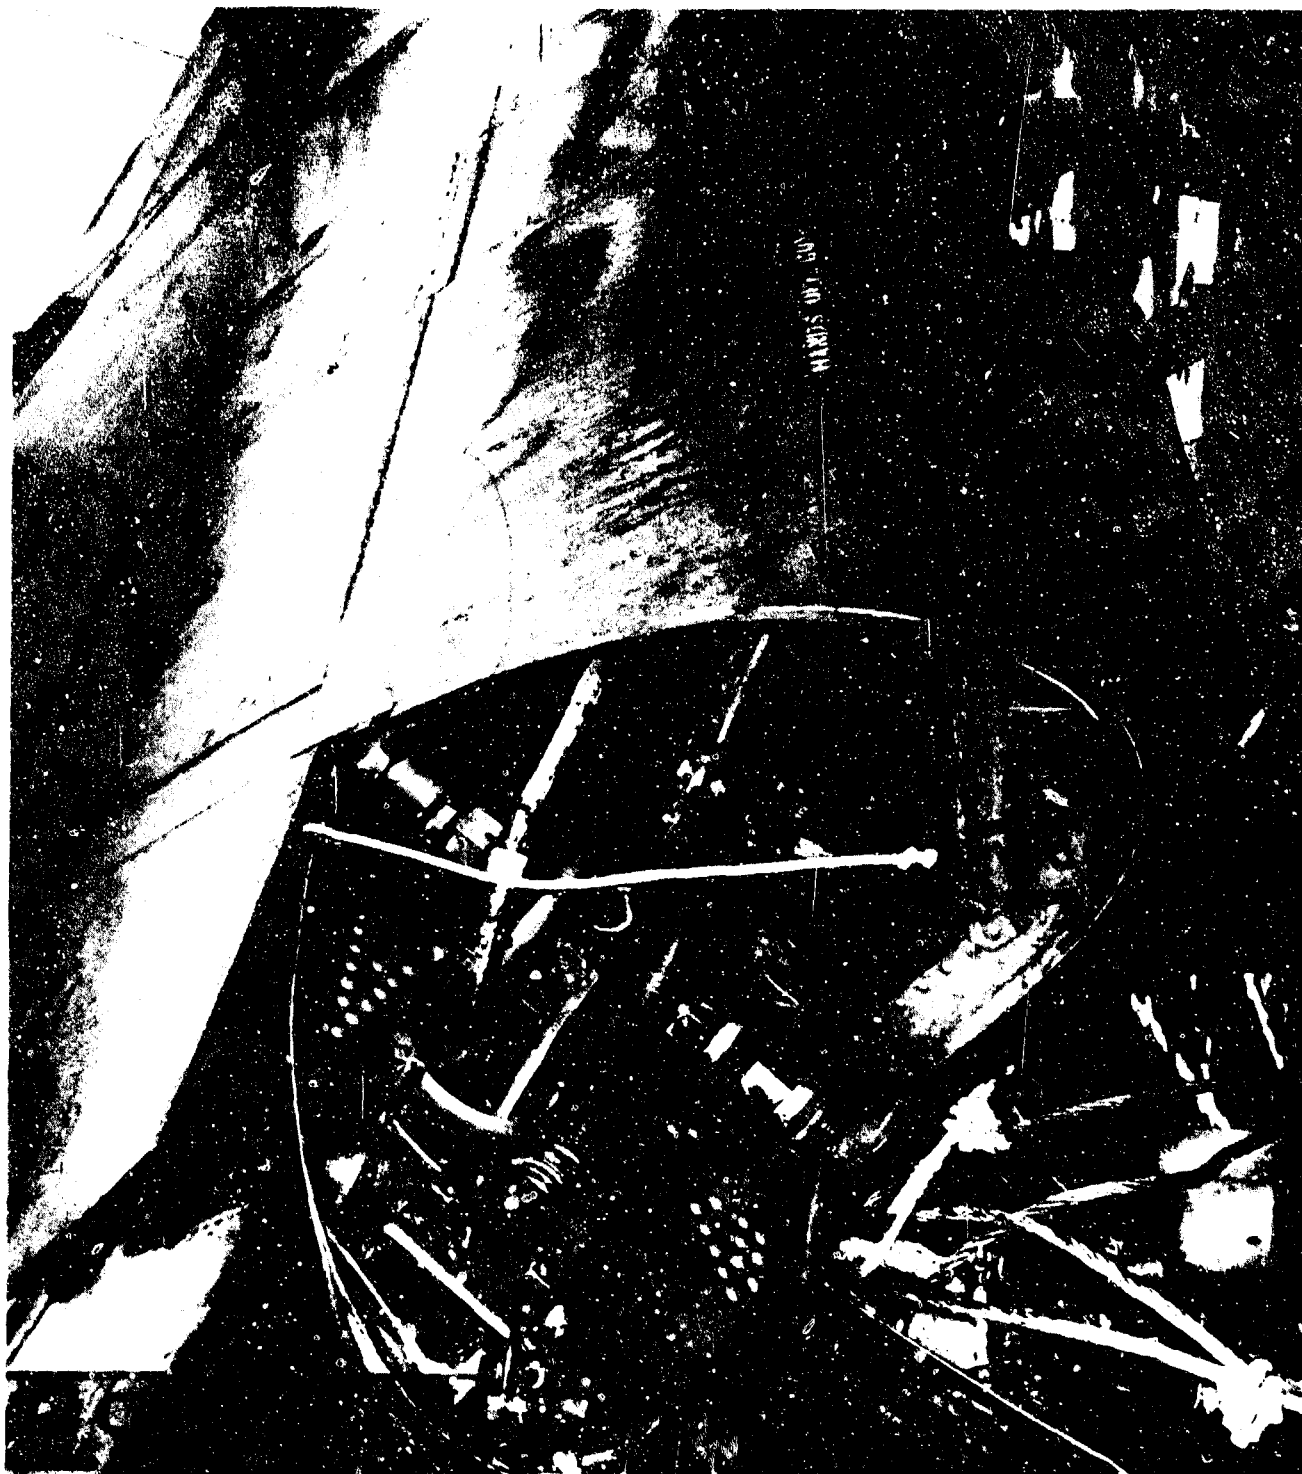
Model F6F-5N BuNo 77749 on main deck of BARROW at approximately 1700 yards, illustrating indications of moderate distortion and twisting of port wing outer panel main spar from underwater shock transmitted through ship's structure.
