COOPERATIVE MARINE PILING INVESTIGATION: PHASE I -
PILE DRIVING AT COCO SOLO, CANAL ZONE

TN-473

29 April 1963

U. S. Naval Civil Engineering
Laboratory
Port Hueneme, California

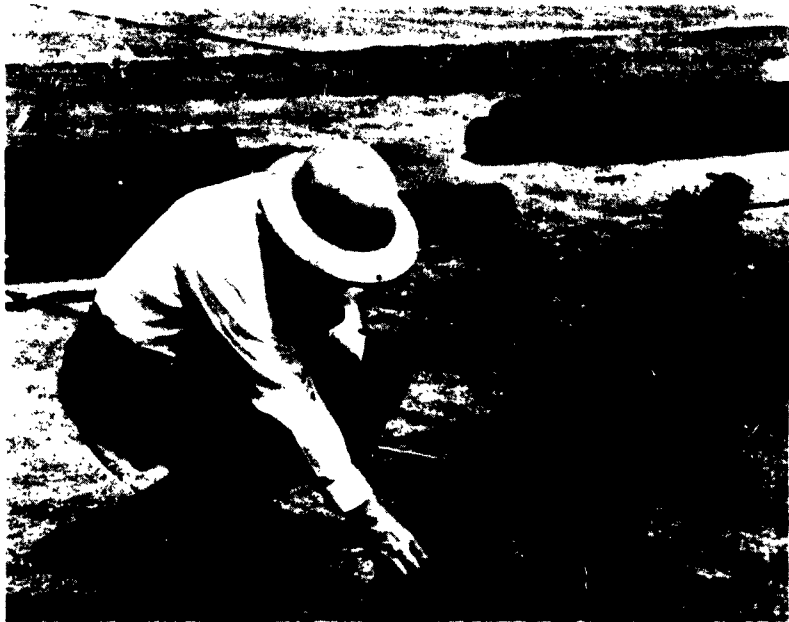
The System 1 Piles -- the Douglas Fir piles treated with ammoniacal copper arsenate followed by creosote -- were all badly checked, as shown in Figures 15, 16, 17, and 18. The crack shown in Figure 17 went all the way through the pile. The pile probably cracked during the drying operation after the initial impregnation with the aqueous solution because the inside surfaces appeared to be well treated with creosote.

Figure 17. Pen being inserted into crack
