**ROCKETDYNE**

R-5316

FINAL REPORT, DEVELOPMENT OF DOWNRATED  
ATLAS YLR101-NA-15 VERNIER ENGINE

Contract AF04(695)-306

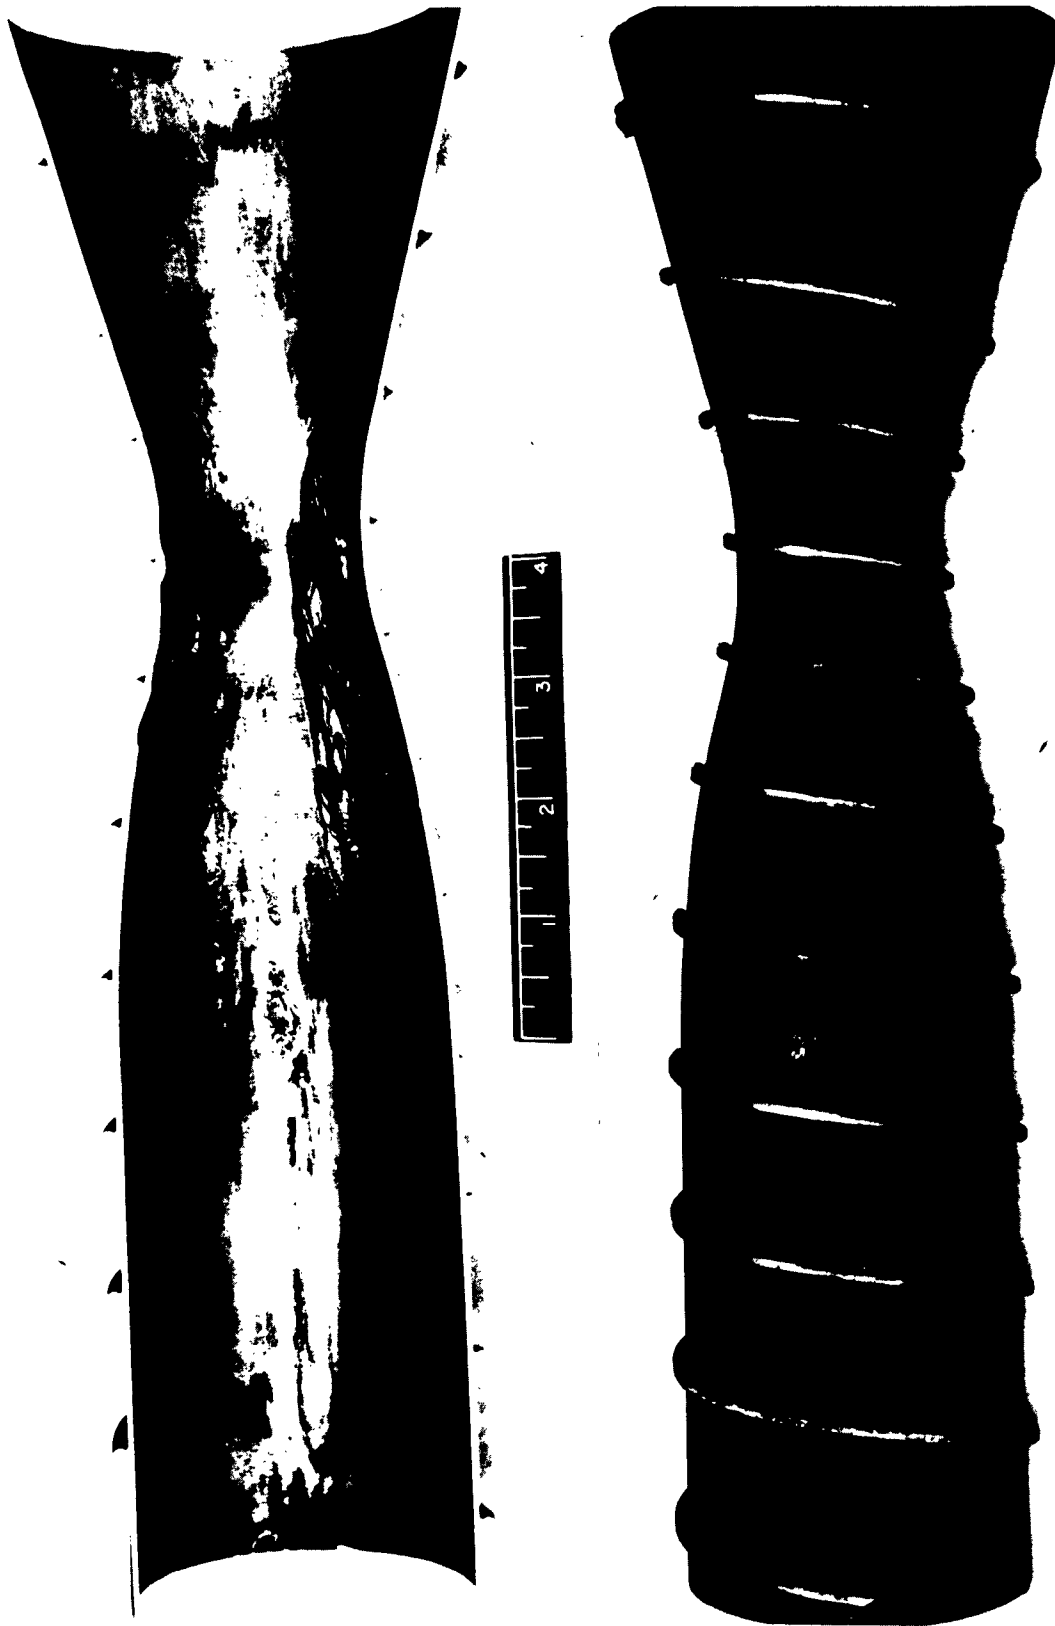
Severe thrust chamber throat erosion occurred during the Phase I test program, and Table 2 lists the chamber damage incurred by each of the three thrust chambers used during the Neosho tests. The initial erosion in each thrust chamber occurred at a different duration varying from 736 seconds to 1859 seconds. Although the first erosion on engines S/N 0002-6 and 0003-4 occurred after tests with low mixture ratio and thrust or excessively high mixture ratio, the first erosion on engine S/N 0003-5 was obtained after 736 seconds of nominal performance operation. The thrust chamber from engine S/N 0003-5 was sliced in half and the inner wall (Fig. 8) was removed for examination. Several erosions had progressed to the point where pinholes appeared through the inner chamber wall.

Figure 8. Thrust Chamber From Engine S/N 0003-5

Although the thrust chamber erosions experienced during the Phase I testing were quite severe (Fig. 8), engine transient and steady-state performance were not affected by the damage. Figure 14 is a plot of rated tank-fed specific impulse during testing of engine S/N 0003-5. No significant decrease in specific impulse or operating level occurred as the chamber erosion progressively worsened. The bulk fuel temperature was measured at the fuel injector manifold during the tests on engine S/N 0003-5. During the first 10 to 12 seconds after ignition of each engine, this temperature rose about 120 degrees above the engine fuel inlet temperature. After 60 seconds, the temperature stabilized at 30 to 50 degrees above the fuel inlet temperature. No data are available for comparison, but it is probable that, except for localized hot spots, this stabilized differential temperature was sufficiently low to rule out an excessively high thrust chamber wall temperature.

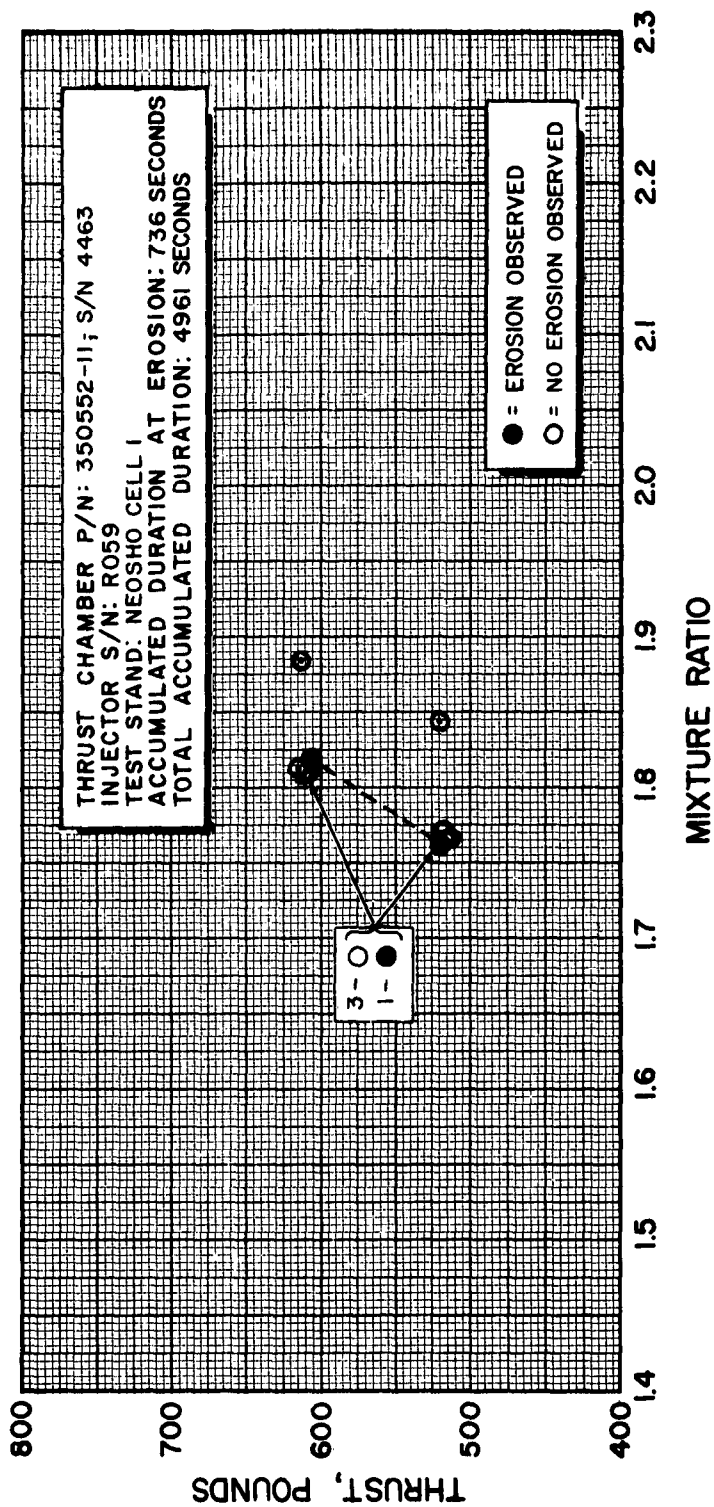
Figure 11. Operating Regime of Standard Injector P/N 350604  
Tested With Engine S/N 0003-5

The erosion spots (Fig. 11) apparently were caused by LOX fans that impinged on the chamber wall. This problem had previously occurred at thrust levels from 830 to 1000 pounds, and was eliminated during development of the P/N 350604 injector by adding 12 fuel showerhead holes around the periphery of the injector. This formed a fuel screen between the LOX fans and the chamber wall. At thrust levels between 525 and 600 pounds, the velocity of the fuel through the injector was reduced by more than half. A subsequent loss in fuel screen momentum also occurred, and apparently allowed the LOX fans to break through to the wall, resulting in hot spots similar to those experienced prior to the last injector modification.

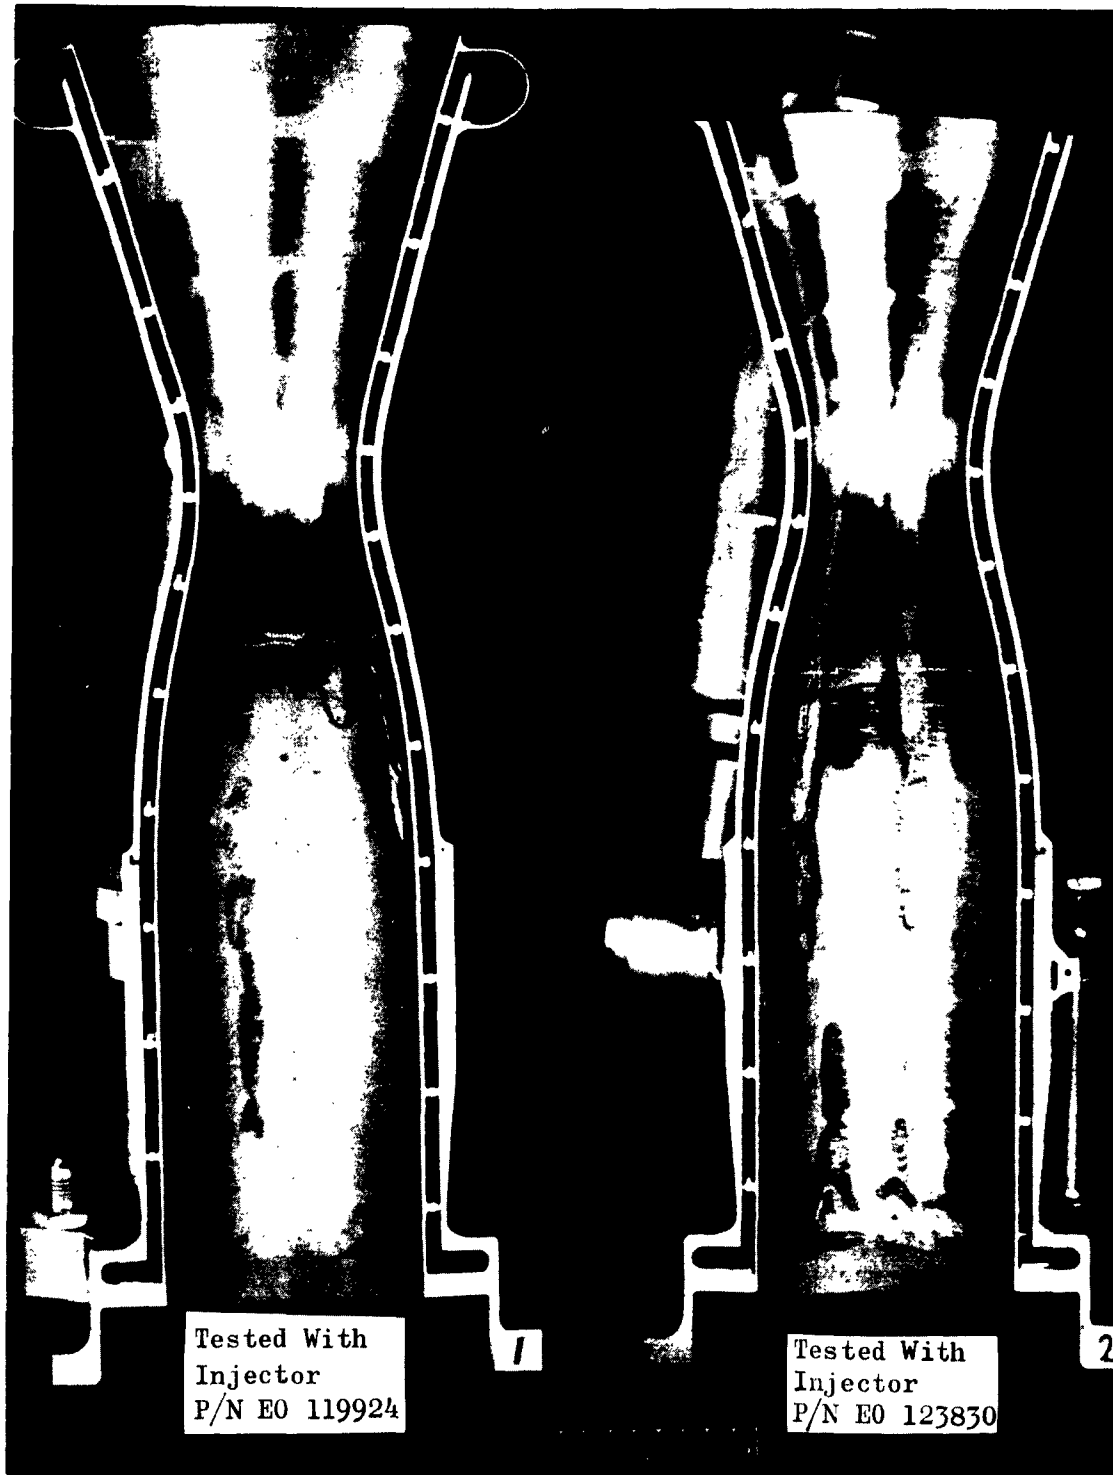
1BS35-9/4/63-C1E

Figure 26. Sectioned Vernier Engine Showing Thrust Chamber Erosion Resulting After Tests With Injectors P/N E0 119924 and P/N E0 123830

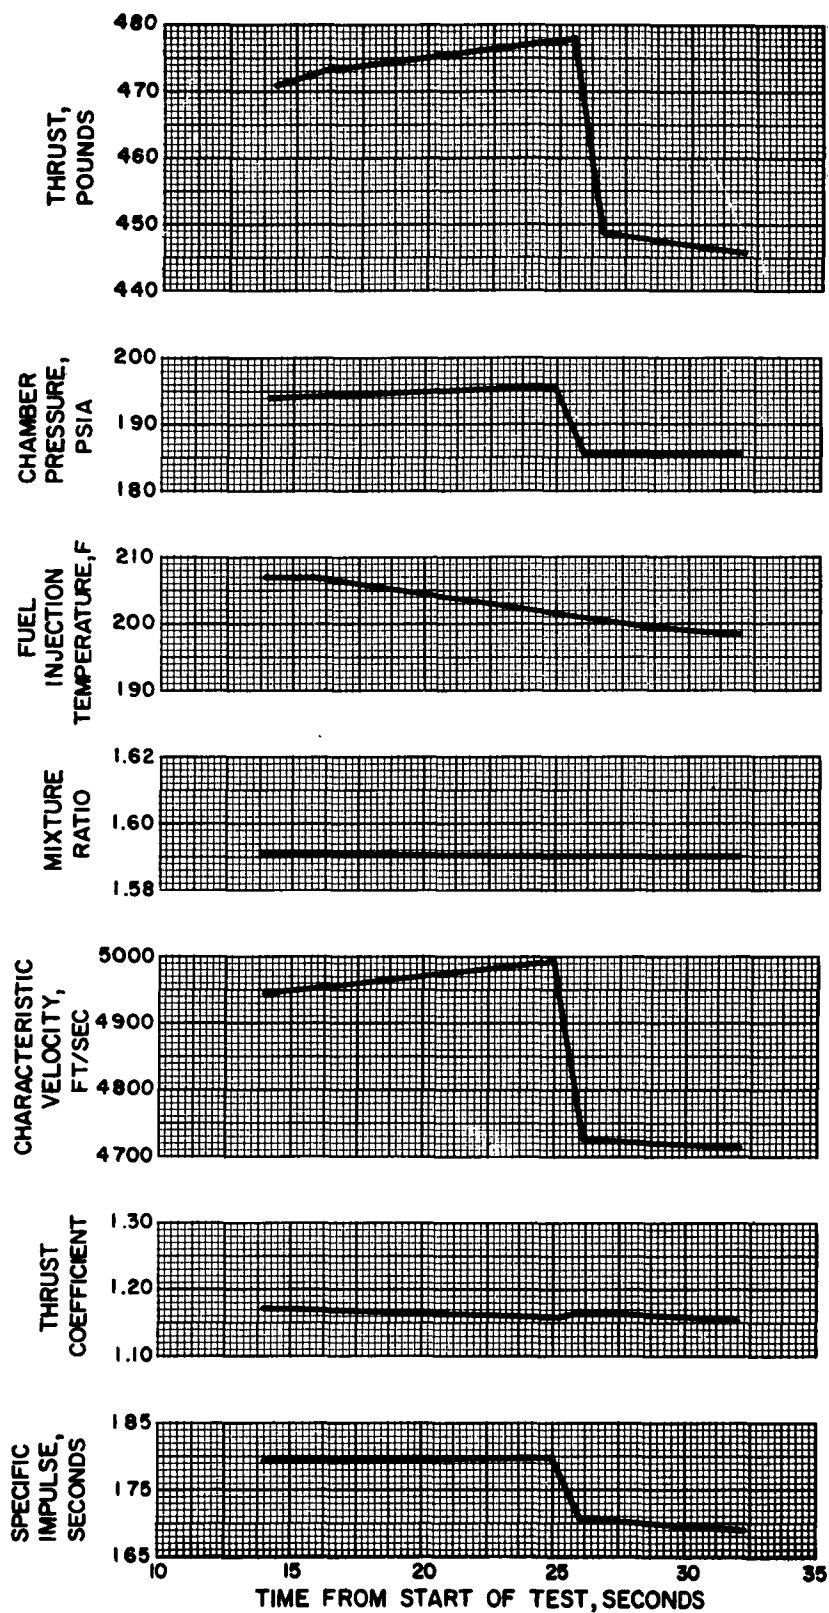
Figure 50. Engine S/N 3401 Performance Shift Caused by Buzzing During Run No. 8954 Using Injector P/N E0 123829, S/N 6320891

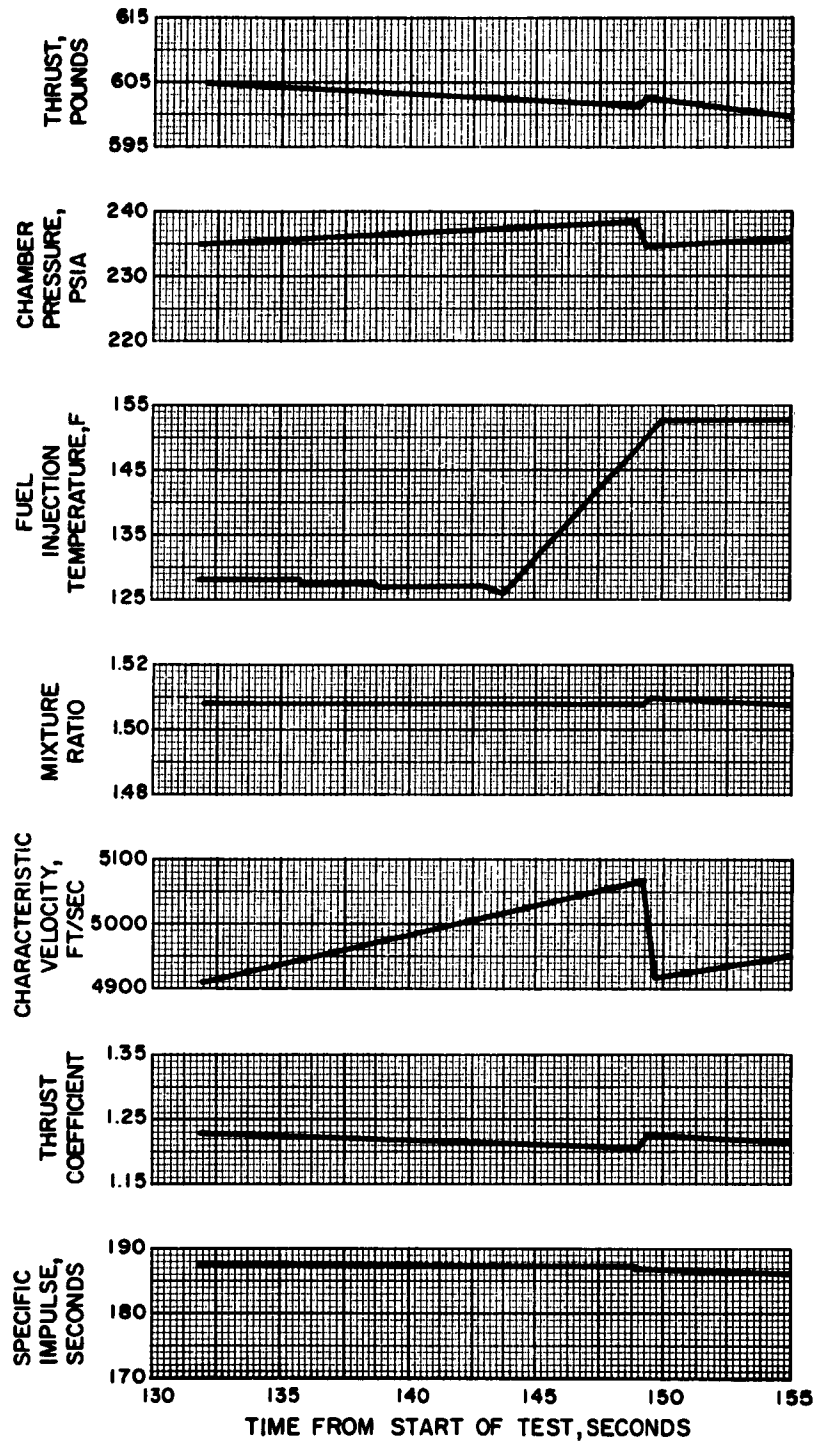
Figure 51. Engine 3402 Performance Shift Caused by Carbon Buildup in Thrust Chamber Throat During Run No. 8987 Using Splash-Plate Injector S/N 6321992

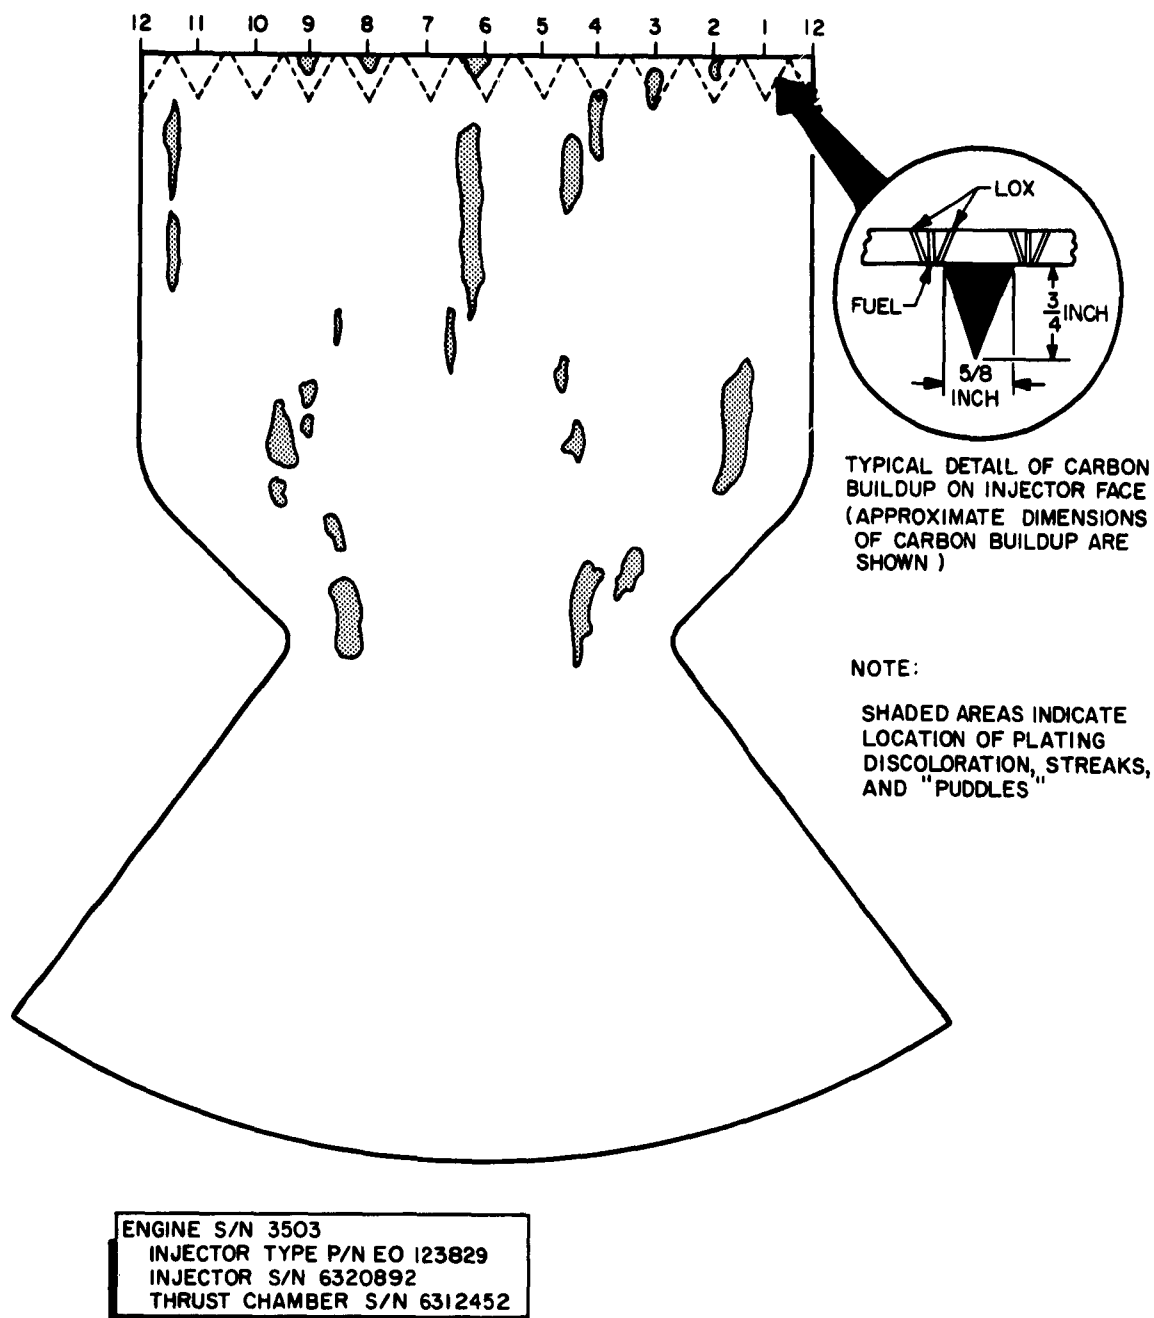
Although the wall of the first thrust chamber tested (engine S/N 3401) was only lightly coated with carbon, erosion was not detected until the thrust chamber was removed and cleaned. A subsequent test of the eroded area using an acid solution of copper sulphate showed that the erosion was into the parent metal. This solution turns exposed parent metal (type 4130 steel) to a copper color. As testing progressed, various means of detecting plating streaks and erosions were employed. These included wiping the carbon from the thrust chamber after every test, removing the injector periodically, and using the copper sulphate solution to check the spots that might be into the parent metal.

Figure 54. Typical Vernier Engine Thrust Chamber Inner Wall Following Testing
