FRANKFORD ARSENAL

EXAMINATION OF ROTATING BANDS FROM 155MM
PROJECTILE, HE, M107, FIRED WITH PROPELLANT CHARGE XM119

Test Report T64-3-1

October 1963

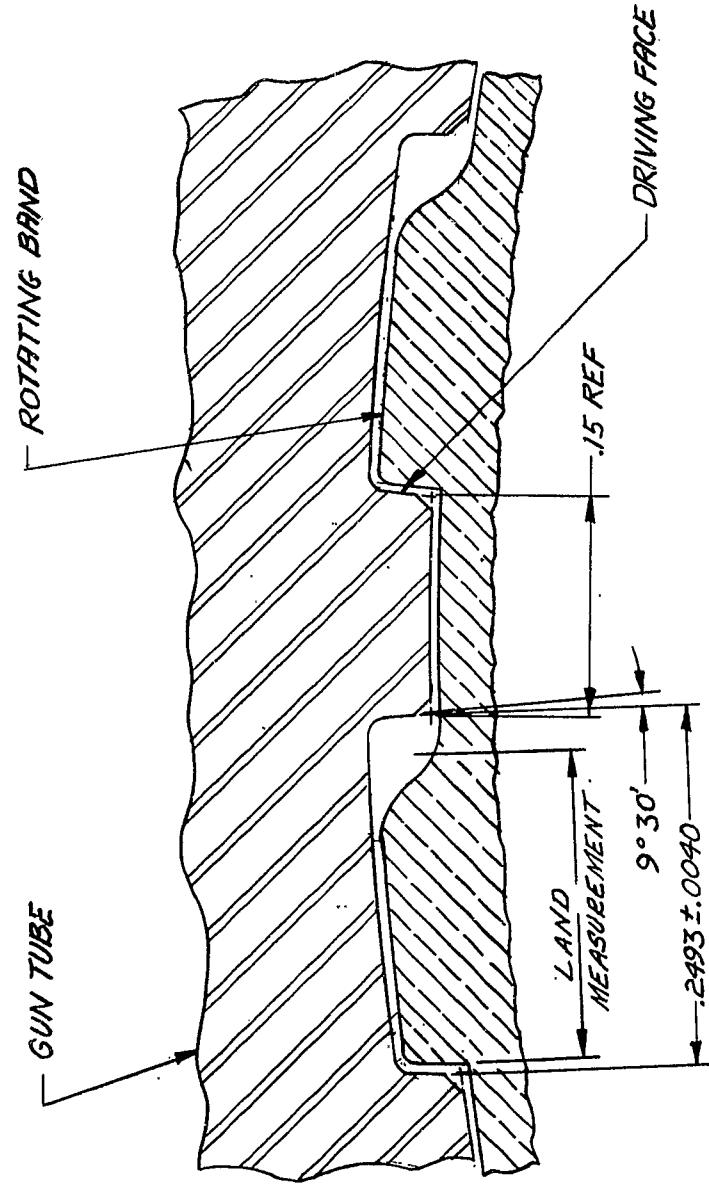
Figure 2. 155mm M107 Rotating Band Wear with Propelling Charge XM119

Examination of the engraving shows considerable but not excessive band "shear"; i. e., wearing away of the driving face thus opening a gap between the nondriving face and the land of the rifling which permits propellant gas blowby and erosion of the nondriving face. See figure 1 showing the band from Shell No. 36 and figure 2 showing the "wear condition" of the band. The wear measurements

are given in table IV. Because of the erosion of the nondriving face, it was not possible to accurately measure the band land width. The measurements were taken as shown on figure 2 and the actual percent of band shear or wear is somewhat greater than that shown by the measurements. On three of the four rounds fired at service pressure, the band wear was 19% with one round of 31%. On three of the four rounds fired at excess pressure, the wear was 38% with one round of 47%. From a new tube, two definite wear levels are evident, proportional to pressure and velocity and fairly consistent with an occasional outlier. The wear level (17-36%) from the worn tube is comparable to that of the new tube; however, the variation of the wear level is greater for the worn tube which is expected due to the worn condition of the tube.

Although considerable wear is evident, sufficient working metal was left to satisfactorily impart full spin to the projectile and because of the consistency of the wear, the wear did not adversely effect either the velocity uniformity or range dispersion of the shell (PE range .20% at 18,000 meters). The rotating bands of four recovered T387E1 projectiles fired at 120% of rated maximum pressure were measured for comparison with M107 and the wear of the T387E1 was 3 to 5%. Diametrical measurements of the band do not appear to be too meaningful or significant. Band land and groove diameters are shown in tables II and III. They exceeded the maximum rifling diameters, although the excess cannot be related to excessive band gap. A possible explanation may be that of elastic deformation of the shell body due to the engraving pressure. Similar measurements of the T387E1 shell were generally within dimensional limits, however, the T387E1 band is supported by the solid base section thus minimizing, if not eliminating, elastic deformation of the shell body.
