Technical Note N-622

TSUNAMI DAMAGE AT KODIAK, ALASKA, AND CRESCENT CITY,  
CALIFORNIA, FROM ALASKAN EARTHQUAKE OF 27 MARCH 1964

U. S. NAVAL CIVIL ENGINEERING LABORATORY  
Port Hueneme, California

The objective of this task is to survey and report on damage to waterfront structures at the Kodiak Naval Station and city of Kodiak, Alaska, and at Crescent City, California, by water waves generated by the 27 March 1964 Alaskan Earthquake.

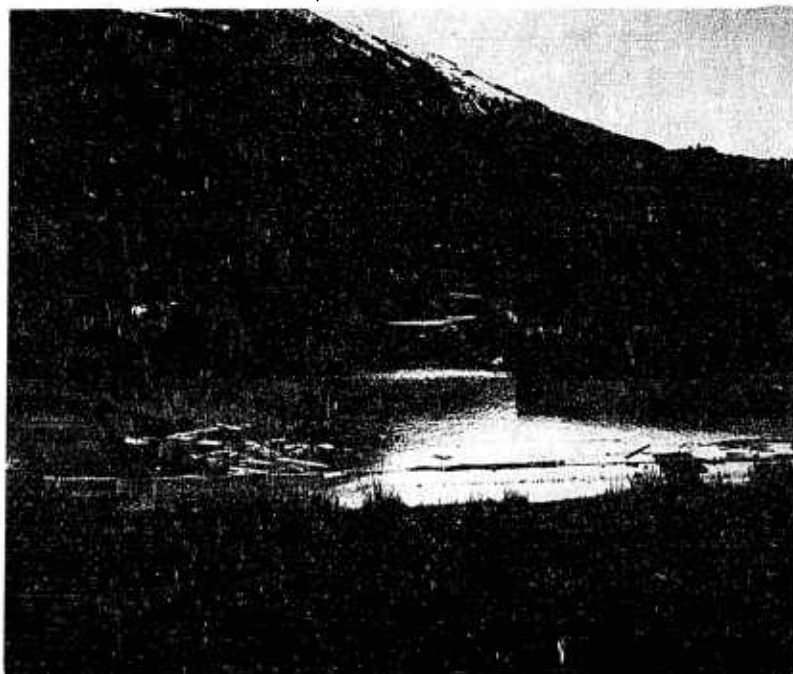
**Fig. 5** Debris and ice cakes are deposited on the seaplane taxiways after recession of first crest. Damage to the Stations three hangers is placed at more than \$1 million dollars. (Photo by PIO, Kodiak NAVSTA)

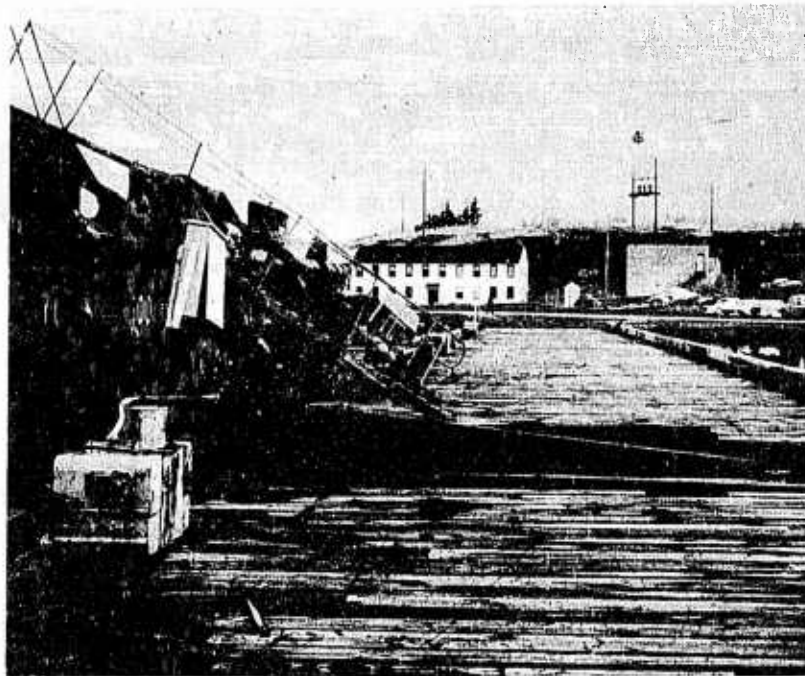
Figure 9. Moored barge under tsunami action pulled decking and bollard loose from marginal pier.

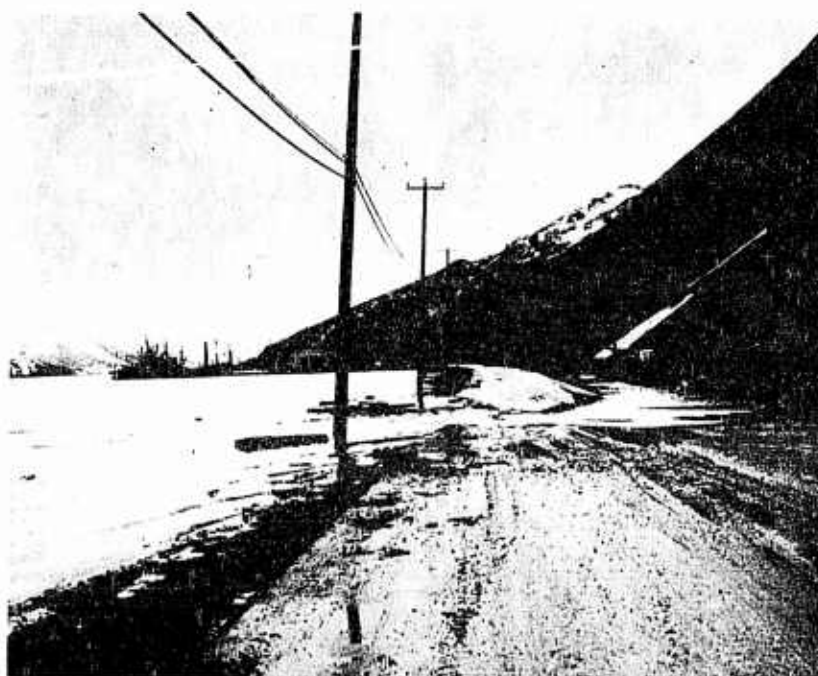
The two bridges and Chiniak Road between the Naval Station and Holiday Beach were washed out causing loss of vehicular contact with the NAVRADSTA (Figure 10). The power line in the swamp flat 4 miles to the south was damaged. NAVRADSTA (T), Buskin Lake, and NAVRADSTA (R), Holiday Beach, stand on high ground and were not damaged. The Holiday Beach barracks cracked open along a line separating the mess hall and the dormitory area.

Figure 10. Kodiak Island subsidence of 5-1/2 feet allows high tide to wash over road to NRS(R) Holiday Beach. Cargo Pier in background.

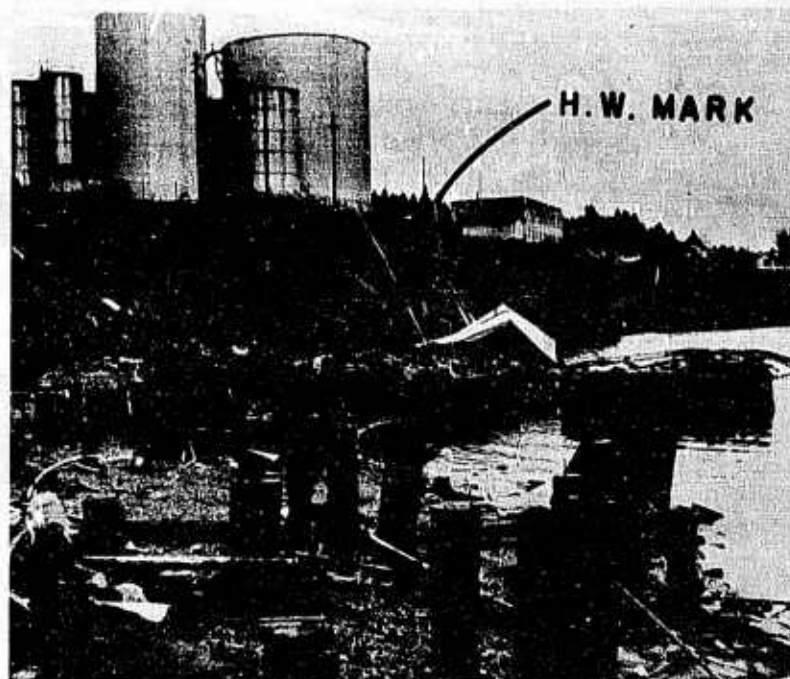
Figure 30. Skeleton-like timber piling marks former site of cannery. Steel drift-pins point direction in which cannery was swept away by second wave.

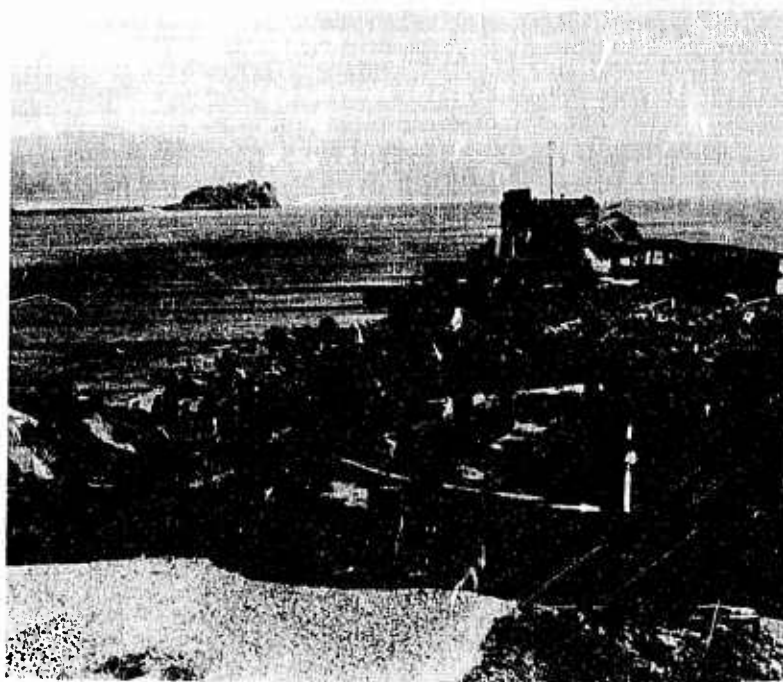
Figure 52. Decking of the Sause Dock sprawls to one side. Drift pins are still embedded in pile tops. Piles and pile caps have survived fairly well.

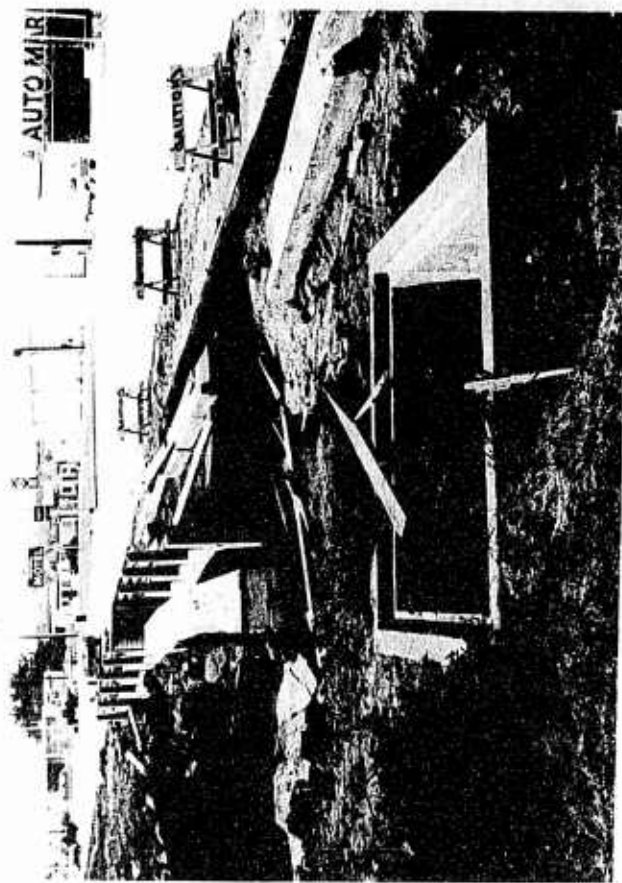
Figure 54. Erosion bares Elk River concrete box culvert and undercuts Highway 101. Steel beam tidal barrier on left normally protects bridge from logs.

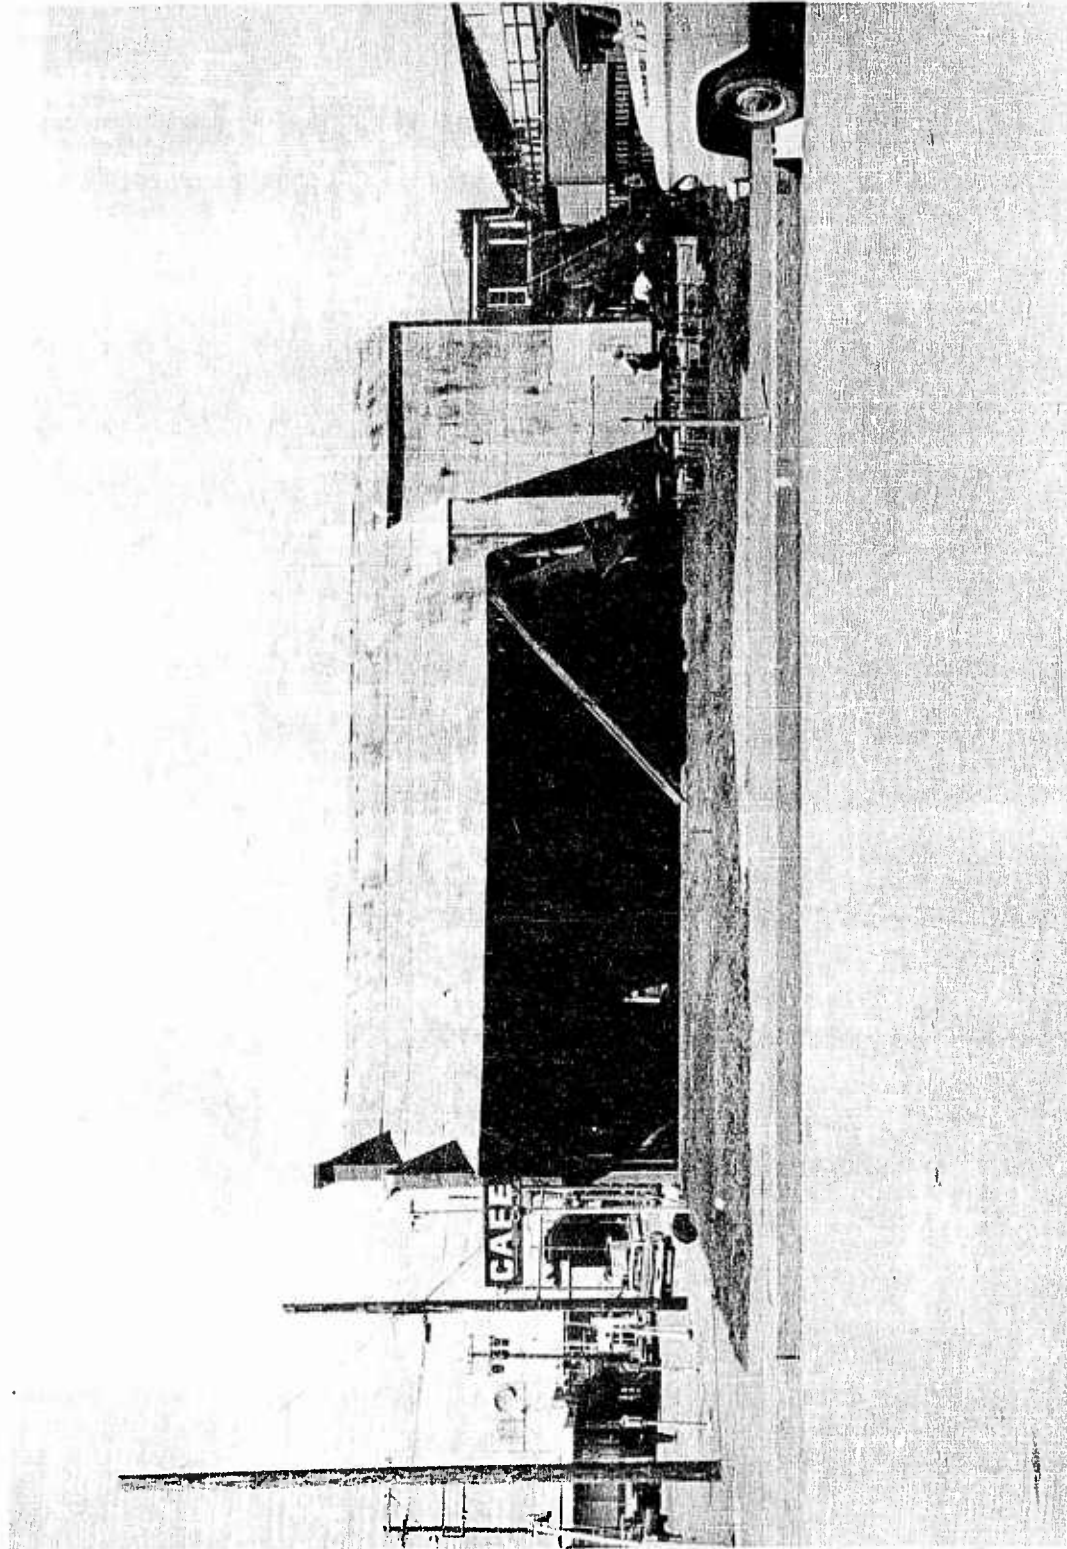
Figure 64. Entire side of corrugated steel transit shed type building along Front Street collapsed.
