Report No. HTC-AD 64-10

Final Report

20MM MARK 4 GUN POD
250,000 ROUND RELIABILITY IMPROVEMENT
PROGRAM

2 February 1964

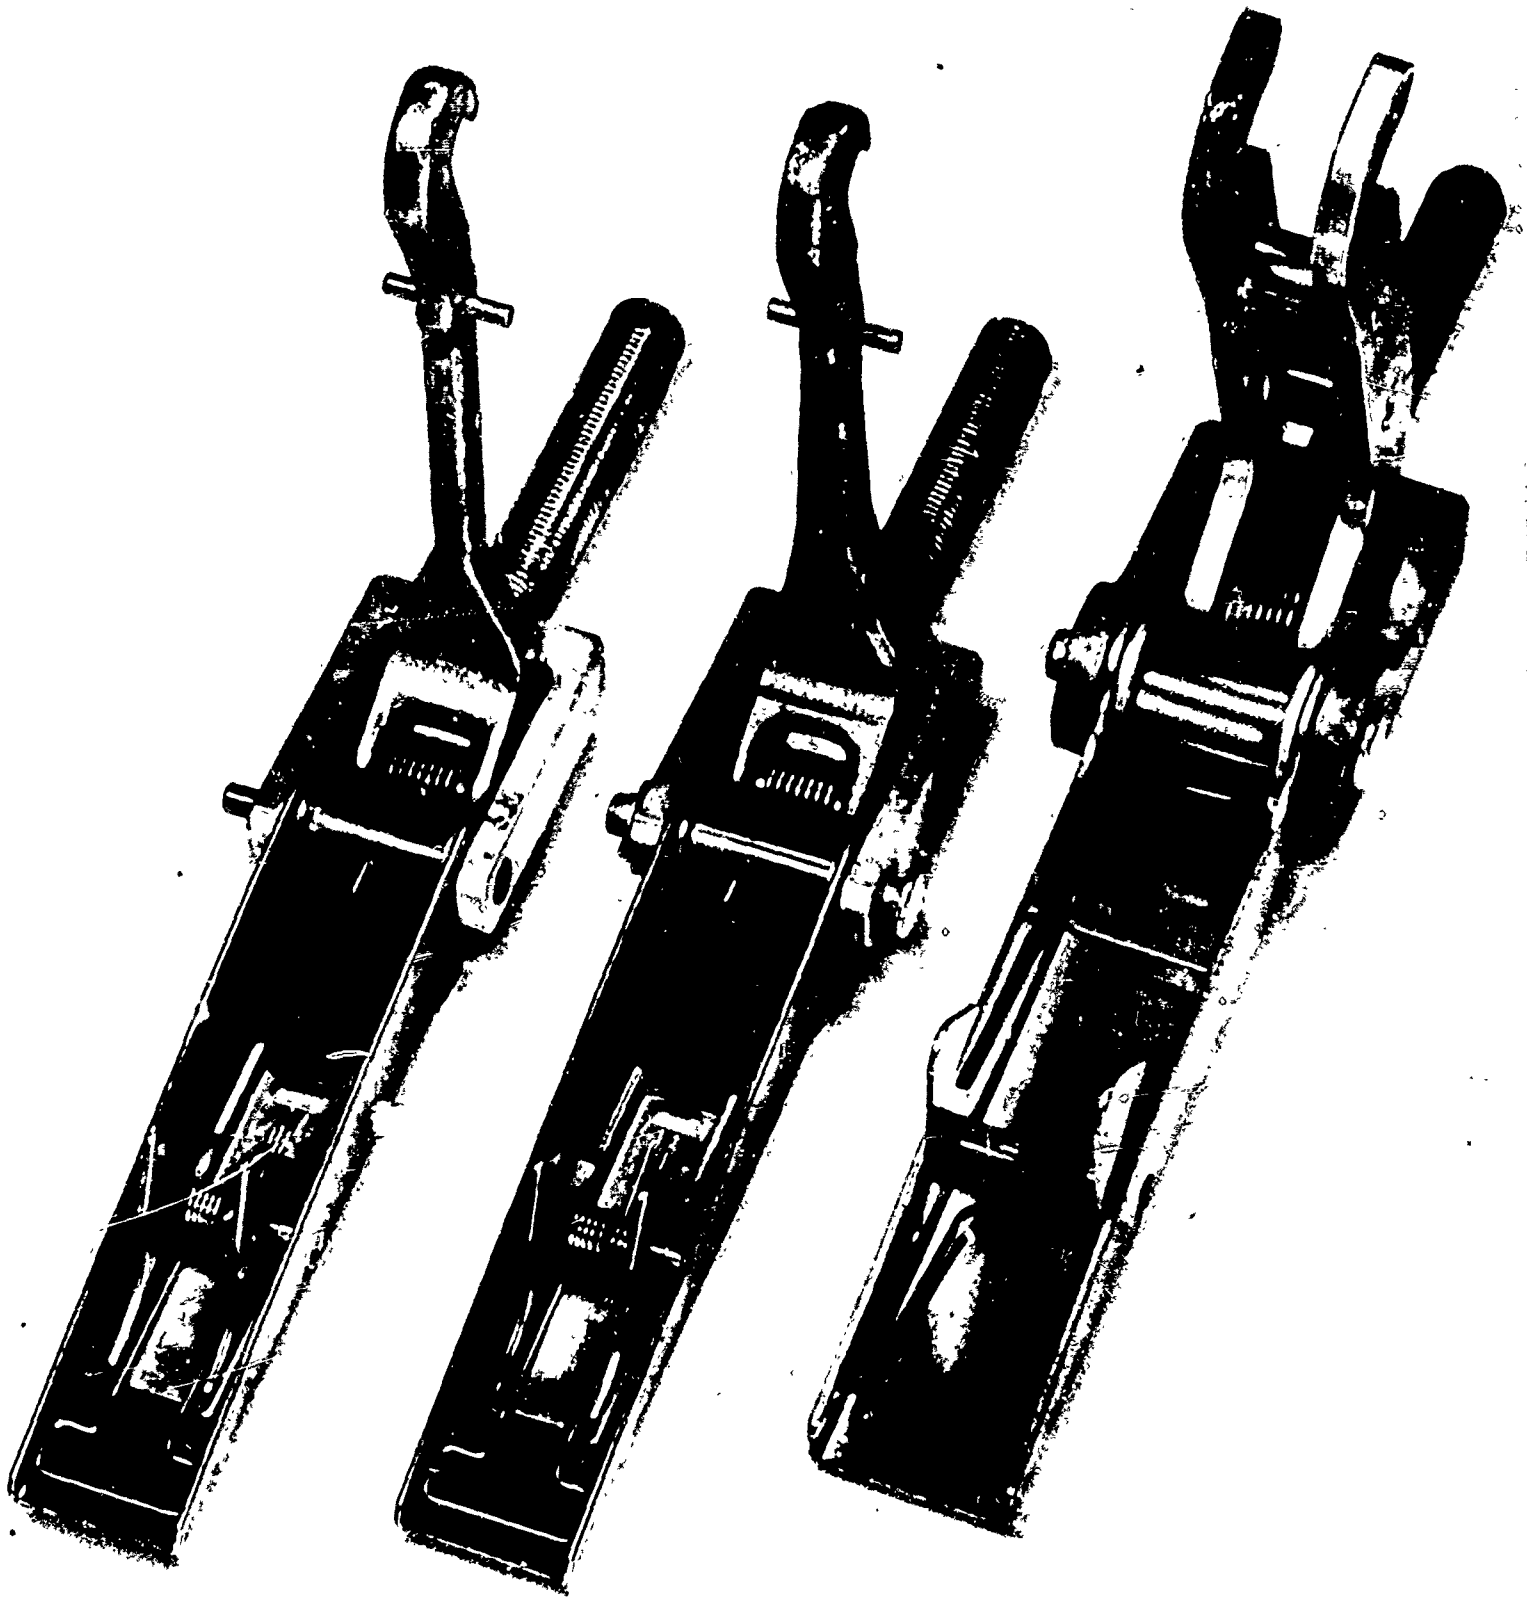
Figure 15. Comparison of the Three Latches

latch. This latch did not have the desired safety factor, however, and a 10,000 lb. latch was installed. There have been no latch failures with the 10,000 lb. latch installation. The blast suppressor was cast of 17-4PH corrosion resistant steel. The nose changes are shown in Figures 15, 16, 17, and 18.

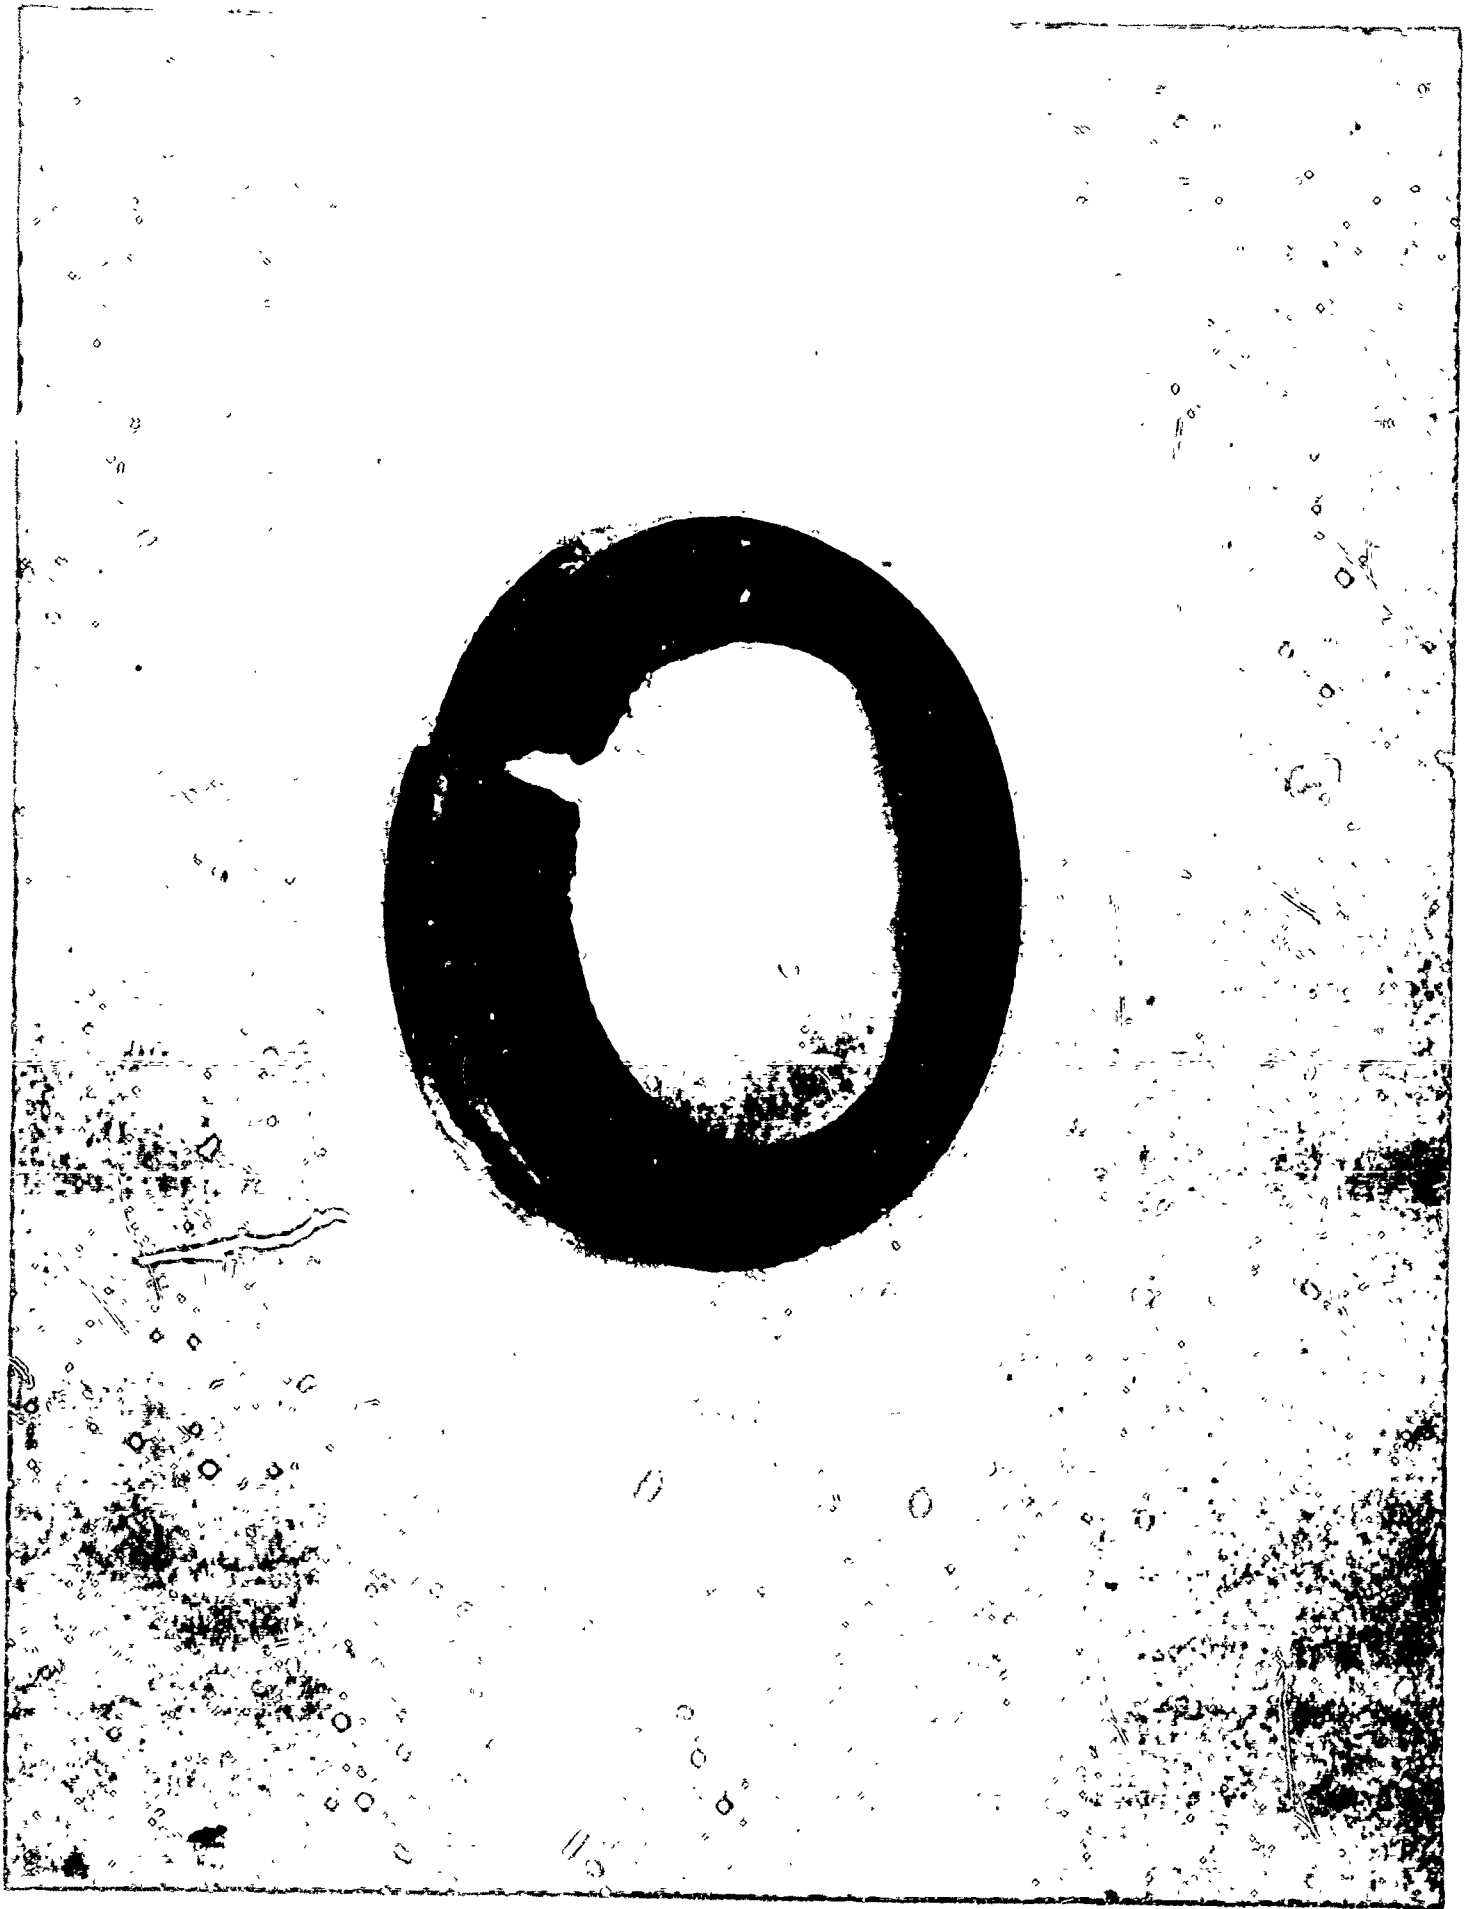
Figure 32. Cracked Ring Seal

without changing ring seals. Although the ring seals stopped the eroding of the barrel face, it was found that the seals themselves would crack within a few thousand rounds with the 2-3/4 second burst firing. Figure 32 shows a cracked ring seal due to the long burst firing. The material in the ring seal was changed from S. A. E. H-13 tool steel to a maraging 18 percent nickel steel. The maraging steel is not sensitive to thermal cycling and shock. Ring seals manufactured of maraging steel have been fired over 9,000 rounds with 2-3/4 second burst firing without any cracking or detrimental effects.

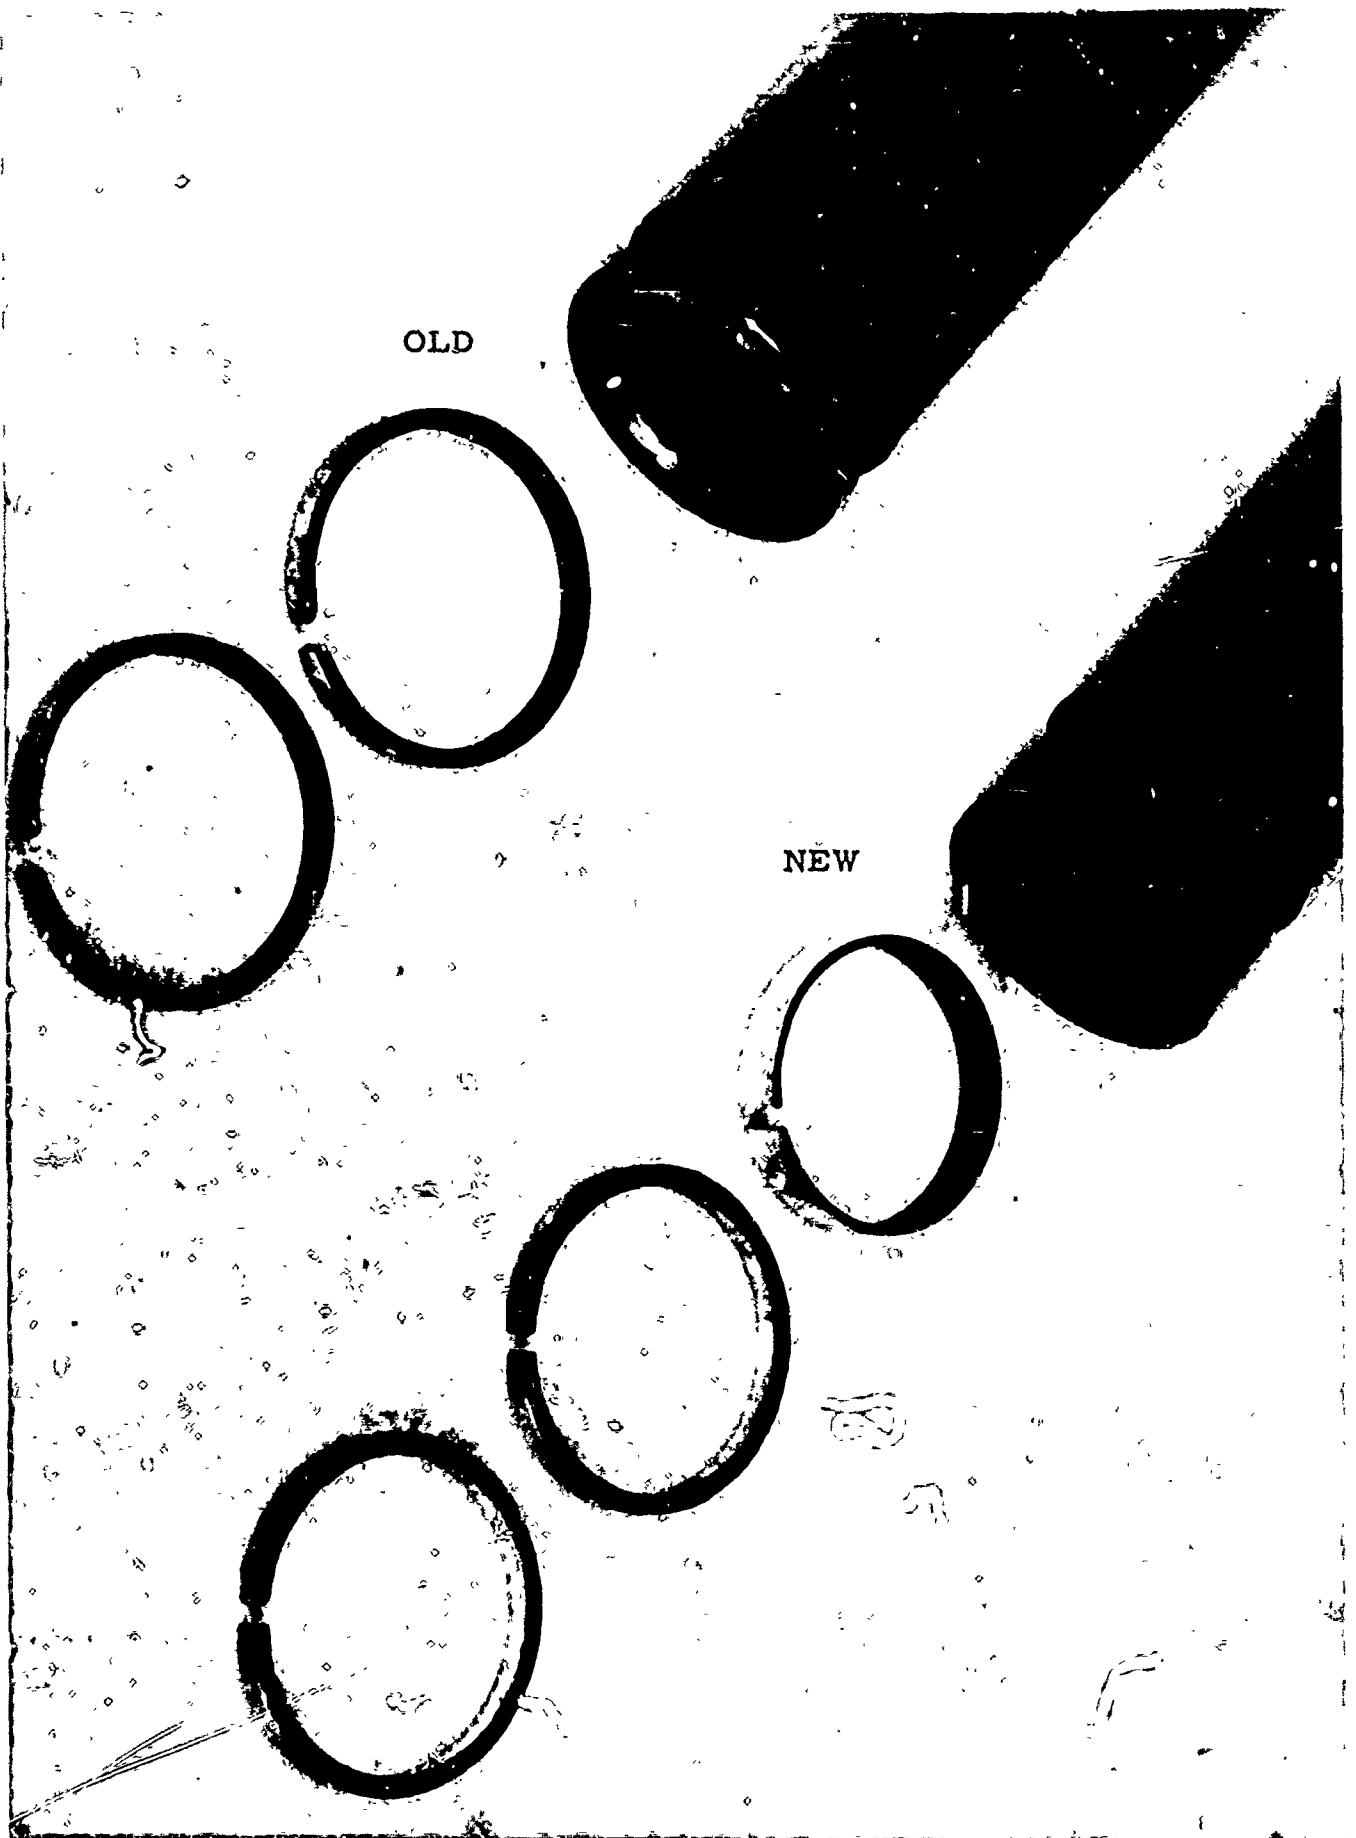
Figure 33. Rammer Piston and Ring Configuration

The increased heat in long burst firing caused the end of the ram piston to fail in both bearing and shear due to the low yield strength of the material at elevated temperatures. The end of the piston went out of round, and the piston ring groove was narrowed by bearing failure, causing the rings to stick in the grooves. A change of material to high strength maraging steel helped, but did not solve the problem. The piston ring groove was then moved back to increase

the bearing area of the piston, and also remove the groove from the point of load application. Figure 33 shows a comparison of the old and new ram piston. This change has proven satisfactory thus far and tests will continue with this configuration.
