VUF-1010
FINAL REPORT

VELA UNIFORM PROJECT **SHOAL**

STRUCTURAL SURVEY OF PRIVATE MINING PROPERTIES

U.S. BUREAU OF MINES

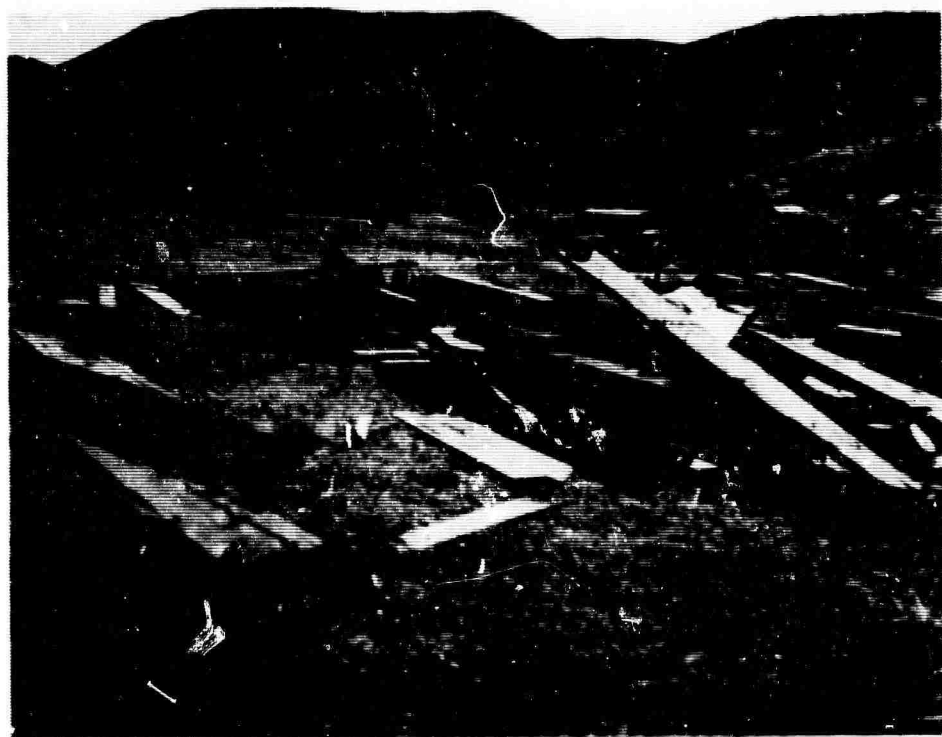
Photo 3-2-10. Preshot. September 30, 1963.

Photo No. 3-2-10. Surface view of inclined shaft on left, main shaft on right. Collars of both shafts are partially dismantled and in a caving condition especially near the surface. A large amount of timber debris covers the surface area.

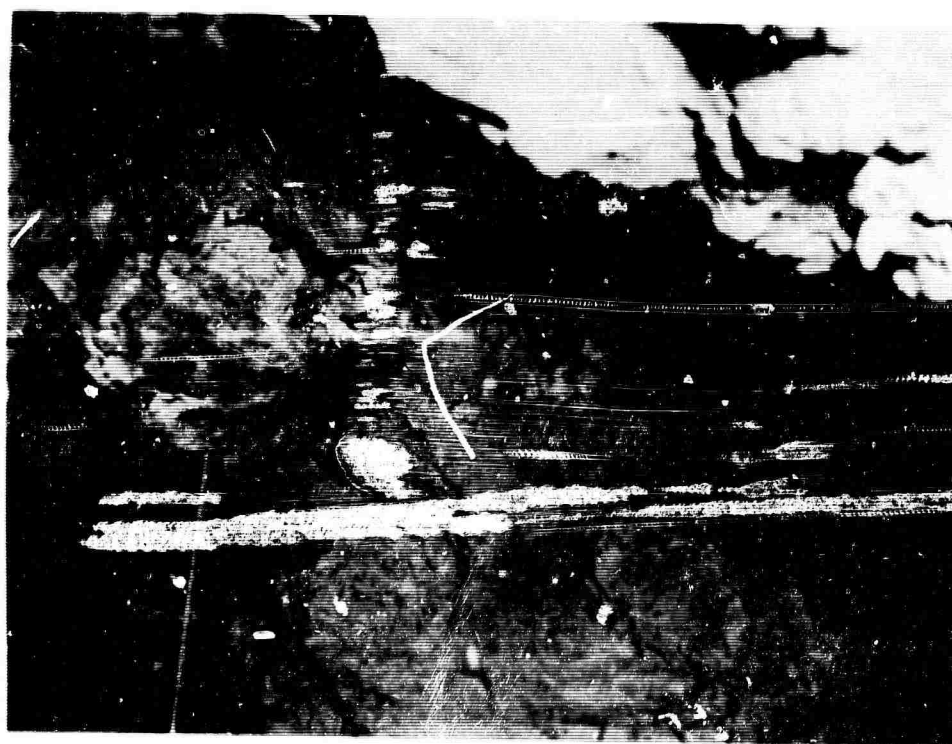
Photo 4-3-13. Preshot. September 30, 1963.

Photo No. 4-3-13. Rock along back at 150-foot level shaft station. The rock is in a generally loosened condition.

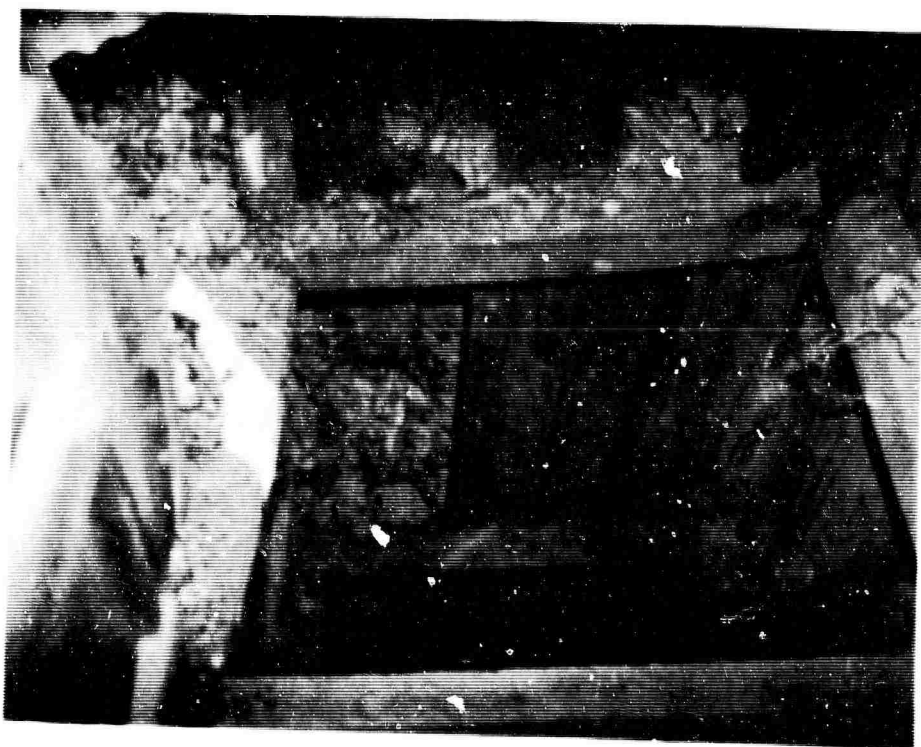
Photo 5-3-20. Preshot. September 30, 1963.

Photo No. 5-3-20. Central vertical shaft. Timbered dimensions are 7 x 6 feet. Other than two timber sets at the shaft collar, the shaft is unsupported. Some lagging from these surface sets is gone while other lagging is in a warped and sprung condition. The shaft is in an incipient caved condition at the surface.

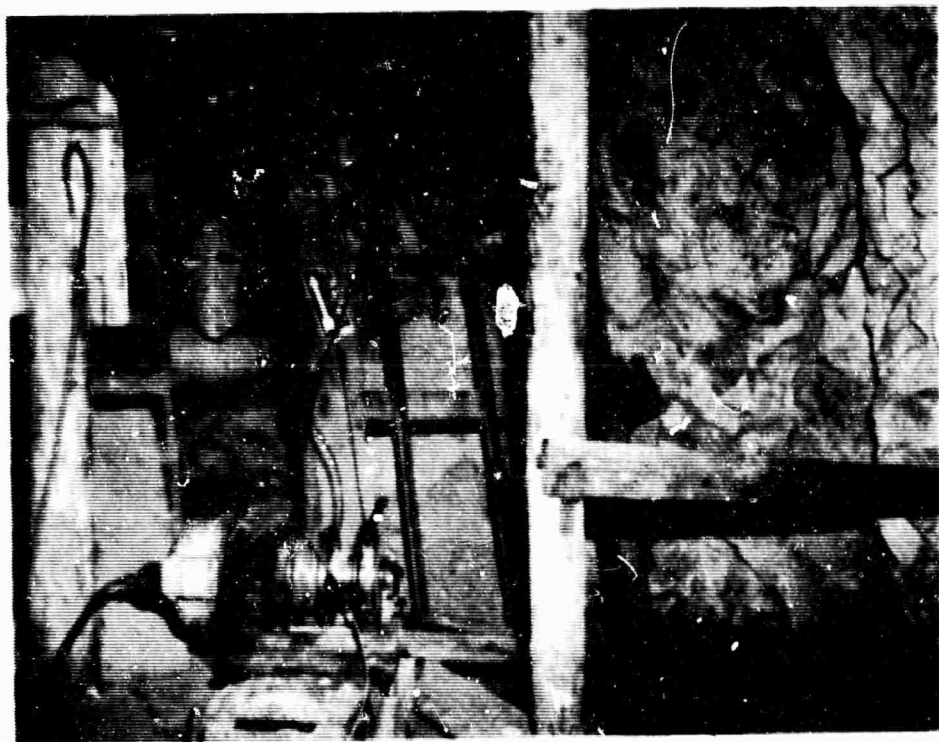
Photo 11-11-54. Preshot. October 2, 1963.

Photo No. 11-11-54. Station for 1000-winze on 400-foot level. Inclination of winze is 72 degrees. Random round 8-inch timbers are used for support. A large amount of mining equipment was found at this winze station.

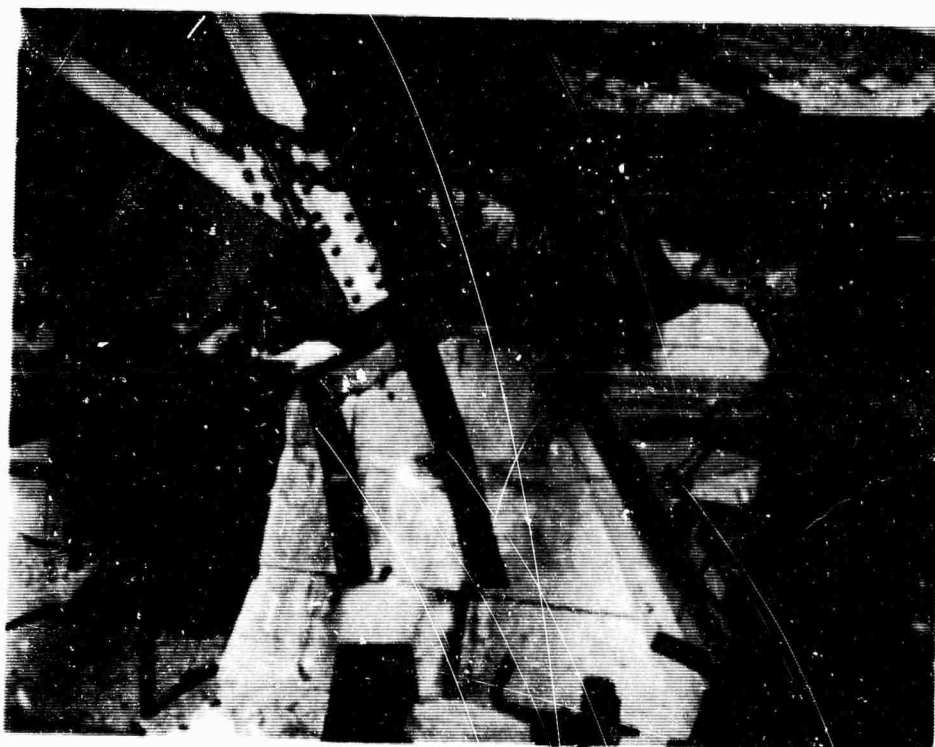
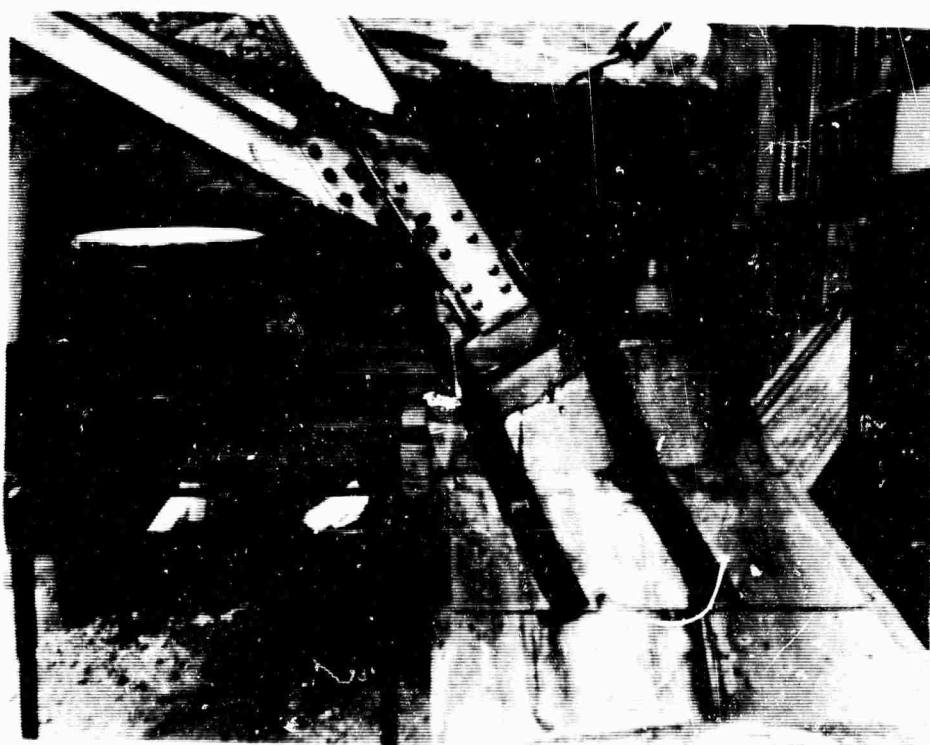
Photo 11-14-57. Preshot. October 2, 1963.

Photo No. 11-14-57. Subsidence by undermining from the 250 stope has caused separation between the steel leg and concrete pier of left rear post of headframe. Reference mark measured 6.05 inches separation both pre- and postshot. The 1/4 x 3-inch steel straps holding the headframe leg to the concrete pier do not form a rigid connection and the steel straps can be deflected by hand pressure.

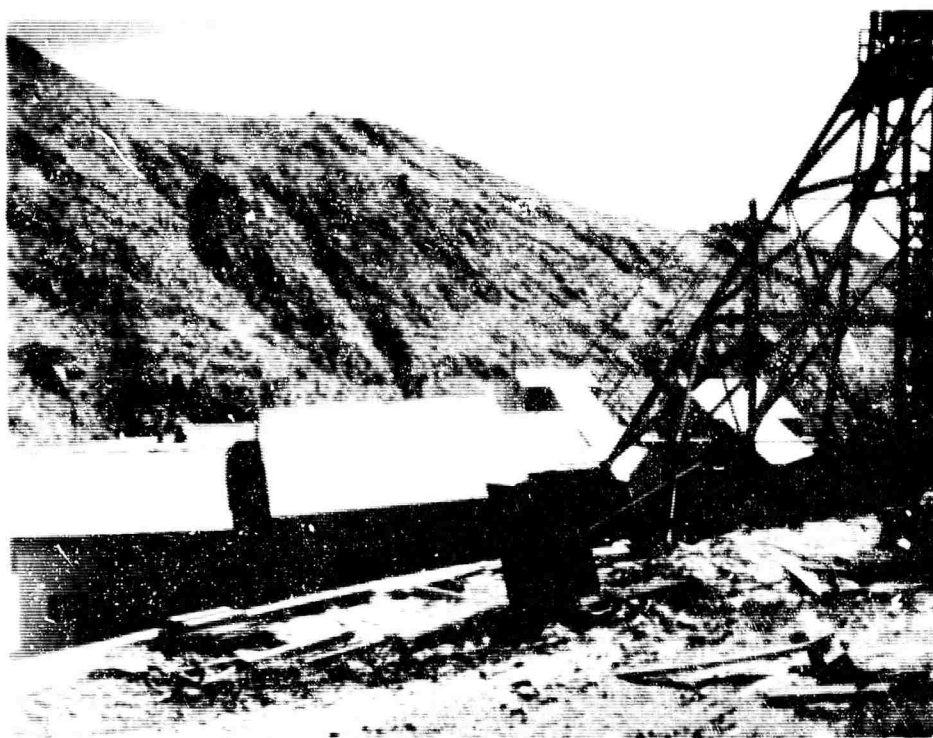
Photo 11-15-58. Preshot. October 2, 1963.

Photo No. 11-15-58. Subsidence by undermining from the 250 stope has caused a four degree northward tilt to hoist house. The concrete foundation for the hoisting equipment has a large crosswise crack immediately behind the main drum. The hoist consists of a cylindrical double drum electric powered system mounted on a steel frame.
