U. S. NAVY SUPPLY OFFICE-SCHOOL
NAVAL SUPPLY DEPOT, BAYONNE, NEW JERSEY

NAVY REPORT SERIAL NO. NT-003-010

DEVELOPMENT OF SHORE PARTY EQUIPMENT
(STEEL WIRE PALLETS)

Authorization - Chief of the Bureau of Supplies and Accounts letter to Chief of Naval Operations, N41(PC-4)AGG, 16 Jan 47.

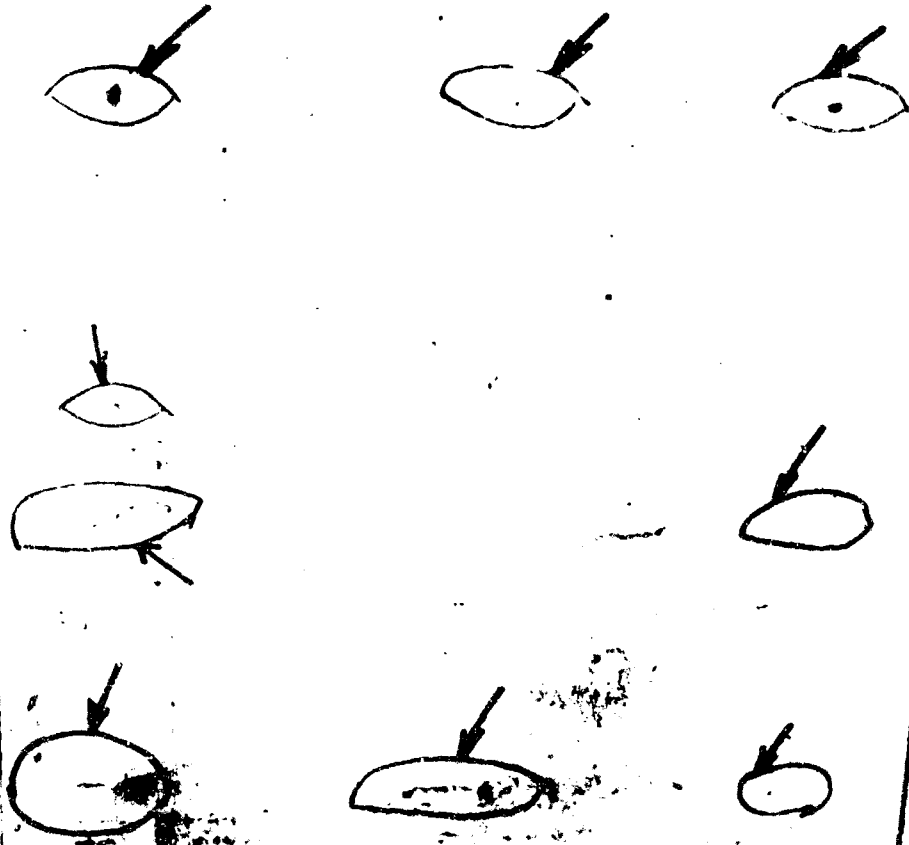
It was also noted that the Fibreboard deck ruptured and cracked due to the non-rigidity of the bagged goods load. These cracks appeared along the pallet deck just above, and in line with the .264" horizontal wires. The exposed ends of the vertical support wires also punched through the Fibreboard top of the pallet. Both of these conditions are indicated in Photo Negative #50-2, Page 25. This failure was due to concentration of weight above the supporting members as is encountered with non-uniformly distributed loads.

SECTION OF FOREBOARD LICK RESULTING FROM HUS-
RIGHT OF BANGED OOPS LOAD.

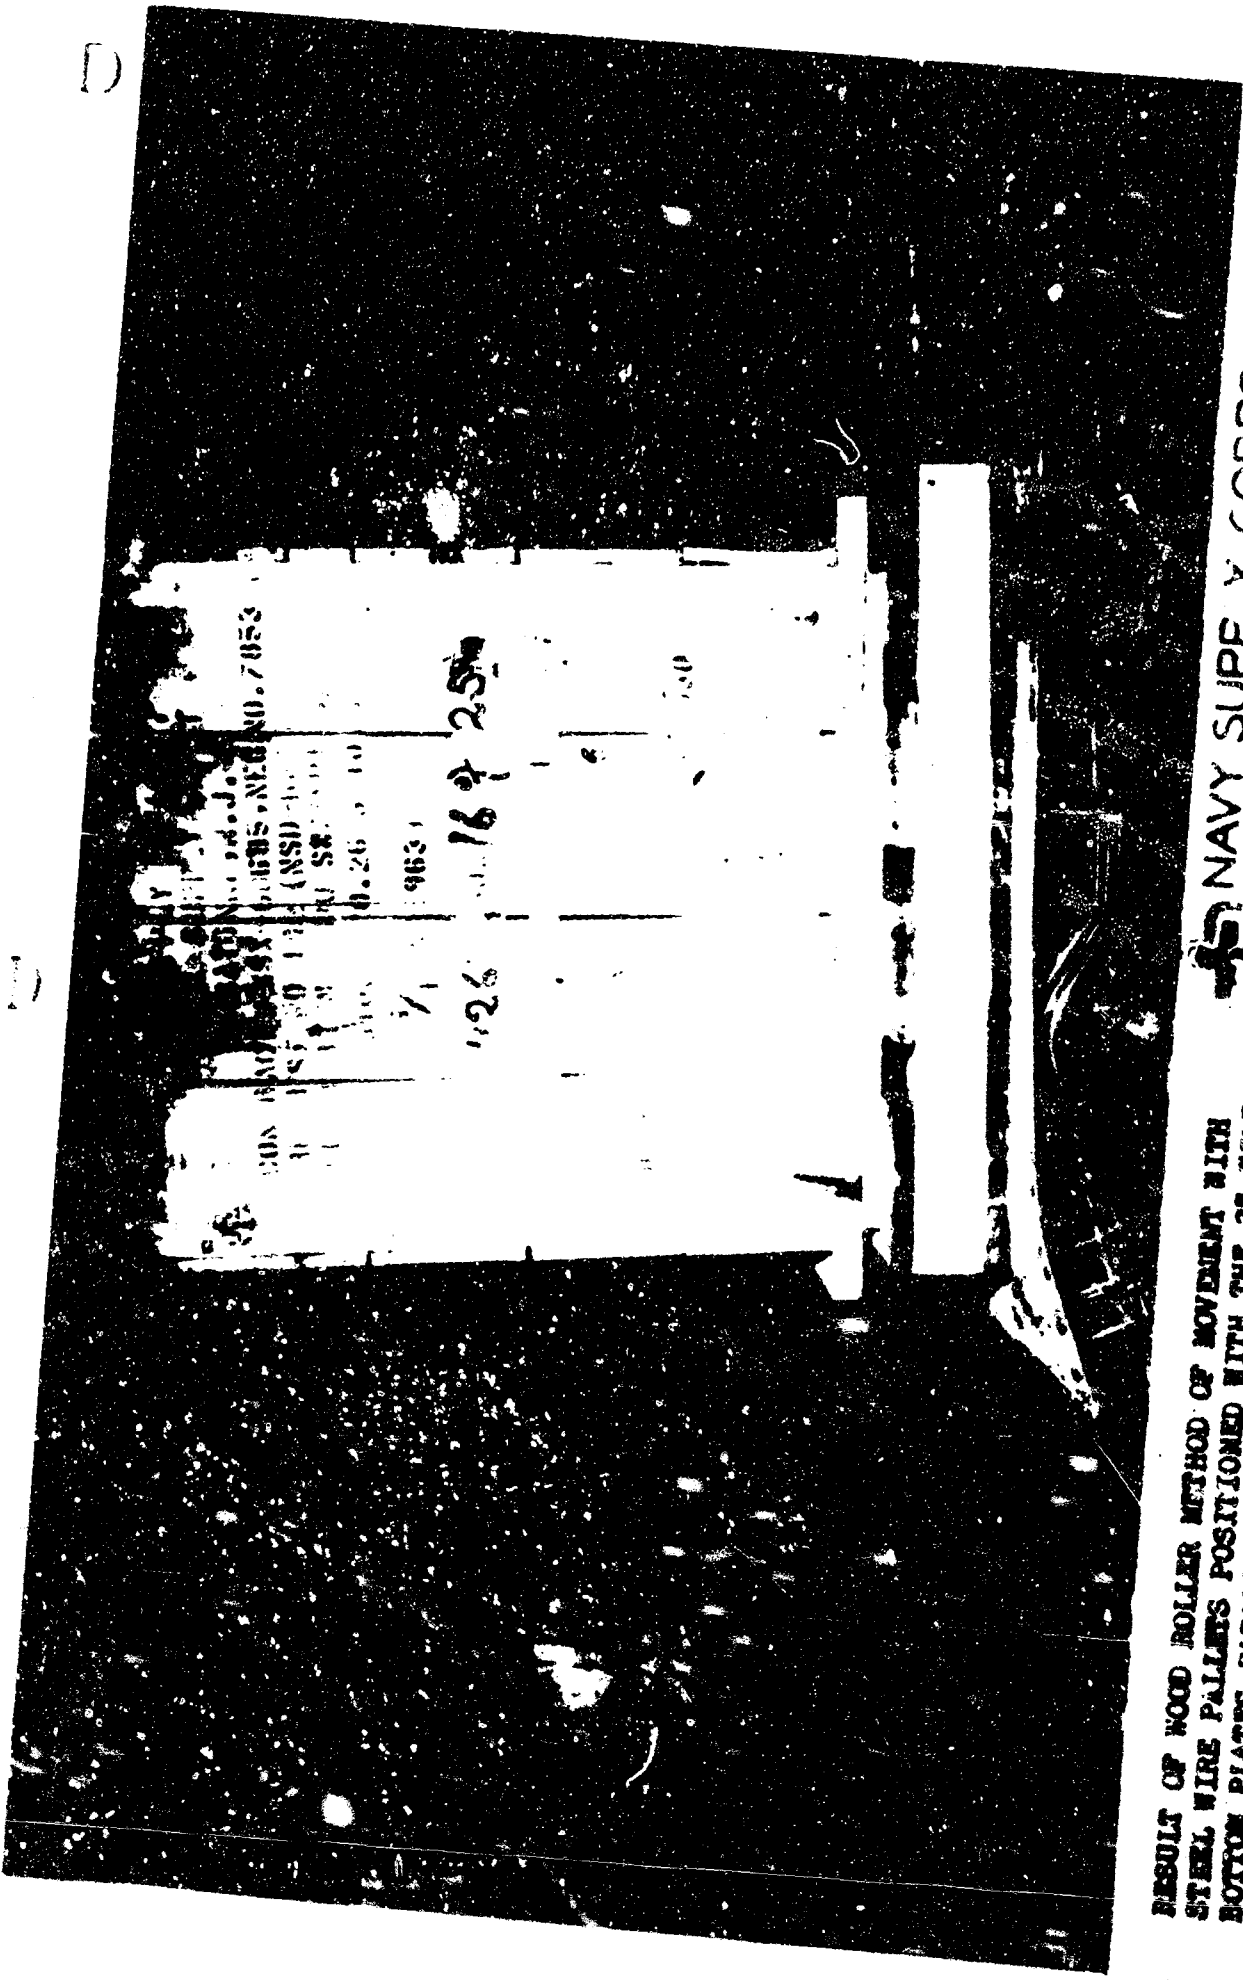
RESULT OF WOOD ROLLER METHOD OF MOVEMENT WITH
STEEL WIRE PALLET POSITIONED WITH THE 3" WIDE
BOTTOM PLATES PARALLEL TO THE WOOD ROLLERS.
PALLET DID NOT PASS THIS TEST.

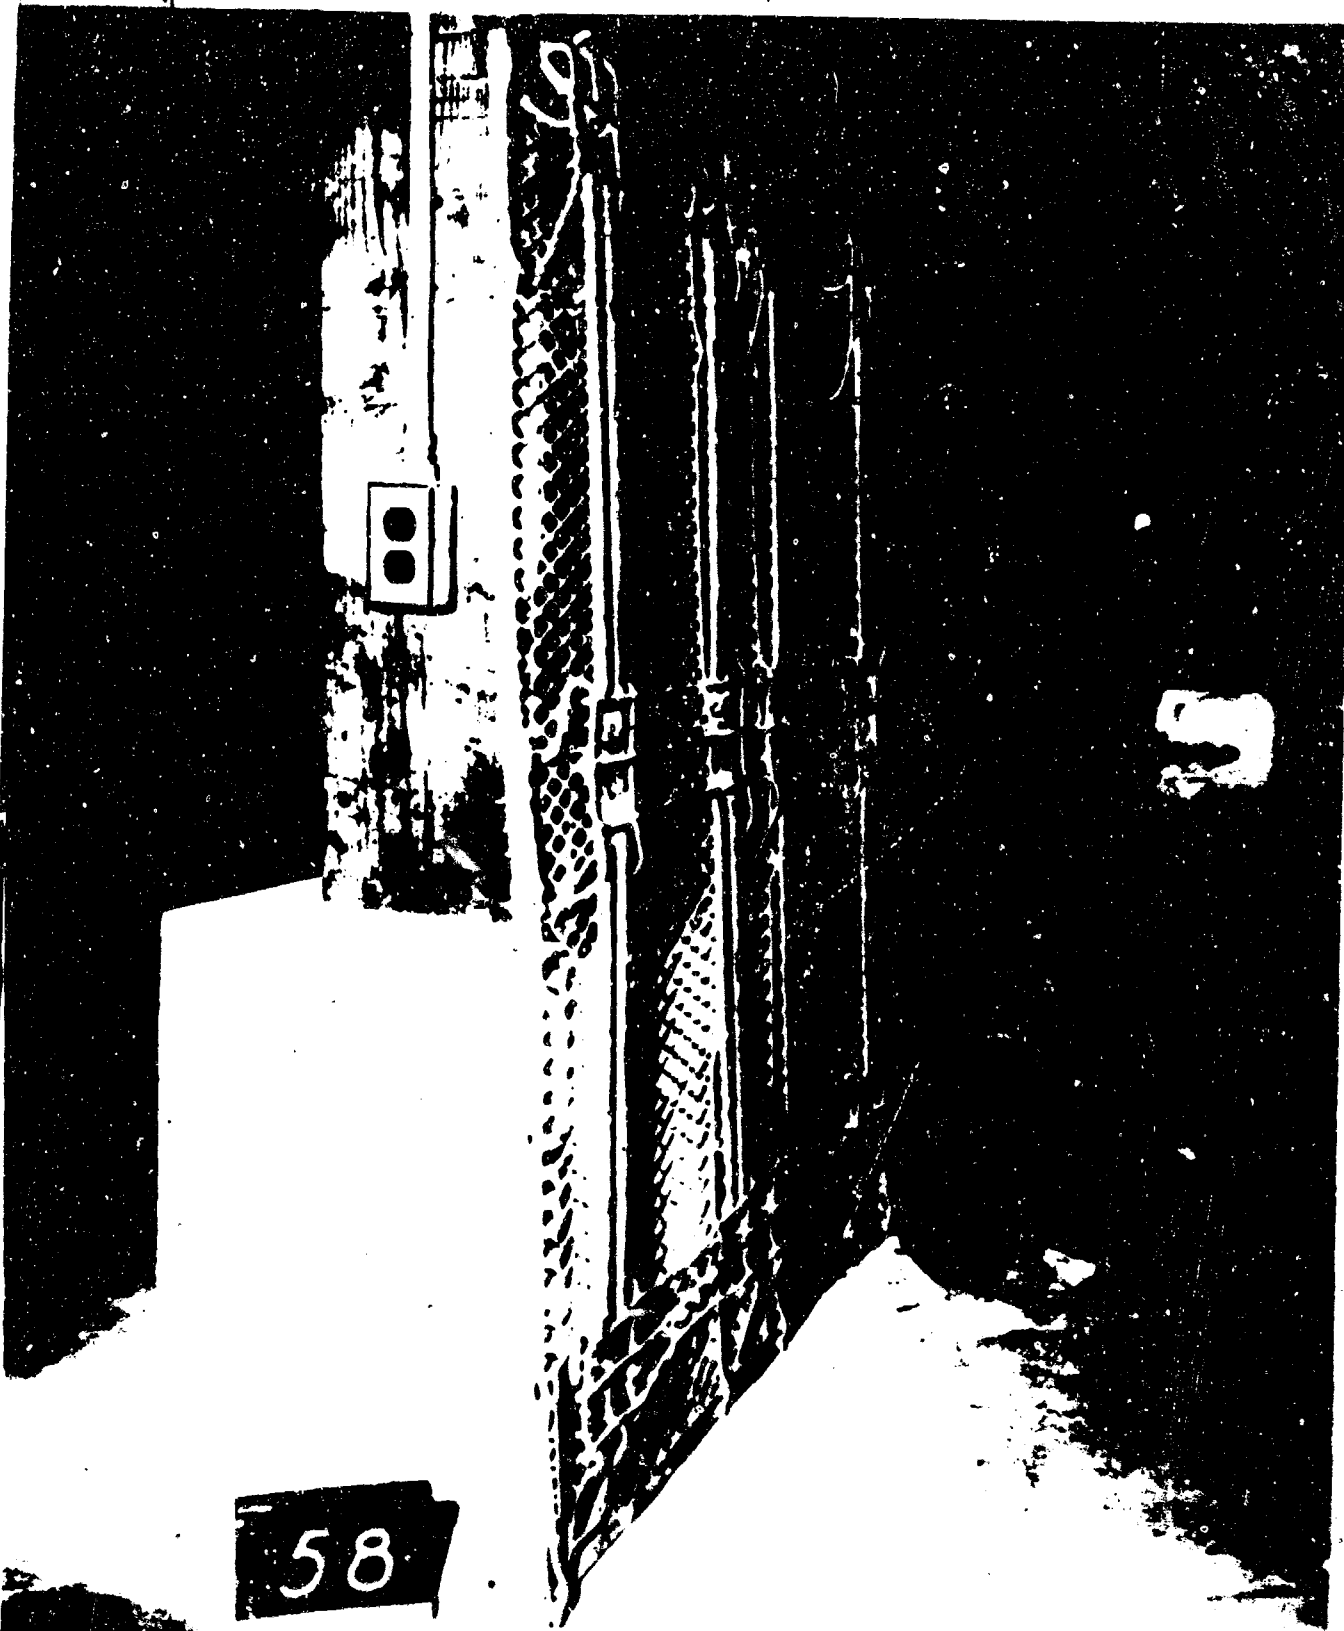
ILLUSTRATION OF RESULT TO
EXPANDED METAL DECK PALLET
"D" IN FREIGHT LIFTING
TEST. PALLET WAS DAMAGED
SLIGHTLY PRIOR TO TEST.
