FULL-SCALE DYNAMIC CRASH TEST
OF A
LOCKHEED CONSTELLATION MODEL 1649 AIRCRAFT

TECHNICAL REPORT

OCTOBER 1965

TECHNICAL REPORT
ADS - 38

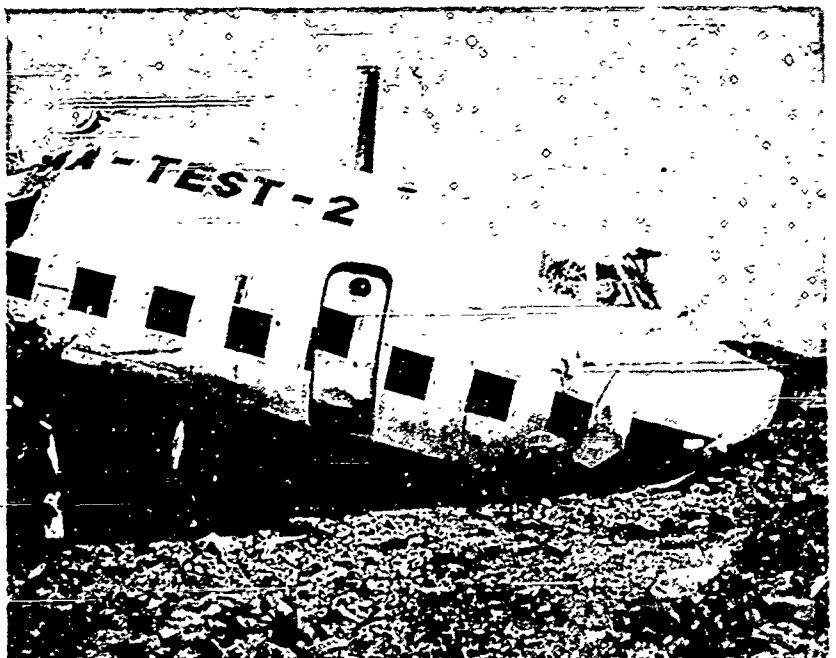
FIG. 29 FORWARD FUSELAGE AND COCKPIT STRUCTURAL
DEFORMATION, RIGHT SIDE

The extreme forward end of the cockpit, as shown in Figures 29 and 30 was pulled under by the impact and friction against the 20 degree slope causing considerable damage in the vertical space forward of the pilot's and copilot's seats. The floor structure beneath the pilot's and copilot's seats was still intact, but the fuselage beneath this position was crushed so that there was no space left beneath the floor. Aft of the pilot's and copilot's position the cockpit floor was deformed upward and twisted. The floor panel normally located between the engineer's seat floor tracks was knocked out, leaving a large opening. The air conditioning and pressurization control panel sprung free from the fuselage station 260 bulkhead and partially blocked the passageway leading to the side, crew entrance door. The upper cockpit structure was deformed to such an extent that the side, crew entrance door could not be opened (see Figure 31), however, exit from the cockpit was still possible through the main cabin.

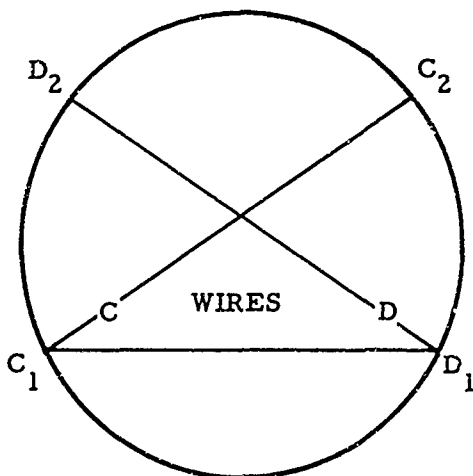
FIG. 35 RESULTS OF FUSELAGE VOLUME REDUCTION EXPERIMENTS

WIRE C. EXPANDED LENGTH
BROKEN AFTER 121.50"
DISTANCE BETWEEN C₁ AND C₂ 113.75"
WIRE D EXPANDED LENGTH 118.5
DISTANCE BETWEEN D₁ AND D₂ 116.5

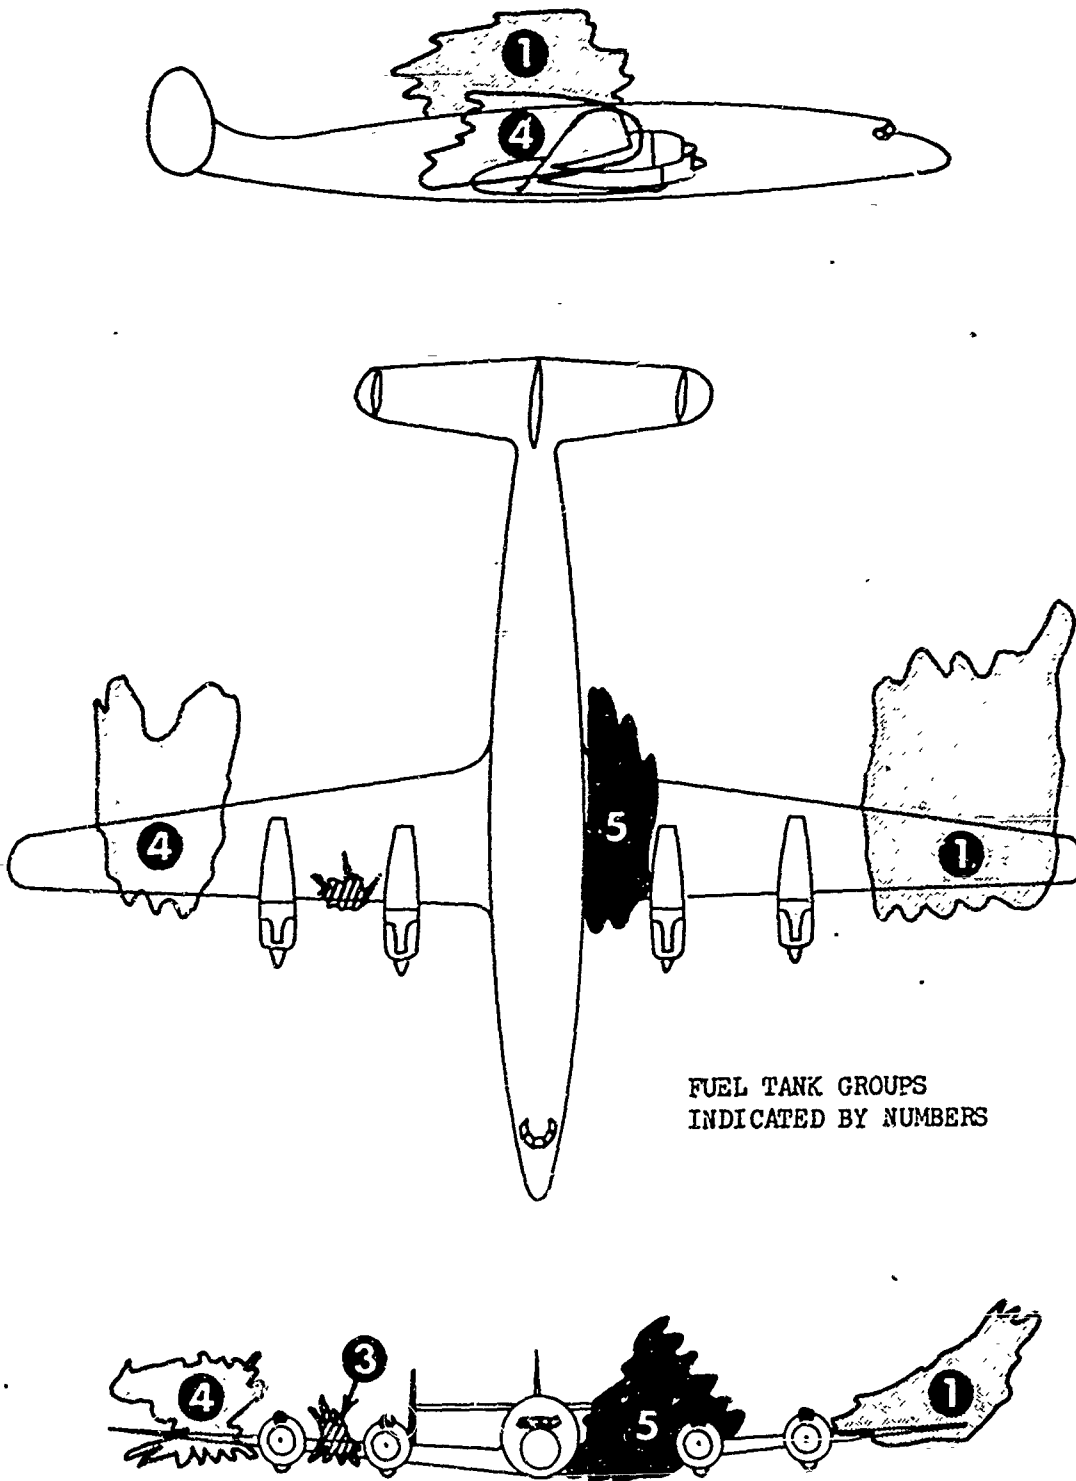
FIG. 40 FUEL SPILLAGE OCCURRING 1.00 SECONDS AFTER
IMPACT WITH MAIN GEAR BARRIERS

Initial impact and subsequent course of the aircraft through the barriers caused the wings to fail or disintegrate, spilling the simulated fuel. Figures 40, 41, 42, and 43 present a kinematic of the fuel spillage during the crash.

The No. 1 fuel tank was ruptured when the outer portion of the left wing impacted against the earthen barrier. The complete destruction of the tank caused the entire volume of simulated fuel to be released in a heavy mist. As the aircraft contacted and slid forward up the 6 degree slope, the wing was partially separated from the fuselage at the root. This failure opened up the No. 5 fuel tank allowing its simulated fuel to be completely expelled in a mist cloud by the time the aircraft came to rest on the 20 degree slope. Traces of the simulated fuel were found 15 feet ahead of the aircraft.

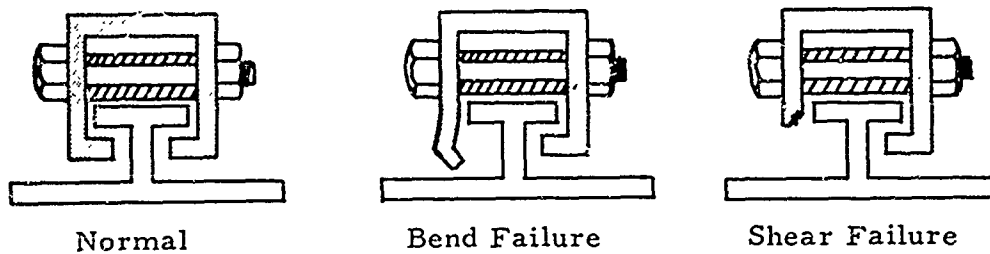
FIG. 51 SEAT TRACK ATTACHMENT FAILURES

The third crew seat was torn free of the floor tracks due to failure of the attachment grips as illustrated in Figure 51. This allowed the seat and its occupant to travel forward and to the left until they contacted the bulkhead at fuselage station 260. The seat and dummy came to rest blocking the cockpit door as shown in Figure 59. The dummy was well restrained in the seat by the diagonal shoulder harness and lap belt throughout the crash. The back of the seat was bent forward, approximately 5 degrees. The complete failure of the attachment of this seat to the floor was attributed in part to a high localized load caused by the nose gear structure which was embedded under the fuselage just beneath the seat. Figures 60 and 61 show the seat tracks and the track grips.

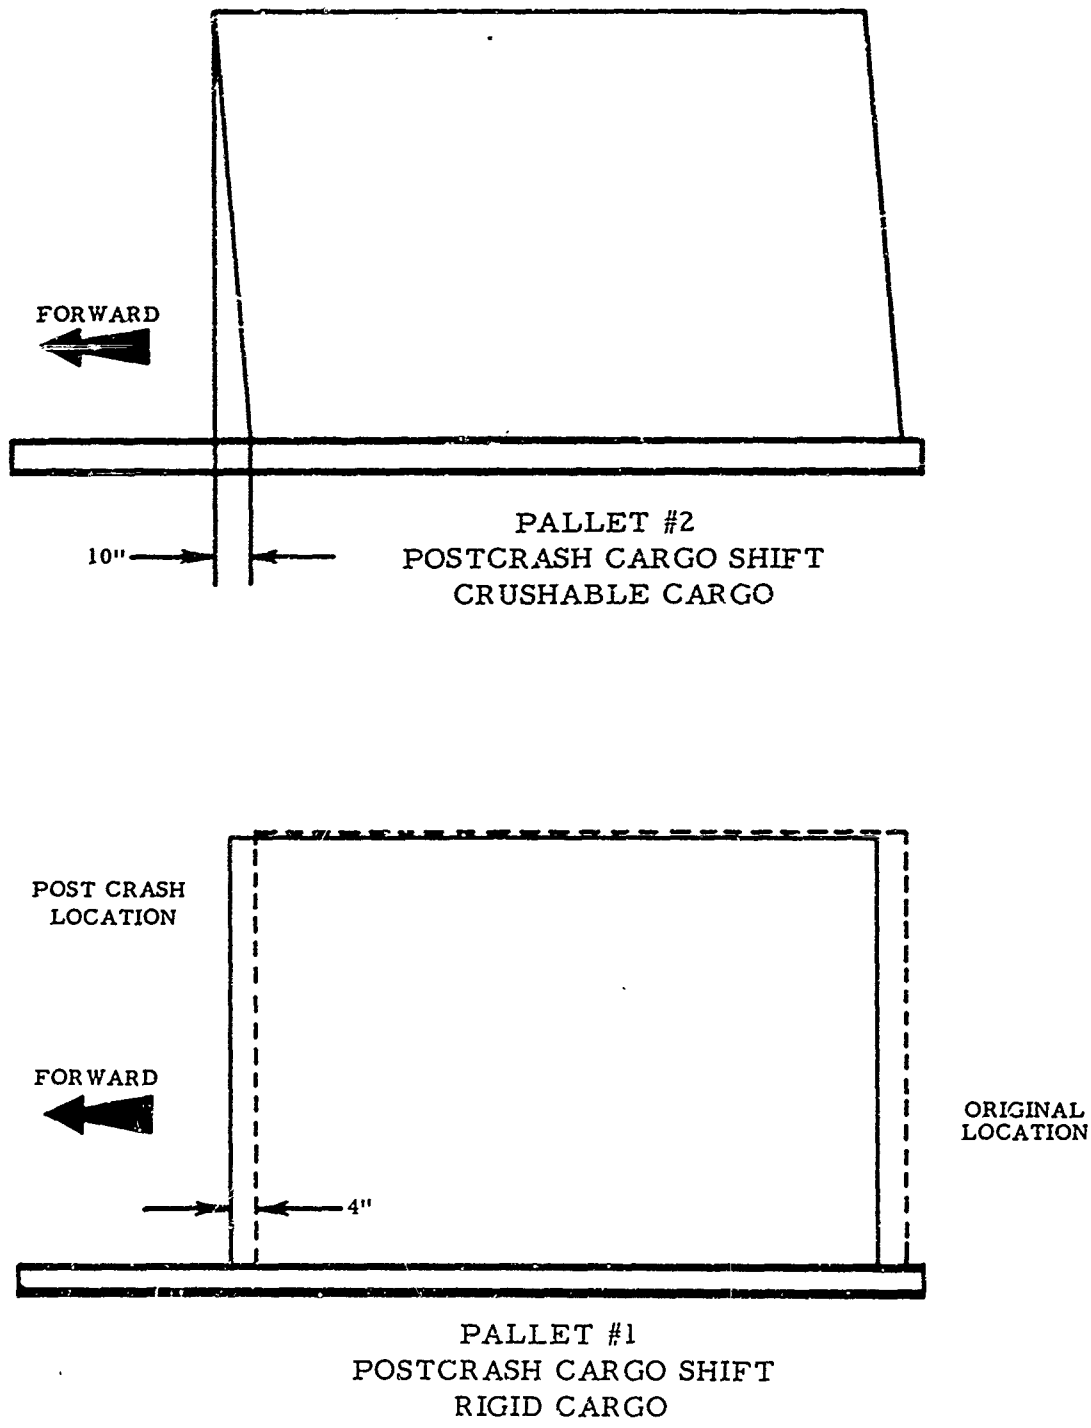
FIG. 78 FORWARD MOVEMENT EXPERIENCED IN CARGO LOADS

During the crash, neither pallet nor cargo separated from its original tiedown, however, both of the longitudinal restraint installations of the cargo pallets deformed approximately 2 inches forward as shown in Figure 77. The flexible nets survived the crash with no load ring deformation, and no failures occurred in either of the cargo tiedown systems. The rigid cargo stack slid forward on the pallet approximately 4 inches while the crushable cargo remained in place and programmed forward ten inches. An illustration of the cargo action is shown in Figure 78.
