**EXPLOSIVES
ACCIDENT / INCIDENT
ABSTRACTS
SEPT. 1961 THRU JUNE 1967**

**ARMED SERVICES EXPLOSIVES SAFETY BOARD
WASHINGTON D.C. 20315**

OCTOBER 1967

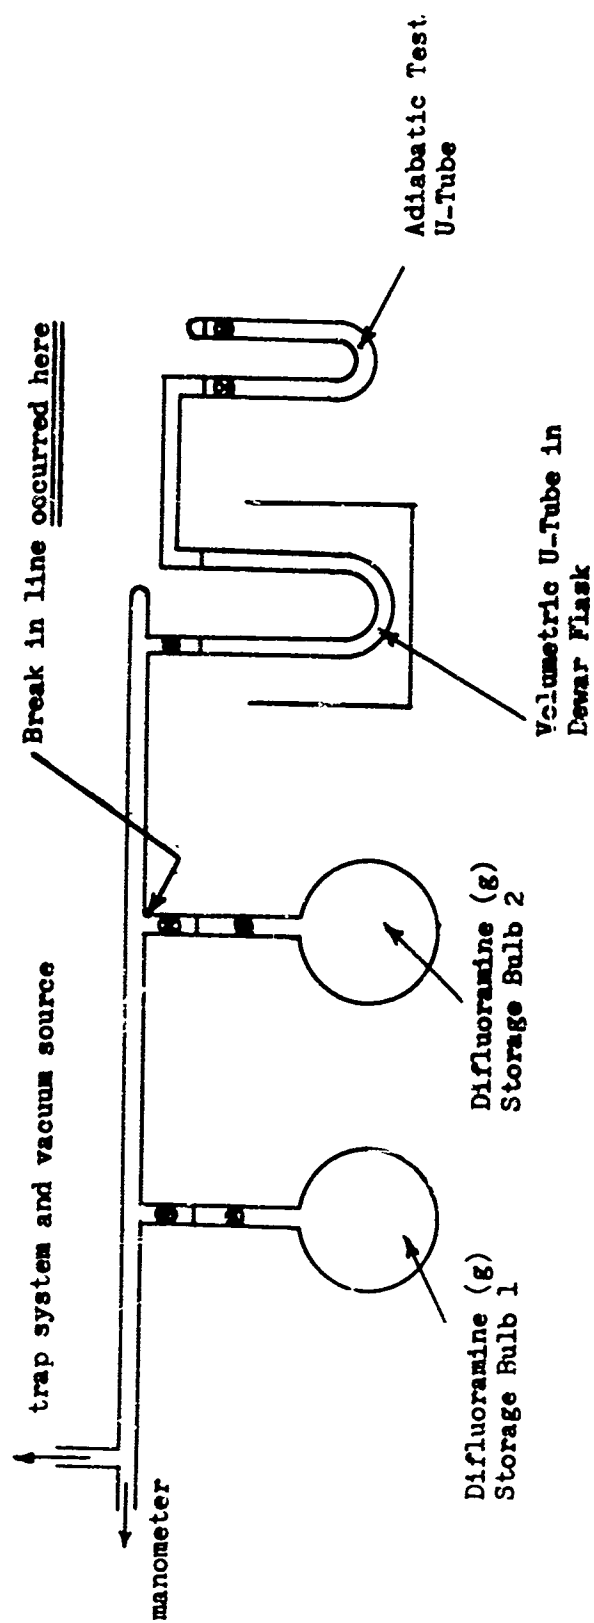
LOADING APPARATUS FOR ADIABATIC
COMPRESSION TEST OF DIFLUORAMINE
