RDTR NO. 160  
3 DECEMBER 1969

# **SAFETY TEST OF FLARE EXTRUSION FACILITY**

**RESEARCH AND DEVELOPMENT DEPARTMENT  
NAVAL AMMUNITION DEPOT, CRANE, INDIANA**

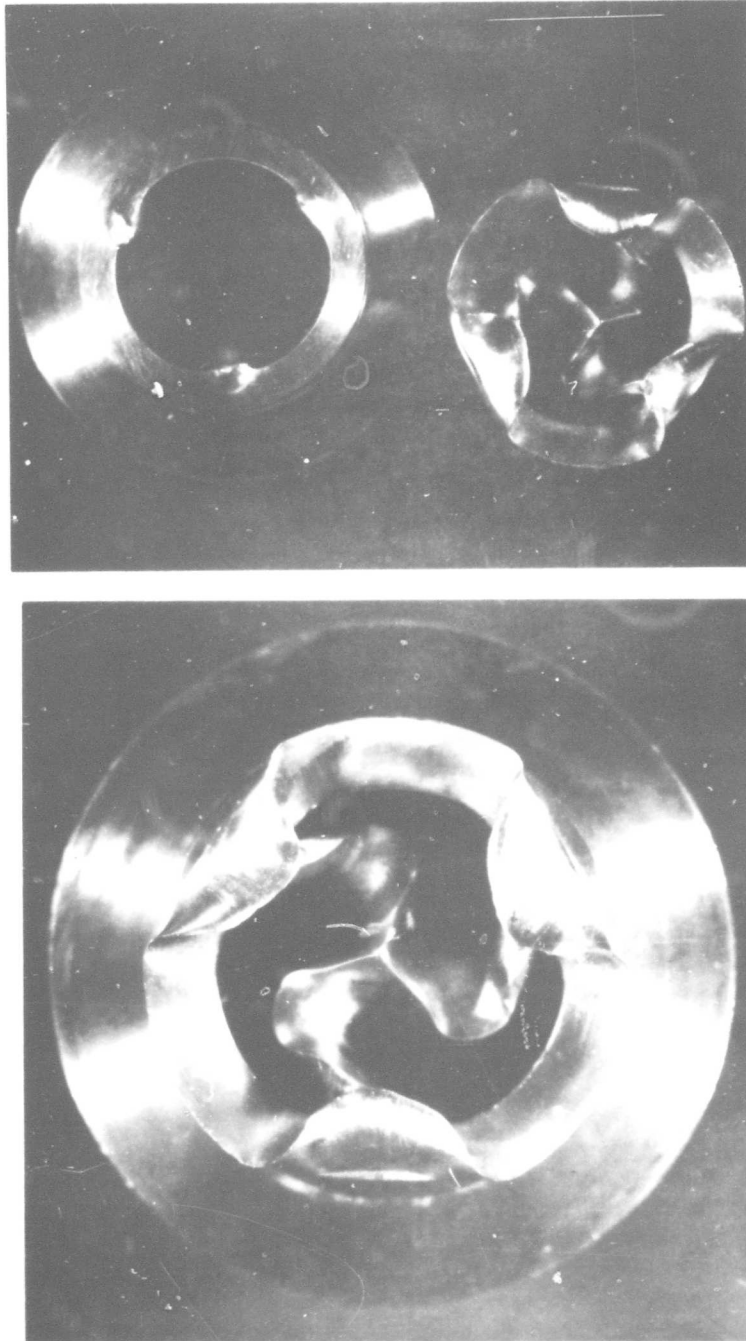
FIGURE 1  
COLLAPSED DIE CROWN

compression of air not evacuated from the charge cylinder, broken extrusion die, or static electricity. The exact cause was not established; however, several opinions strongly favored a broken extrusion die. After the extrusion facility was restored, an extrusion die for the MK 46 flare grain with a crown made of material that had twice the tensile strength of the crown being used in December was installed in the press. Several inert extrusions were made at a line pressure of 1000 psi and at 130°F charge cylinder temperature. In order to increase the stress on the die, additional inert extrusions were made at a line pressure of 1500 psi and with the charge cylinder at ambient temperature. During the second run, the die crown collapsed as can be seen in Figure 1. Die collapse with only 50% over stress adds strength to the opinions that the die crown broke and caused ignition in the press on December 18.

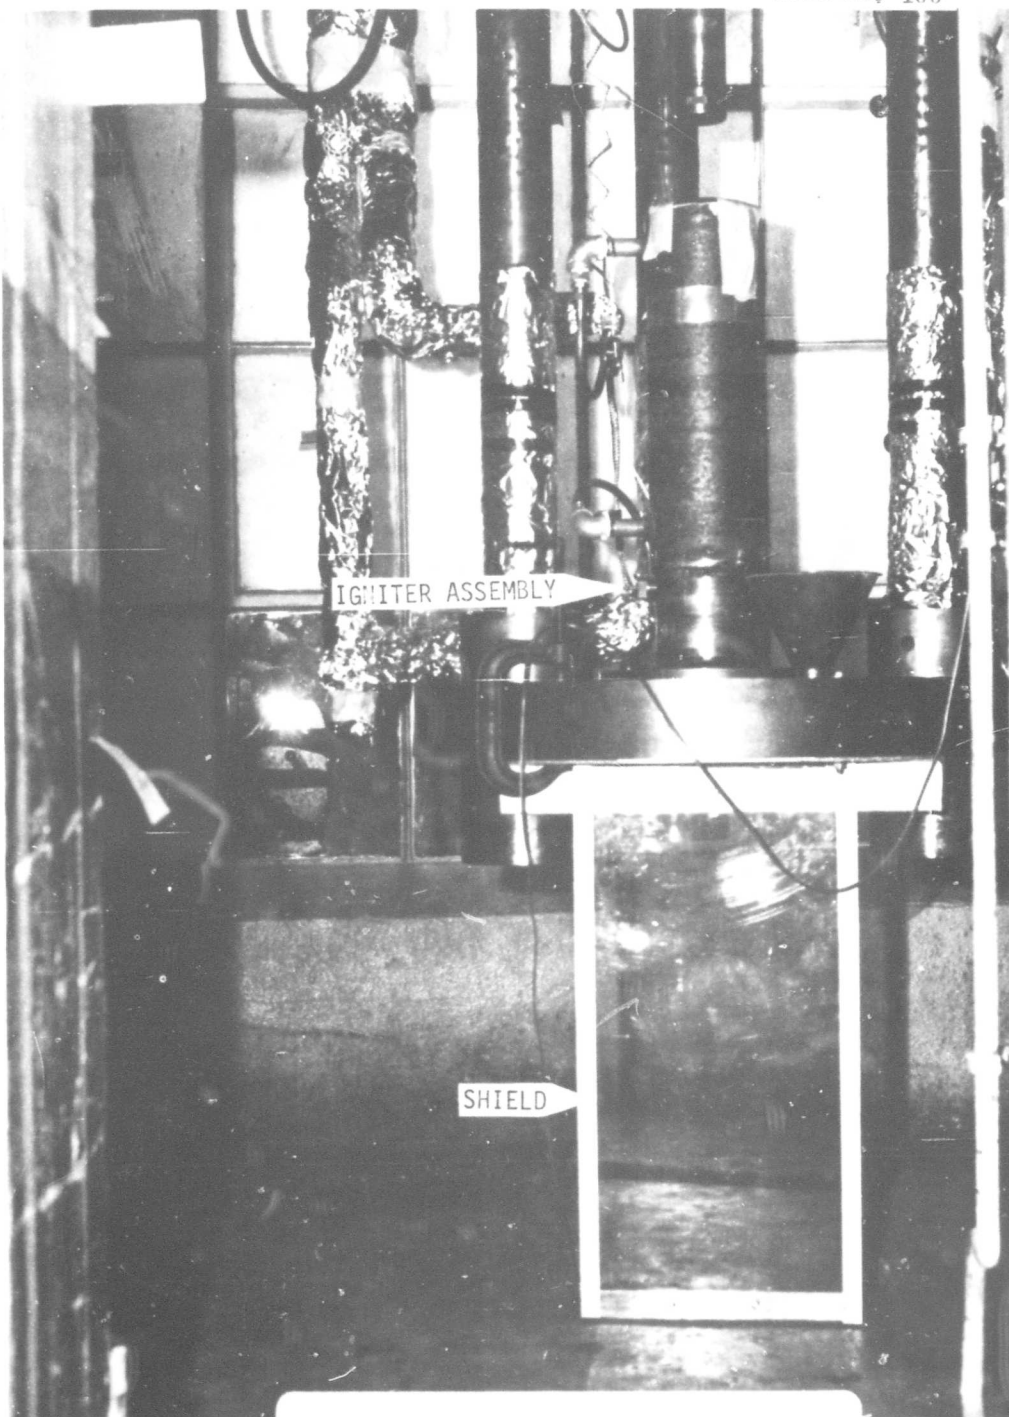
FIGURE 3  
PRESS CELL BEFORE TEST

3. Figure 3 shows the press before the test and the shield which was installed to help deflect flame away from the loose-fitting cell door and to provide more protection for personnel entering the cell to remove extrusions.

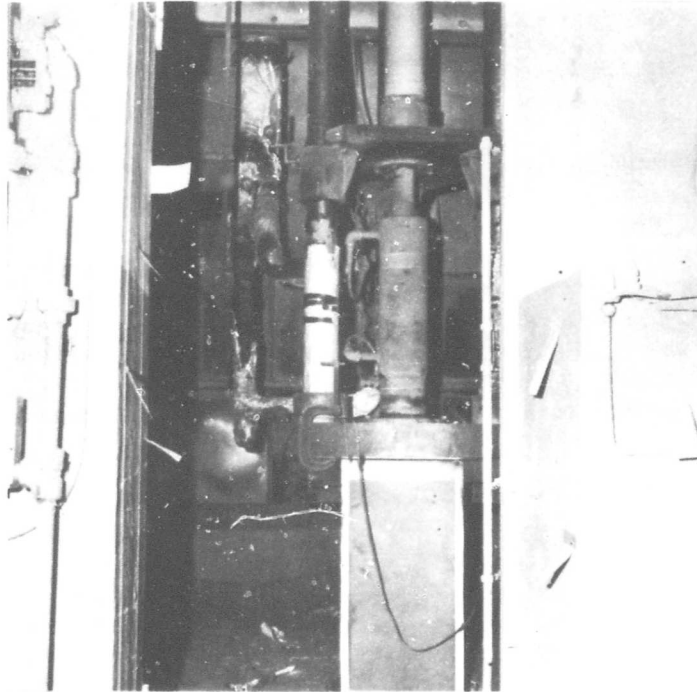
FIGURE 8a PRESS CELL AFTER TEST

2. Figure 8a shows the cell after the test. The shield deflected much of the heat away from the front of the cell. None of the newspaper in the doorway burned. Figure 8b shows the blowout window from the outside. The lower two rows of window sections were badly distorted. One section fell to the inside of the cell after the composition had burned out. The temperature under the press rose high enough to melt aluminum, as can be seen by figures 9a and 9b, but was insufficient at the front of the cell to burn all the newspaper on the inside of the cell door, figure 10a. Figure 10b shows the top part of the door where two pieces of newspaper scorched and the third piece mostly burned.

a. The extrusion facility has been restored so as to afford adequate safety protection to the press operating personnel. None of the newspaper in the doorway to the press cell burned, indicating that the press operators would not have received serious burns.

b. The polycarbonate shield between the press and floor deflected heat from the cell door much better than anticipated. We now have greater confidence in polycarbonate shielding used in other operations.

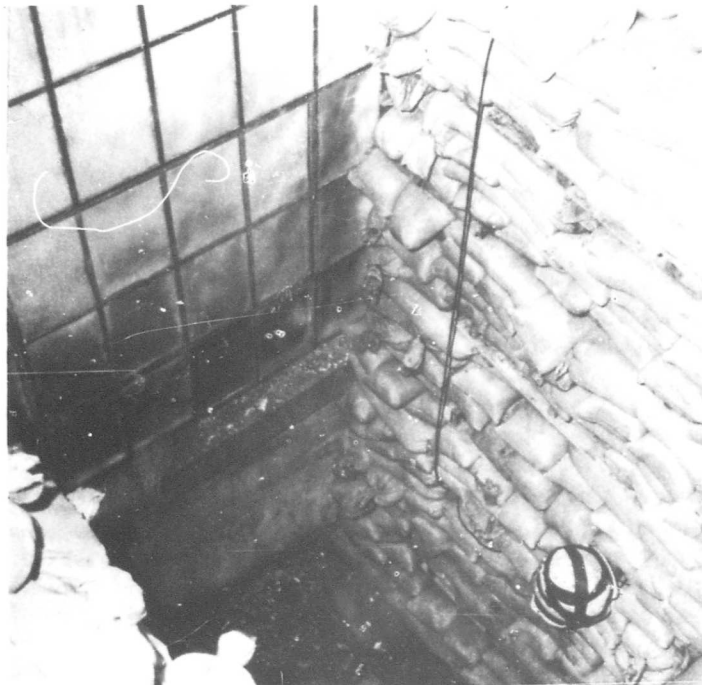
FIGURE 8b BLOWOUT WINDOW AFTER TEST

7. P3 indicated a maximum overpressure in the cell of 3.2, however, the blowout windows did not blow. If the window had blown as it should have, most of the smoke and heat that went around the cell door into the building would have exhausted to the outside.

The pressure rise in the cell of approximately three psi was not great enough to blow the windows. The window should be replaced with one that blows at a lower pressure.

c. Blowout window improvement is needed. If the window had blown, as it should have, much less smoke and heat would have been forced past the door.

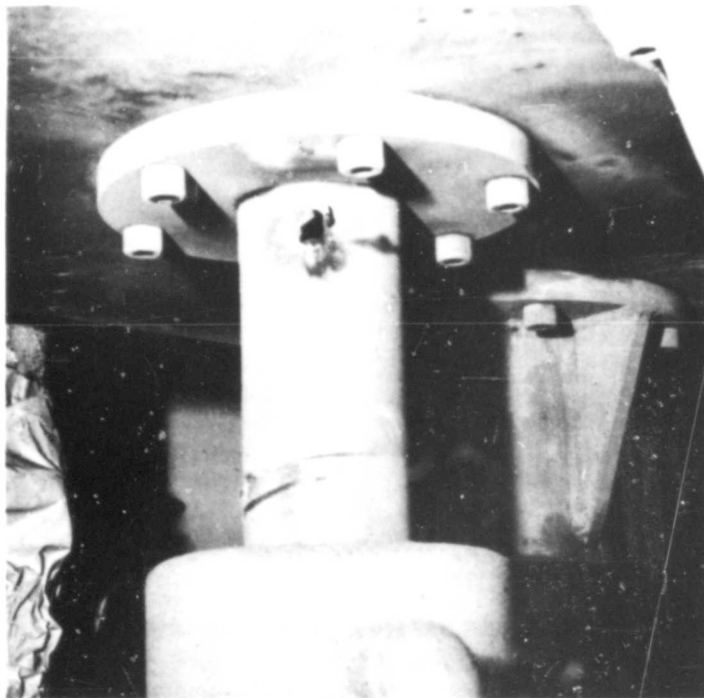
FIGURE 11b TOP OF RAV

3. Burning inside the press was very vigorous and hot, as was expected. A total time of nine seconds of audible burning was indicated by the audio tape. The combustion pressure in the charge cylinder vented in two directions, up through the vacuum passage in the ram and down through the die. Flame venting through the ram melted steel pipe fittings as shown in Figure 11a. These fittings were originally located at the top of the ram--figure 11b. The beryllium copper ram was eroded as shown in figure 12a.

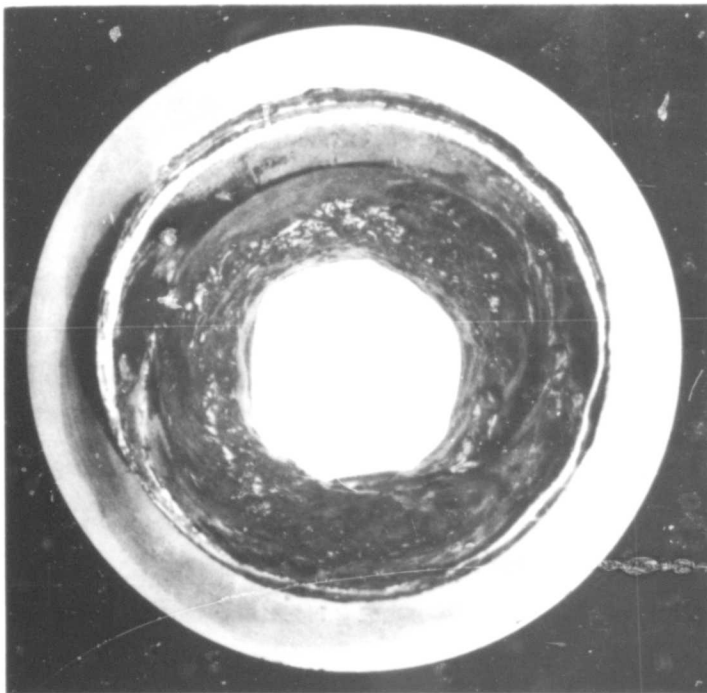
FIGURE 12b DIE EROSION

The O ring on the ram (not shown) was not damaged significantly. The stainless steel die, figure 12b, was eroded in a spiraling pattern. The vacuum pump was pumping during the test which definitely promoted venting through the ram. Venting through the ram began at approximately 0.15 seconds from test initiation.

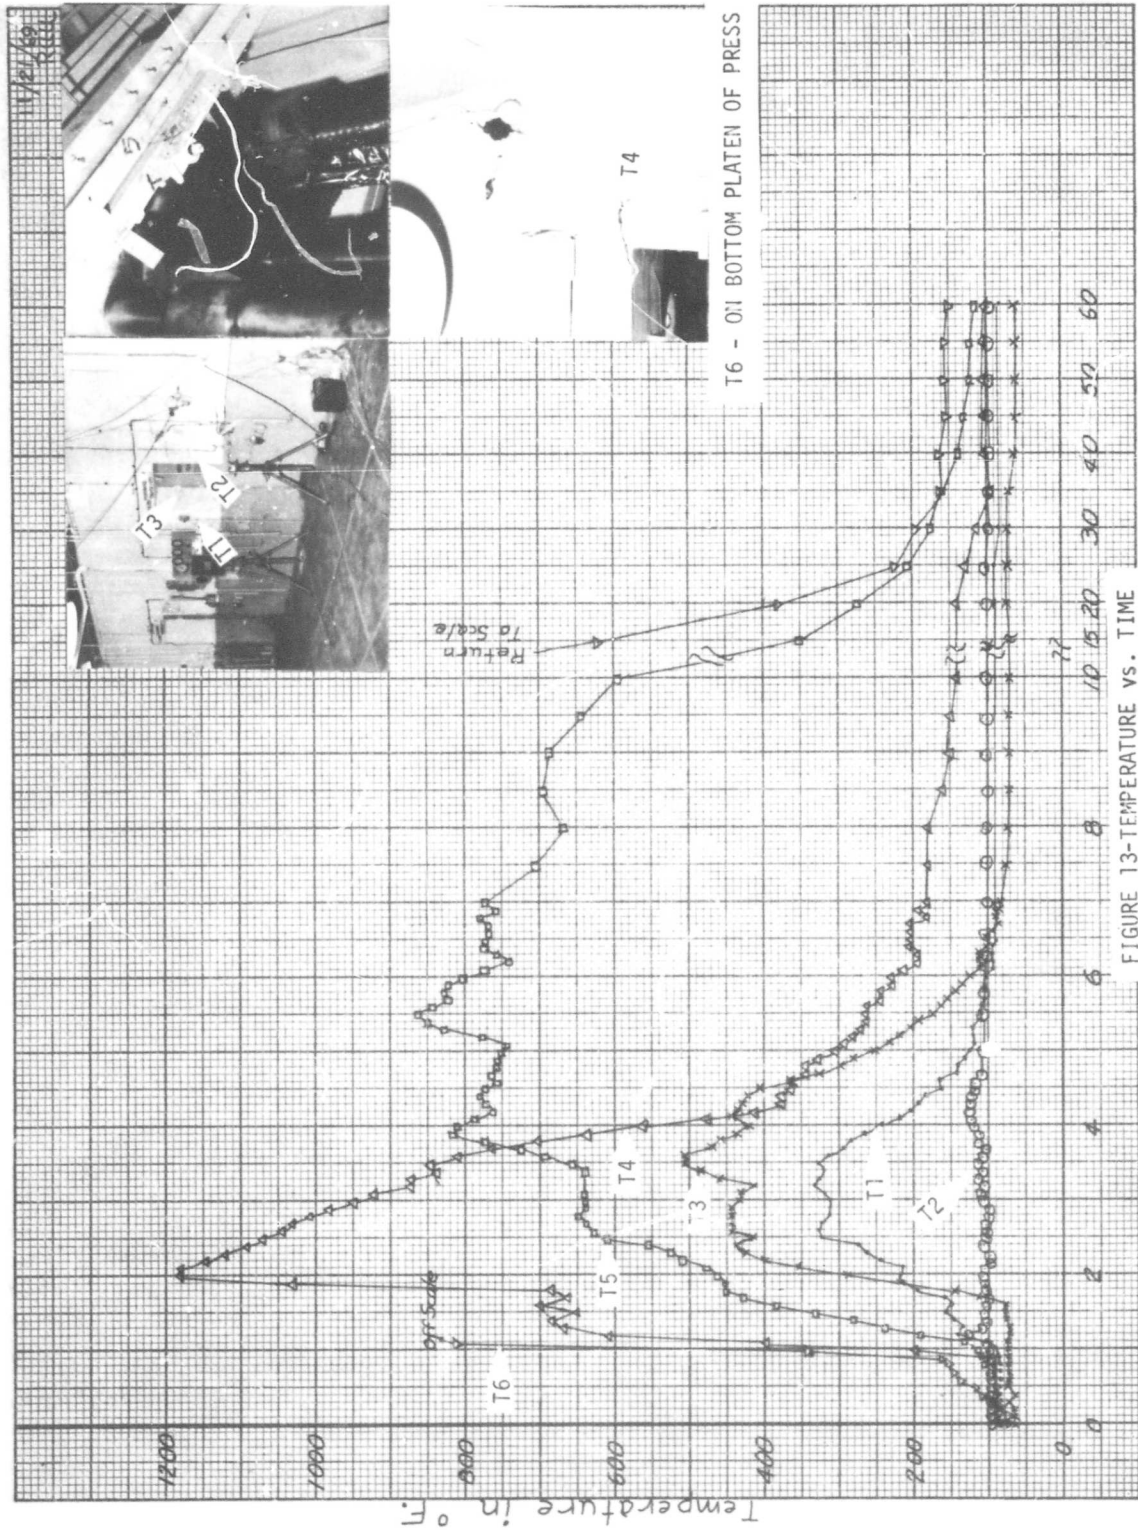
FIGURE 13-TEMPERATURE VS. TIME

4. The temperatures indicated by six thermocouples are shown in figure 13. T1 and T2 were located so as to record temperatures that would be endured by operating personnel. T1, on the right side of the cell door where the cutoff control is located, indicated a negligible temperature rise. T2, near the press controls, indicated 330°F for one second. The temperature rise and fall was fast, above 200°F for two seconds, and probably would not have burned a person seriously. The 16mm movie showed a large cloud of smoke coming through the gap on the right side of the door into the area where the highest outside temperature was recorded. The duration and location of the smoke cloud was quite similar to the duration and location of the highest temperatures, which indicates that closing the gaps around the cell door would further reduce hazards to operating personnel. T3, in the doorway on the left side, indicated a significantly higher temperature than T2. Since T3 was somewhat closer to the heat source, the higher temperature was expected. The high temperature recorded by T4 (inside cell at upper corner of door) of almost 1200°F is relatively short lived, showing a rapid decay of intensity as the combustion pressure inside the charge cylinder relieved. T5, near the top of the press, and T6, on the bottom platen, show overall intensity and duration of burning inside the cell.
