EXPERIMENTS TO DETERMINE DEBRIS FORMATION
FROM CORRUGATED STEEL AND BRICK WALLS

Final Report

January 1970

OCD Contract No. DAHC20-69-C-0129
OCD Work Unit No. 3313C

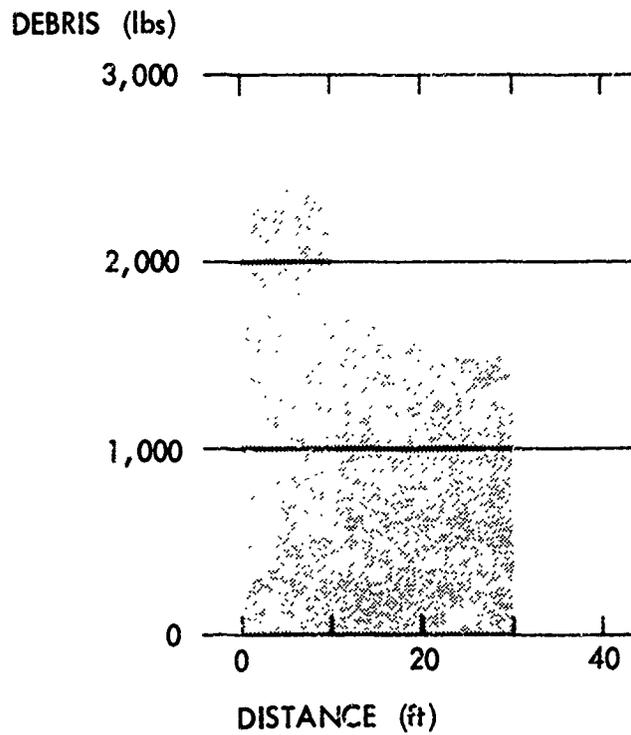
Debris Distribution, Wall Number 5

Results: The wall collapsed and debris scattered to 24 ft (See debris distribution chart below).

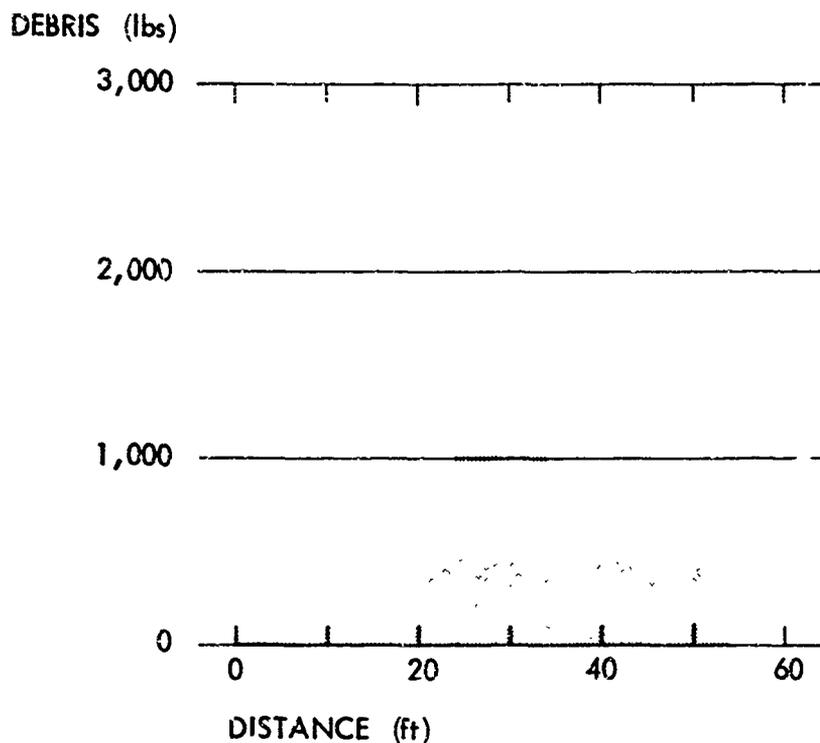
Debris Distribution, Wall Number 6

Results: First cracks appeared as horizontal lines at heights of ~ 4 and ~ 6 ft. The wall failed and debris scattered to 54 ft. (See debris distribution chart below).

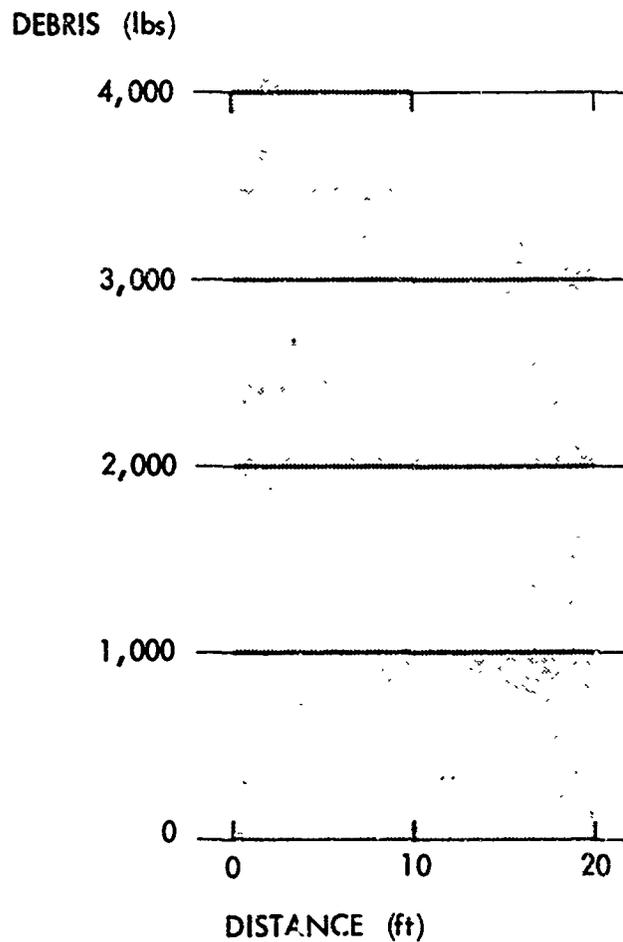
Debris Distribution, Wall Number 7

Results: The initial crack appeared horizontally at a height of ~ 4 ft. The wall failed and debris scattered to 19 ft. (See debris distribution chart below).

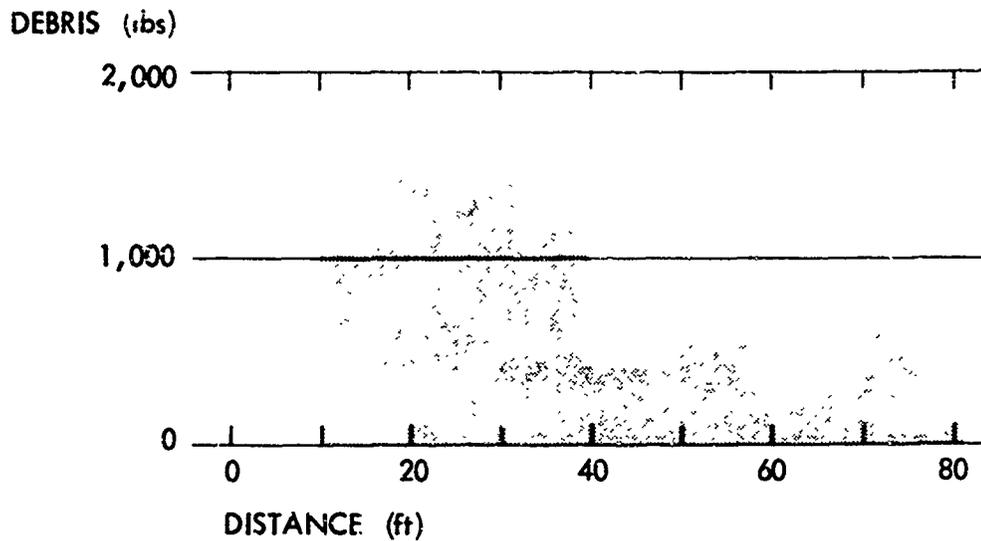
Debris Distribution, Wall Number 20

Results: Two essentially horizontal cracks occurred initially at heights of ~ 3 and ~ 5 ft. The wall failed, scattering debris to ~ 80 ft. (See debris distribution chart below).

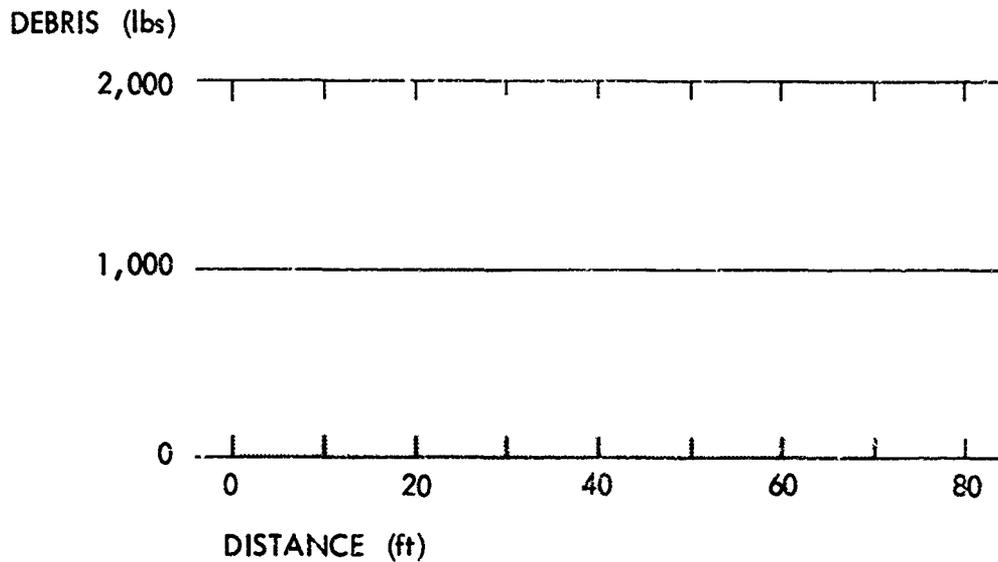
Debris Distribution, Wall Number 22

Results: Two initial horizontal cracks were noted at heights of ~3 ft and 6.5 ft. The wall failed and scattered debris to 70 ft. (See debris distribution chart below).

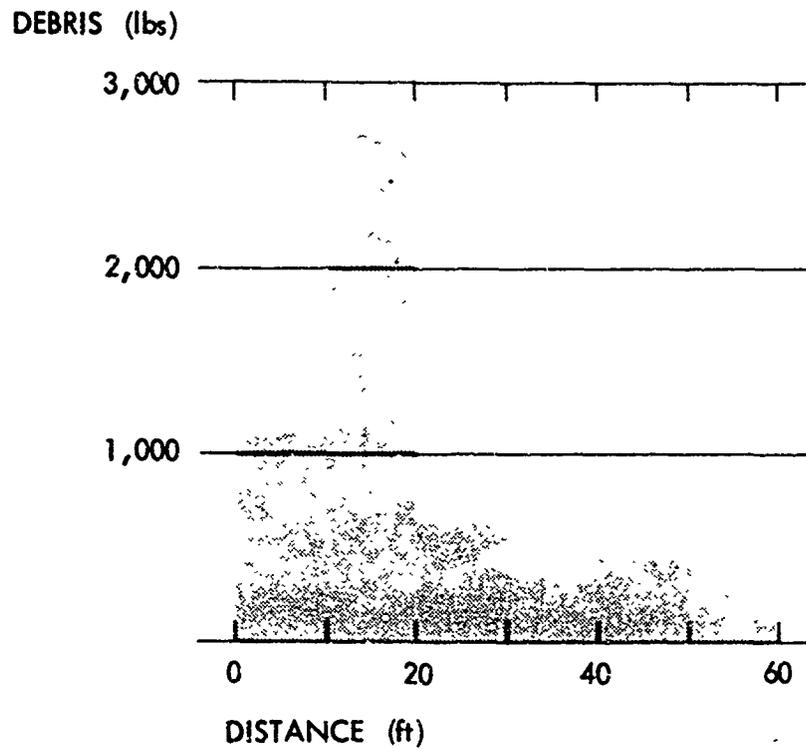
Debris Distribution, Wall Number 23

Results: Initial cracks formed as shown in sketch below. The wall failed, and debris was scattered to 57 ft. (See debris distribution chart).

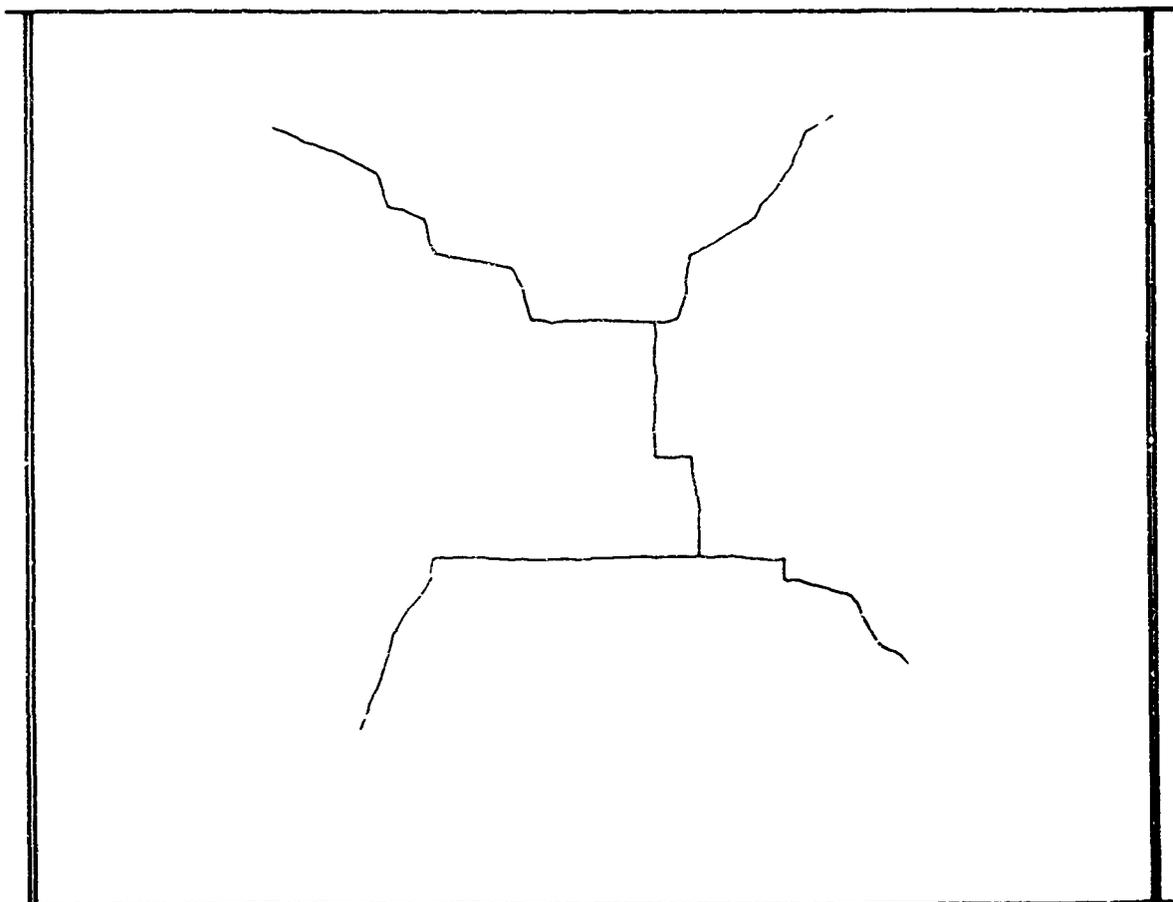
Results: The wall cracked as shown in the sketch below but did not collapse. (The wall failed on second test at 3.0 psi peak reflected overpressure).

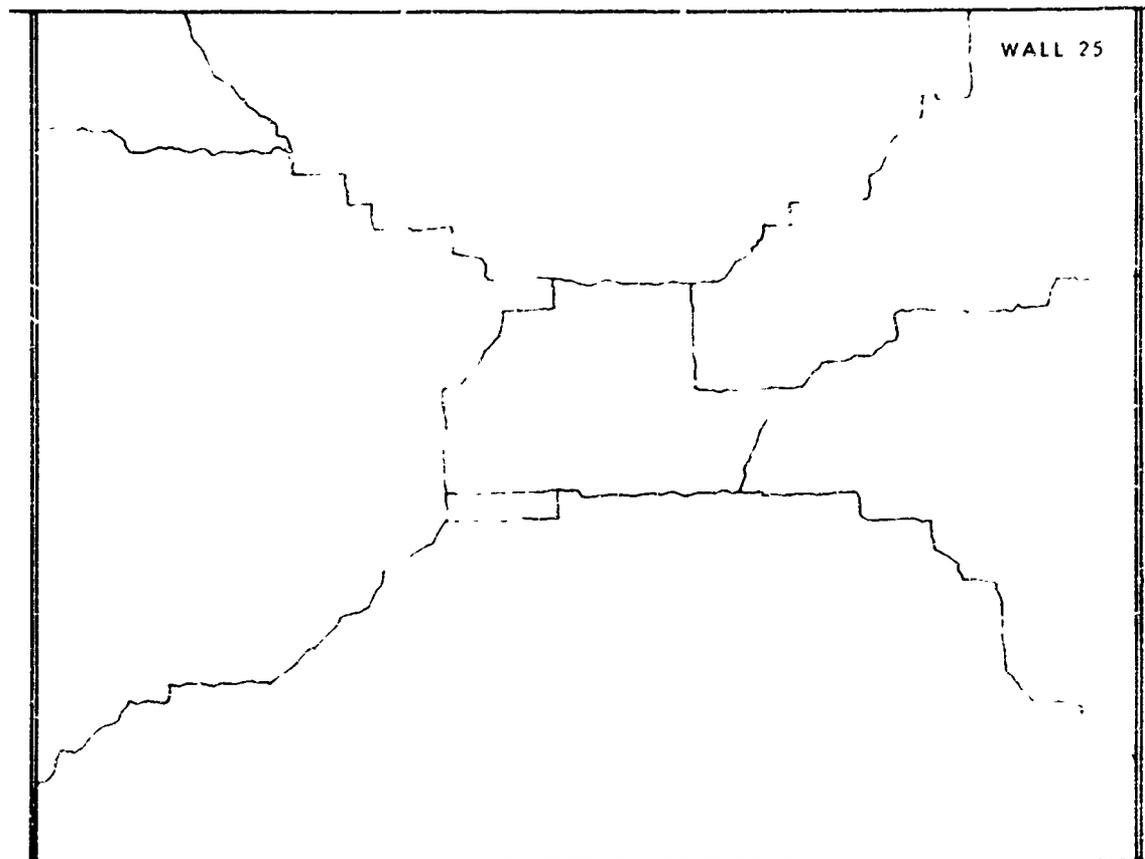
Results: Wall cracked as shown in sketch below but did not collapse.

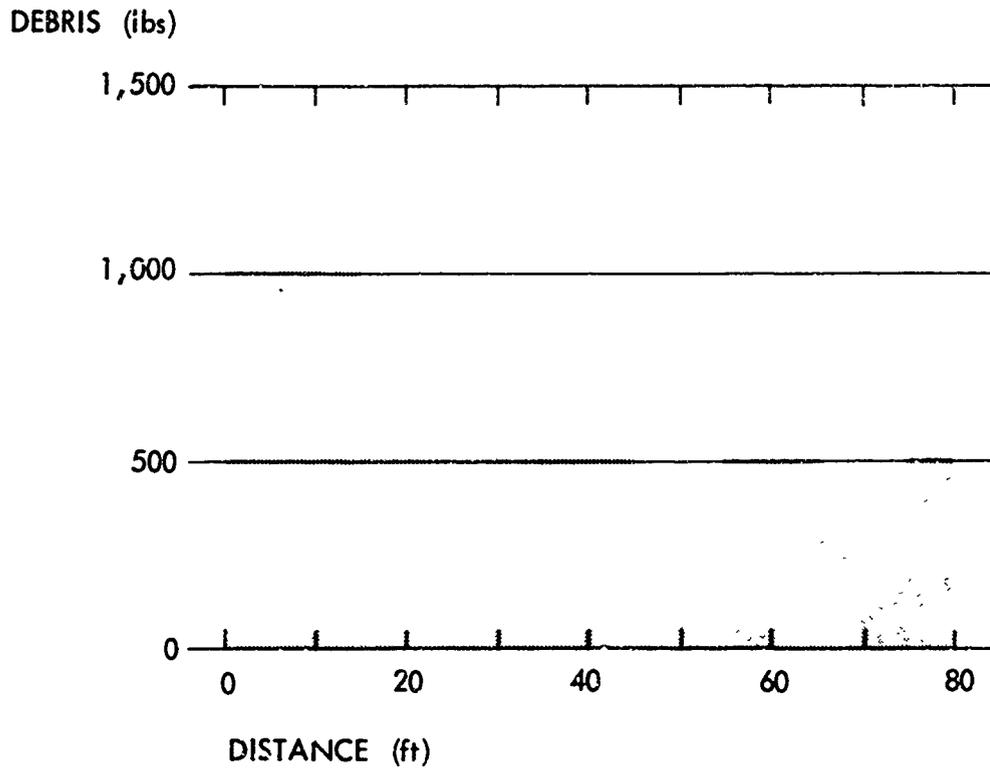
Debris Distribution, Wall Number 26

Results: The wall failed, and debris scattered to 80 ft. (See debris distribution chart below).

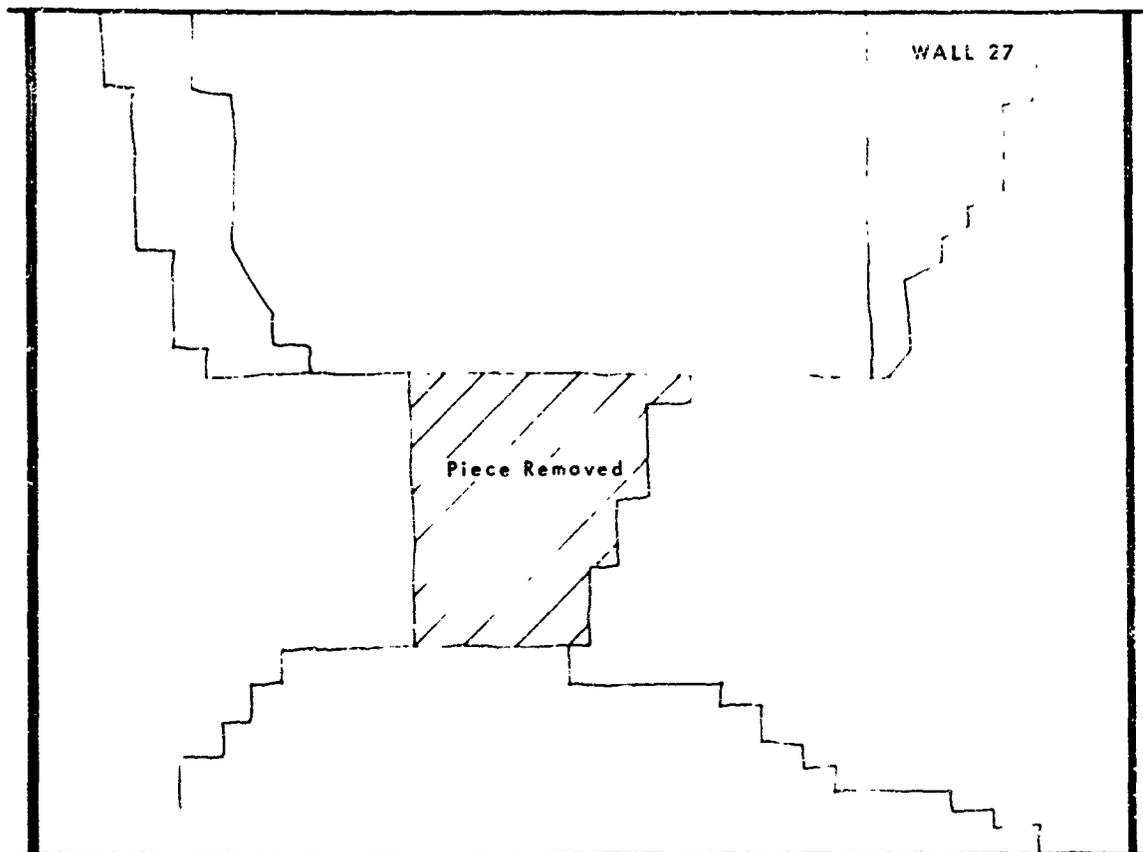
Results: The wall cracked, and a section weighing ~ 500 lb fell out of the center. The remainder of the wall stayed in place. (See crack pattern sketch below).

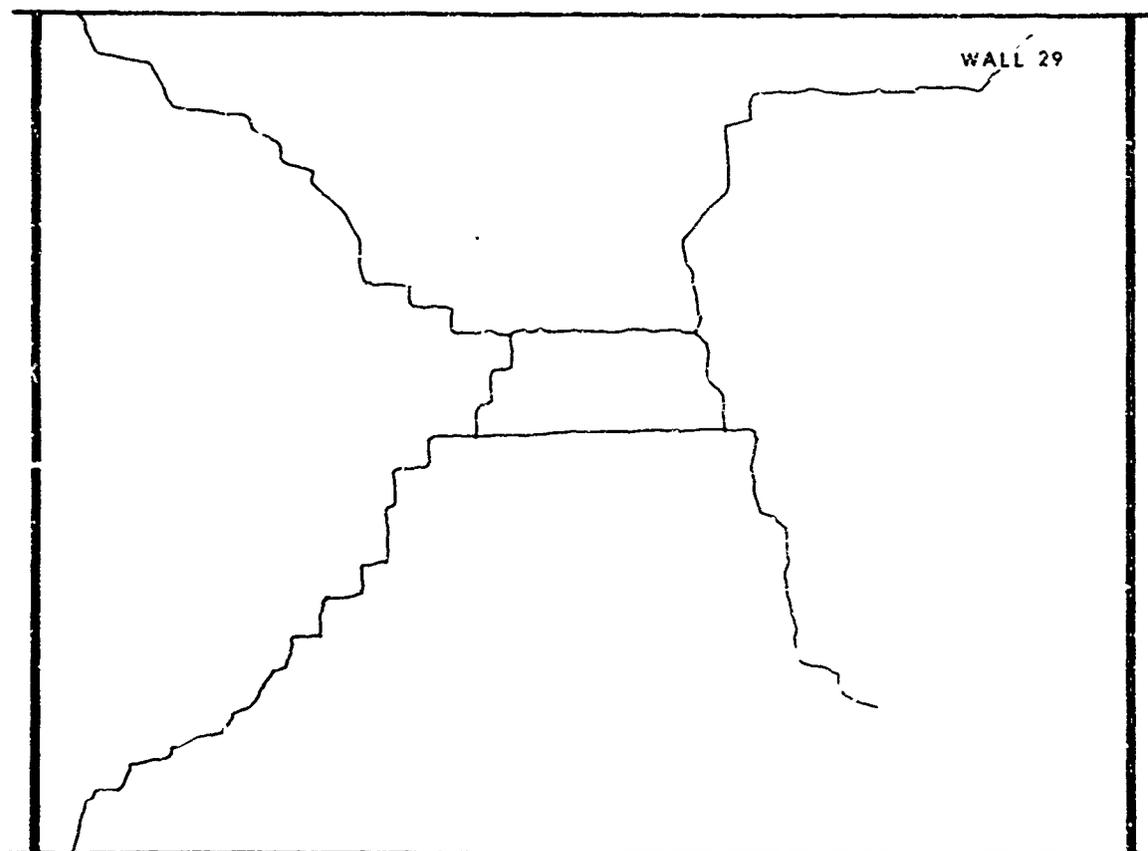
Results: The wall cracked but did not collapse. (See crack pattern sketch below). A second test on this same wall at a peak reflected overpressure of 4.2 psi caused about 350 bricks to fall out of the wall, all landing within 10 ft.

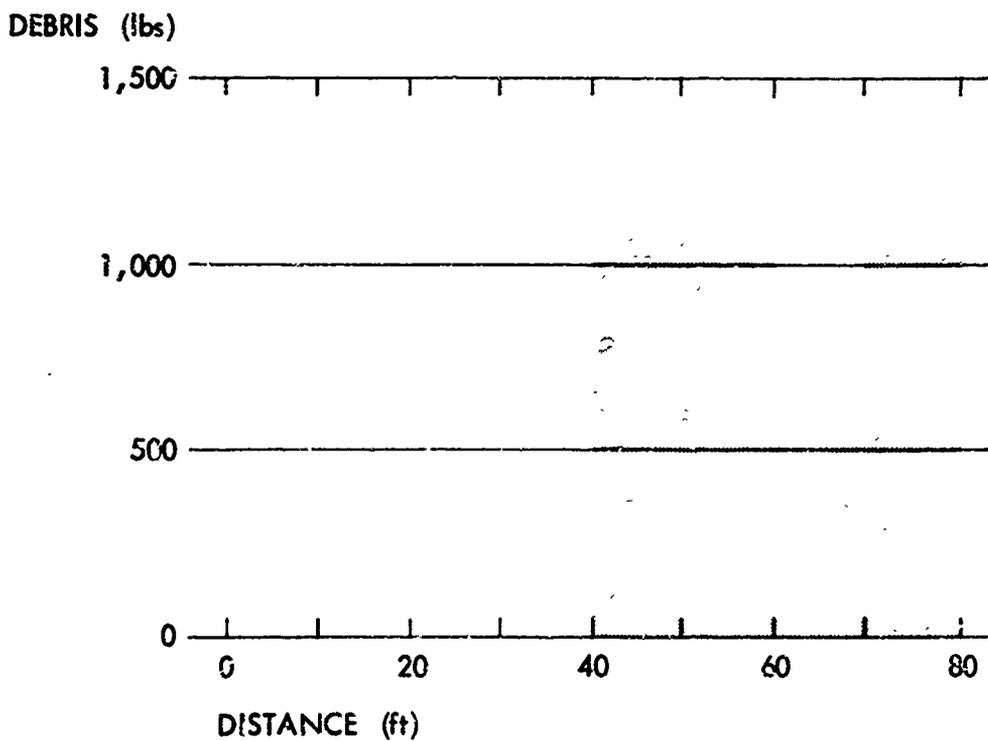
Debris Distribution, Wall Number 30

Results: The wall failed and debris scattered more than 70 ft. (See distribution chart and initial crack pattern sketch below).

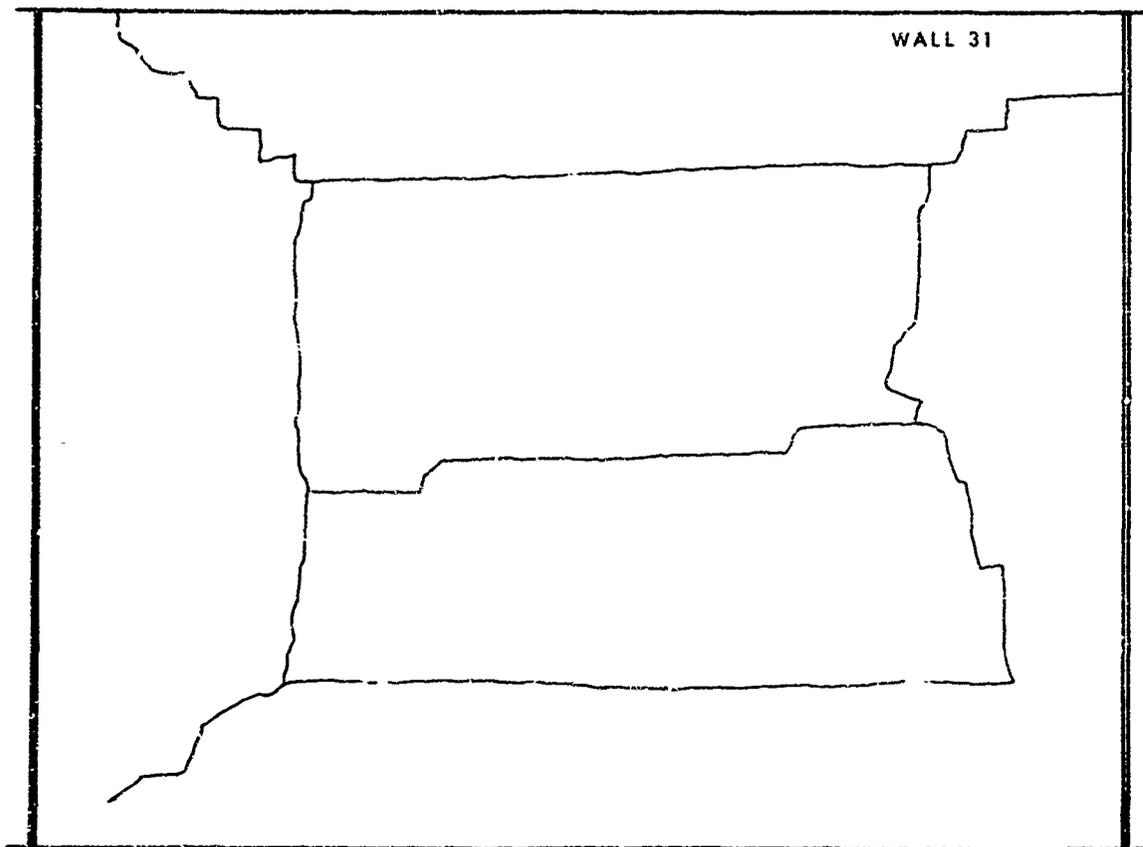
Results: The wall failed. (See initial crack pattern sketch.)
