TECHNICAL REPORT N-70-10

**SURVEY OF GULF COAST  
STRUCTURAL DAMAGE RESULTING FROM  
HURRICANE CAMILLE, AUGUST 1969**

Final Report

April 1970

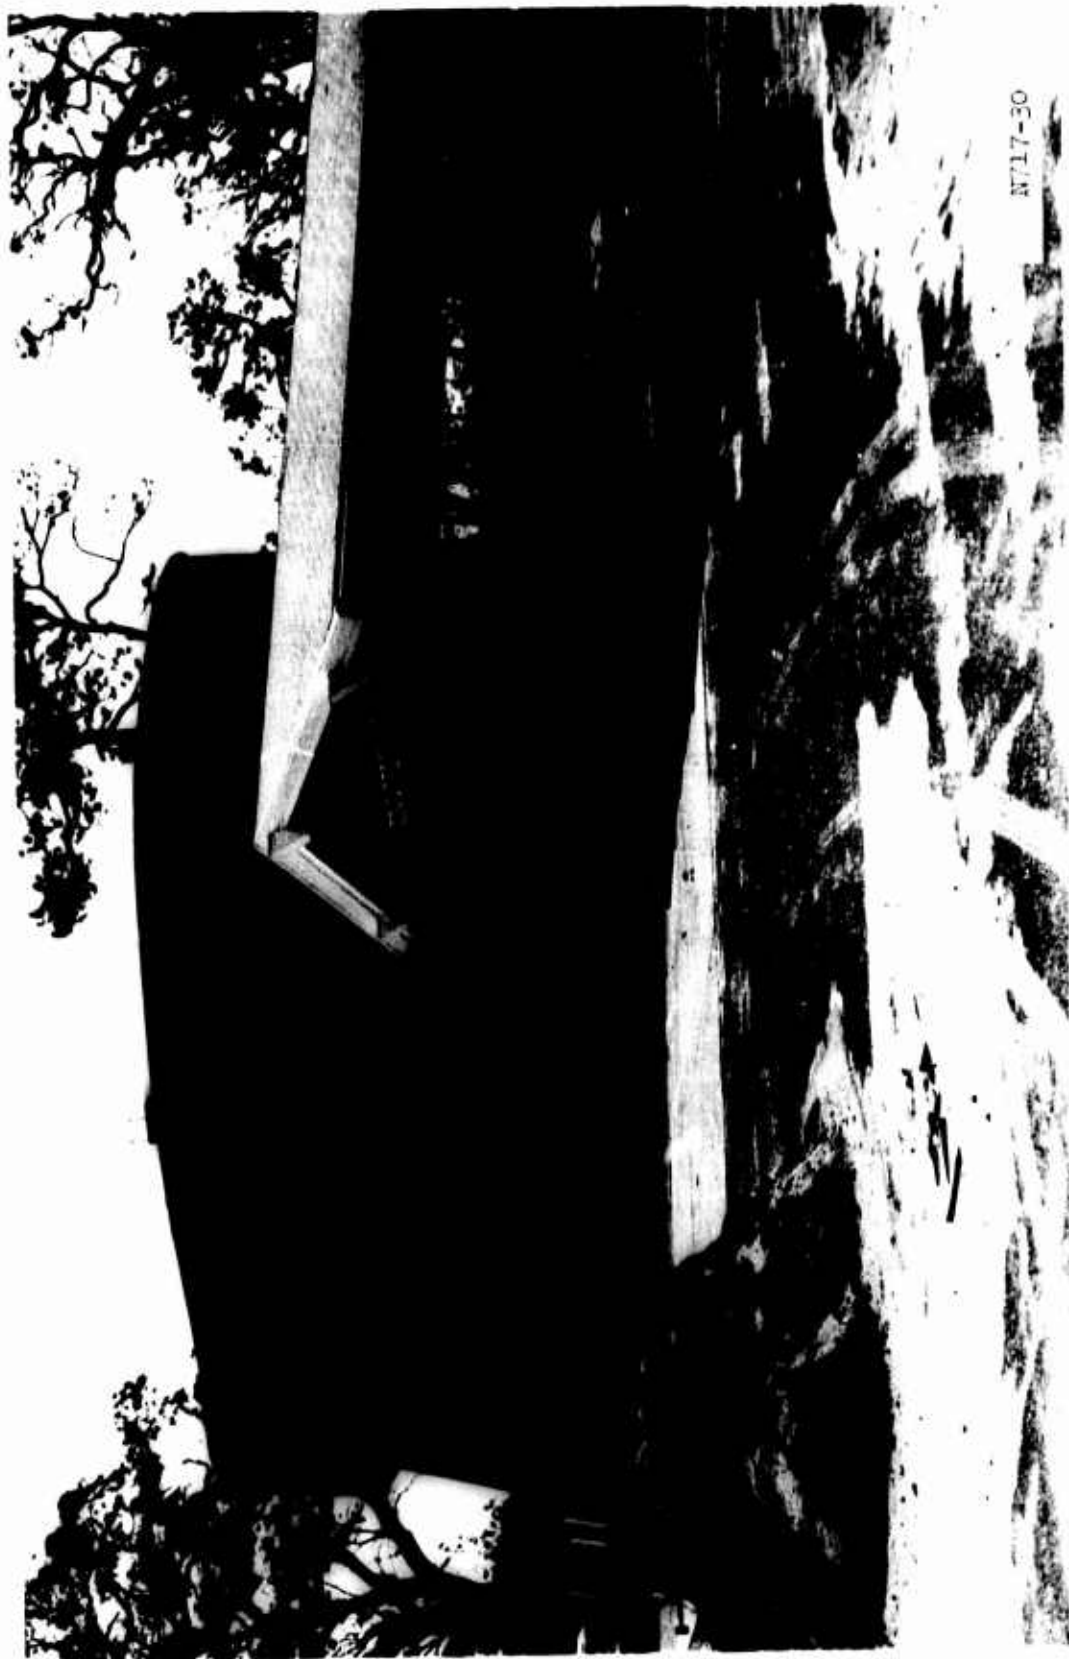
Figure 2.30 Tank floated in from harbor, west Gulfport, Mississippi.

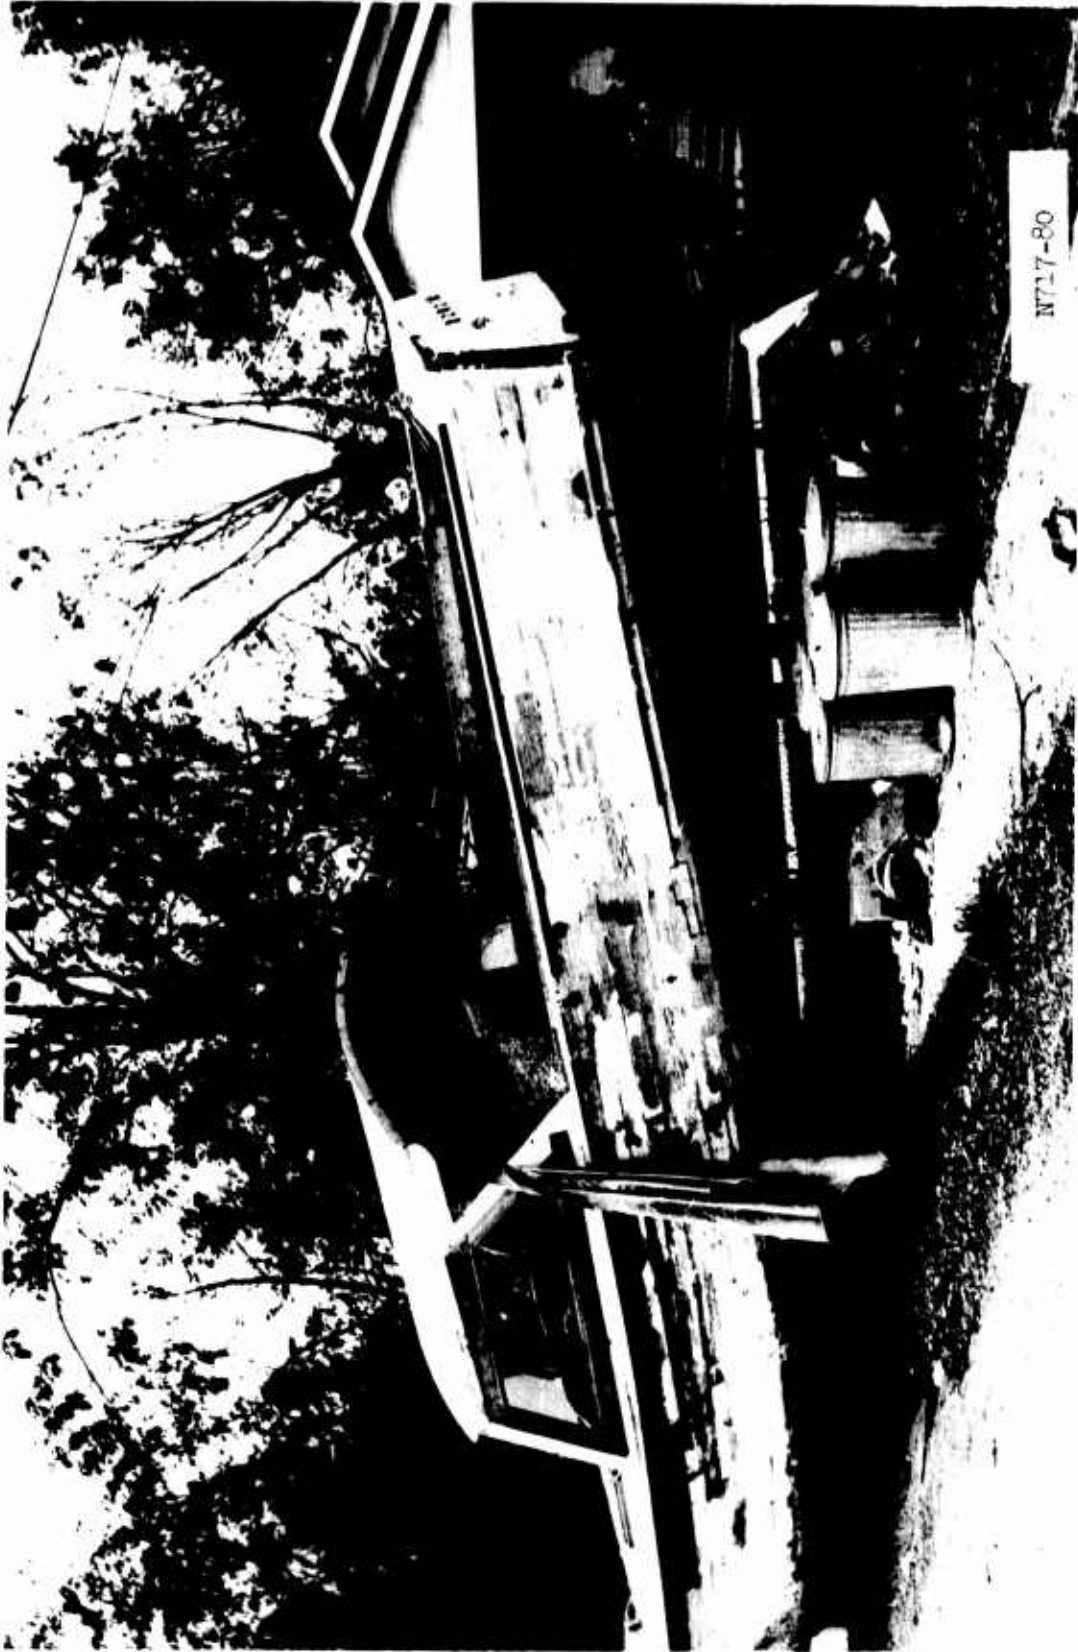
Figure 2.36 Boat ashore, east end of Biloxi, Mississippi.

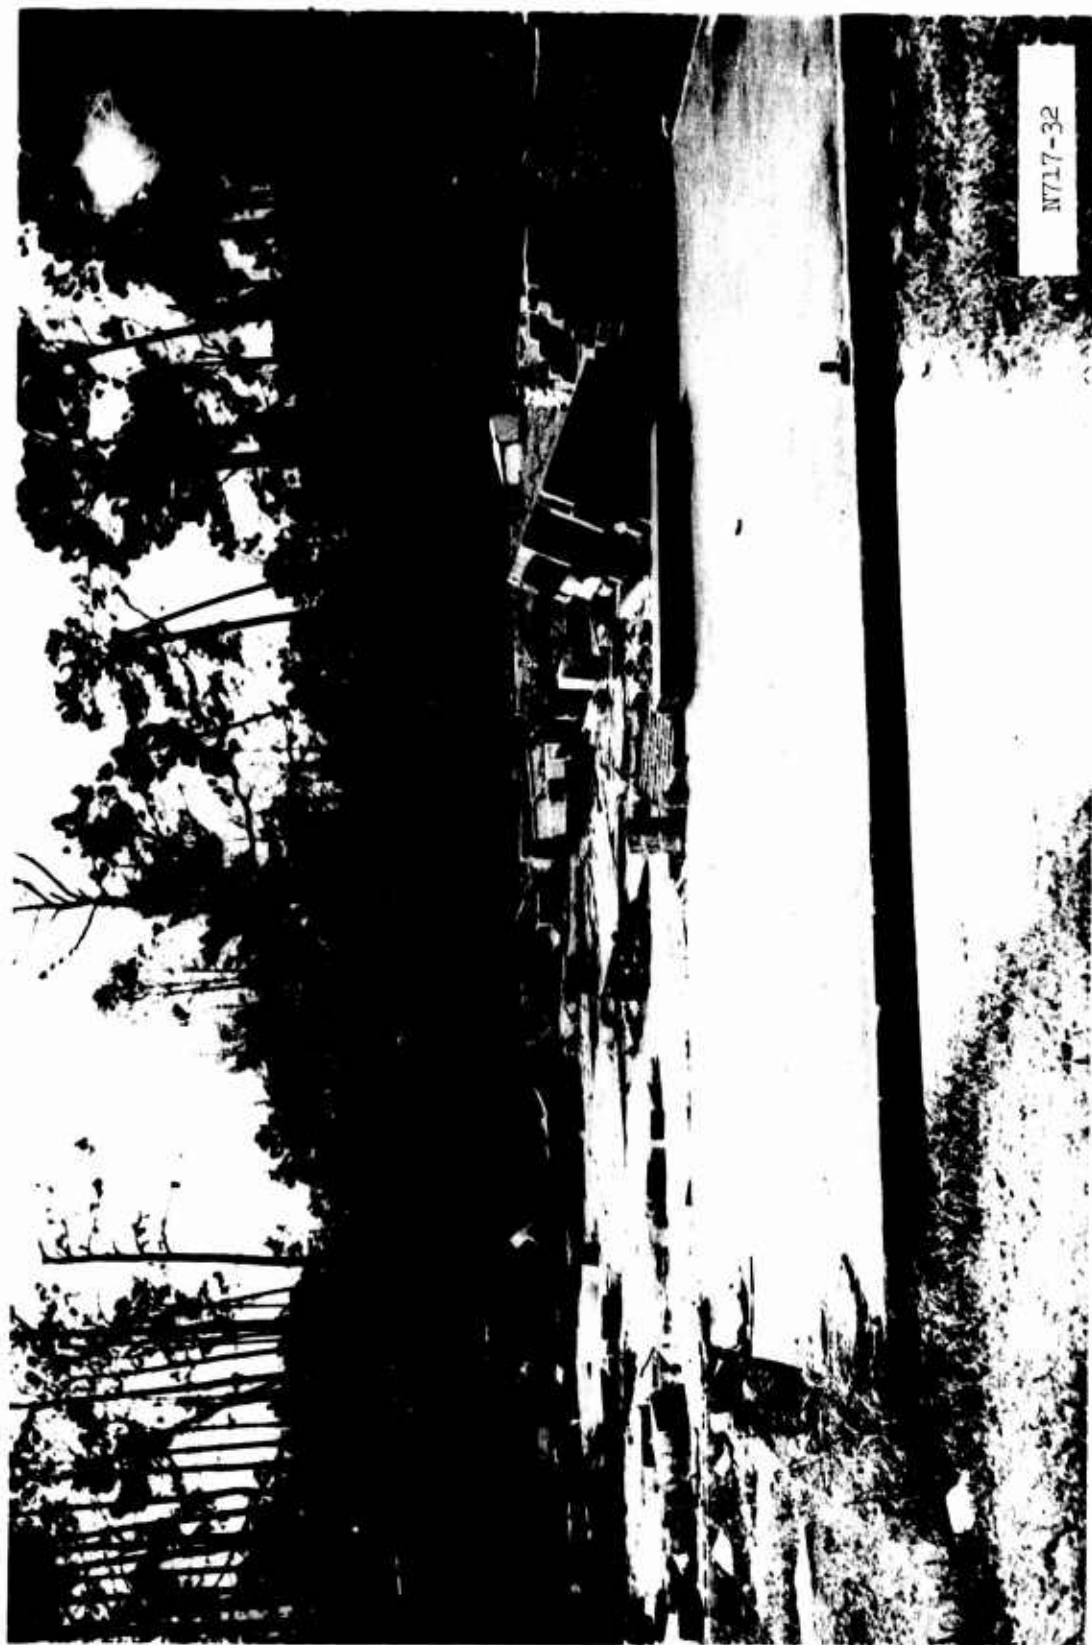
Figure 2.40 Remains of brick and block residence, Long Beach area.

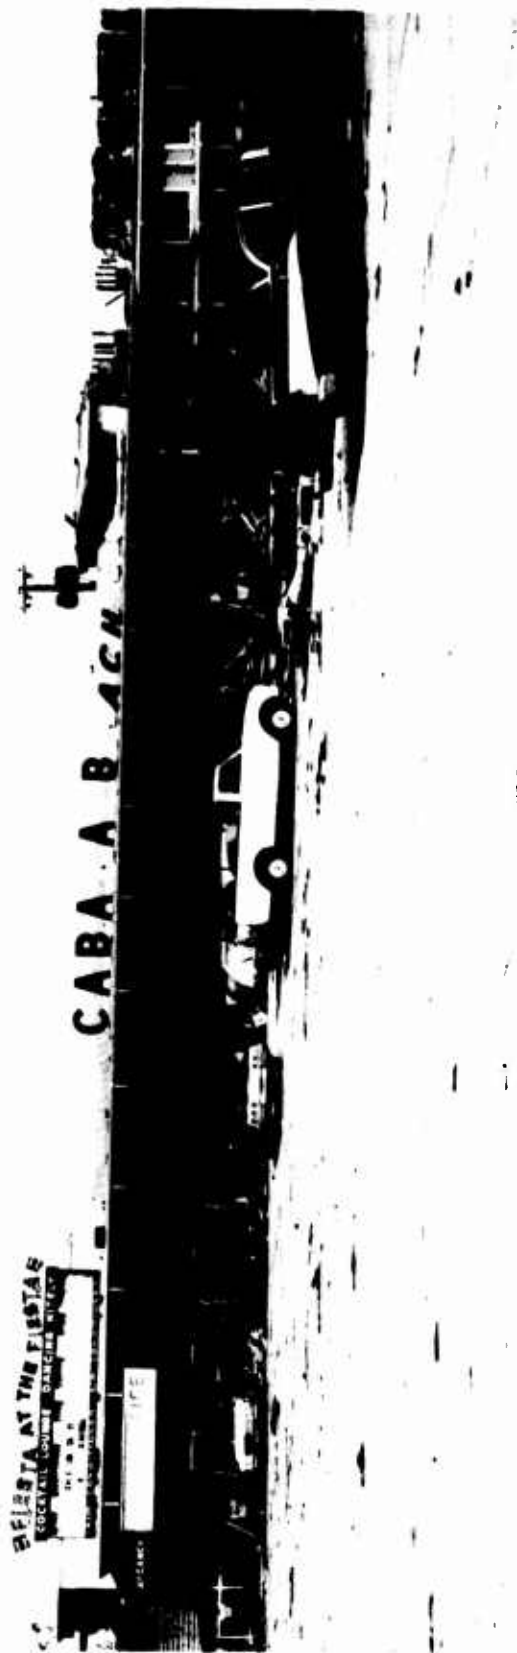
N717-79

Figure 2.52 Frame motel structure, Biloxi, Mississippi. There had been fire damage before the storm to the building shown at the right.

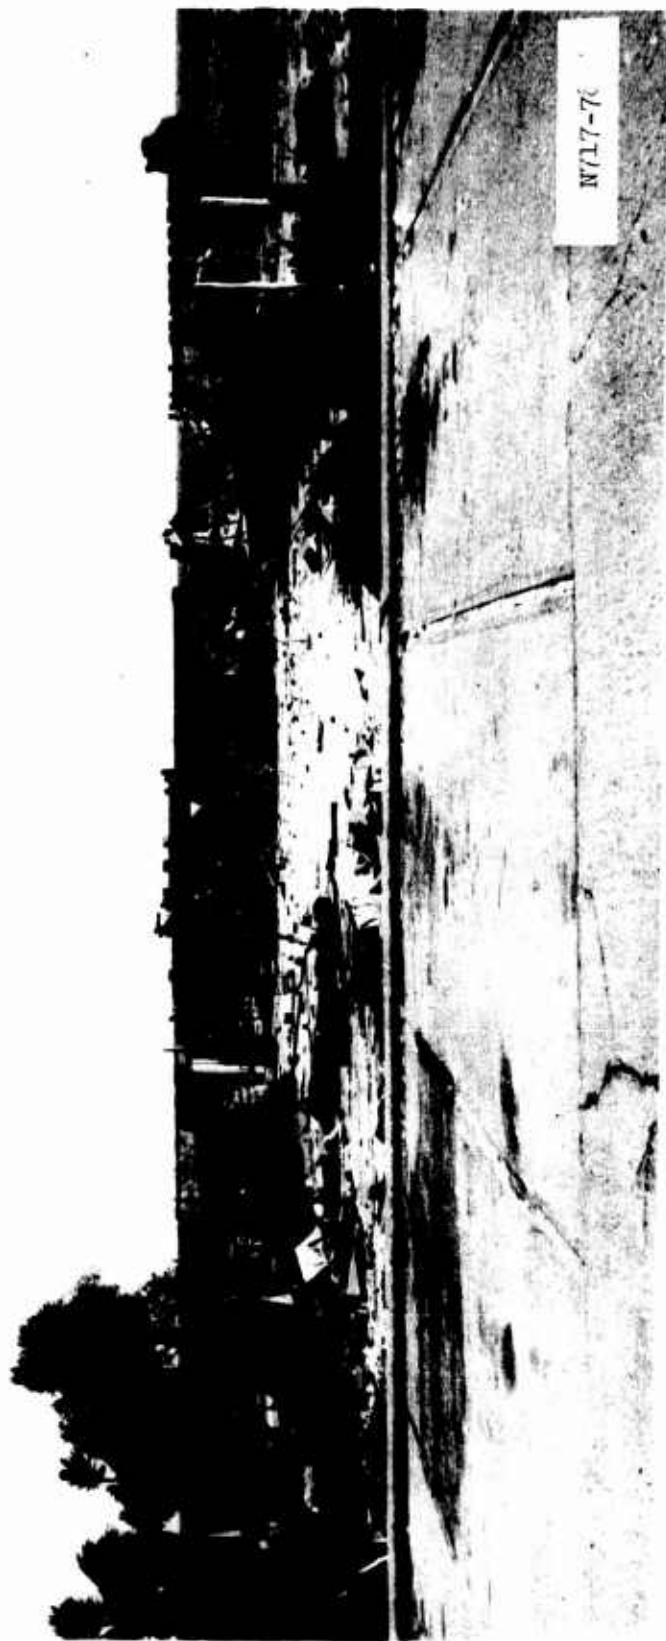
Small concrete frame buildings were not numerous. The walls and roofs usually failed before the frame. Figure 2.53 shows one such building.

Figure 2.53 Concrete frame restaurant, Biloxi, Mississippi.
