Special Report 150

CAMP CENTURY REVISITED A PICTORIAL VIEW-JUNE 1969

Austin Kovacs

July 1970

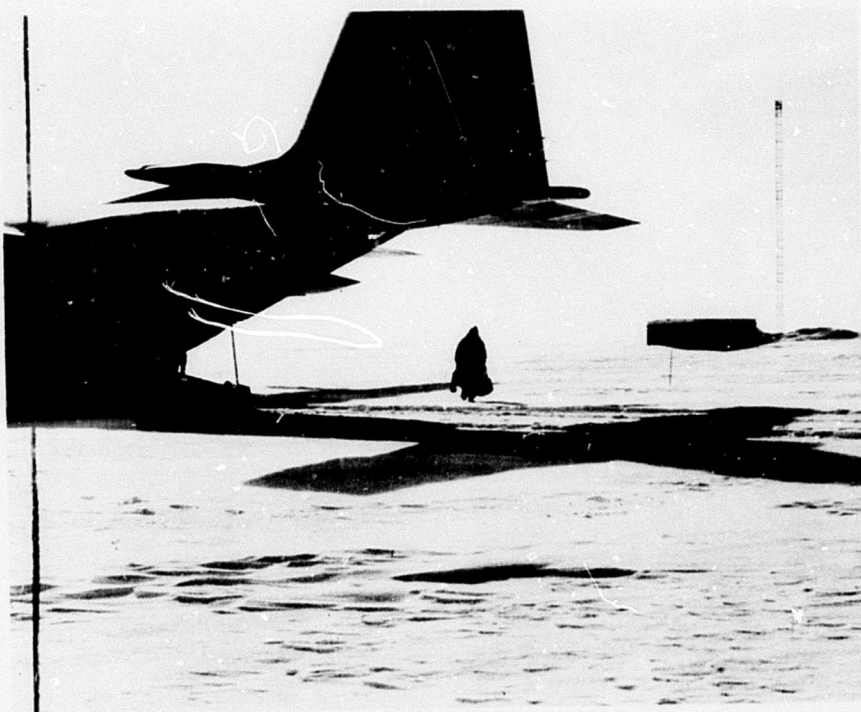
Figure 3. Arrival day. The structure protruding above the snow surface was built in 1964 on piles and was at that time 12 ft above the surrounding snow surface (see Fig. 4). This facility was occupied by the 1967 and 1969 field parties. In the background is the Sig. Met Tower.

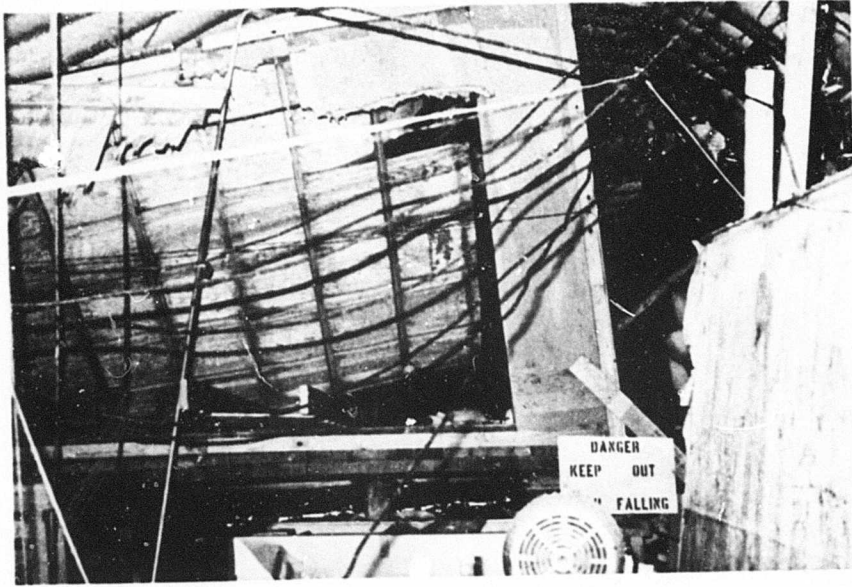
Figure 13. Snow load from above deforms metal arch, crushing wooden structure in Trench 2.

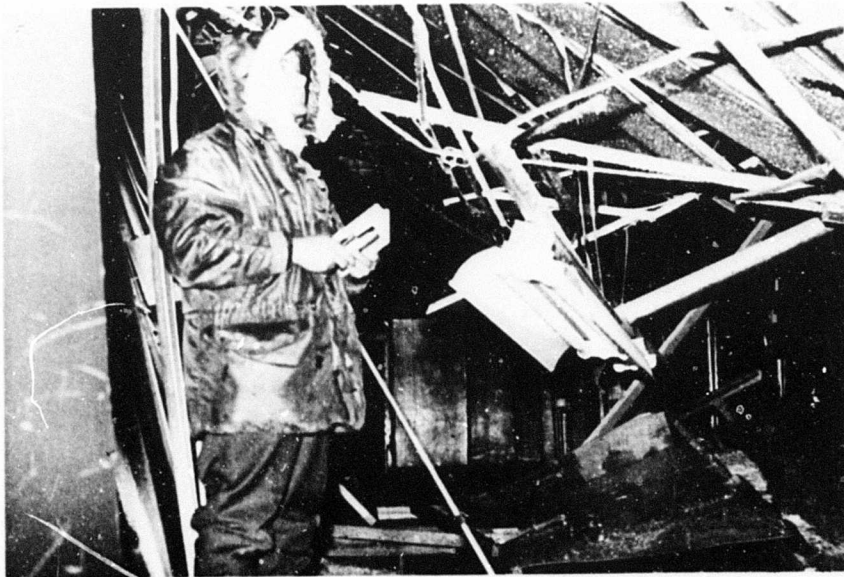
Figure 14. Crushing of wood and steel reactor building in Trench 3.

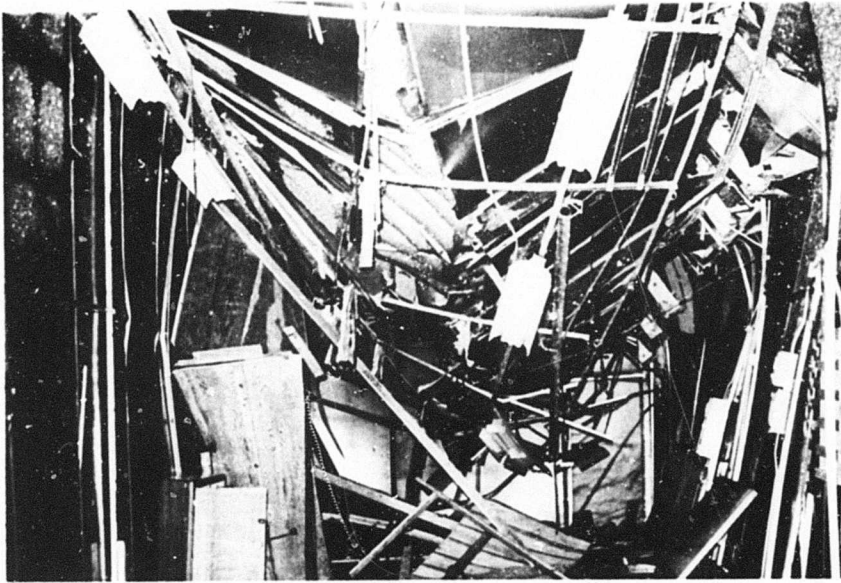
Figure 15. Snow-loaded arch pushes through roof of a reactor building in Trench 3.

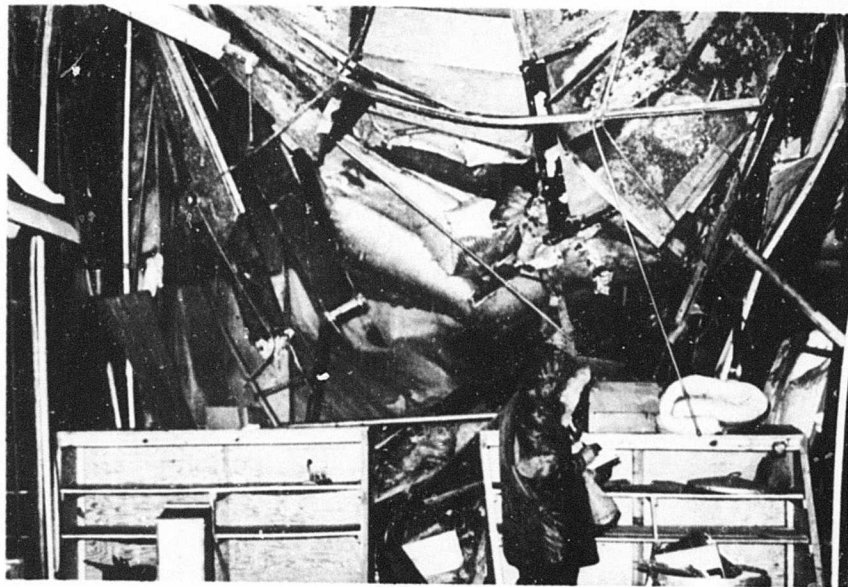
Figure 17. Metal arch pushing through roof at west end of reactor building (Trench 5).

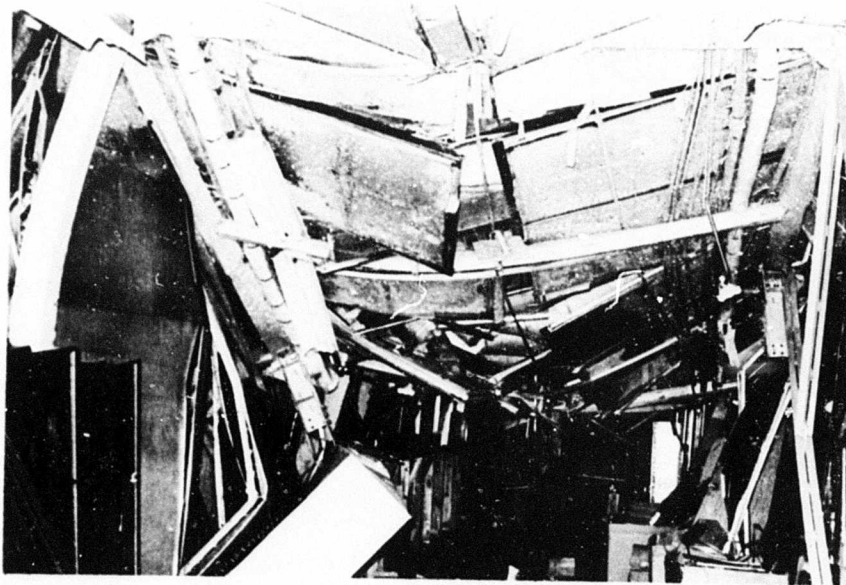
Figure 18. Deterioration of reactor building (Trench 5).

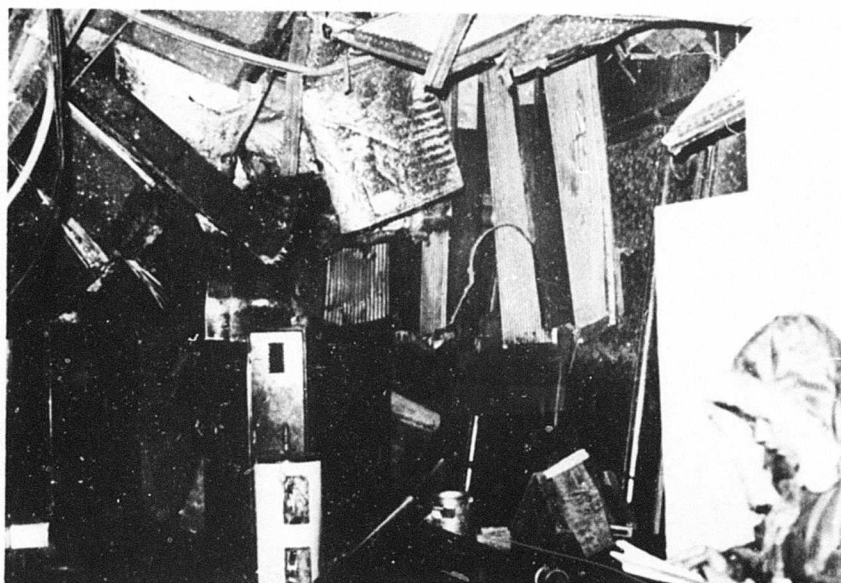
Figure 19. Deterioration of reactor building (Trench 5).

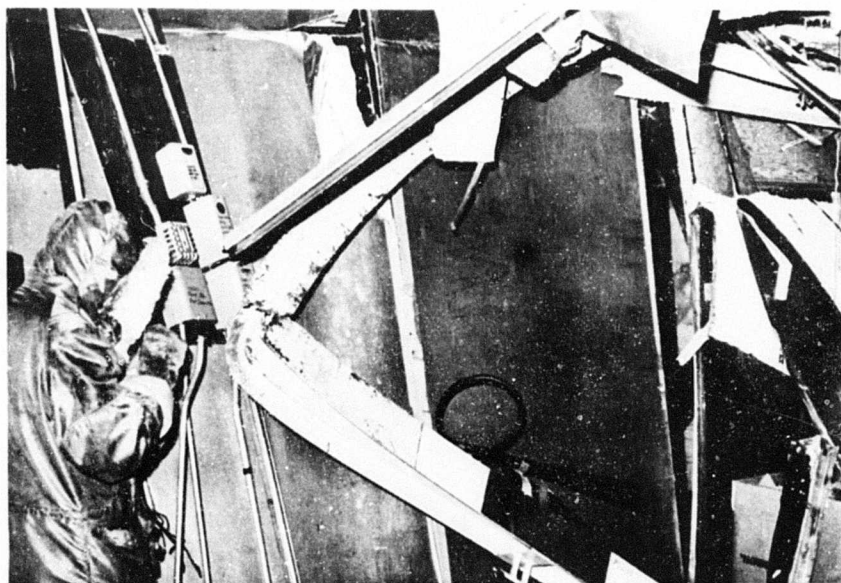
Figure 20. Torn and twisted steel (Trench 5).

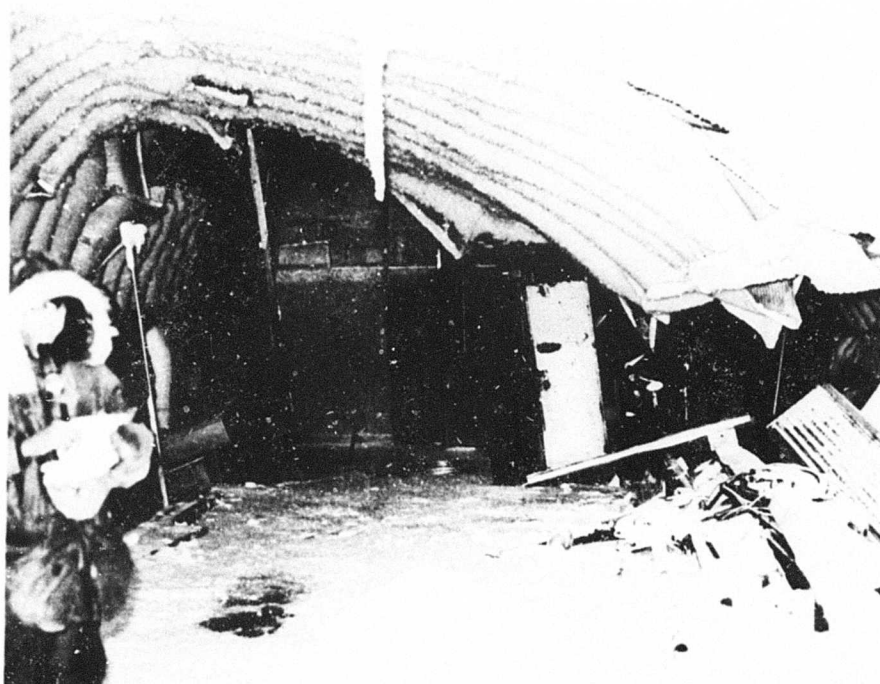
Figure 21. Metal arch buckling (Trench 5).

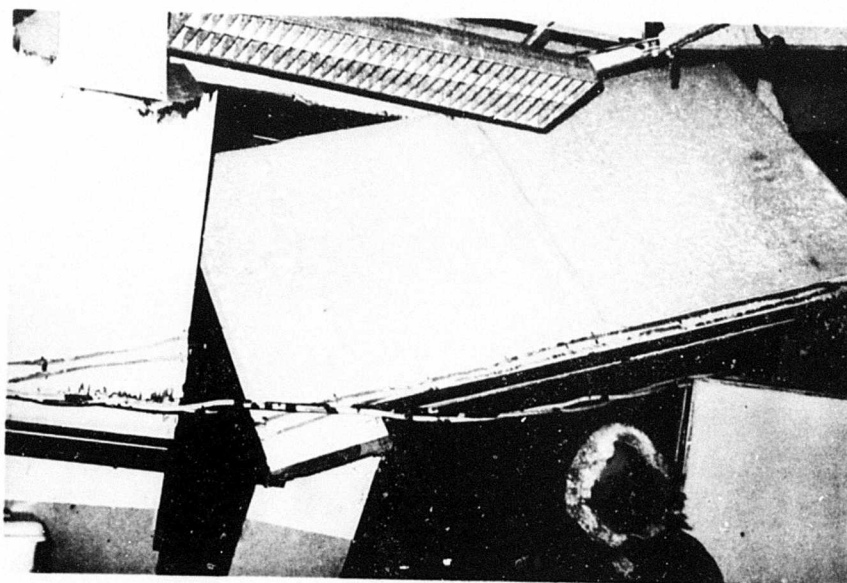
Figure 25. Wall and ceiling destruction in mess hall.

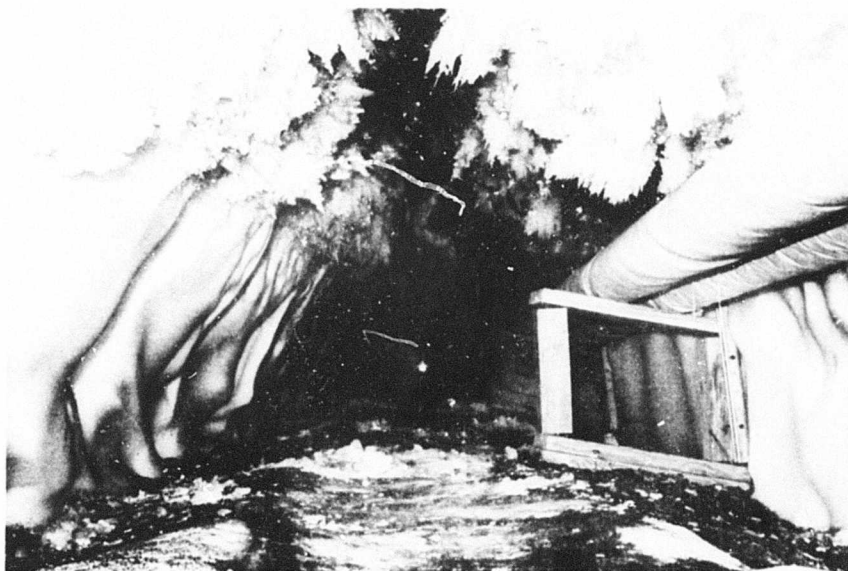
Figure 29. Where a man could once walk upright, only a crawl space exists in the passageway to water well 2.

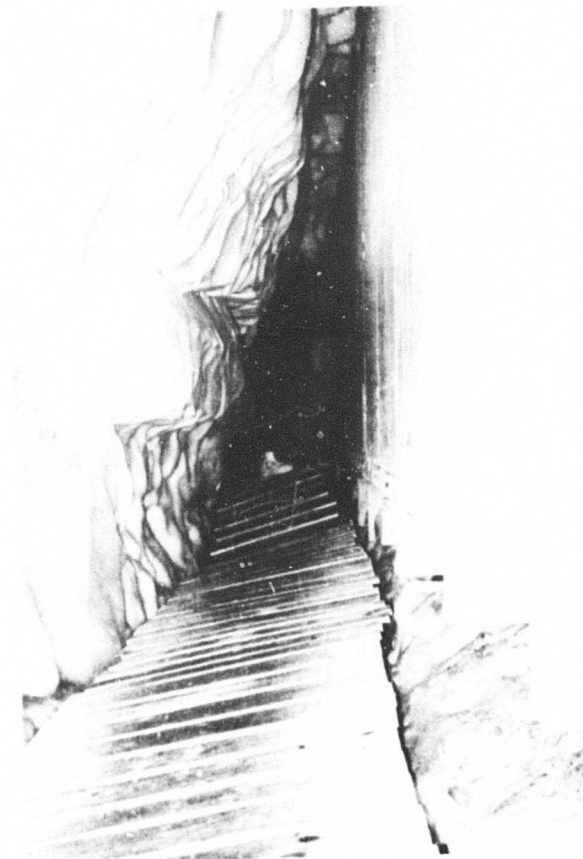
Figure 35. Trench floor arching causes board walkway to tilt (Trench 7).

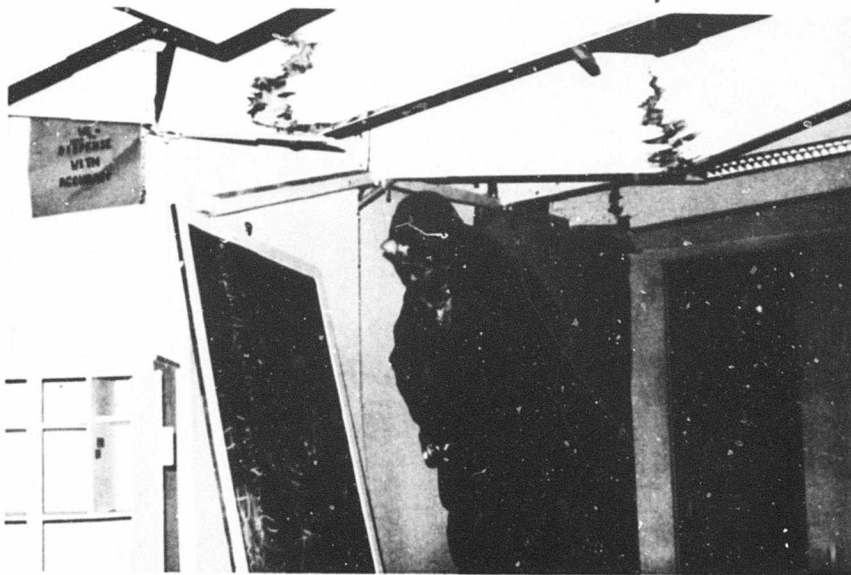
Figure 37. Overloaded ceiling joists in dispensary.

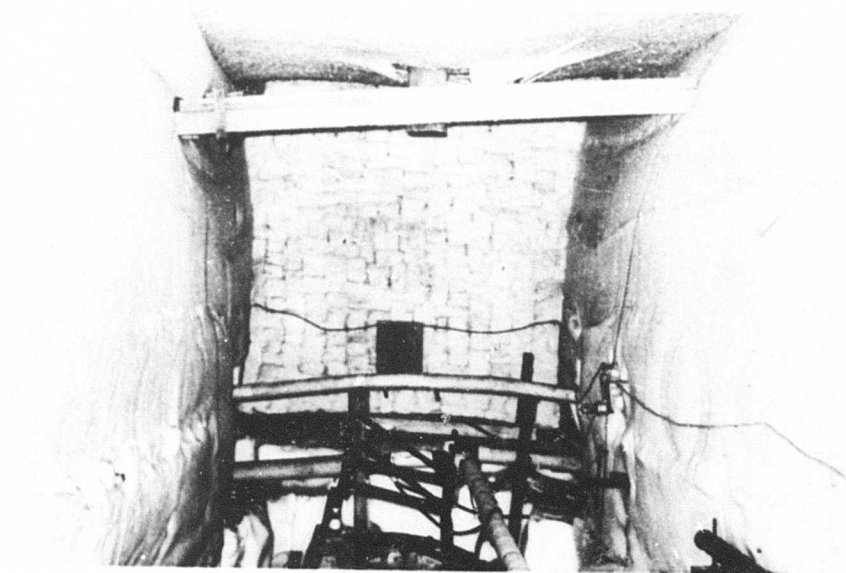
Figure 39. Snow deformation in Trench 8 causes pipeline to buckle.

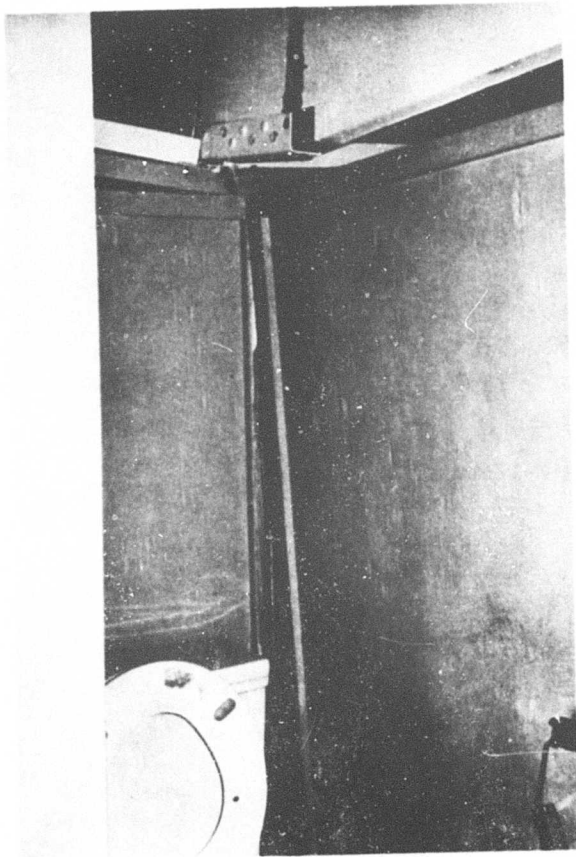
Figure 43. Ceiling and wall deterioration.

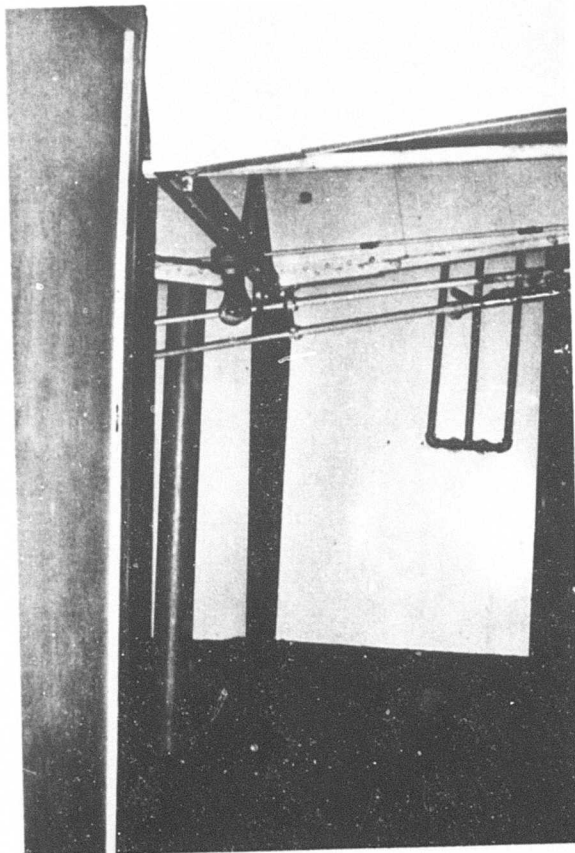
Figure 44. Roof deformation pushes shower stalls apart.

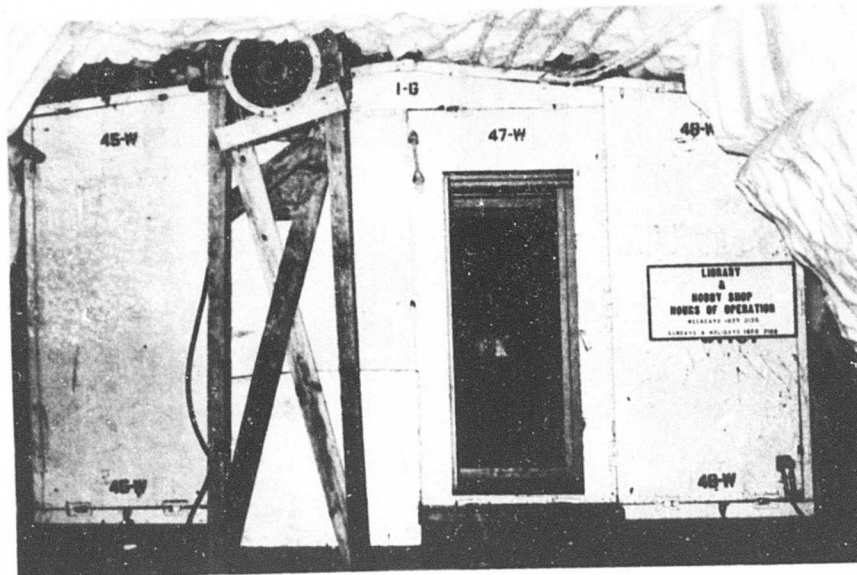
Figure 45. Snow encroaching on hobby shop and fan mounted on wooden framework.

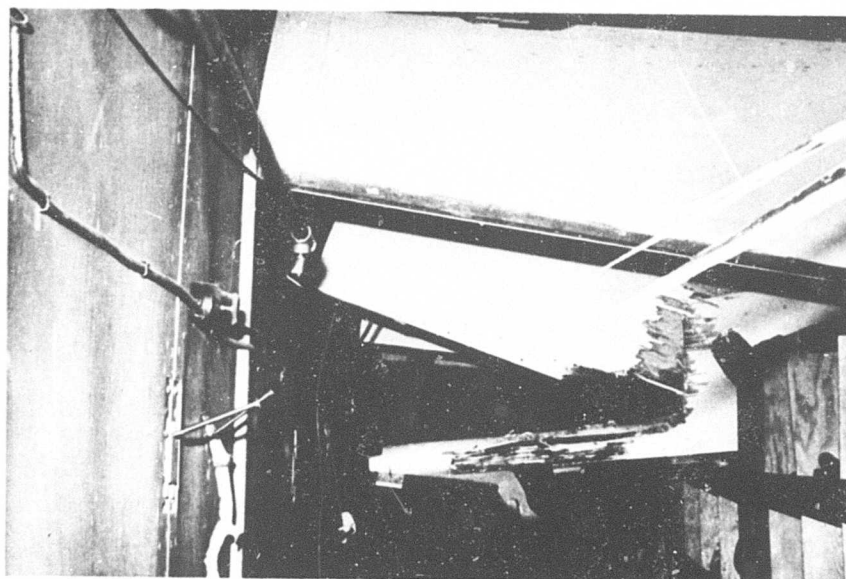
Figure 50. Split ceiling joist in R & U shop.

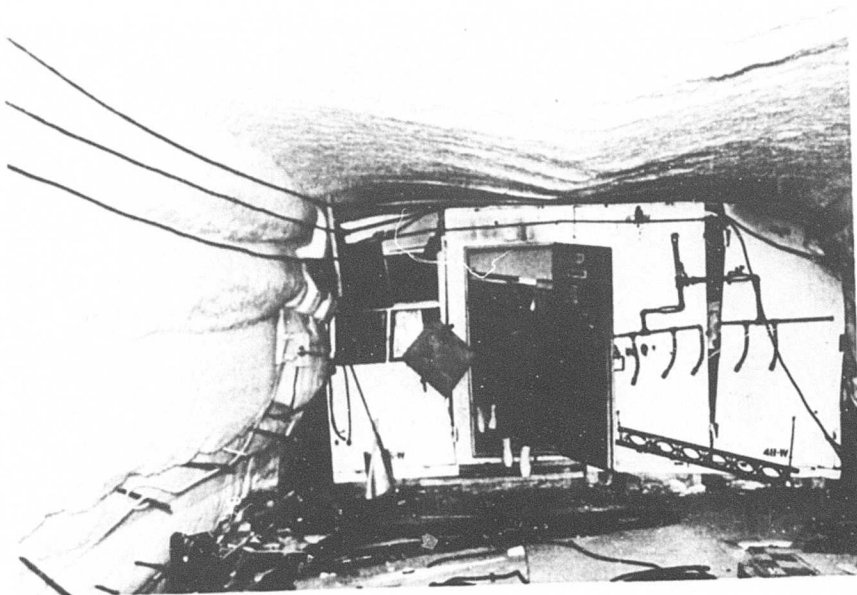
Figure 52. Back entrance to R & U shop. Note displaced wall panels.

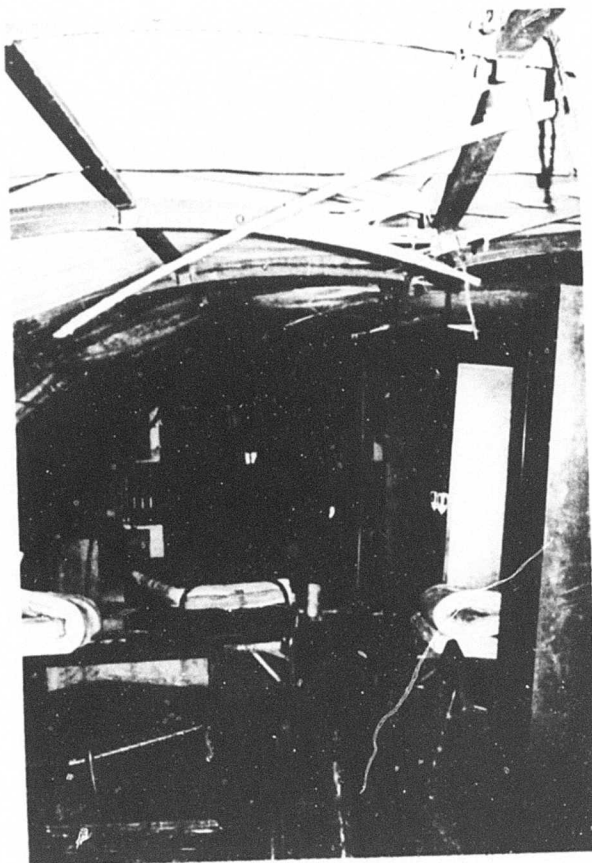
Figure 53. Interior view of Jamesway, Trench 10. Note floor panel being displaced by effect of trench floor arching.

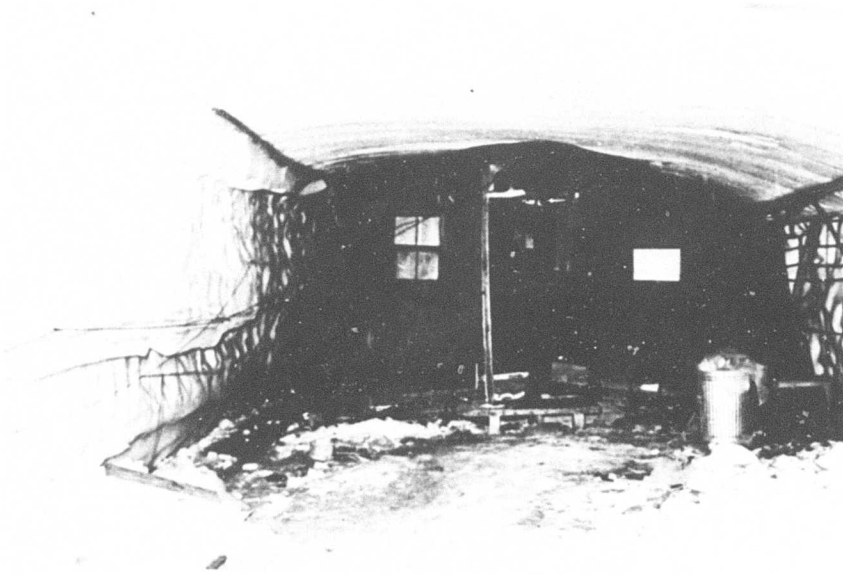
Figure 58. Jamesway Lab. Note effect of trench floor arching on Jamesway floor panels.

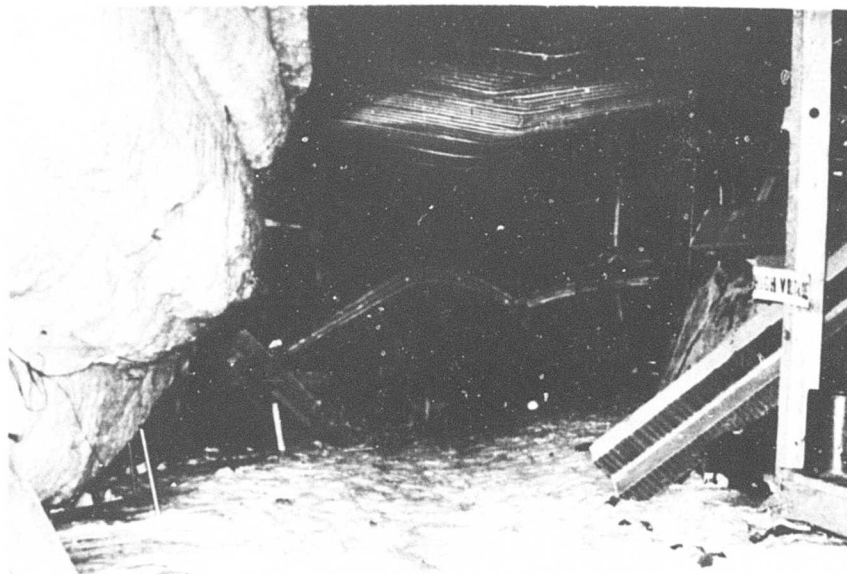
Figure 60. The floor and end wall panels of this plastic building known as the CRREL Lab were removed in 1966 to allow the removal of drilling equipment from the rear of Trench 12. The wall-roof panels later collapsed under excessive snow loading.

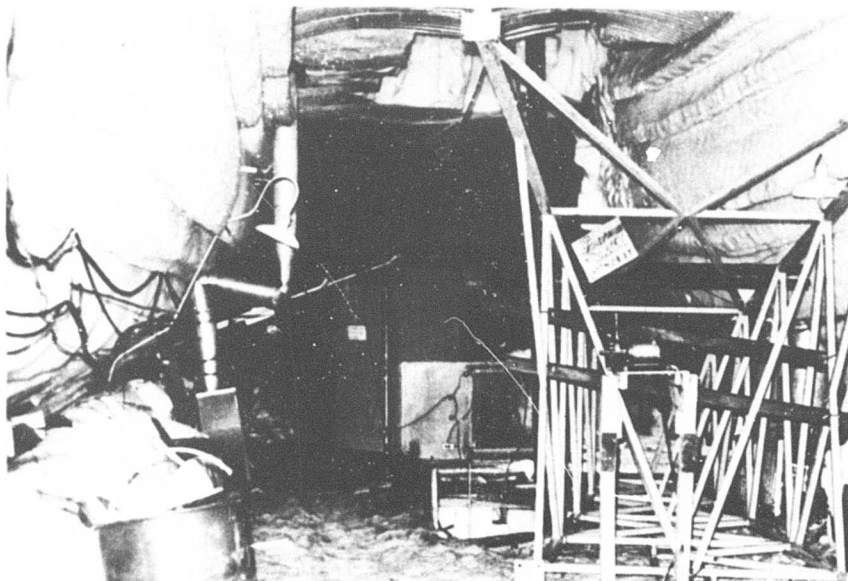
Figure 64. Drill rig and tower. Note kink in stack as a result of ceiling and snow subsidence.

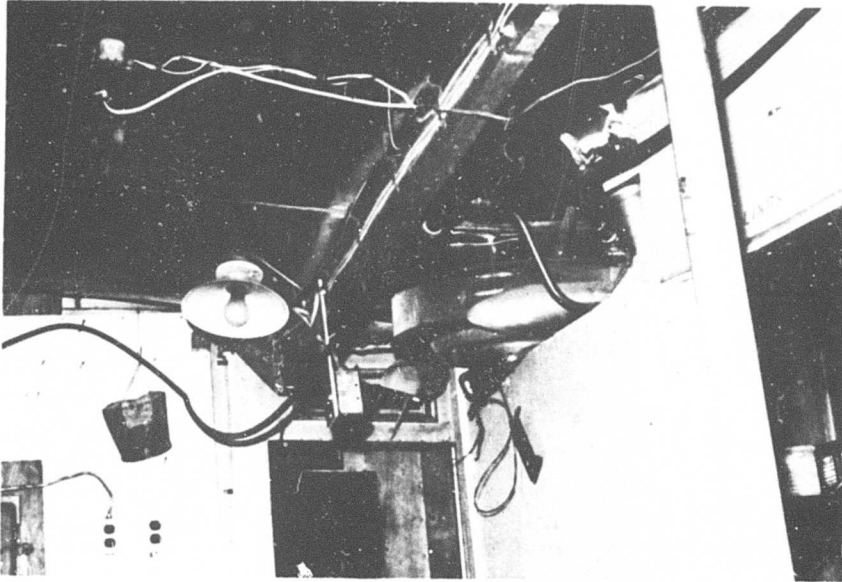
Figure 66. Snow loading of workshop ceiling has caused carrying beam to fracture and heating fan housing to be pushed into partition.

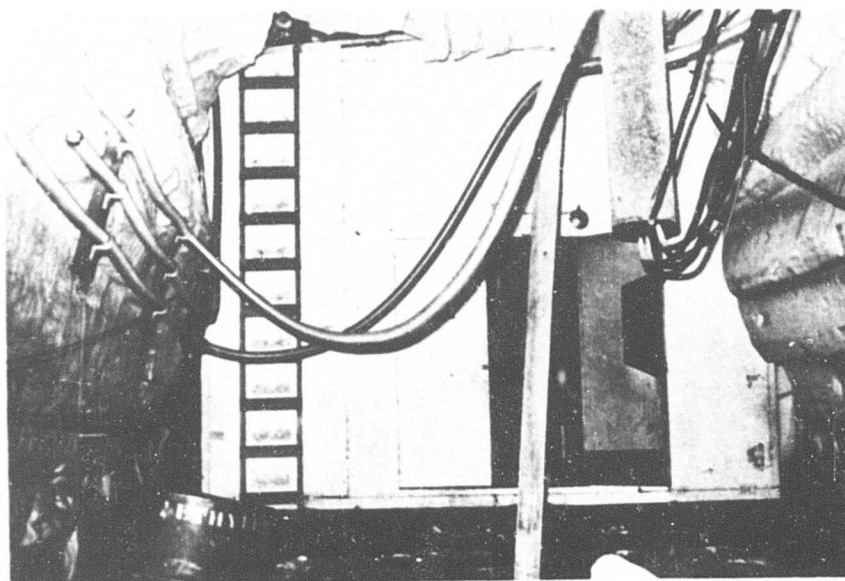
Figure 68. Snow encroaching on standby generator building.

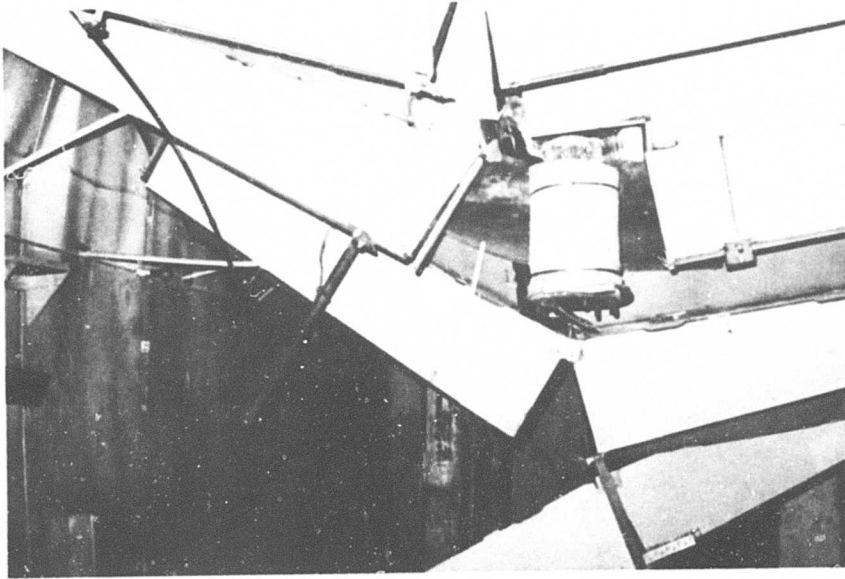
Figure 69. Effect of snow on truss ceiling Trench 15.

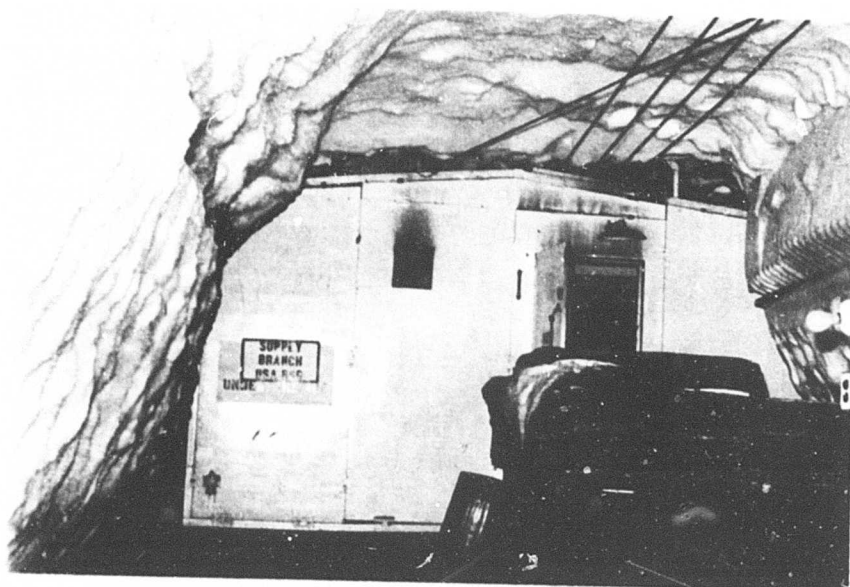
Figure 72. Snow load on roof and walls causes T-5 end wall panels to pull apart.

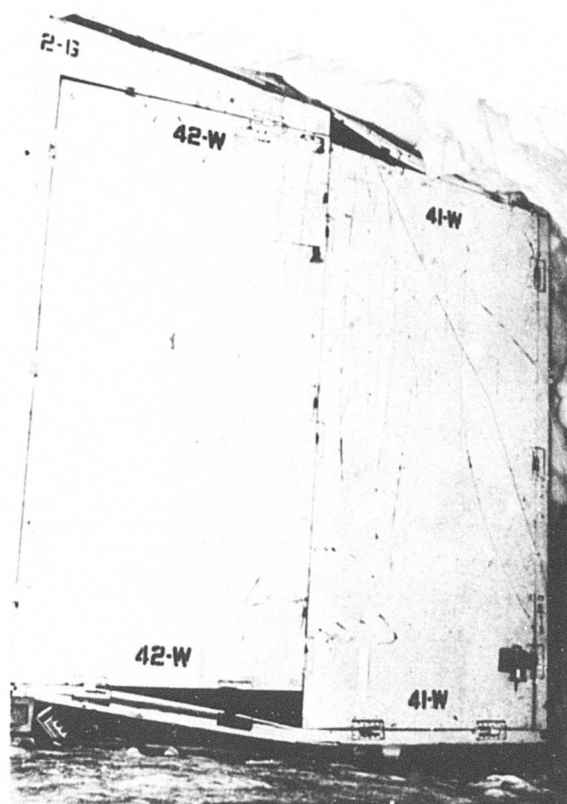
Figure 74. End wall deterioration of T-5 quarters (Trench 16).

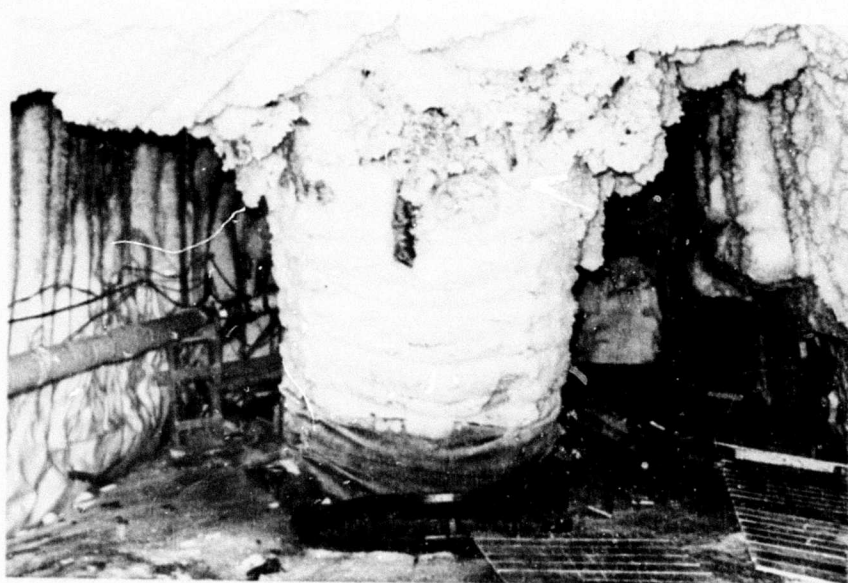
Figure 78. Crumpled escape tower (Trench 19).

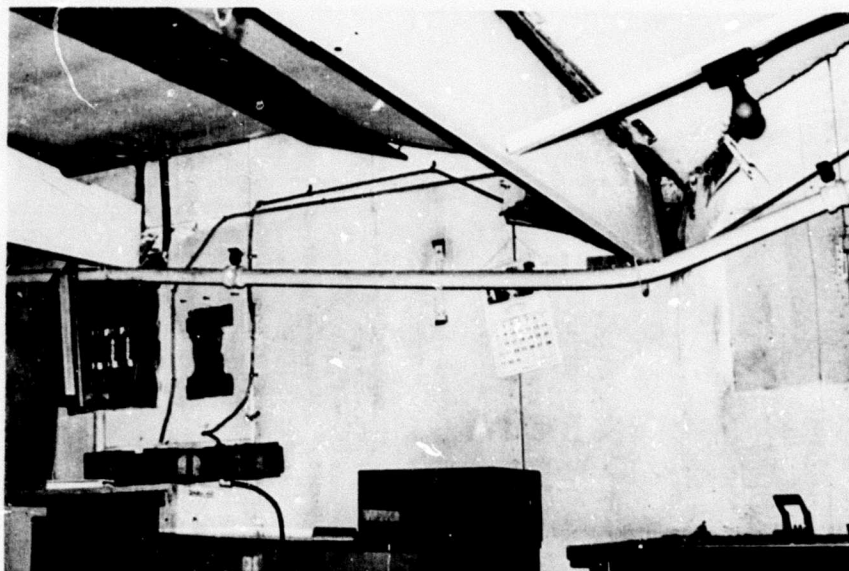
Figure 80. Sheared wall panel in headquarters building, Trench 20.

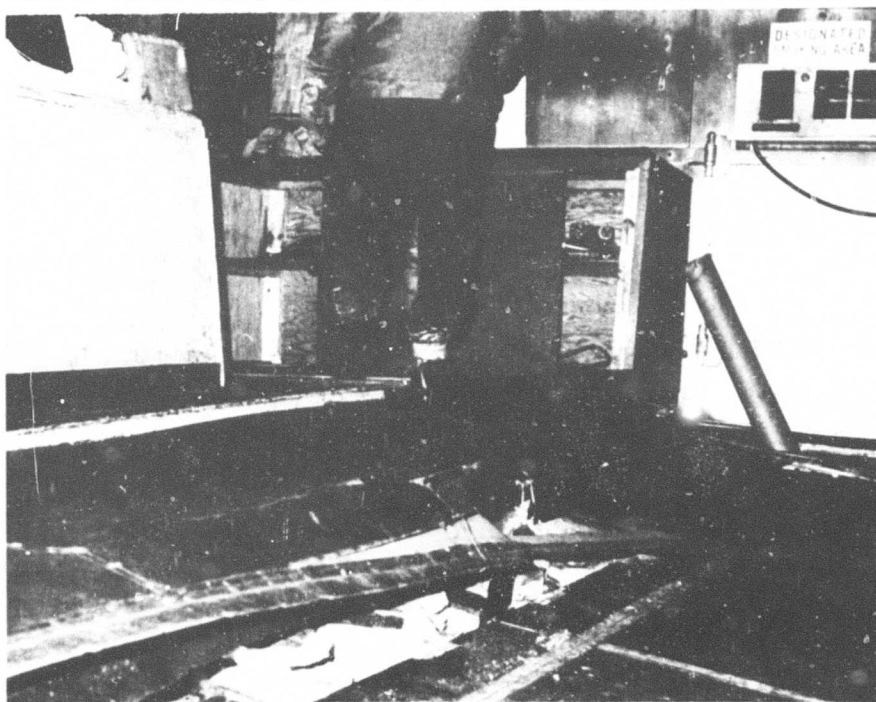
Figure 83. Tearing of maintenance shop floor as a result of trench floor arching.

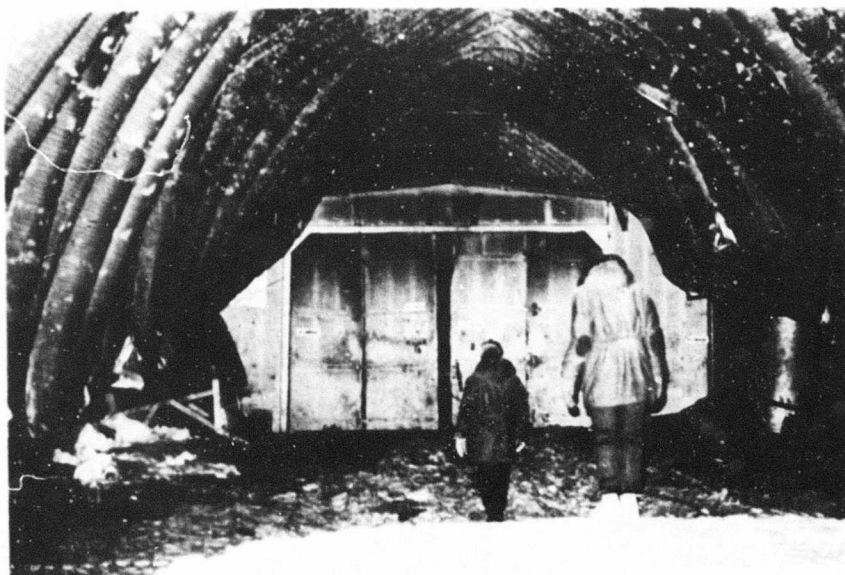
Figure 85. Steel arch deformation around maintenance shop.

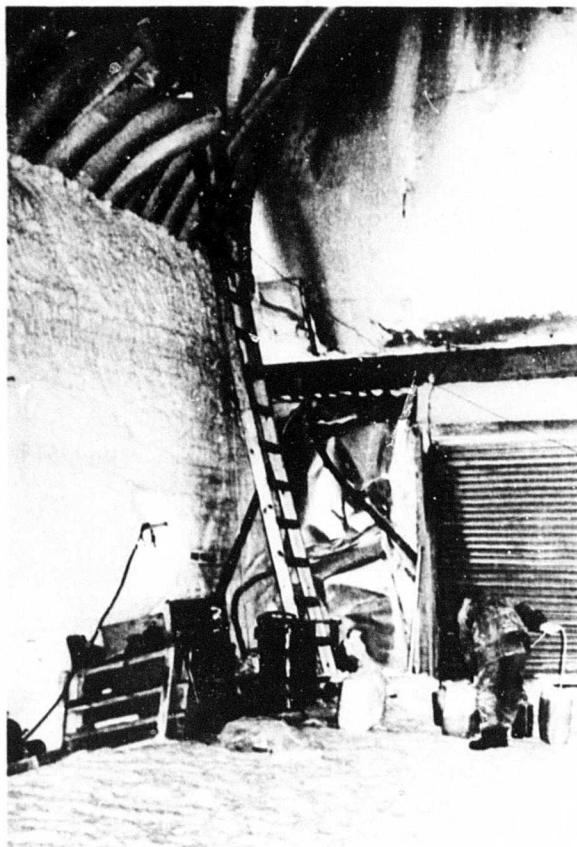
Figure 94. Effects of snow load are visible on Trench 33's deformed arch, end wall and access ladder.

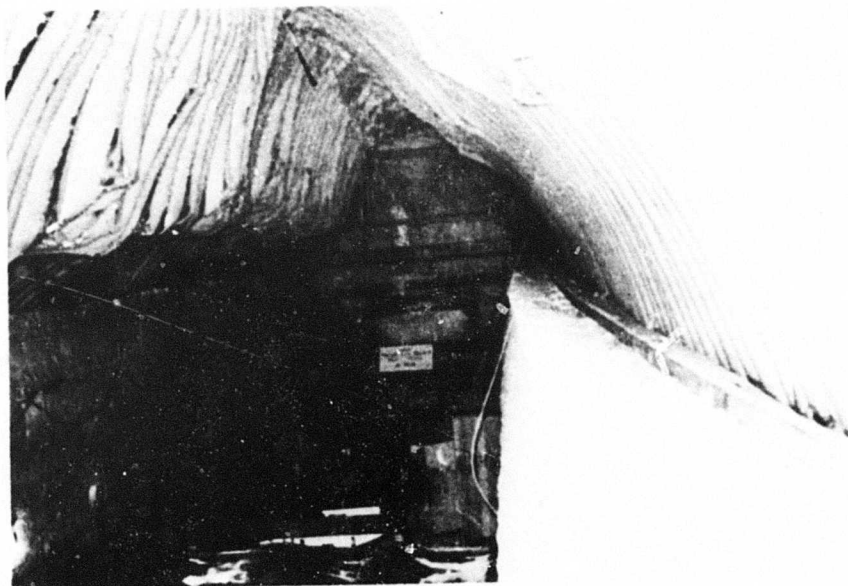
Figure 95. Looking toward north end wall of Trench 33. Note bowing and bulging of side walls.
