TEST REPORT

ENGINE SNOW INGESTION IN THE BELL 206A JET RANGER HELICOPTER

J. R. STALLABRASS

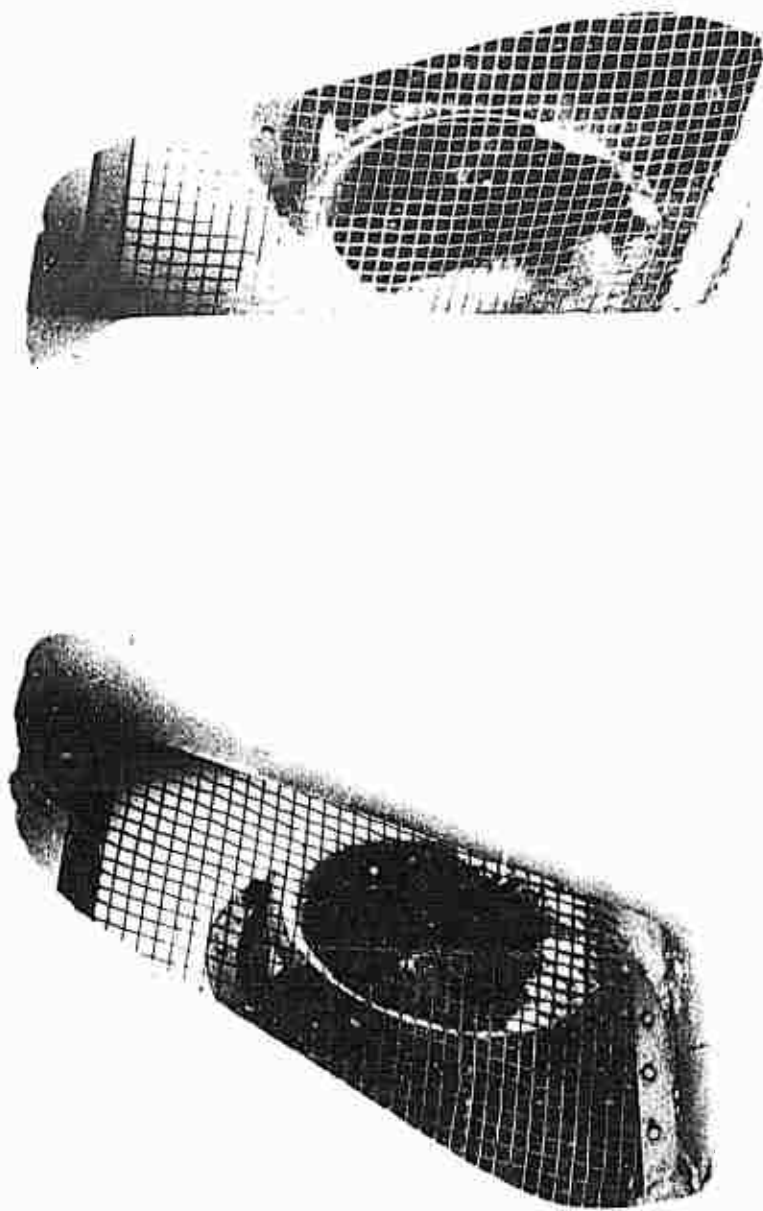
Run 6 was the first run with the snow generator and was regarded more as a trial run for the generator than for the helicopter. However, the results were so revealing as far as the helicopter was concerned that there was little doubt as to the generator's usefulness, providing that the wetness fraction of the "snow" could be reduced. Accordingly, for subsequent tests an air-to-air heat exchanger was inserted in the compressed air line and resulted in cooling the air by some 25°C, reducing the wetness fraction appreciably. Run 6 indicated very clearly that a greater risk of flameout, and even engine damage, could result from the ice that formed within the plenum than from compacted snow entering from without. Figure 2 shows the ice formed around the bellmouth lip and on the plenum floor ahead of the bellmouth.

FIG.2: ENGINE INLET AFTER TRIAL RUN WITH SIMULATED SNOW  
RUN NO 6. 20 MINUTES AT  $-5^{\circ}\text{C}$ . NOTE ICE RING IMMEDIATELY BEHIND BELLMOUTH LIP,  
RAGGED ICE FINGERS GROWING INTO BELLMOUTH AT BOTTOM, AND  
JAGGED MOUNDS OF ICE ON PLENUM FLOOR

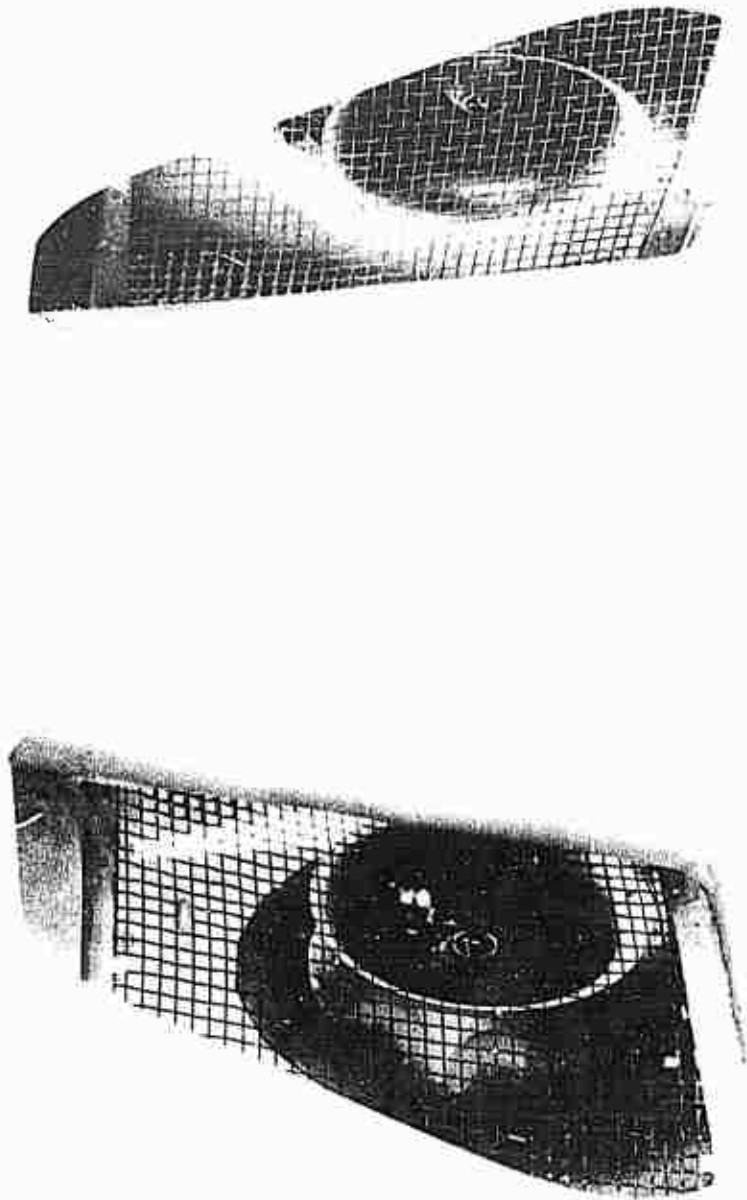
Run 18 and its continuation, Run 19, which were at the lowest temperature attempted with the snow generator, were prematurely terminated because of problems encountered with the air compressor used to supply the snow generator. However, even at this low temperature, it was shown that there was enough heat in the firewall, bellmouth, and plenum floor to permit partial melting and refreezing of the impinging snow. Figure 3 shows the compacted snow/ice behind the bellmouth lip (thickest at the 9 o'clock position) and extending down to the plenum floor. That the artificial snow was completely dry was demonstrated by the absence of any formation on the wire screen.

21/12	15	3	-0.5	11½	35	Snow generator placed in front of helicopter nose. <u>Flameout</u> at 11½ min caused by snow shedding from plenum roof where it had formed a 1/8" layer.
24/12	16	4	-	-	35	Water ingestion test. 20 cc water squirted into engine - no flameout. 30 cc water squirted into engine - <u>flameout</u> . Slight puff from exhaust at flameout.
26/12	17	2	-16.5	15	-	Light natural snow, augmented by recirculating snow on ground by hovering. After 15 min slight moisture on firewall, small piece of ice on floor beneath bellmouth. No problems.
26/12	18	3	-15.7	20	35	Snow generator in front of helicopter, but moved to starboard side after 10 min because of low concentration entering engine. Run discontinued at 20 min - compressed air supply failed. Snow compacted at 3 and 9 o'clock on outer edges of bellmouth. Ice also on firewall and floor. Frosting on plenum roof. No blocking of screen (Fig. 3).

FIG. 3: ENGINE INLET AFTER 25 MINUTES OF SIMULATED SNOW AT  $-16^{\circ}\text{C}$   
RUNS NO 18 AND 19. NOTE ABSENCE OF RING OF CLEAR ICE IMMEDIATELY BEHIND BELLMOUTH  
LIP AS AT  $-5^{\circ}$  (RUN 6), BUT GREATER EXTENT OF PACKED SNOW EXTENDING OVER  
BELLMOUTH MOUNTING FLANGE. ICE BELOW LOWER PART OF BELLMOUTH  
AND ON PLENUM FLOOR
