FIRE TESTING OF INDEPENDENT FIBERGLASS  
FUEL TANKS WITH AND WITHOUT PROTECTIVE  
COATING OF FIRE RETARDANT PAINT

UNITED STATES COAST GUARD  
OFFICE OF RESEARCH AND DEVELOPMENT  
APPLIED TECHNOLOGY DIVISION

LTJG J. D. RICHART, USCG  
MERCHANT MARINE TECHNICAL DIVISION  
OFFICE OF MERCHANT MARINE SAFETY

Date: 2 July 1971  
Submitted: J. L. Coburn Jr.  
J. L. COBURN, CDR, USCG  
Chief, Marine Safety Projects Branch  
Approved: J. R. Iversen  
J. R. IVERSEN, CAPT, USCG  
Chief, Applied Technology Division  
U. S. Coast Guard Headquarters  
400 7th Street, S. W.  
Washington, D. C. 20591

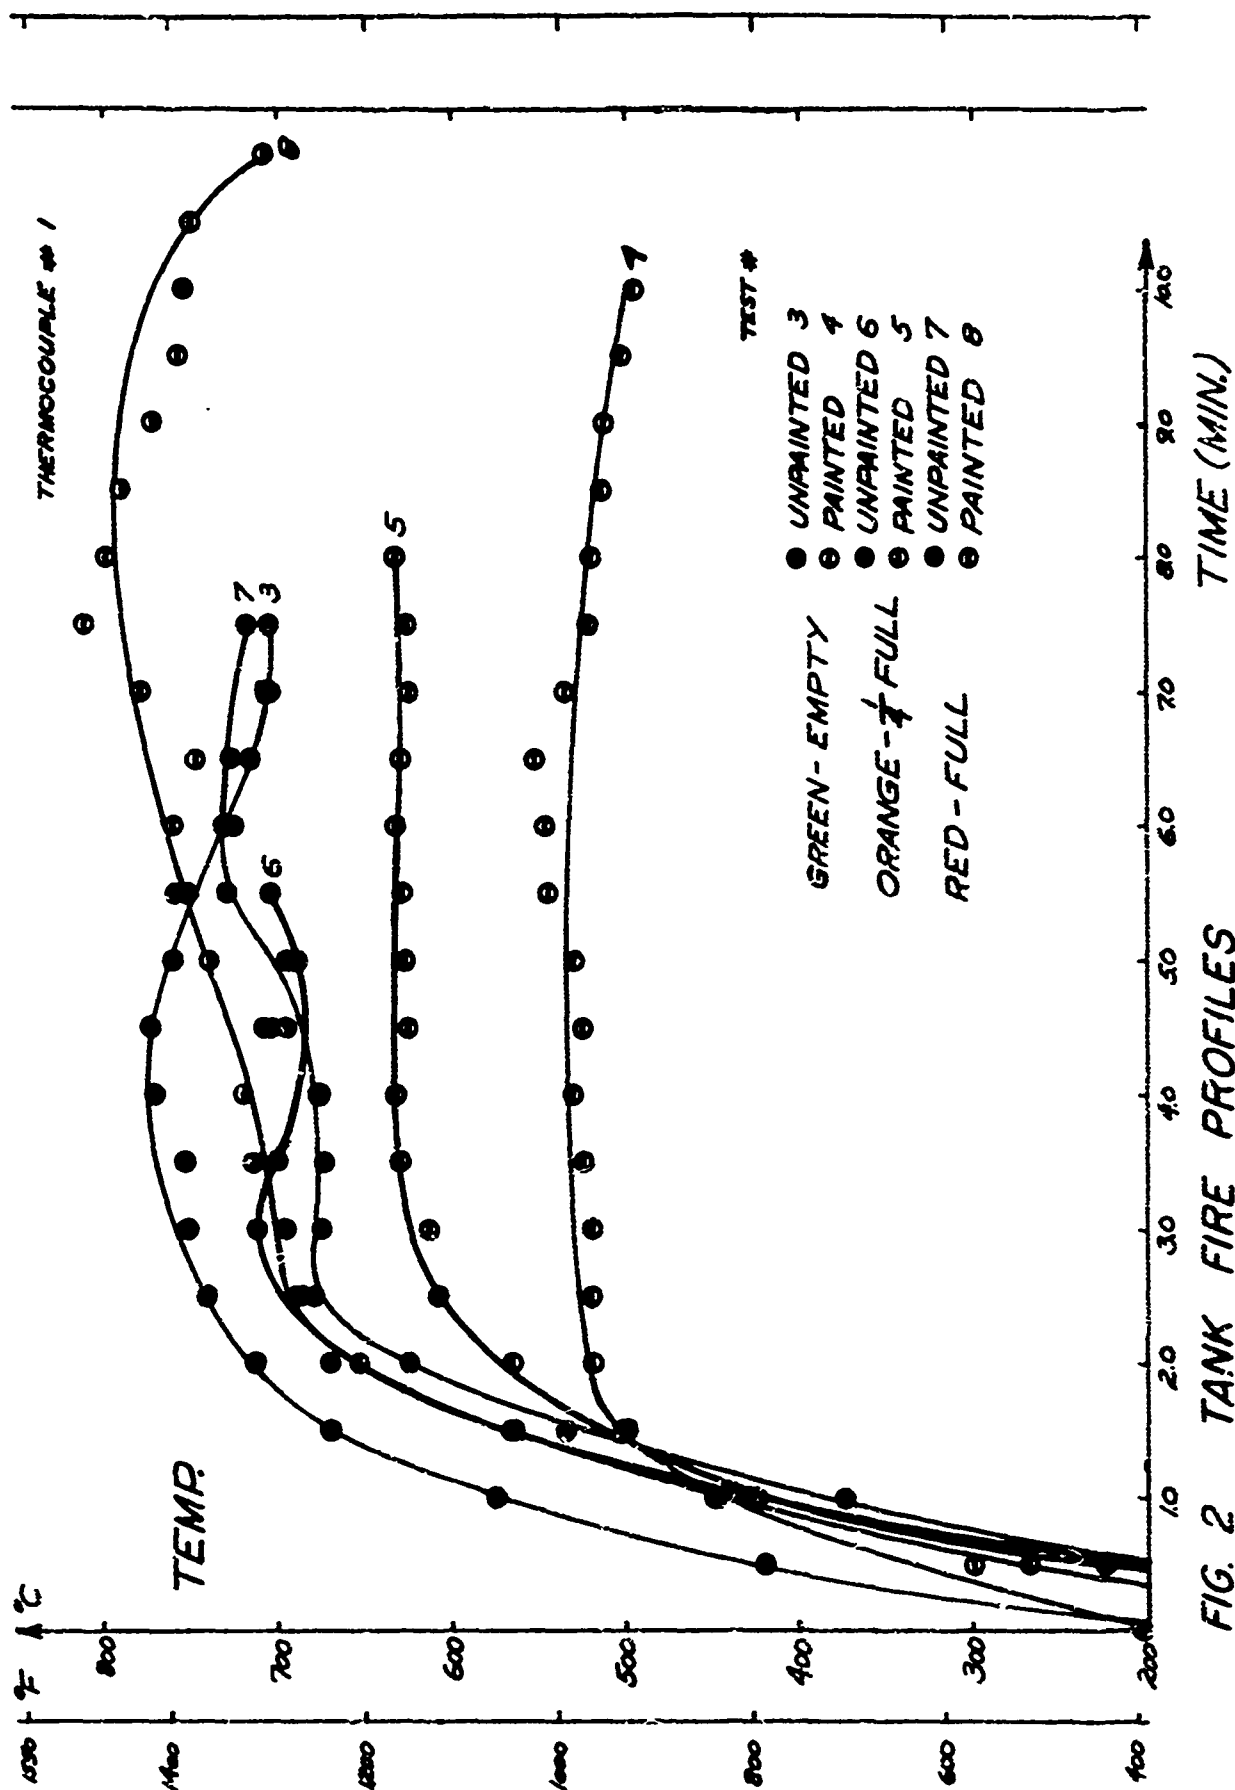
FIG. 2 TANK FIRE PROFILES

A brief overall view of the time-temperature data yields some interesting observations. The scatter in the data was much wider at thermocouple #1 (nearer the two-part door) than at thermocouple #2, indicating that wind conditions were locally affected by the door behind the test set-up (see FIGS. 2 and 3). The test temperature range was about  $440^{\circ}\text{F}$  ( $980^{\circ}\text{F}$ - $1420^{\circ}\text{F}$ ) at thermocouple #1, whereas the difference between fires varied only  $225^{\circ}\text{F}$  ( $1150^{\circ}\text{F}$ - $1375^{\circ}\text{F}$ ) at thermocouple #2. A look at FIG. 7 shows that all the painted tanks were insulated significantly better than the unpainted ones. In tests #7 and #8 the fires were very similar, eliminating the difficulty in comparing results from differing exposures, and the painted tank took two minutes longer to reach the  $200^{\circ}\text{F}$  internal temperature mark than did the unpainted tank. The tanks which were  $\frac{1}{4}$  full of fuel, providing the most severe fuel conditions for a fire, had four minutes separating their internal behavior. The empty tanks cannot be compared realistically, because of the difference in fire intensity.

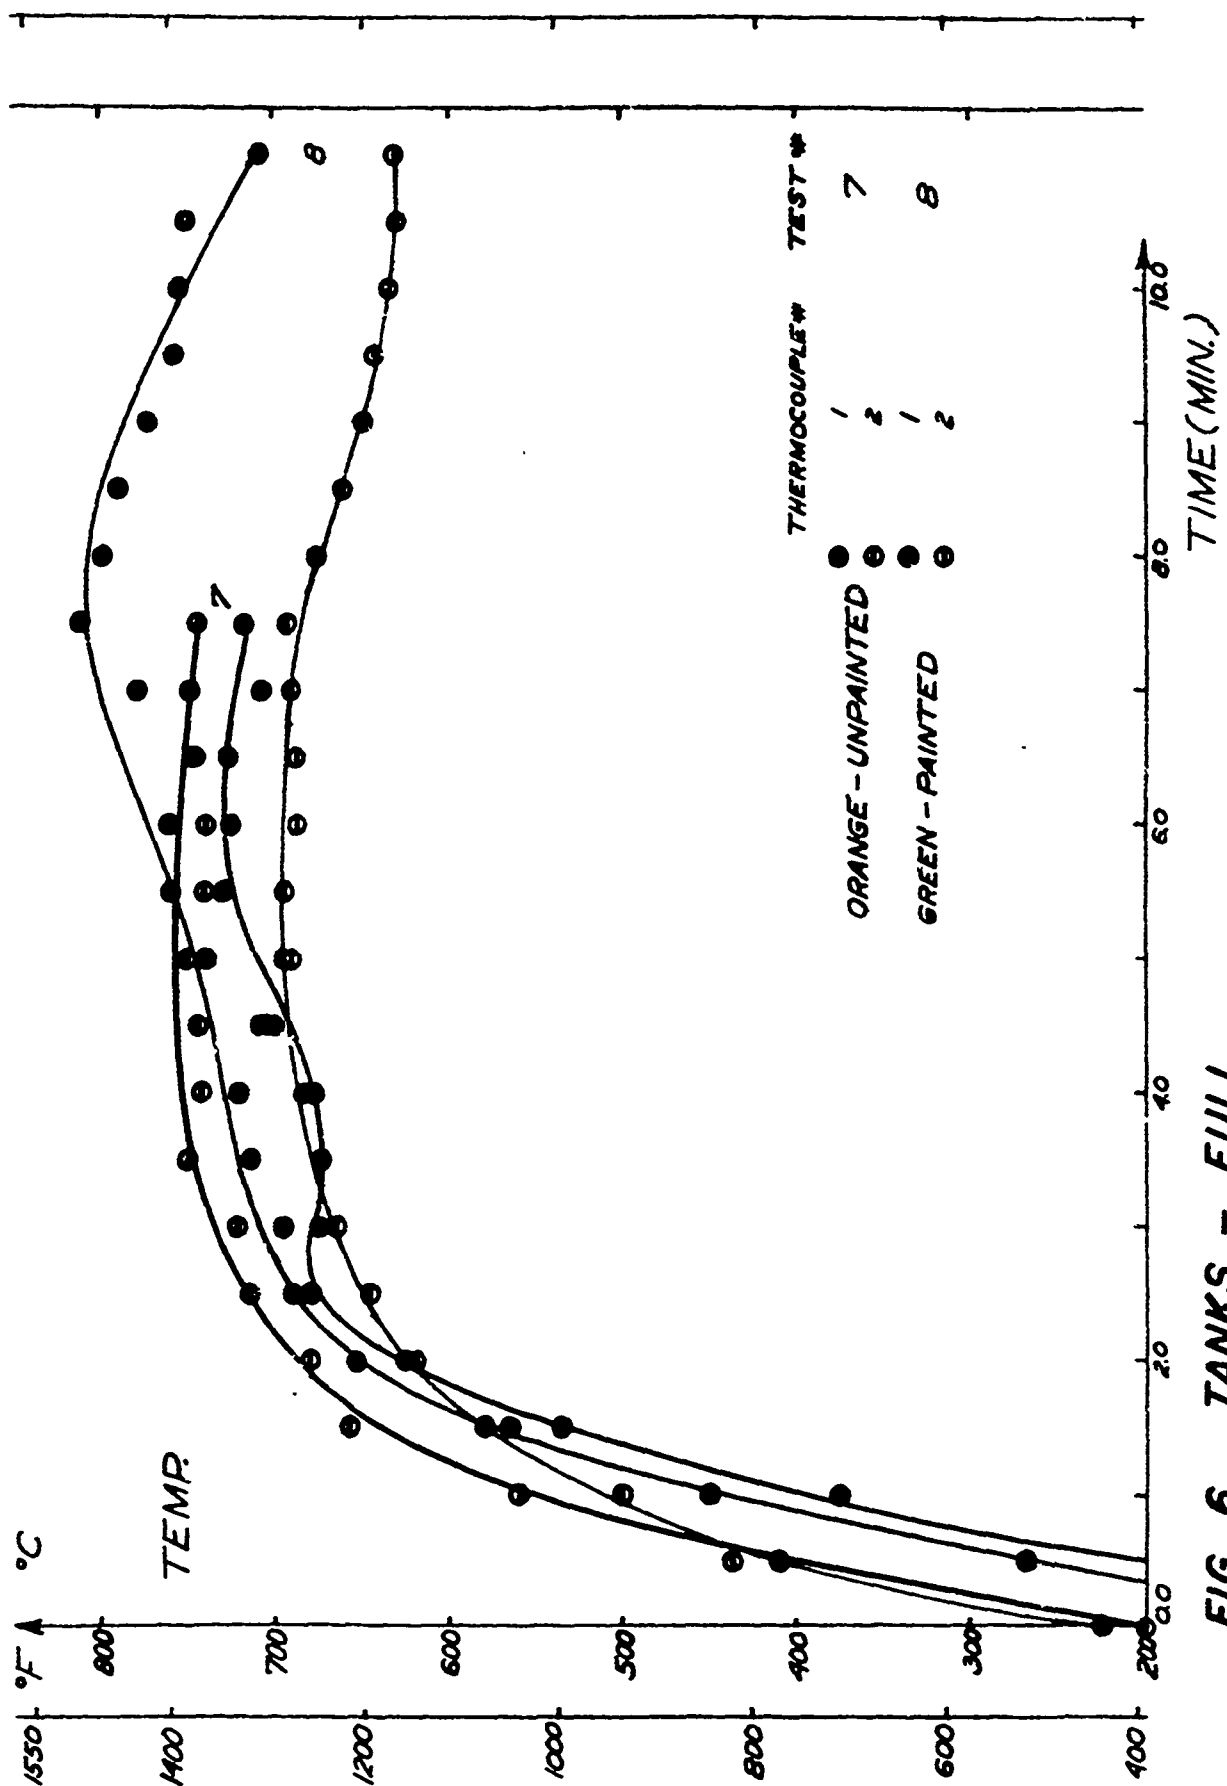
FIG. 6 TANKS - FULL

Test #8, painted and full of fuel, showed the tank to withstand severe fire exposure. As in the previous test the tank was engulfed in flames the entire time (see photographs (25) and (26)). At the eight minute mark flames were four feet high and vapors were burning at the top of the vent spud at a controlled rate. The final two photographs show the tank to be in better condition after an 11 minute fire than the unpainted counterpart was after less than 8 minutes of exposure to similar intensities (see FIG. 6).
