# SONIC BOOM AND NATURAL DETERIORATION EFFECTS ON BUILDINGS: WHITE SANDS, N.M. STRUCTURE RESURVEY

J.H. WIGGINS, JR.

FEBRUARY 1972  
FINAL REPORT

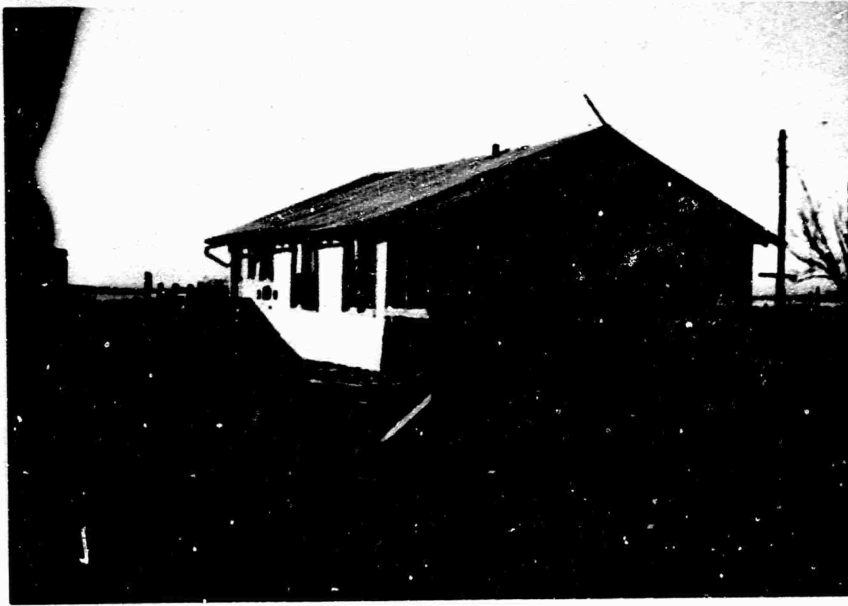
I visited the "Abandoned Ranch" shown in Figs. 3 and 4. Its condition is still bad with the additional glass damage. It was reported by Mr. Withers that the glass was broken by vandals some time earlier.

Fig. 3 "Abandoned Ranch" is still in bad condition. The windows were broken by vandals, as reported by Mr. Withers. All were new and unbroken at the beginning and end of the program.

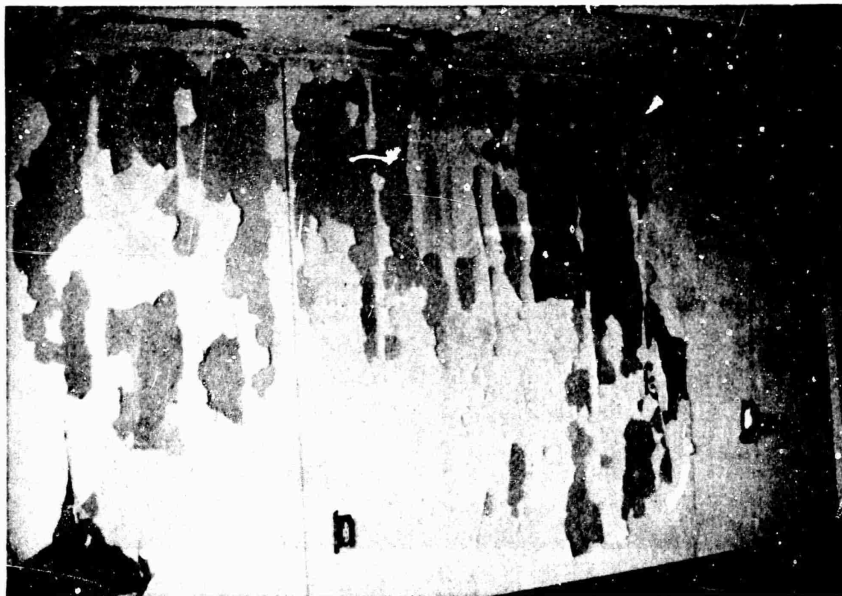
Fig. 4 The interior of the "Abandoned Ranch" is still in bad condition.

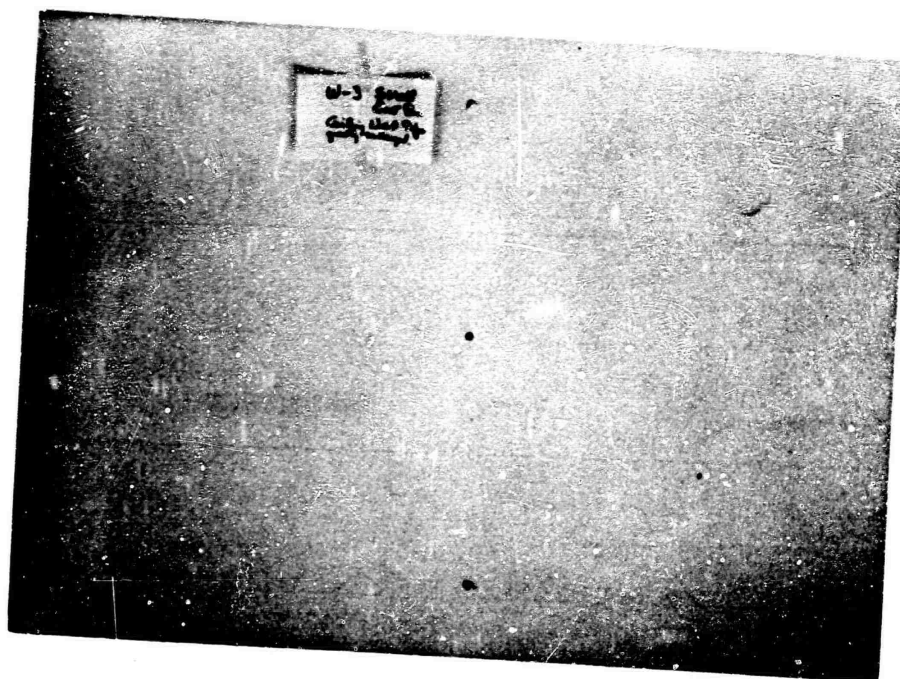
Fig. 27 W-3, New Nail Pops Recorded after the 5-2-65 Inspection. No Nail Pops Occurred as the Result of Booms up to 23.4 psf overpressure During Part B

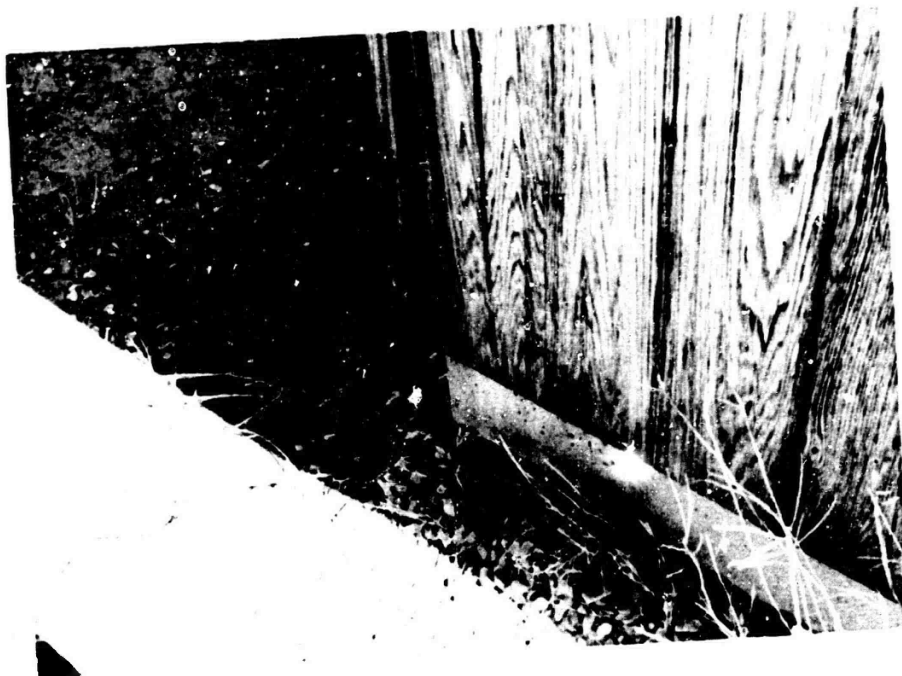
The exterior wood sidings on W-4 and PF-6 had deteriorated considerably. The wood was warped and most of the paint was off the buildings.

Fig. 45 PF-6, Closeup of Northwest Corner Damage

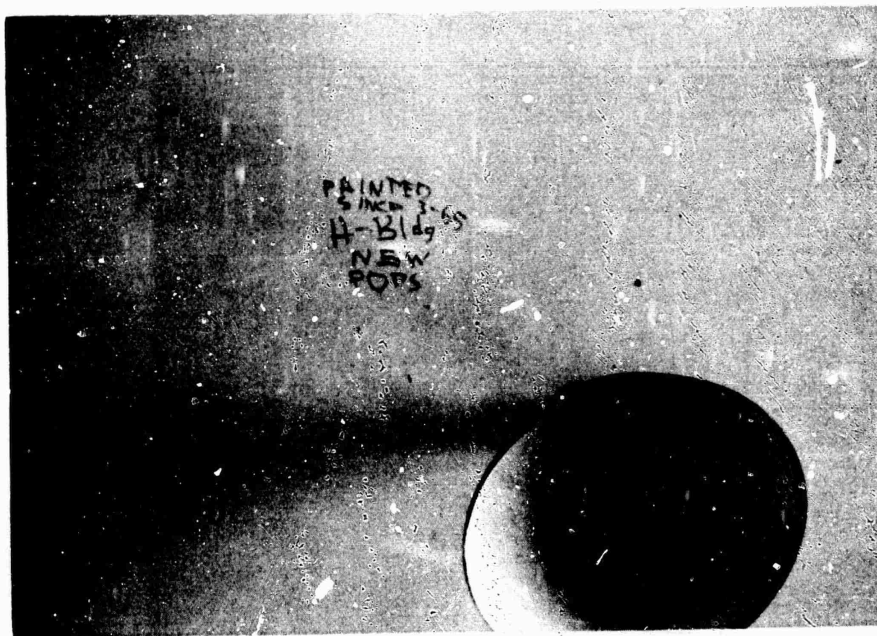
Fig. 51 H-Building, New Nail Pops after Redecoration Between Inspection Periods.

Part of the H building had been repainted and nail-pops and ceiling damage sufficient to warrant replacing part of the ceiling had occurred since the boom program. Even so nail-pops have reappeared in the ceiling and walls.

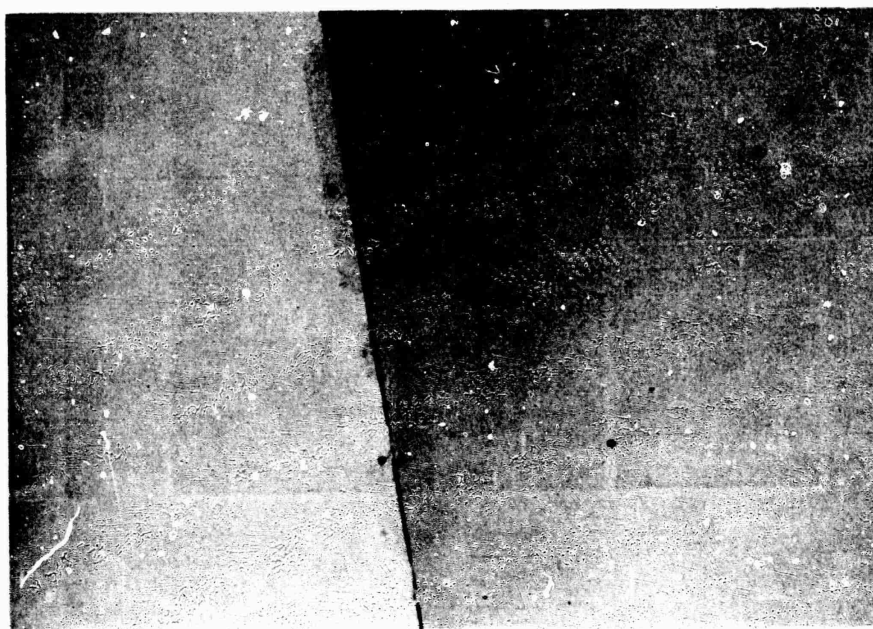
Fig. 52 H-Building, Replaced Ceiling Since Program and Since Redecoration.
