MISCELLANEOUS PAPER S-72-22

# CONDITION SURVEY, FORNEY ARMY AIRFIELD FORT LEONARD WOOD, MISSOURI

June 1972

Conducted by U. S. Army Engineer Waterways Experiment Station  
Soils and Pavements Laboratory  
Vicksburg, Mississippi

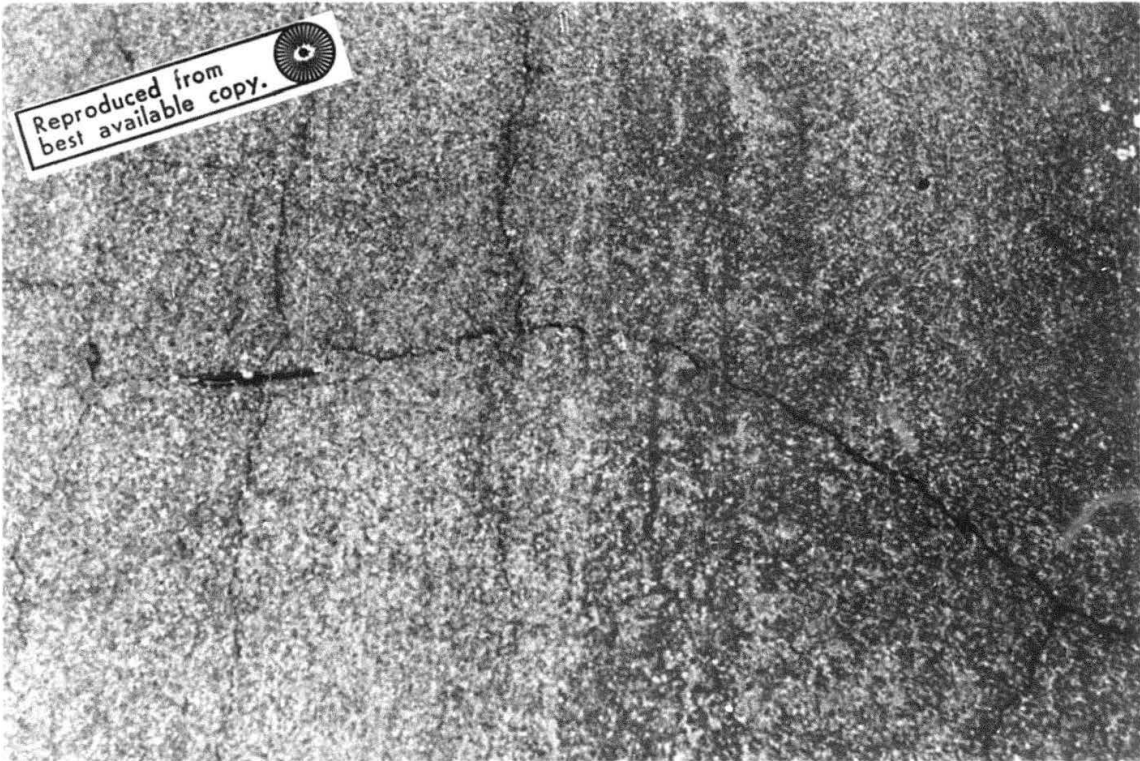
8. A visual inspection of the pavements in April 1971 indicated the airfield pavement to be generally in fair condition. The runway contained numerous cracks; however, the major portion appeared to be adequately supporting the aircraft using the pavement. The typical condition of the major portion of the runway pavement is shown in photograph 1. Photograph 2 shows the condition of an area about 25 ft wide, located east of the center line and extending from the vicinity of runway sta 34+60 to 40+60; this area is showing considerable distress. Another area, approximately 25 by 100 ft and located near runway sta 65+00, showed some distress

Photograph 1. Typical condition of runway pavement

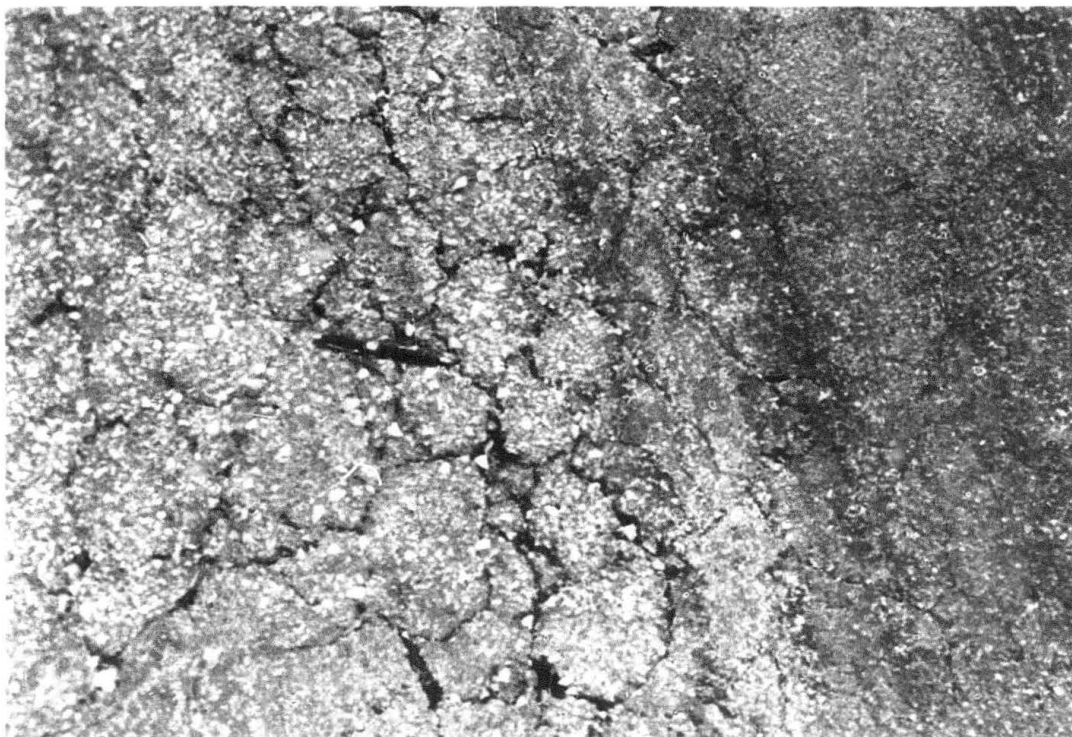
Photograph 2. Distressed area near middle of runway

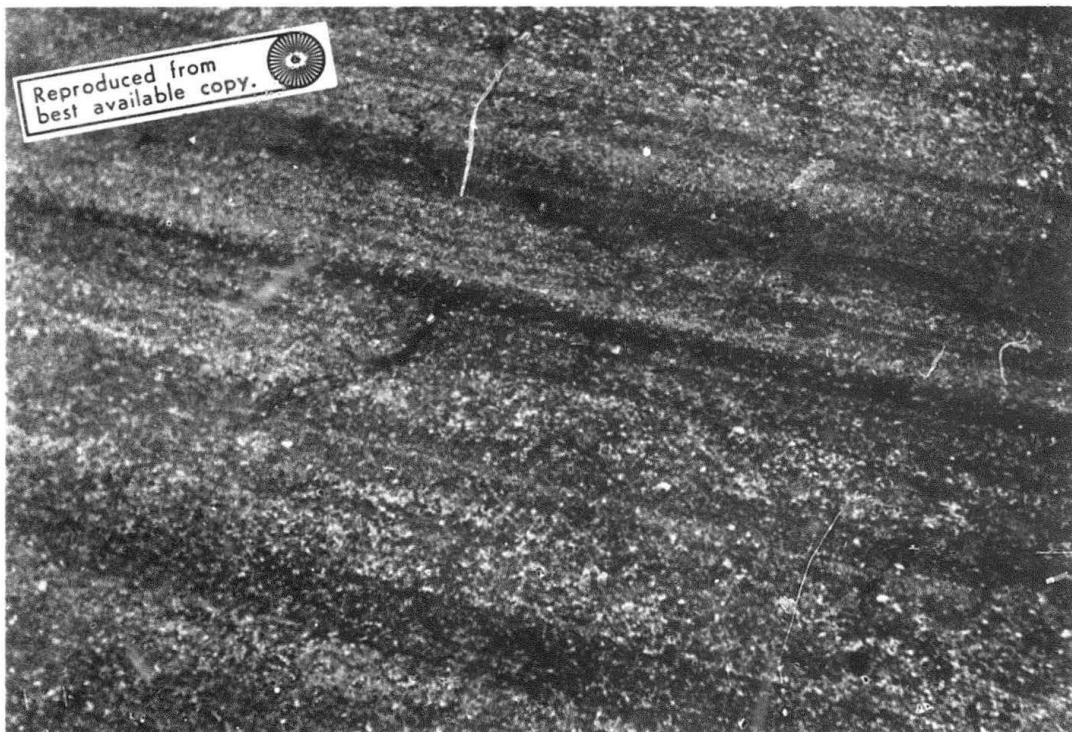
(photograph 3); however, distress in this area was not as severe as that in the area near the middle of the runway.

Photograph 3. Distressed area near north end of runway

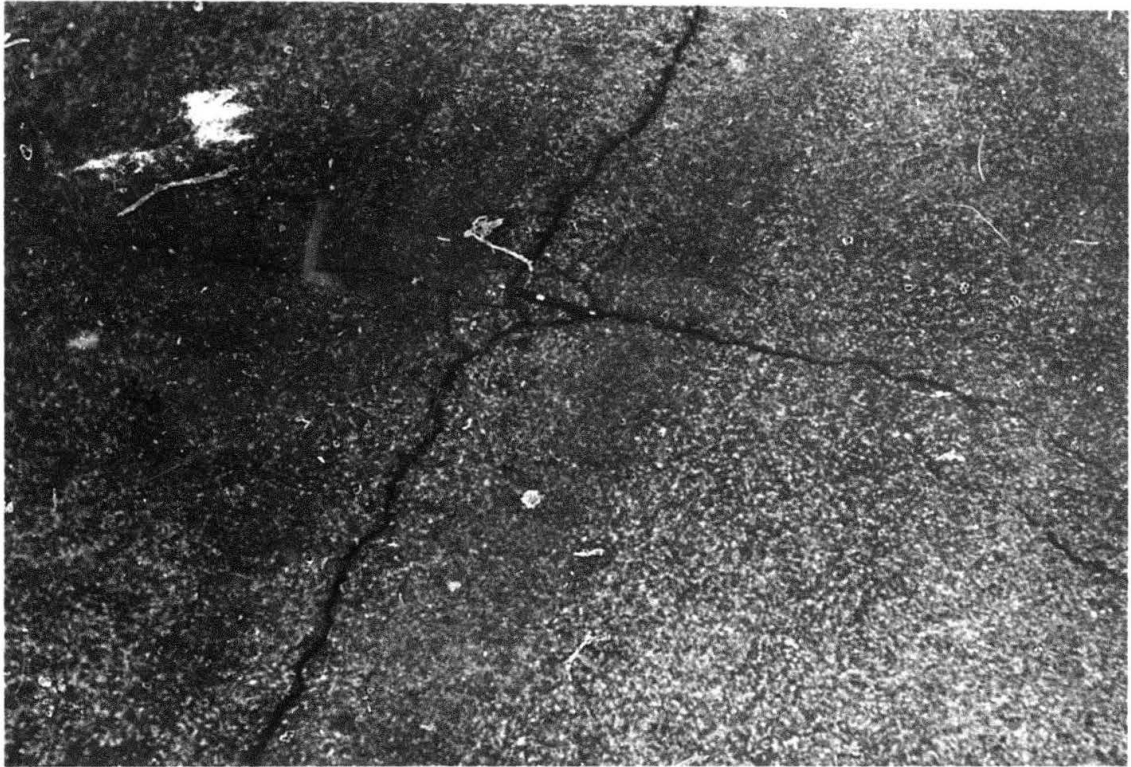
9. The taxiway and apron contained numerous cracks. Views of typical pavements of the taxiway and apron are shown in photographs 4 and 5, respectively. The cracks in the taxiway were approximately 25 ft apart in each direction and appeared to be contraction cracks. Neither the taxiway nor the apron showed any structural distress.

Photograph 4. Typical condition of taxiway pavement

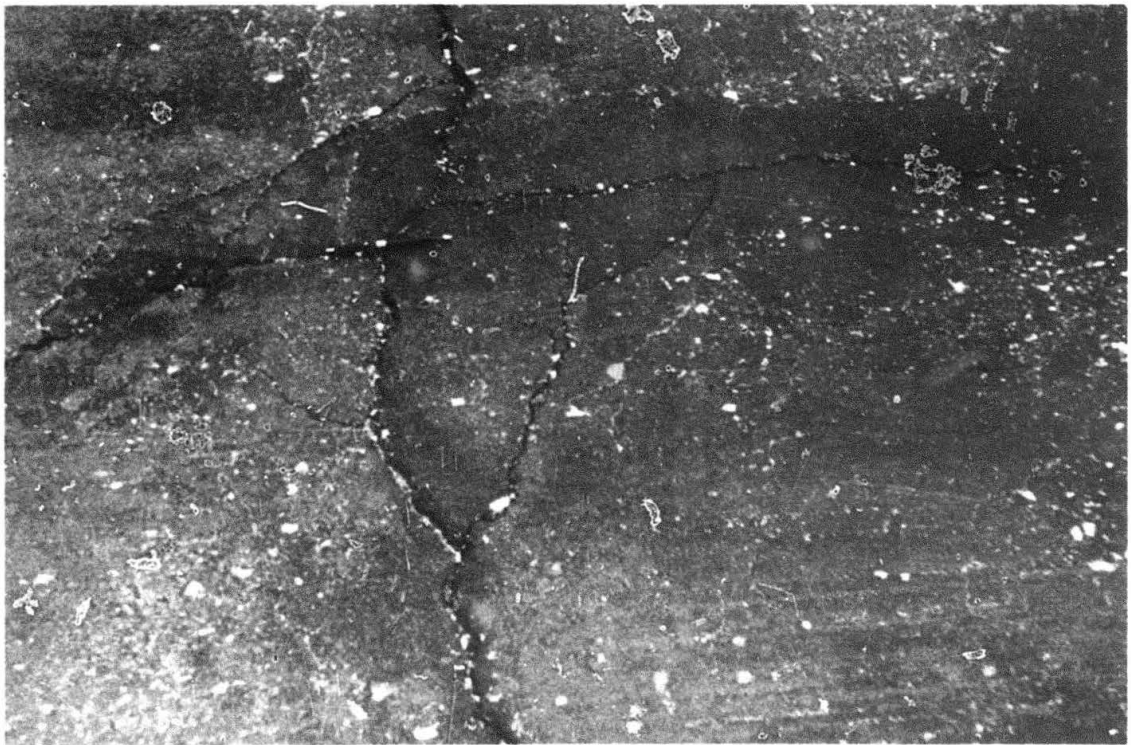
Photograph 5. Typical condition of apron area
