AEDC-TR-72-161

**RESEARCH AND DEVELOPMENT TESTING  
OF YTTRIA/RARE EARTH  
STABILIZED ZIRCONIA MATRIX BRICKS  
IN THE PILOT TEST UNIT (PTU) AT AEDC**

**C. R. Tinsley**

**November 1972**

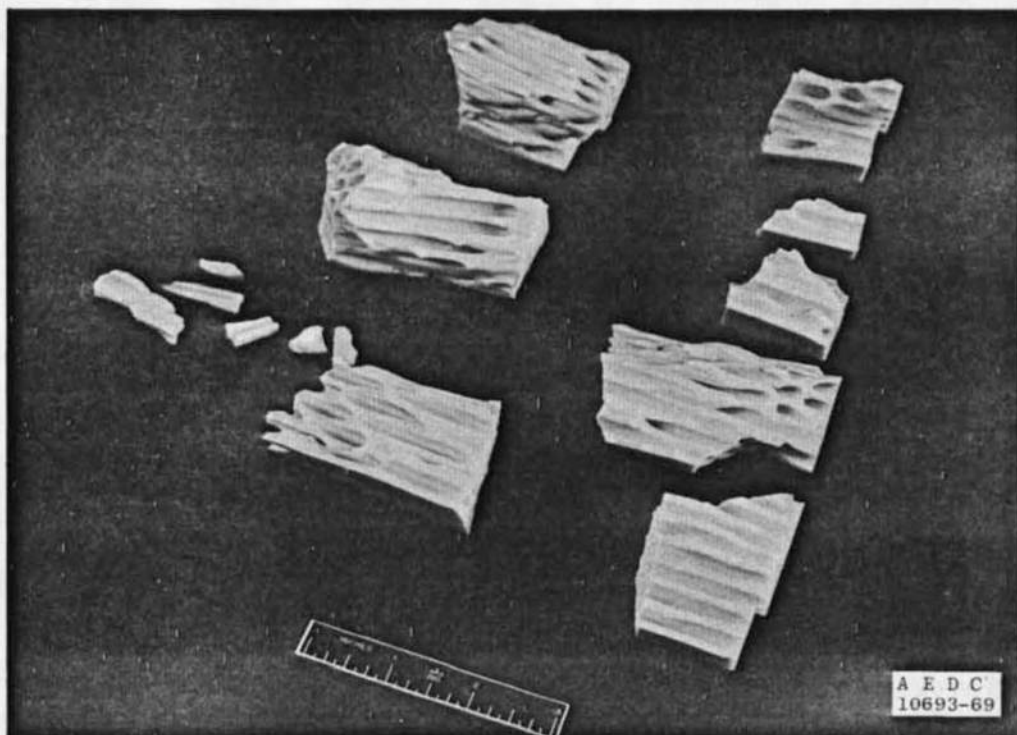
Inspection of the matrix revealed that excessive fracturing and cracking had occurred as a result of the reactant flow anomaly. Of particular note was the tendency of relatively long bricks to fracture into shorter segments. All matrix bricks inspected including the original cored bricks were hard indicating no destabilization. Pertinent photographs taken during the inspection are presented in Fig. 10.

a. Buffer Bricks, Coors  
Fig. 10 Post-Run 32 Inspection

e. Original Matrix Brick, Column 17, 9.25 w/o, Coors  
Fig. 10 Concluded

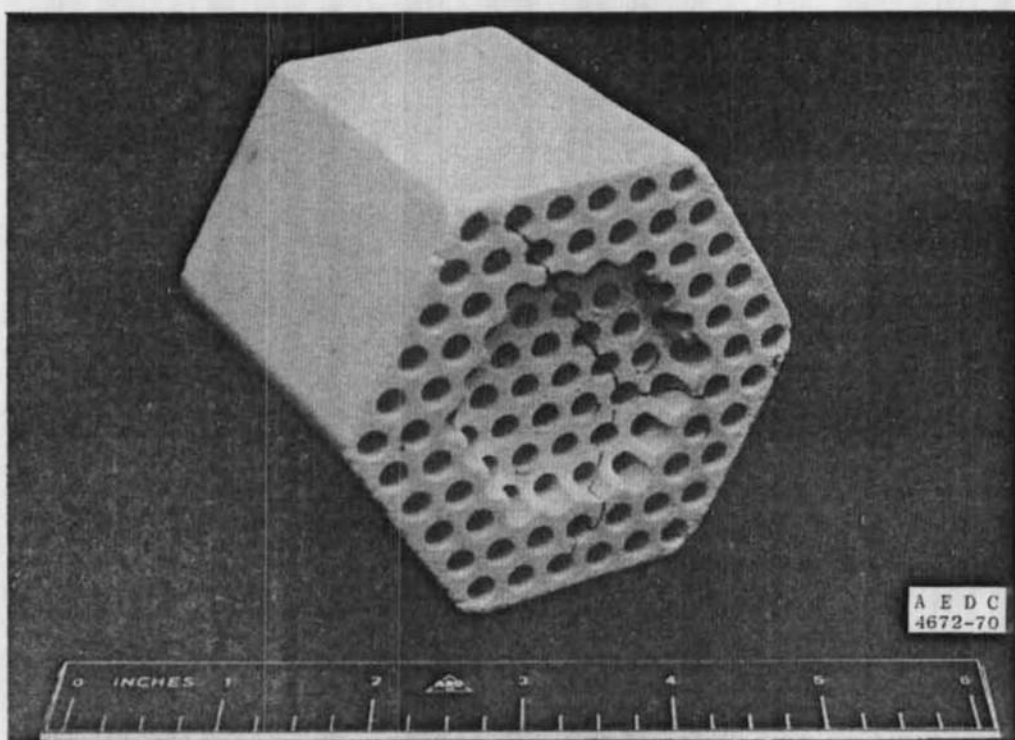
Inspection of selected matrix bricks revealed them to be in good condition and practically unchanged since inspected after test 38. Pertinent photographs taken during the inspection are presented in Fig. 16. The matrix bricks presented in Fig. 16 were also photographed after test 38 (Fig. 15).

a. Zircoa, Low Density, 12.5 w/o, Upper Block  
Fig. 16 Post-Run 39 Matrix Inspection

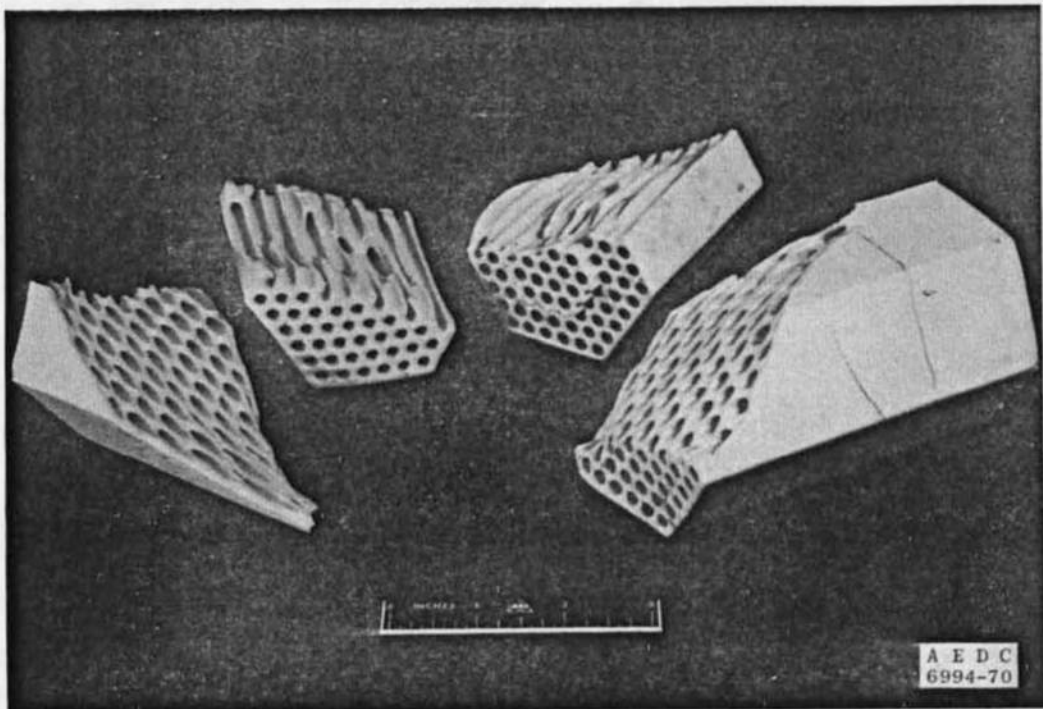
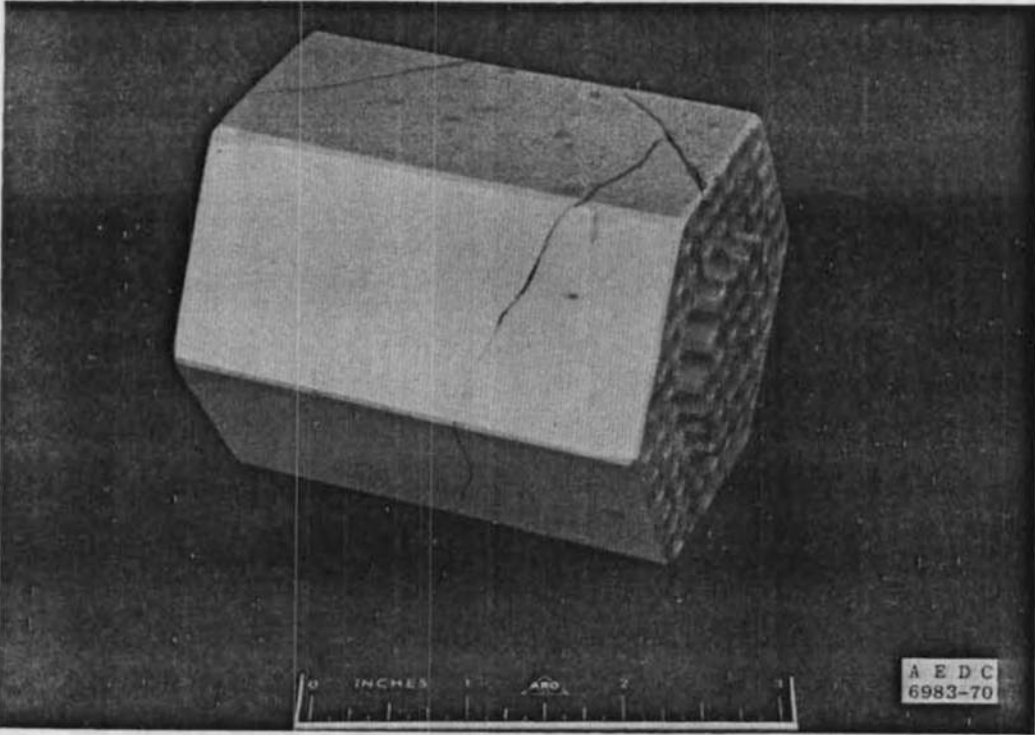
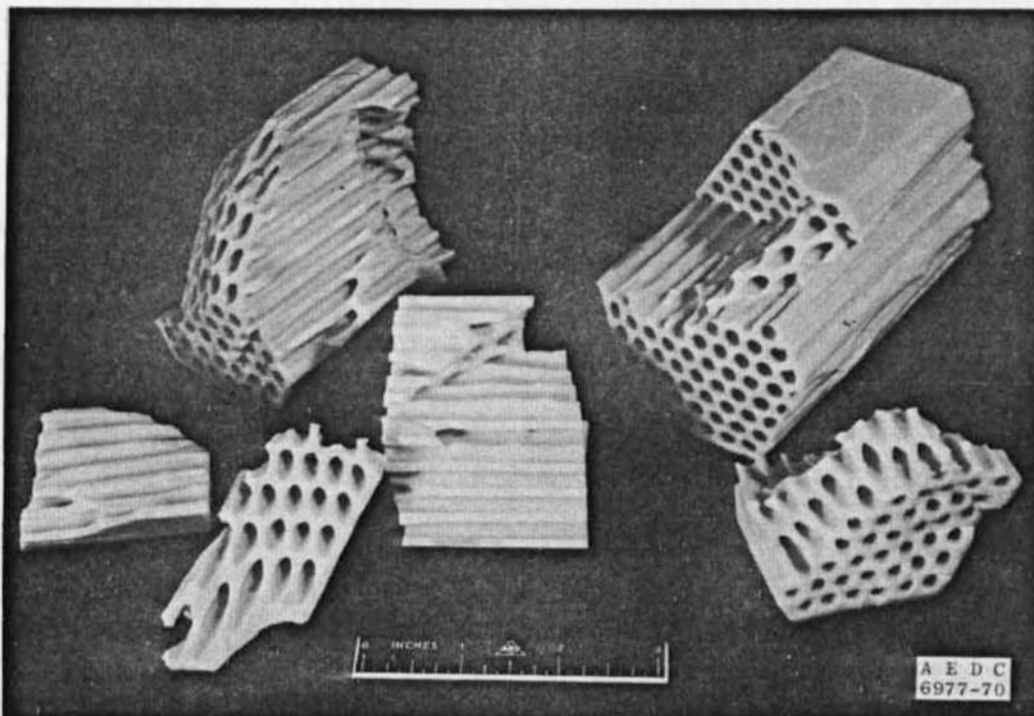
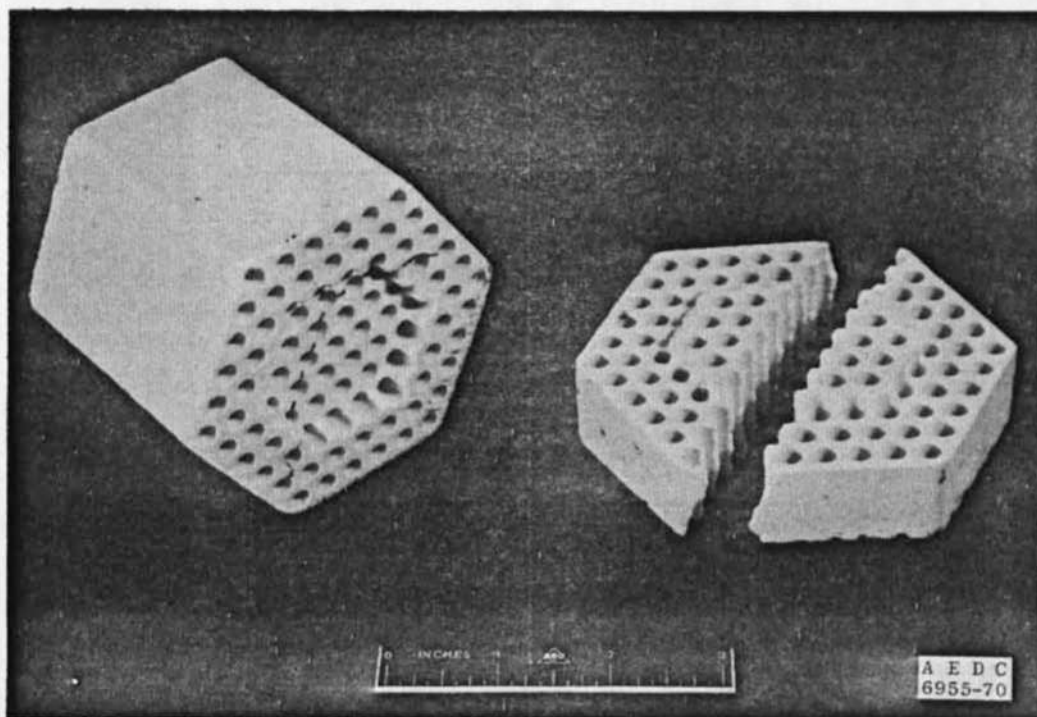
c. Column 17, 12.6 w/o, Coors

e. Column 14, 13.8 w/o, Coors

g. Column 13, 9.25 w/o, Coors

h. Zircoa, Low Density, 12.5 w/o  
Fig. 17 Concluded

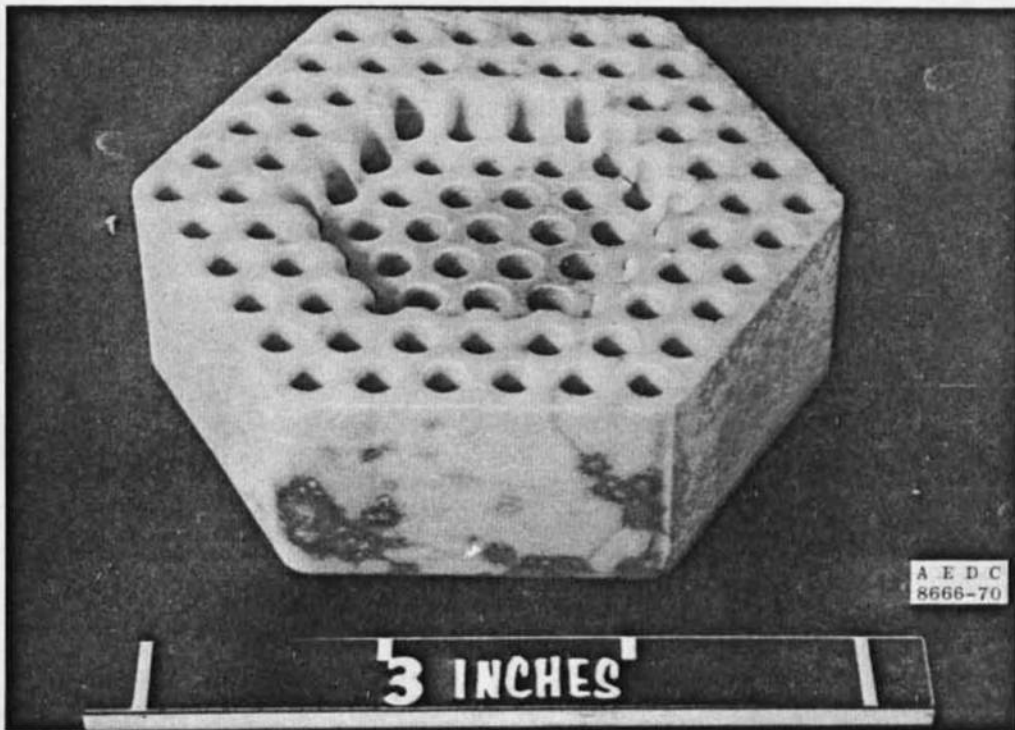
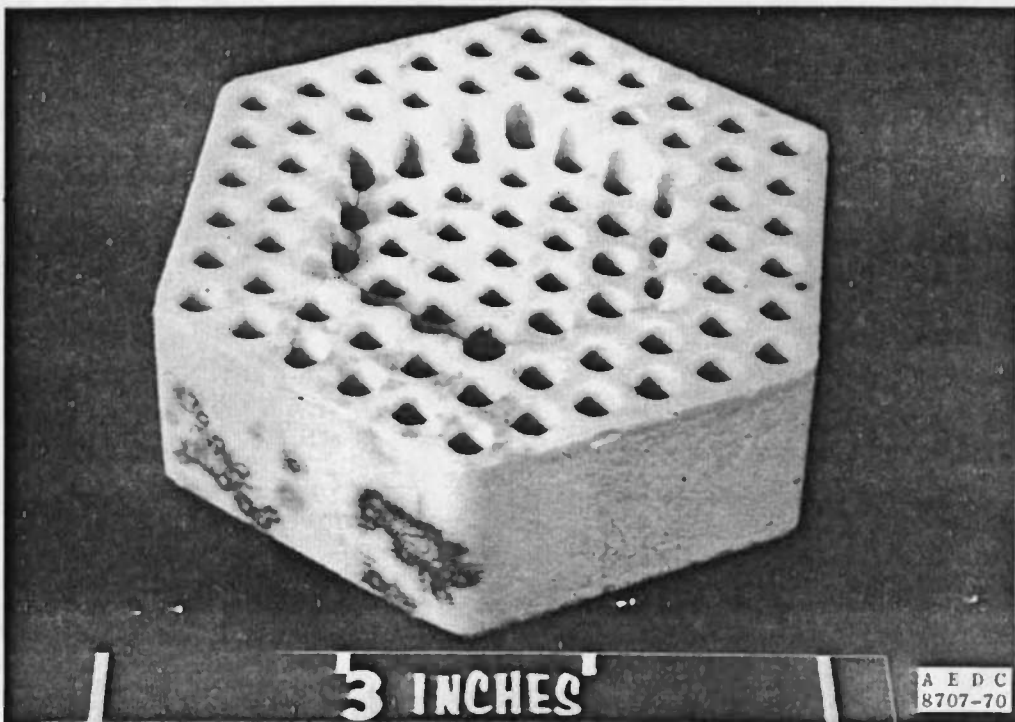
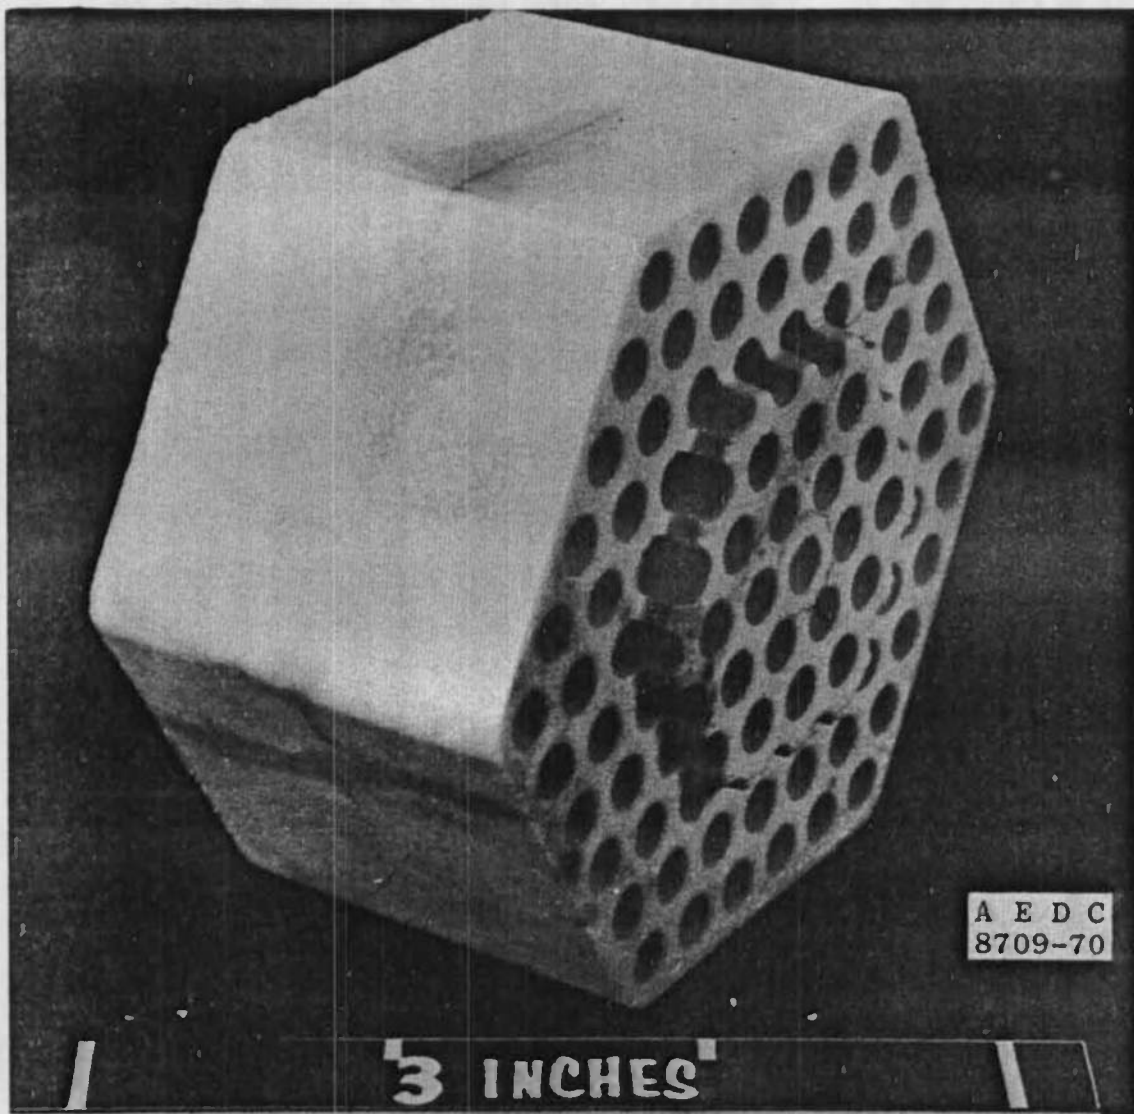
Presented in Fig. 19 are photographs typical of the various high density bricks removed from the heater for inspection. It may be noted that practically all cracks are in the vertical (longitudinal) direction.

d. Zircoa, 10.8 w/o, Location 14-3  
Fig. 19 Continued

e. Zircoa, 12.5 w/o, Location 17-4

f. Zircoa, 16.5 w/o, Location 18-5  
Fig. 19 Continued

g. Zircoa, 16.5 w/o, Location 18-7  
Fig. 19 Concluded

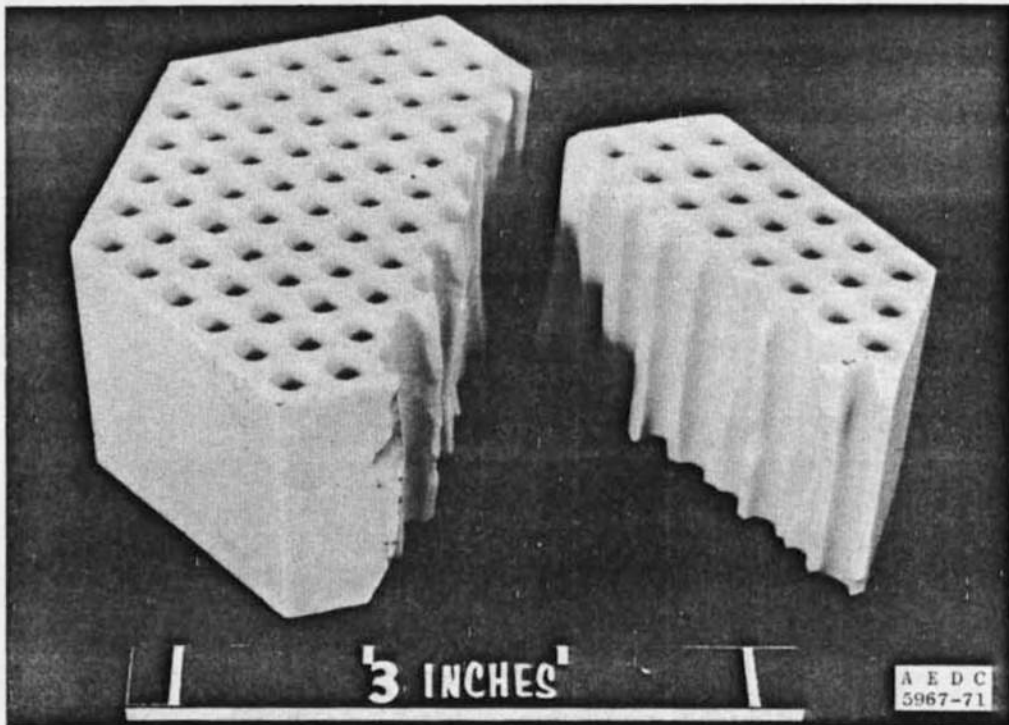
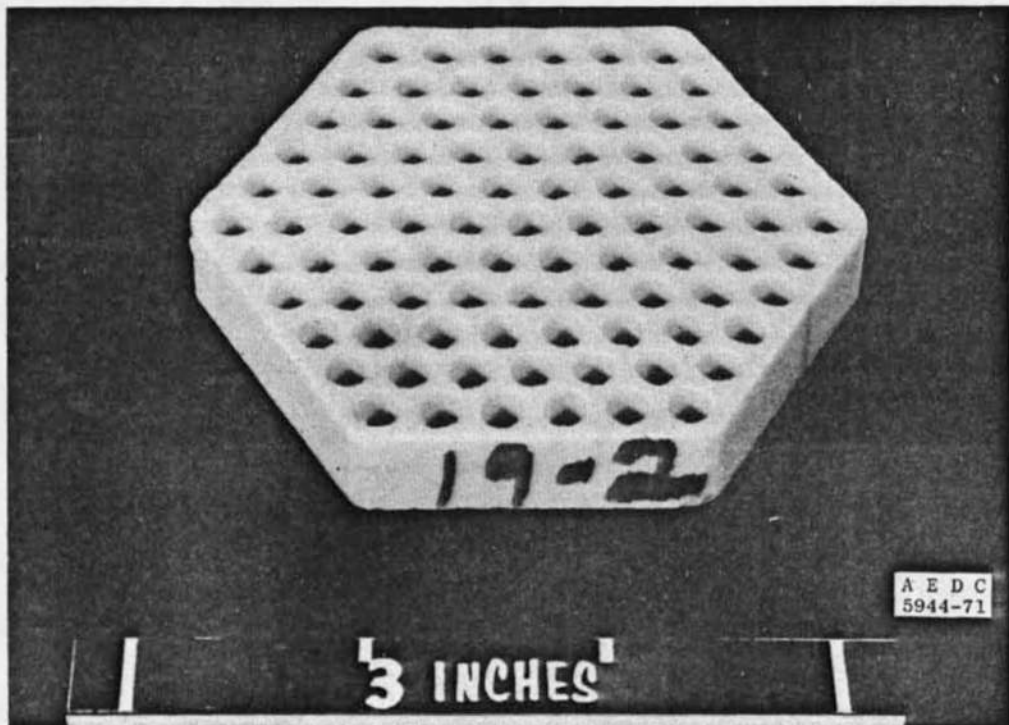
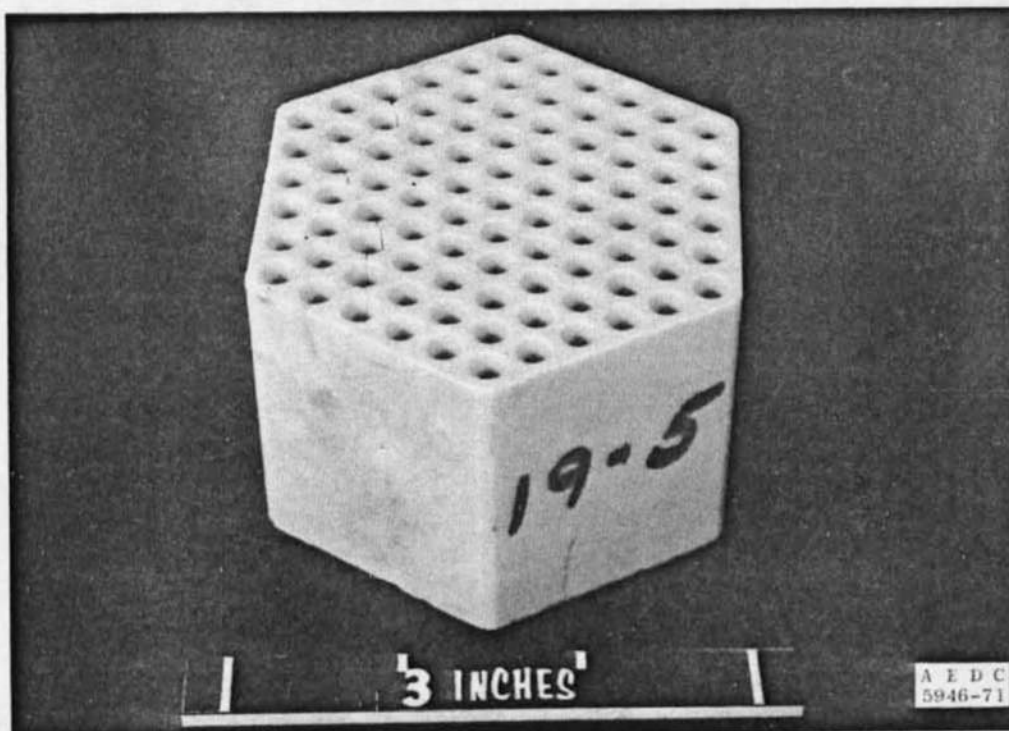
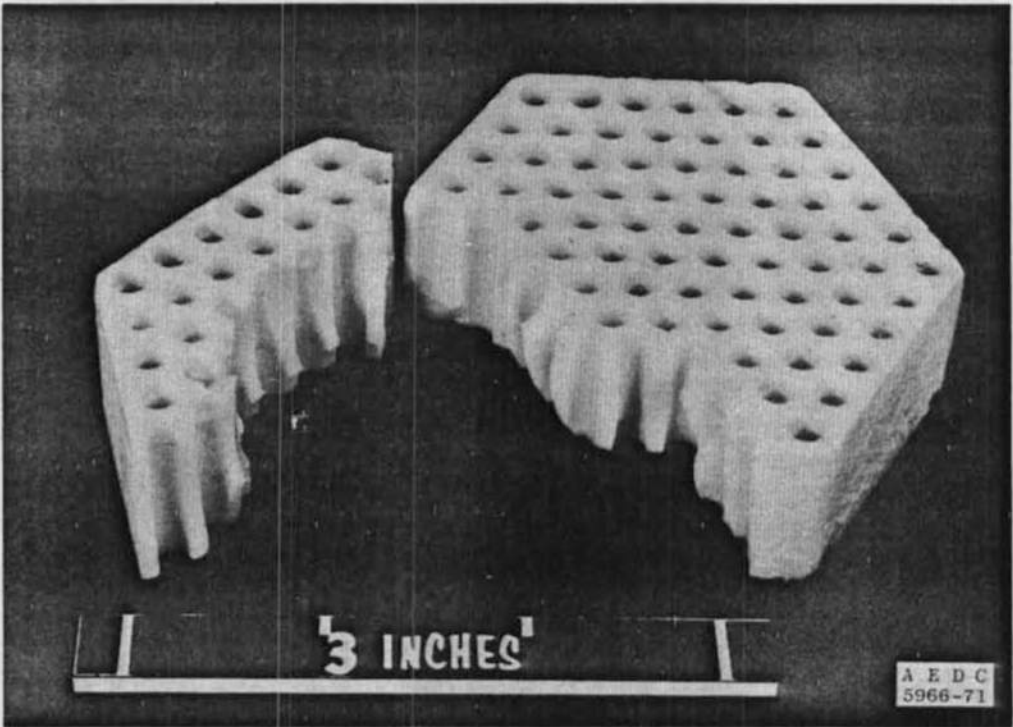
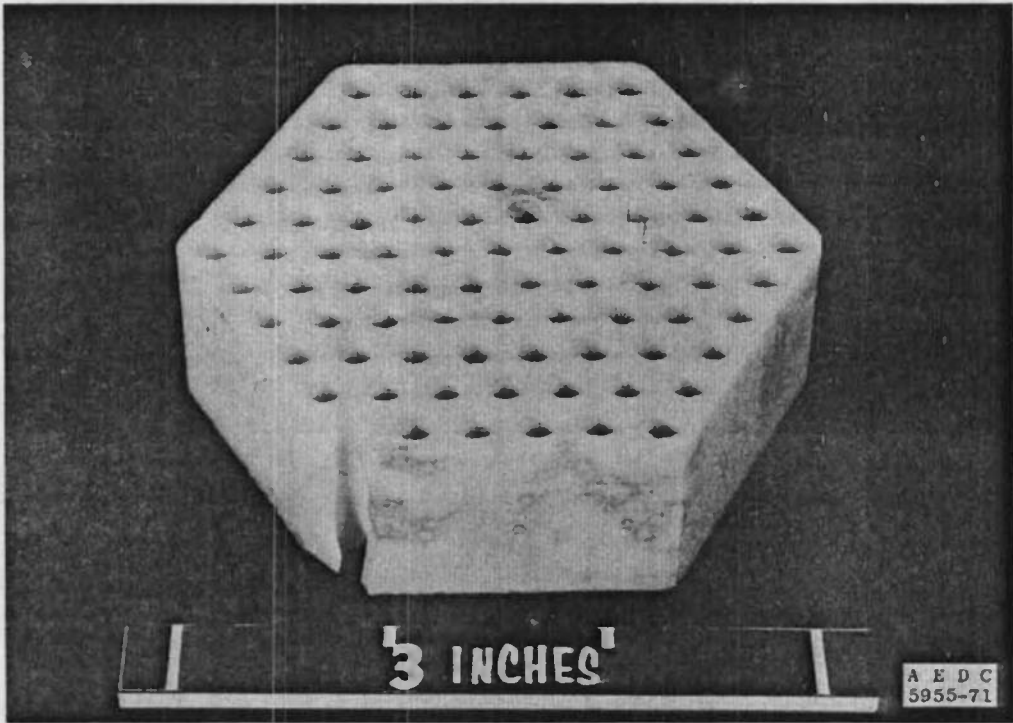
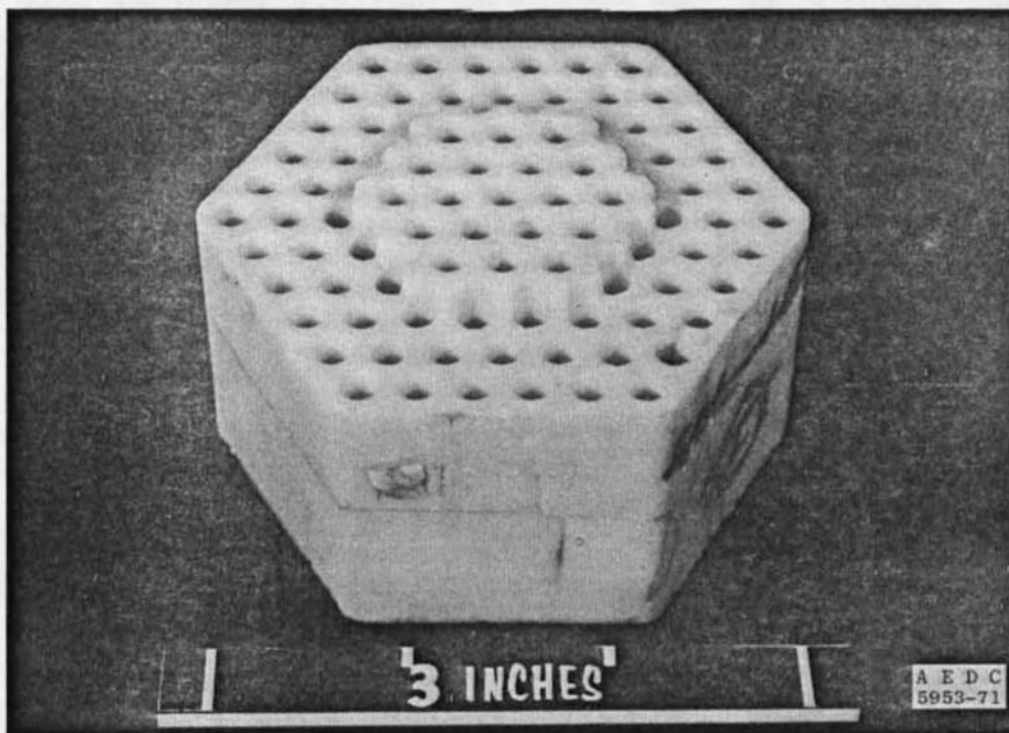
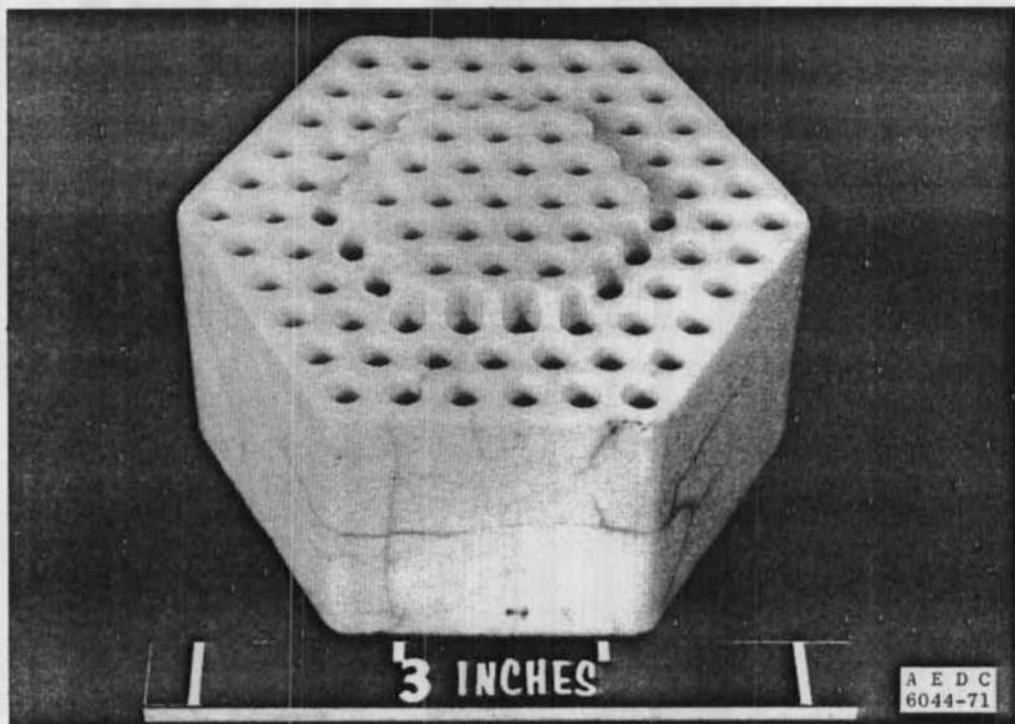
Presented in Fig. 23 are representative photographs obtained after run 85 which depict typical crack and fracture patterns. These photographs are not intended to indicate statistics such as percentage of fractured or cracked bricks. Many of the bricks shown in Fig. 23 were also photographed during the post-run 69 inspection and were previously presented in Fig. 19. Therefore, any degradation of these bricks resulting from runs 70 through 85 may be noted. Listed in the following table are those bricks for which photographs after runs 69 and 85 are presented and the respective figure numbers.

a. Coors, 12.6 w/o, Location 16-7

b. Coors, 13.8 w/o, Location 19-2

Fig. 23 High Density Sample Bricks, Post-Run 85

c. Coors, 13.8 w/o, Location 19-5

e. Zircoa, 12.5 w/o, Location 17-4

f. Zircoa, 16.5 w/o, Location 18-5  
Fig. 23 Continued

g. Zircoa, 16.5 w/o, Location 18-7

i. Zircoa, 16.5 w/o, Location 1-8  
Fig. 23 Concluded

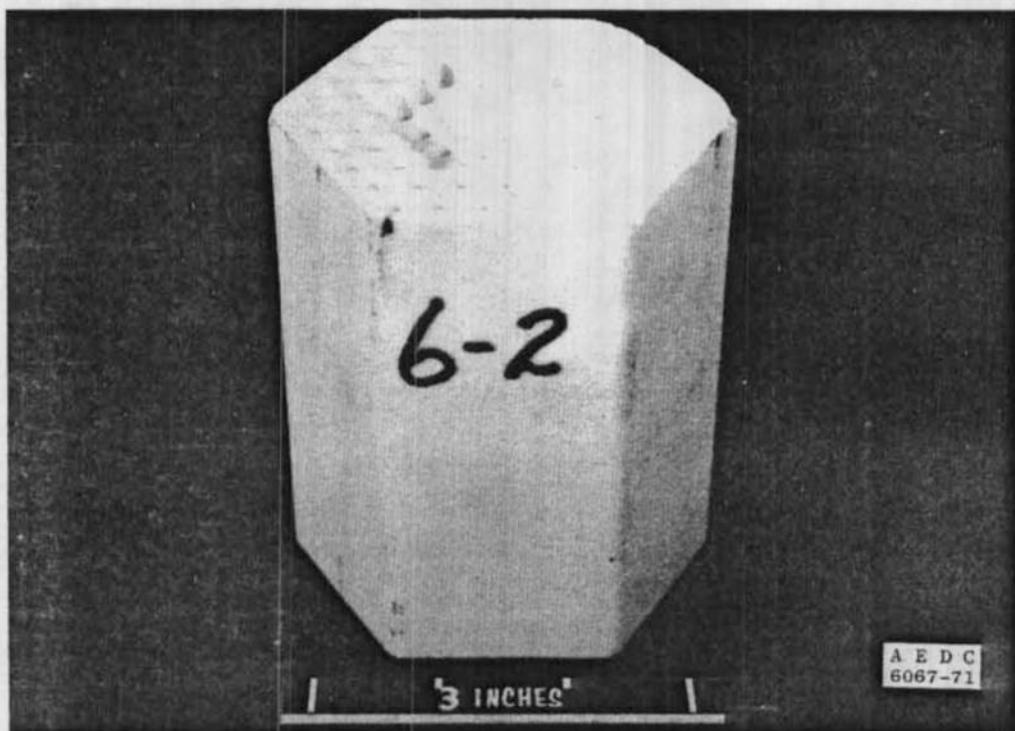
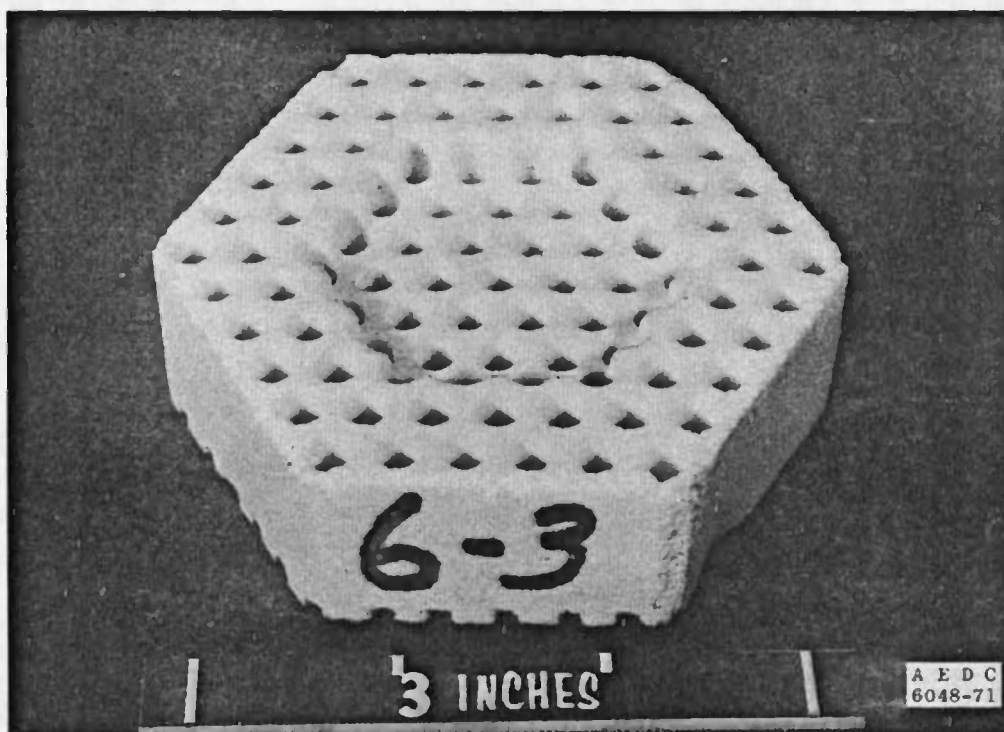
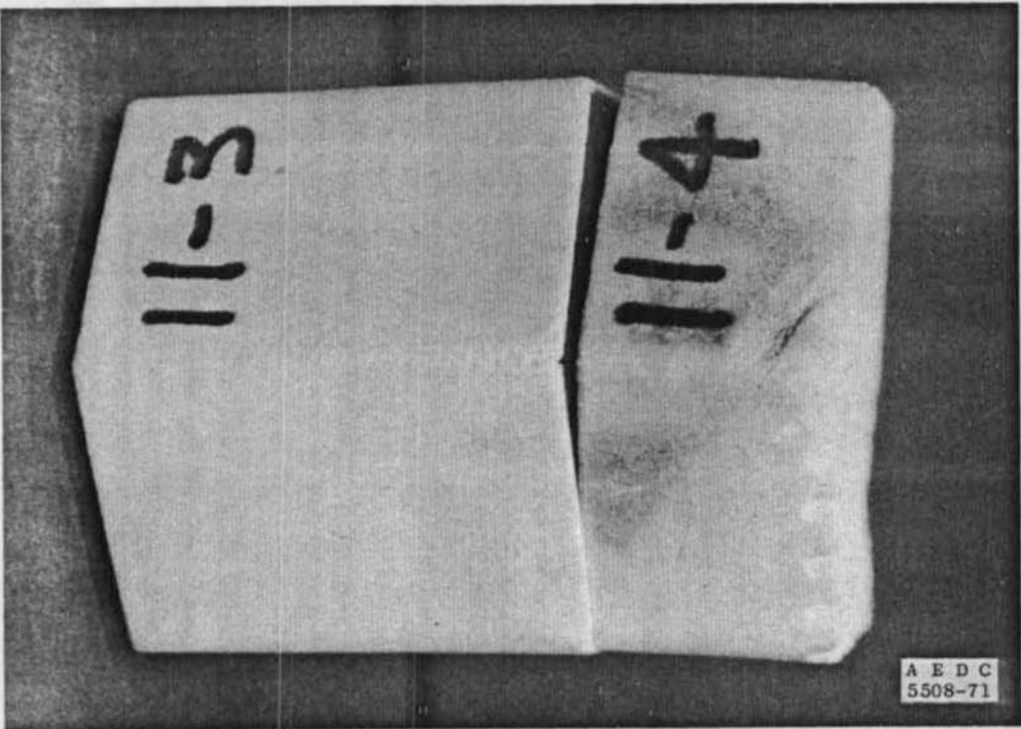
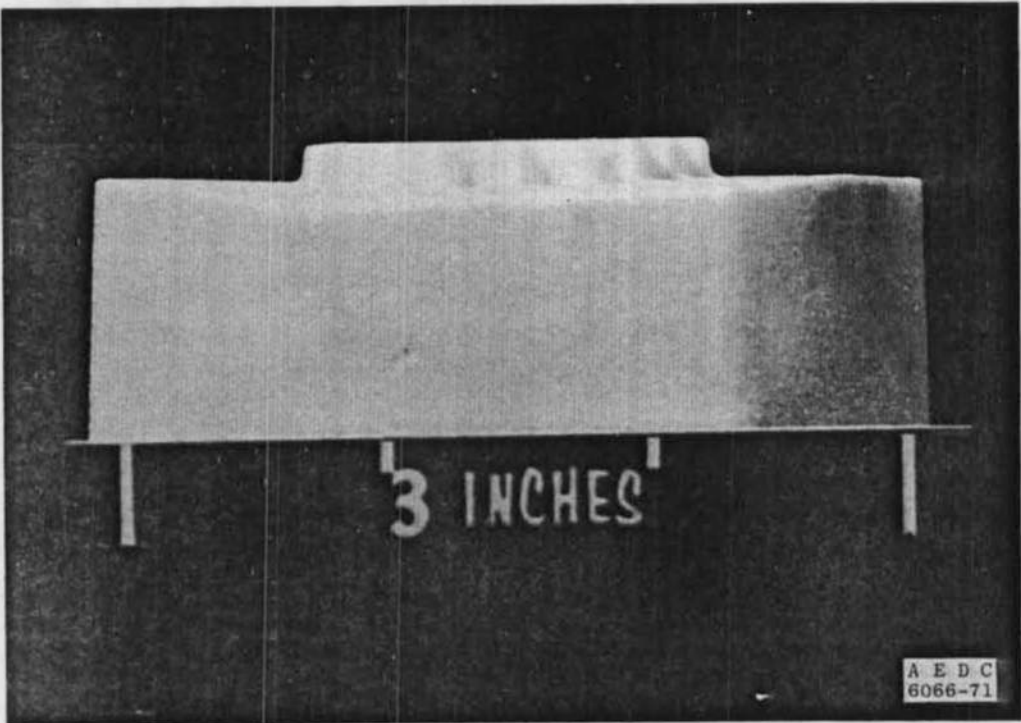
a. Zircoa, 12.5 w/o, Location 6-2  
Fig. 24 Low Density Sample Bricks, Post-Run 85

b. Zircoa, 12.5 w/o, Location 6-3

d. Zircoa, 14.5 w/o, Location 11-3 and 11-4

e. Zircoa, 14.5 w/o, Location 11-4  
Fig. 24 Concluded

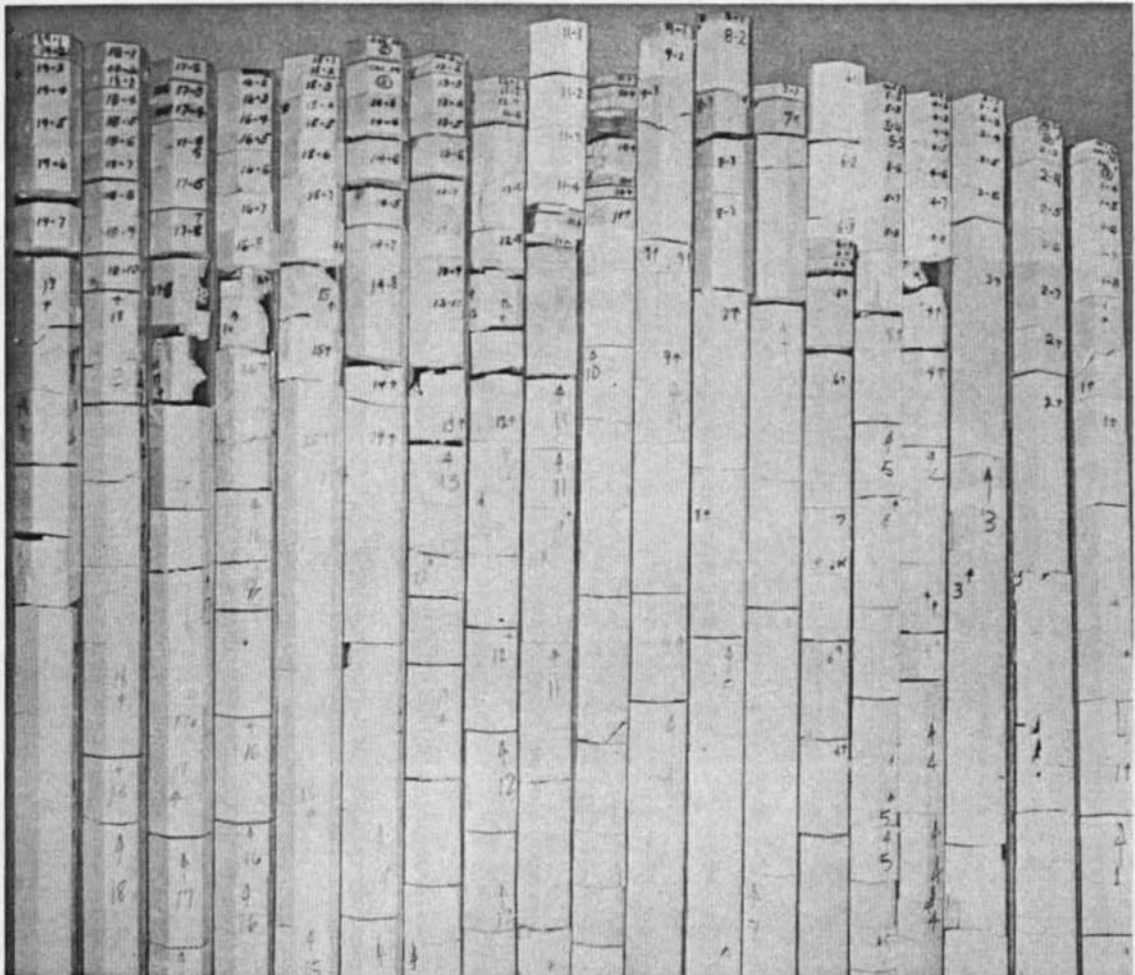
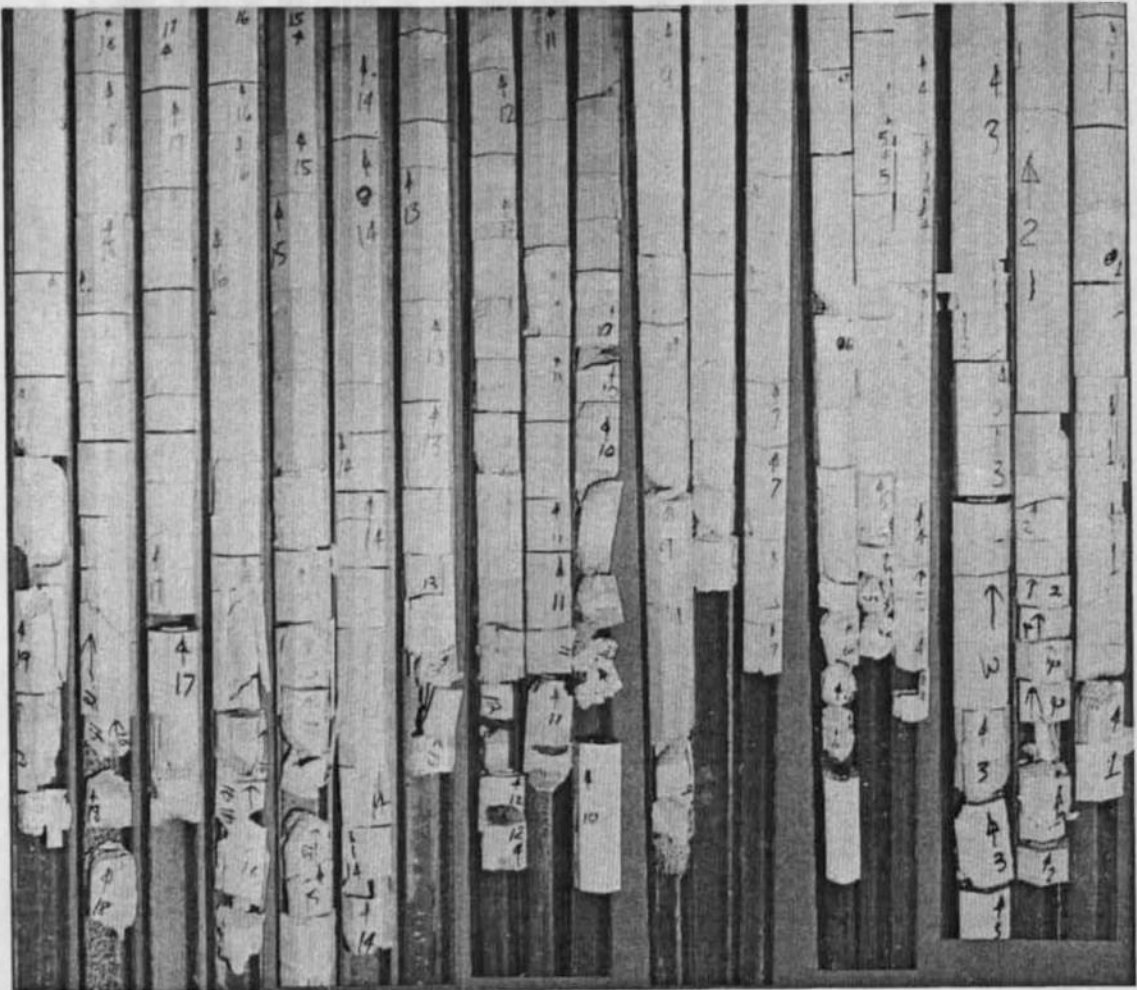
a. Upper Portion

Fig. 25 Zirconia Matrix Overall View, Post-Run 85

b. Lower Portion  
Fig. 25 Concluded

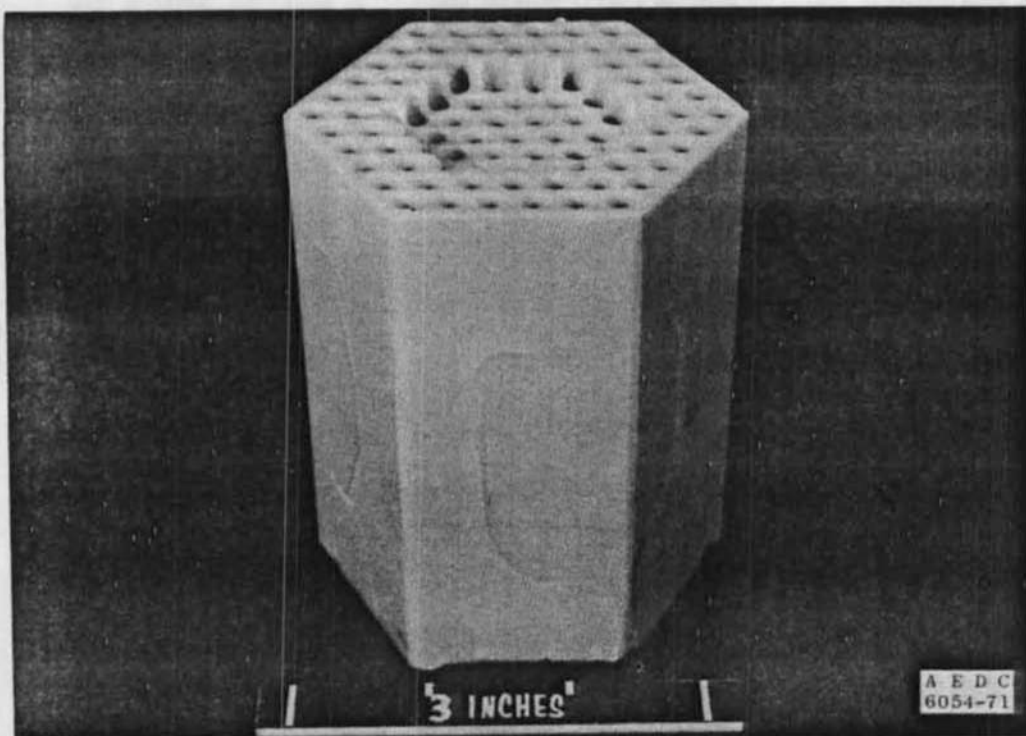
Fig. 26 Zirconia Matrix Bricks Located Directly below Sample Bricks, Post-Run 85

c. Coors, 9.25 w/o, Column 6, 13-ft Bed Level  
Fig. 26 Concluded

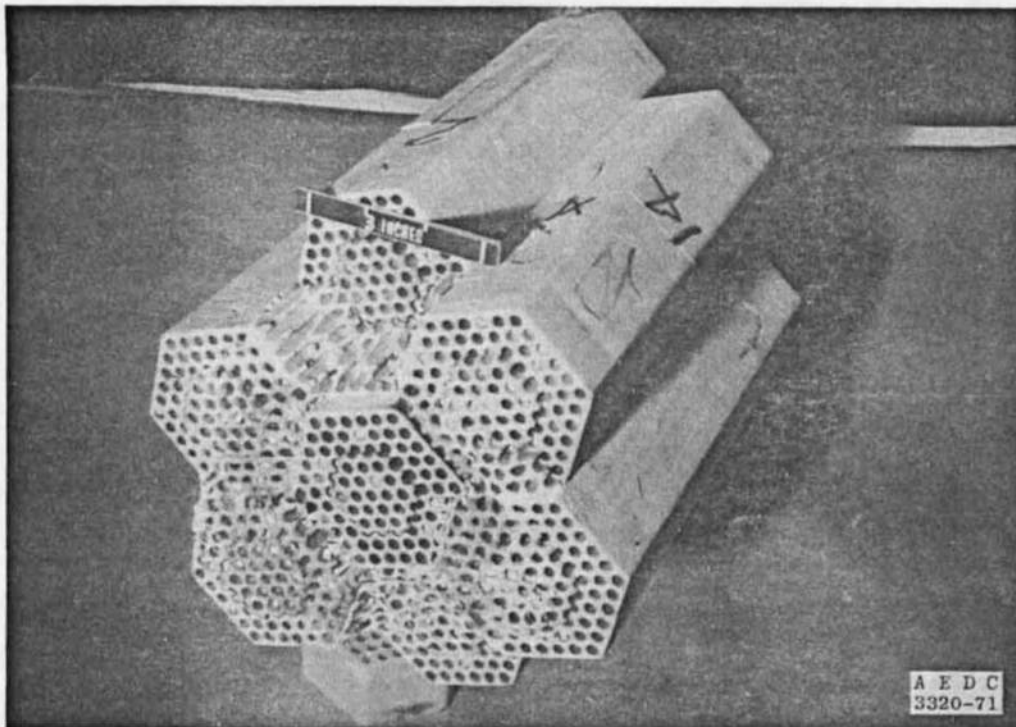
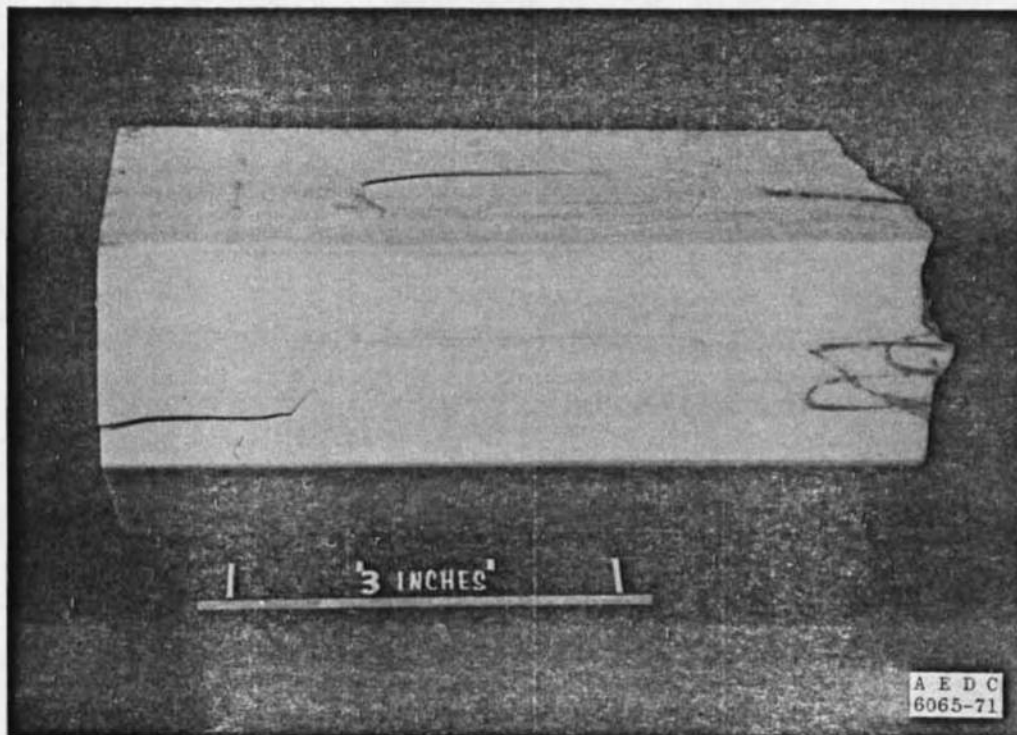
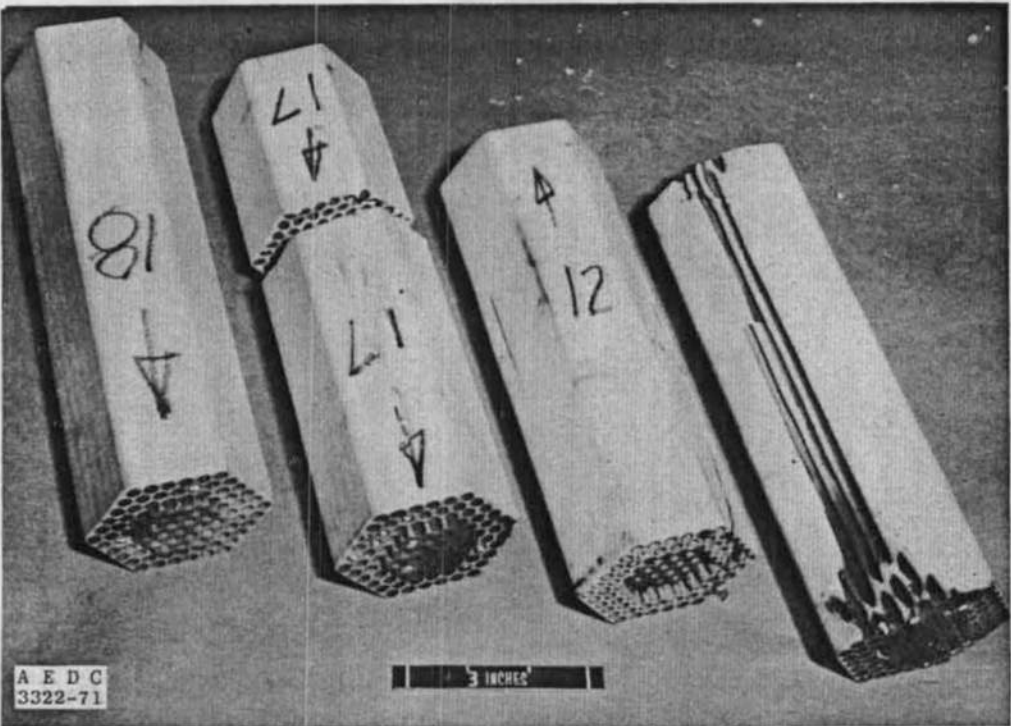
a. Alumina Upper Surface at the Zirconia/Alumina Interface  
Fig. 27 Alumina Matrix, Post-Run 85

b. Center Portion of the Alumina Matrix at the Interface

c. Lower Portion of Alumina Interface Brick from Column 7  
Fig. 27 Continued

d. Alumina Bricks Located at the Interface
