AEDC-TR-72-161

**RESEARCH AND DEVELOPMENT TESTING  
OF YTTRIA/RARE EARTH  
STABILIZED ZIRCONIA MATRIX BRICKS  
IN THE PILOT TEST UNIT (PTU) AT AEDC**

**C. R. Tinsley**

**November 1972**

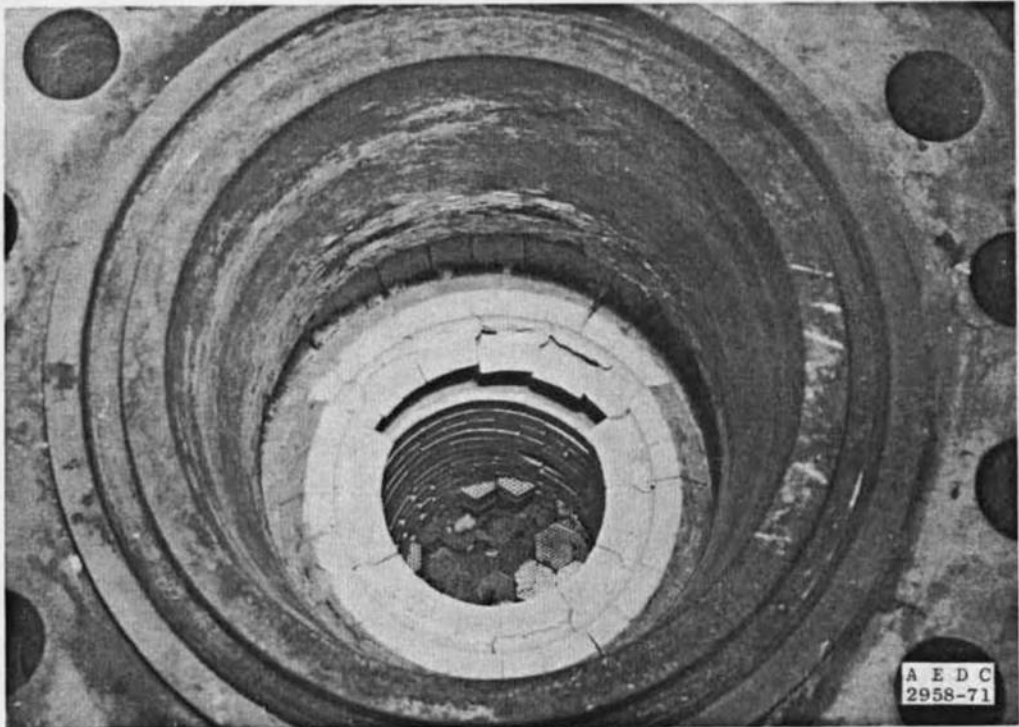
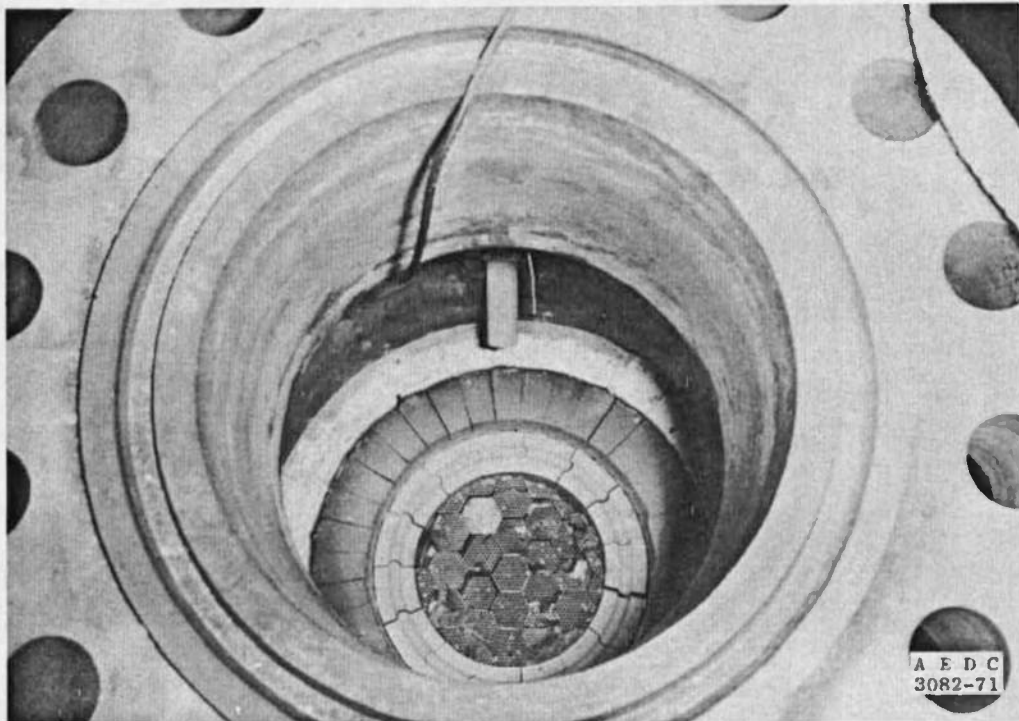
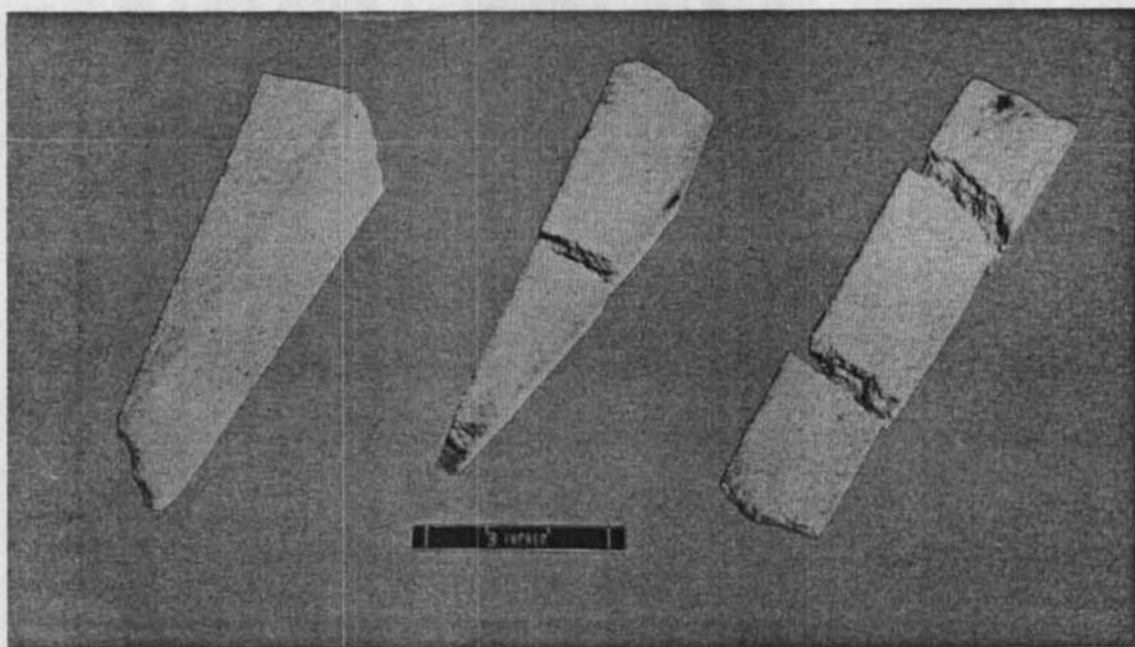
a. Dome Hot Face Liner Bricks

b. Heater Dome Support Shelf and Top of Matrix Refractories  
Fig. 28 Various Heater Refractories, Post-Run 85

d. Typical Dome Insulation, 3250°R Firebrick  
Fig. 28 Continued

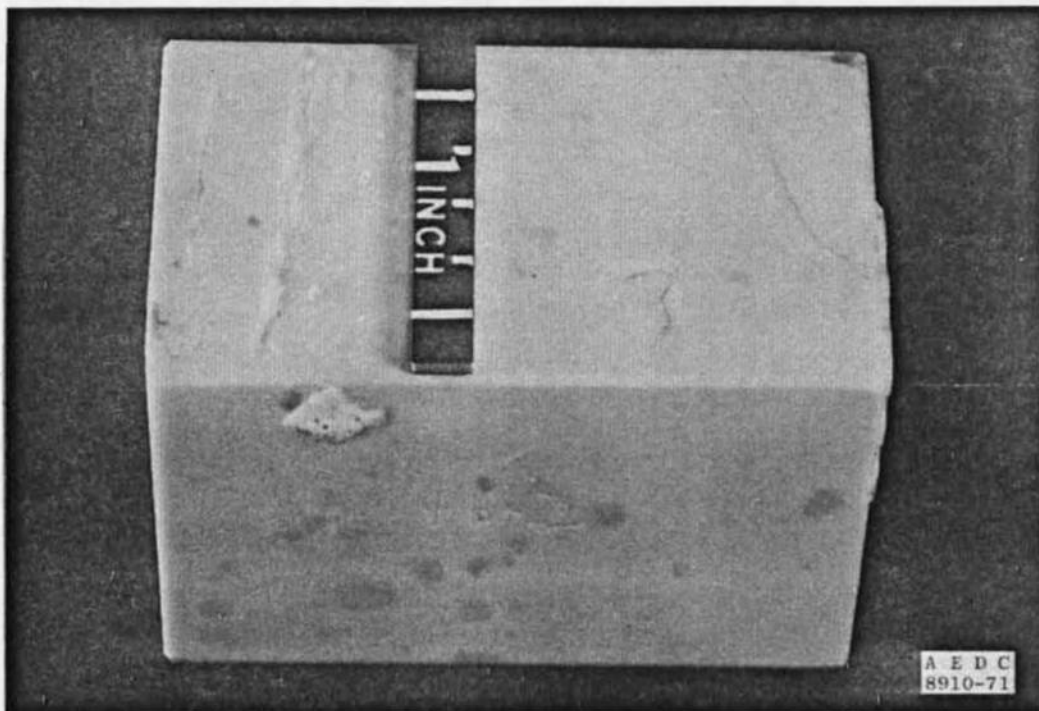
a. Side "A"

Fig. 29 Matrix Brick Exhibiting Stress Marks, Post-Run 44

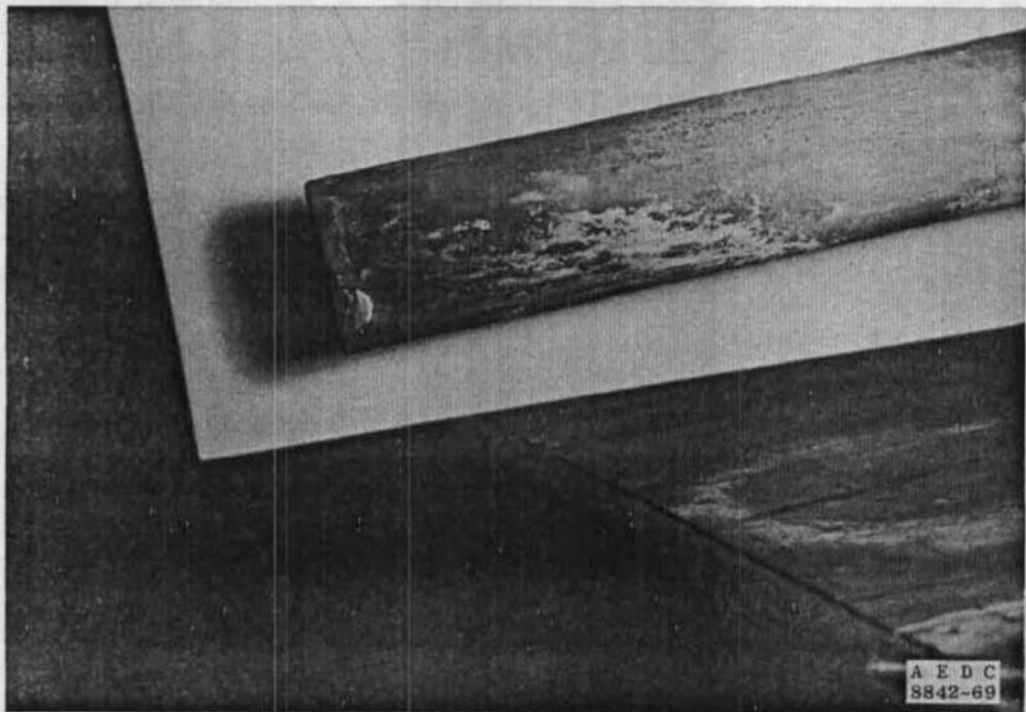
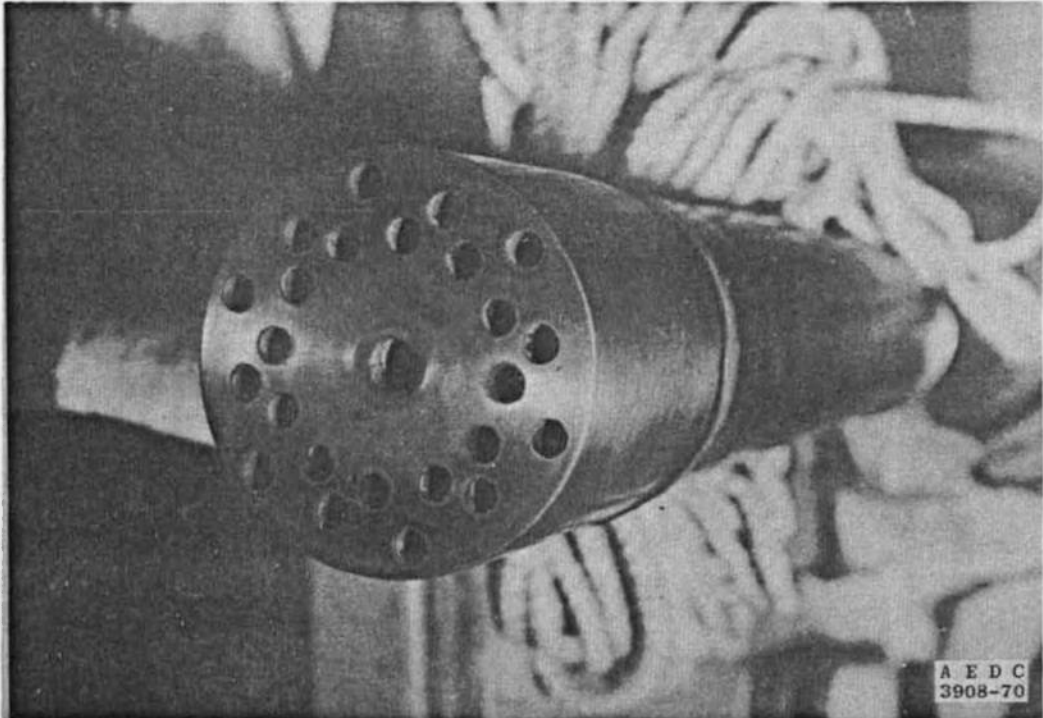
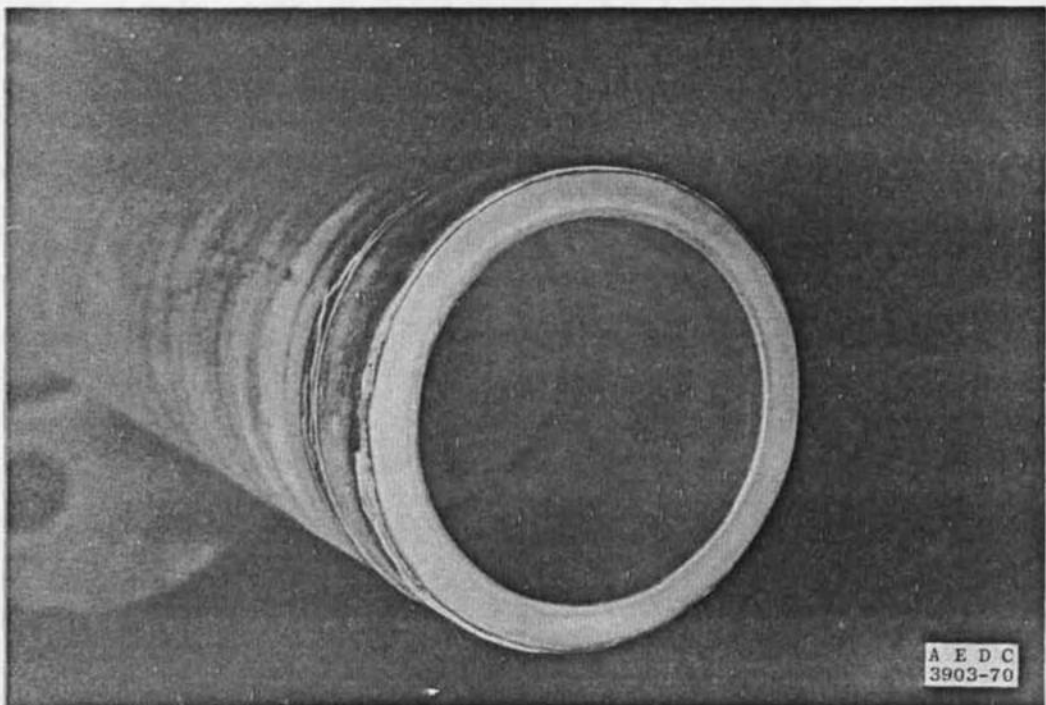
Inspection of the burner revealed severe erosion of the combustion chamber. Details of this inspection and other burner inspections during the test program are provided in Appendix V.

a. Post-Heat Soak

Fig. V-1 First Generation Burner

**b. Post-Heat Soak**

d. Pre-Run 39

e. Pre-Run 39  
Fig. V-1 Concluded
