IMPROVED MATERIALS AND MANUFACTURING  
METHODS FOR GUN BARRELS. PART I

SWERR-TR-72-54

**IMPROVED MATERIALS AND MANUFACTURING  
METHODS FOR GUN BARRELS  
(PART I)**

**Dr. R. P. O'Shea, IIT Research Institute  
G. S. Allison, Battelle Northwest  
and  
J. D. DiBenedetto,  
Dr. K. R. Iyer  
USAWECOM**

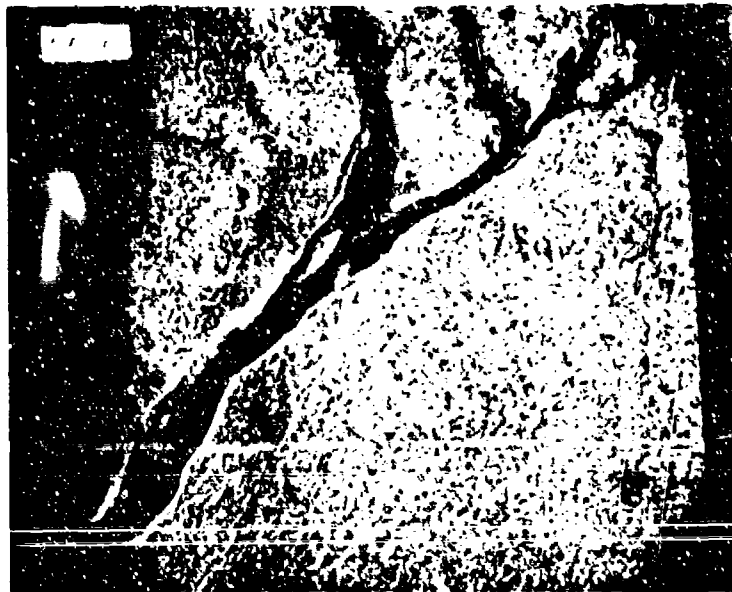
FIGURE 3 SCANNING ELECTRON MICROGRAPH SHOWING TYPICAL CRACK AND ASSOCIATED WHITE LAYER ON FAILED GUN BARREL.

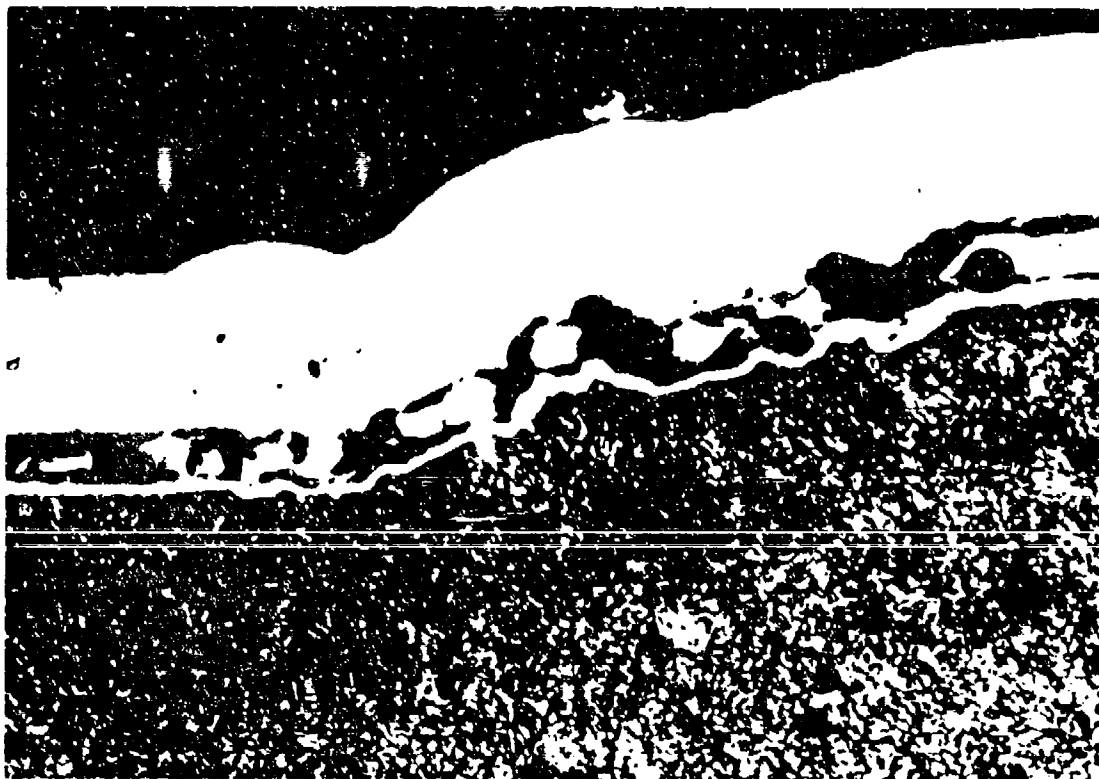
Examination of the fired unplated barrels revealed that material removal or erosion was the prime mode of failure for gun steel. The lands are flattened considerably by firing. Figure 5 typifies the microstructure along the bore surface and shows the intersection of a land and groove.

FIGURE 5 PHOTOMICROGRAPH SHOWING THE TRANSVERSE STRUCTURE  
ALONG THE BORE SURFACE OF UNPLATED GUN BARREL AFTER 300 SHOTS.  
(Bore surface was nickel plated for metallographic examination.)

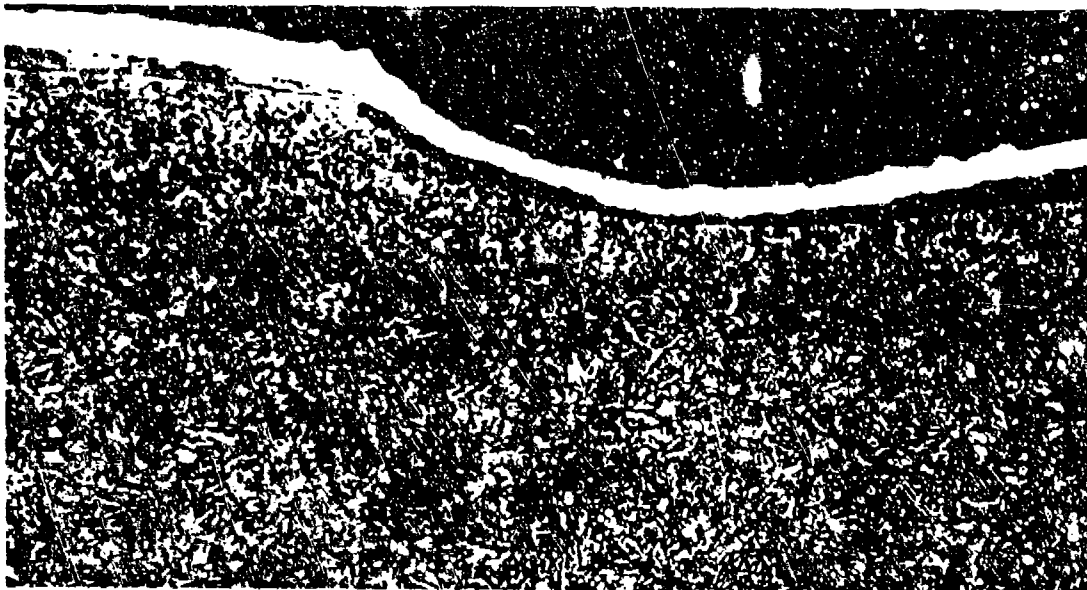
Each of the three vented bomb fired materials was metallographically examined. Figures 8 and 9 show the bore surface of the unplated rifled inserts which were fired with IMR and WC846 propellants. The bore surface was plated with nickel to preserve surface effects. Both sections shown in these figures are at a land and groove intersection. Evidently in the vented bomb gun steel does not crack, but rather there appears to be a general removal of metal along the bore surface and a rather sharp heat-affected zone present. In both cases, the rifling is flattened but much more extremely with the IMR propellant. This mode of failure is similar to that encountered in gun tests.

FIGURE 8 PHOTOMICROGRAPH REVEALING THE TRANSVERSE STRUCTURE  
ALONG THE BORE SURFACE OF AN UNPLATED RIFLED INSERT AFTER  
5 VENTED BOMB SHOTS WITH WC846 PROPELLANT.

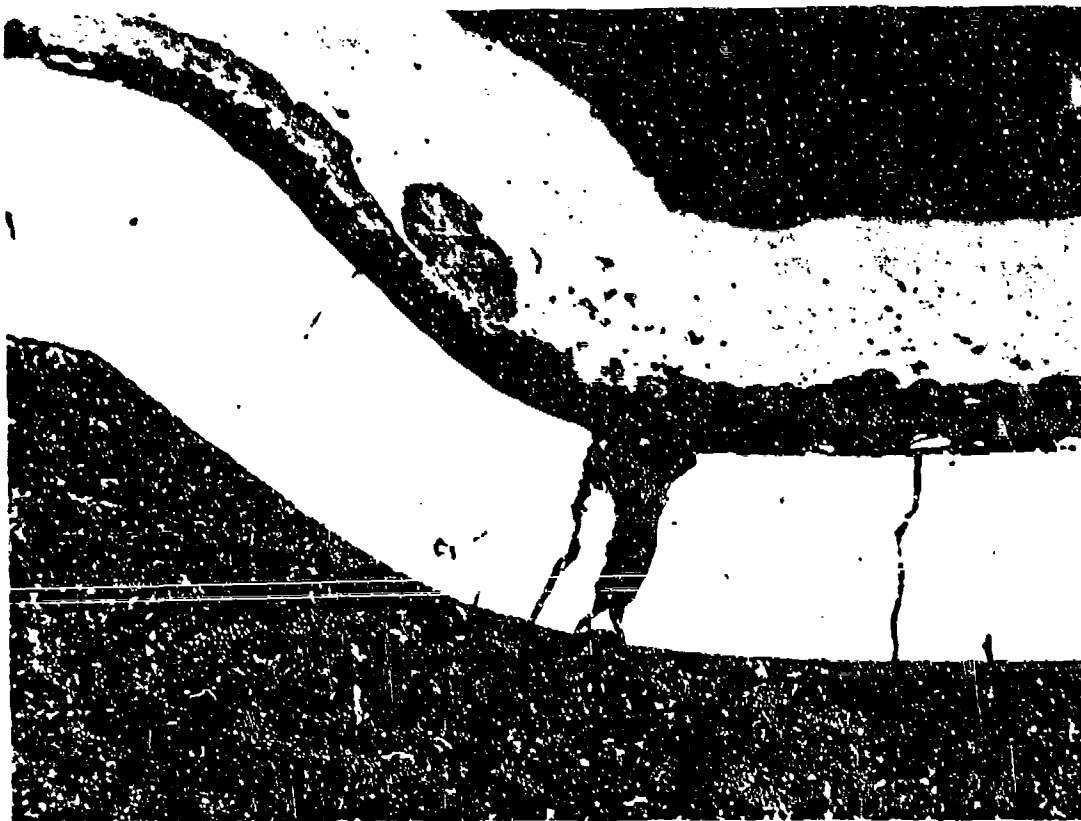
Typical land and groove intersections of the rifled, chromium-plated inserts subjected to 5 firings in the vented bomb with WC846 and IMR propellants are shown in Figures 10 and 11. It is apparent that cracking from the chromium plate has progressed into the steel, but no spalling off has occurred. This mode of failure is similar to that encountered in gun tests.

FIGURE 10 PHOTOMICROGRAPH REVEALING THE TRANSVERSE STRUCTURE  
ALONG THE BORE SURFACE OF A CHROMIUM-PLATED RIFLED INSERT  
AFTER 5 VENTED BOMB SHOTS WITH WC846 PROPELLANT.

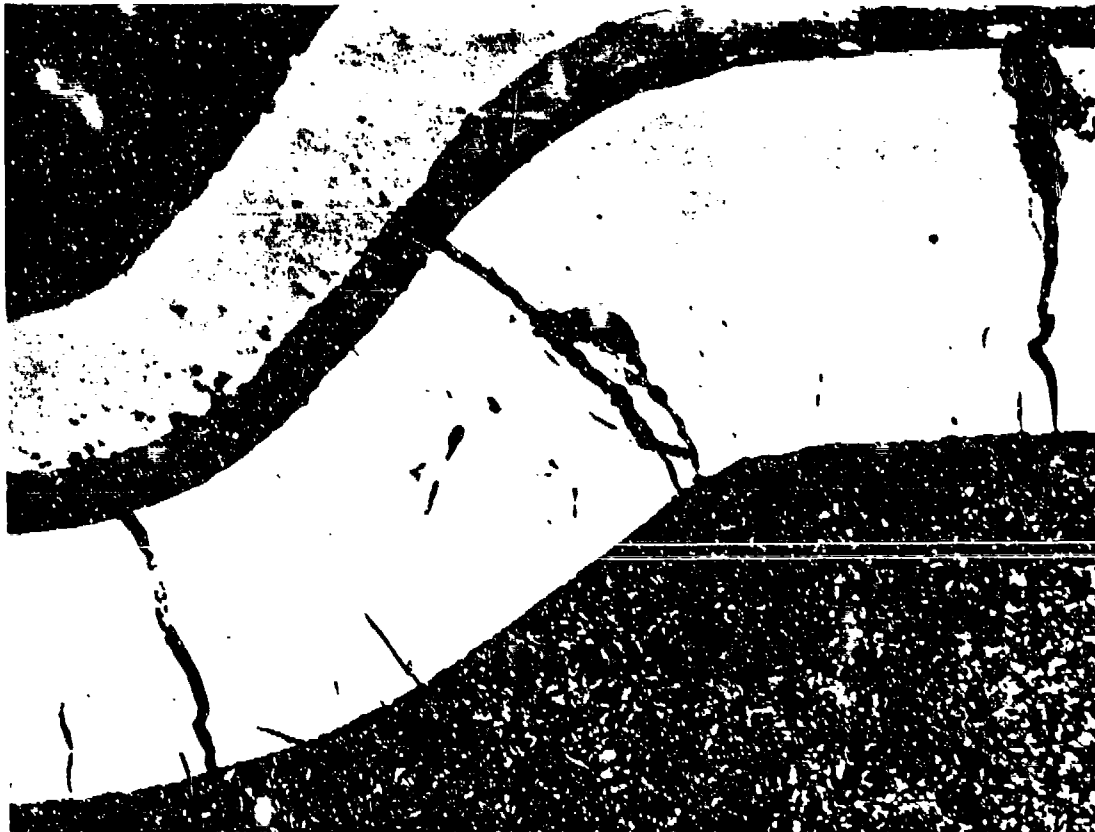
FIGURE 11 PHOTOMICROGRAPH REVEALING THE TRANSVERSE STRUCTURE  
ALONG THE BORE SURFACE OF A CHROMIUM-PLATED RIFLED INSERT  
AFTER 5 VENTED BOMB SHOTS WITH IMR PROPELLANT.

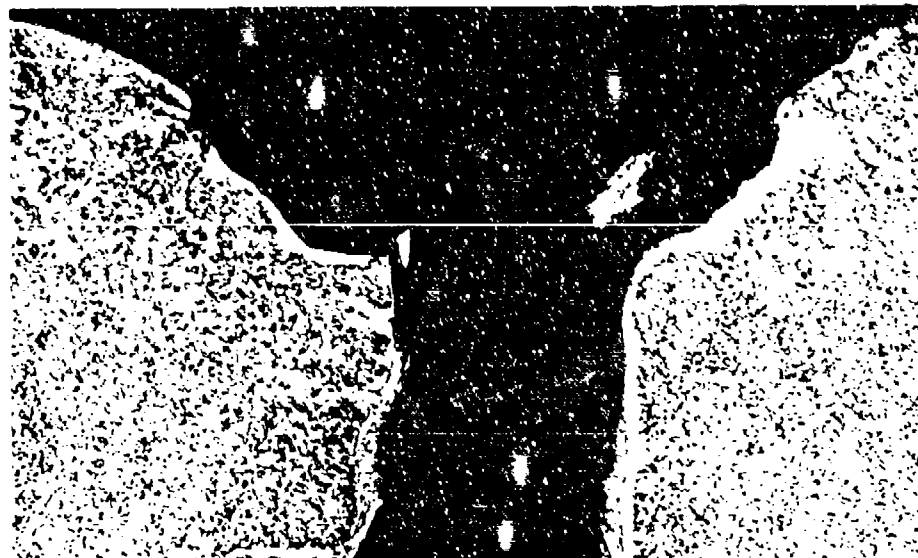
FIGURE 50 TRANSVERSE SECTION AT 1 1/2 INCHES FROM THE CHAMBER OF A STANDARD CHROME-PLATED GUN BARREL AFTER FIRING 11,283 ROUNDS AND BEING DECLARED UNSERVICEABLE.

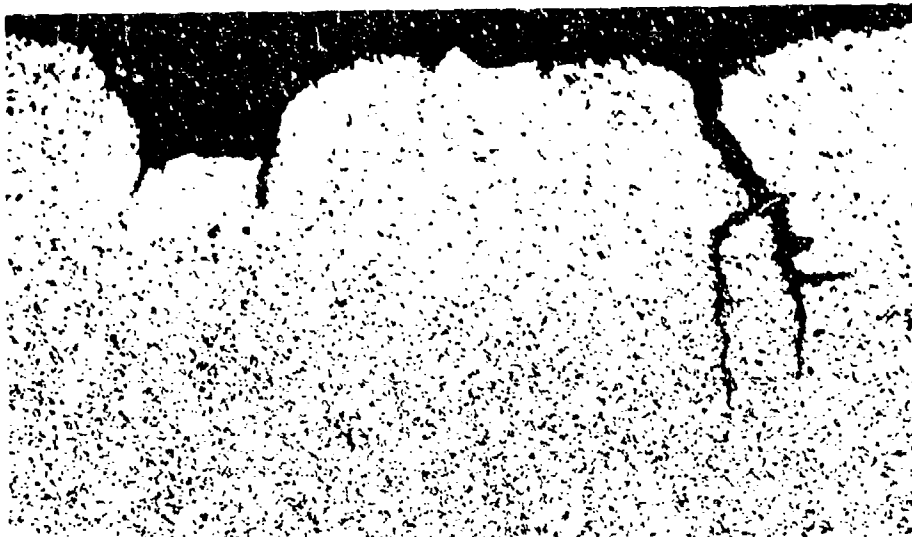
FIGURE 51 TRANSVERSE SECTION AT 2 INCHES FROM THE CHAMBER OF A STANDARD CHROME-PLATED GUN BARREL AFTER FIRING 11,283 ROUNDS AND BEING DECLARED UNSERVICEABLE.

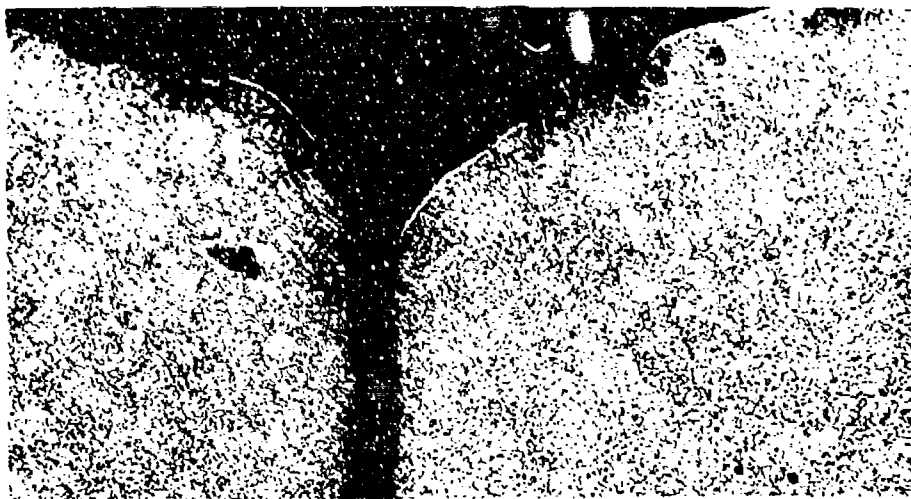
FIGURE 67 TRANSVERSE SECTION AT 1/2 INCH FROM THE CHAMBER OF A CHROME-PLATED H11 STEEL GUN BARREL AFTER FIRING 24,466 ROUNDS AND BEING DECLARED UNSERVICEABLE.
