AD801410

XRD-138  
Report Number

USS LST-133

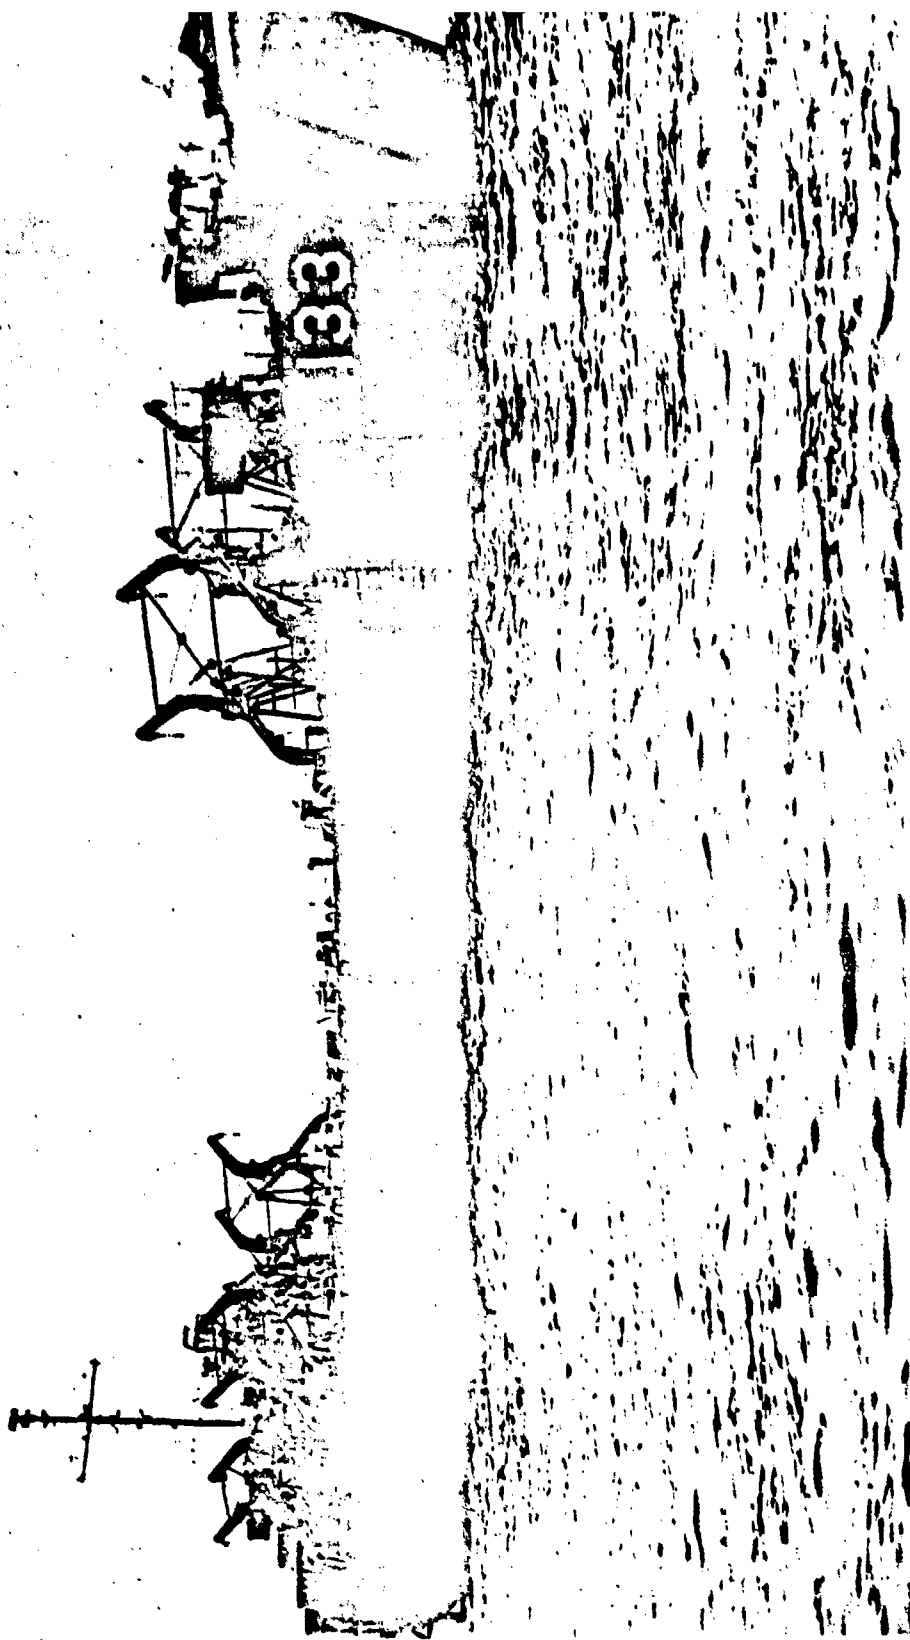
AB-CR-227-289-99. Starboard bow after Test B.
