SUBJECT: Operational Report - Lessons Learned, Headquarters, 93d
Engineer Battalion (Const), Period Ending 31 January 1968 (U)

3
DEPARTMENT OF THE ARMY
Headquarters, 93d Engineer Battalion (Const)
APO San Francisco 96370

SUBJECT: Operational Report - Lessons Learned
for Quarterly Period Ending 31 January 1968

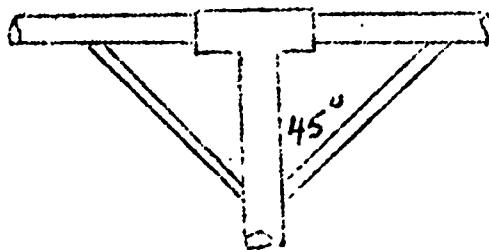
Discussion: The horizontal pipe on fill stands has been found to receive an undue amount of abuse by personnel using the fill stand. In several instances, the problem was solved by welding a pipe as a 45° brace between the vertical pipe and the horizontal pipe.
