Technical Note N-986

AIRFIELD PAVEMENT EVALUATION, ROYAL THAI NAVY STATION,  
BAN U-TAPAO AIRFIELD, THAILAND

D. J. Lambiotte and R. B. Brownie

August 1968

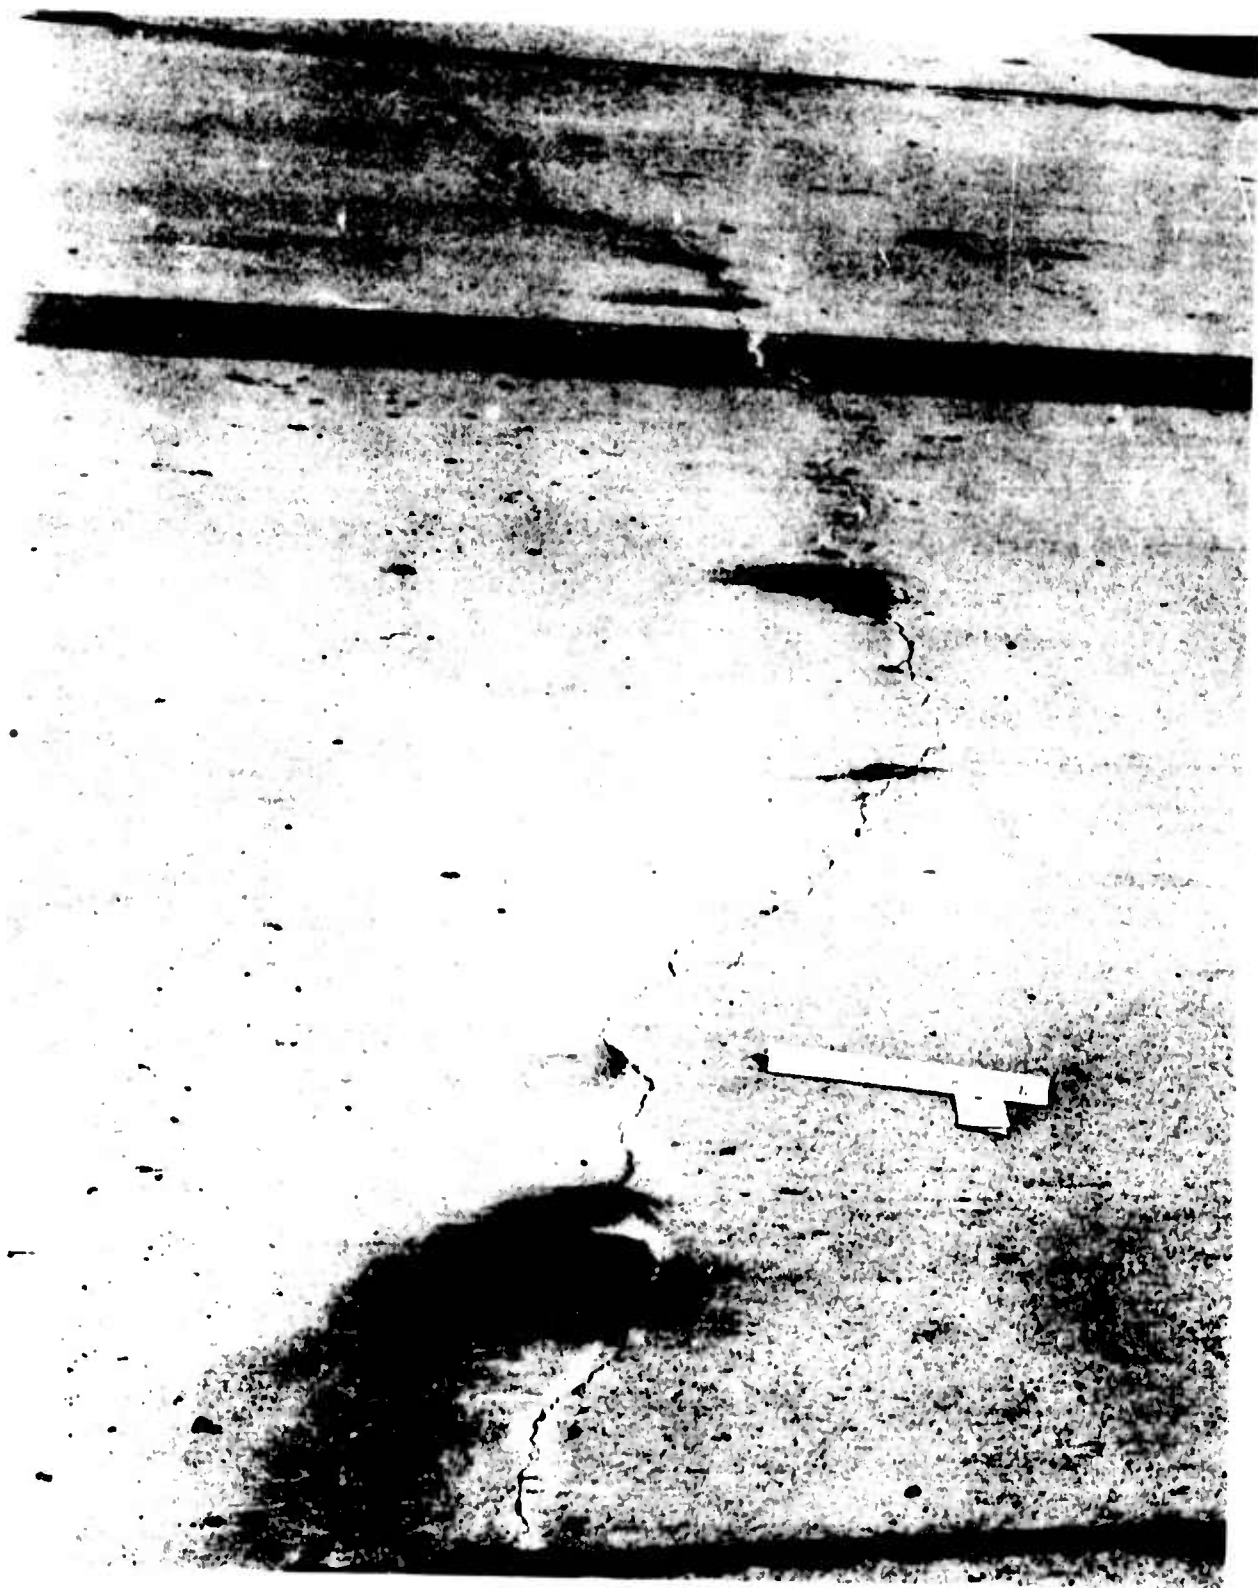
Figure A-15. Typical unsealed transverse crack in Hardstand Taxiway 1, Ban U-Tapao Airfield.
