NWC TP 4738

SAFETY TESTS OF EXPLOSIVES TRANSPORT TRUCKS

This report summarizes the results of five tests conducted at the Naval Weapons Center to study the effectiveness of flash shields placed between the cab and the bed of pickup trucks of the type used for hauling explosives at NWC.

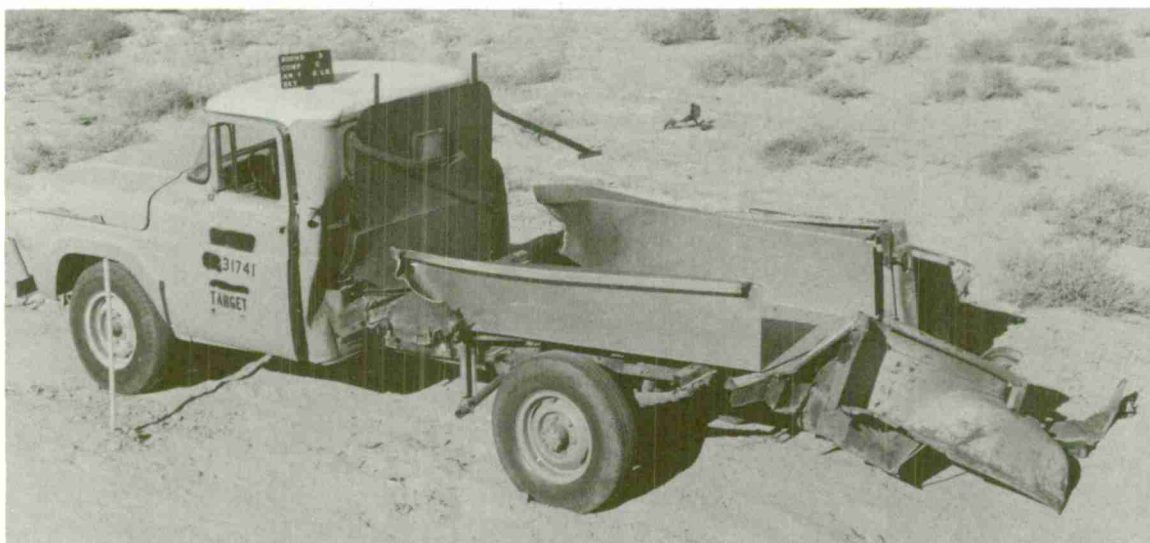
Detonation was high order and complete. The whole left side of the truck bed was torn loose and peeled back from the bed (Fig. 10). The rear of the right side was pulled back to the fender area. The tail gate was torn loose and blown back 68 feet beyond the rear of the truck. Other pieces of the truck metal were blown as far as 70 feet from the truck. The lower corner of the steel shield was pushed into the cab below the driver's seat with sufficient energy to tear a hole in the metal of the cab (Fig. 11). Figure 11 also shows that the welded aluminum bed was torn and pulled back at the front corners. A 32-in² hole was blown through the bed of the truck in the place where the Composition C-3 block had been.

FIG. 10. View of Truck After Detonation, Test 3.

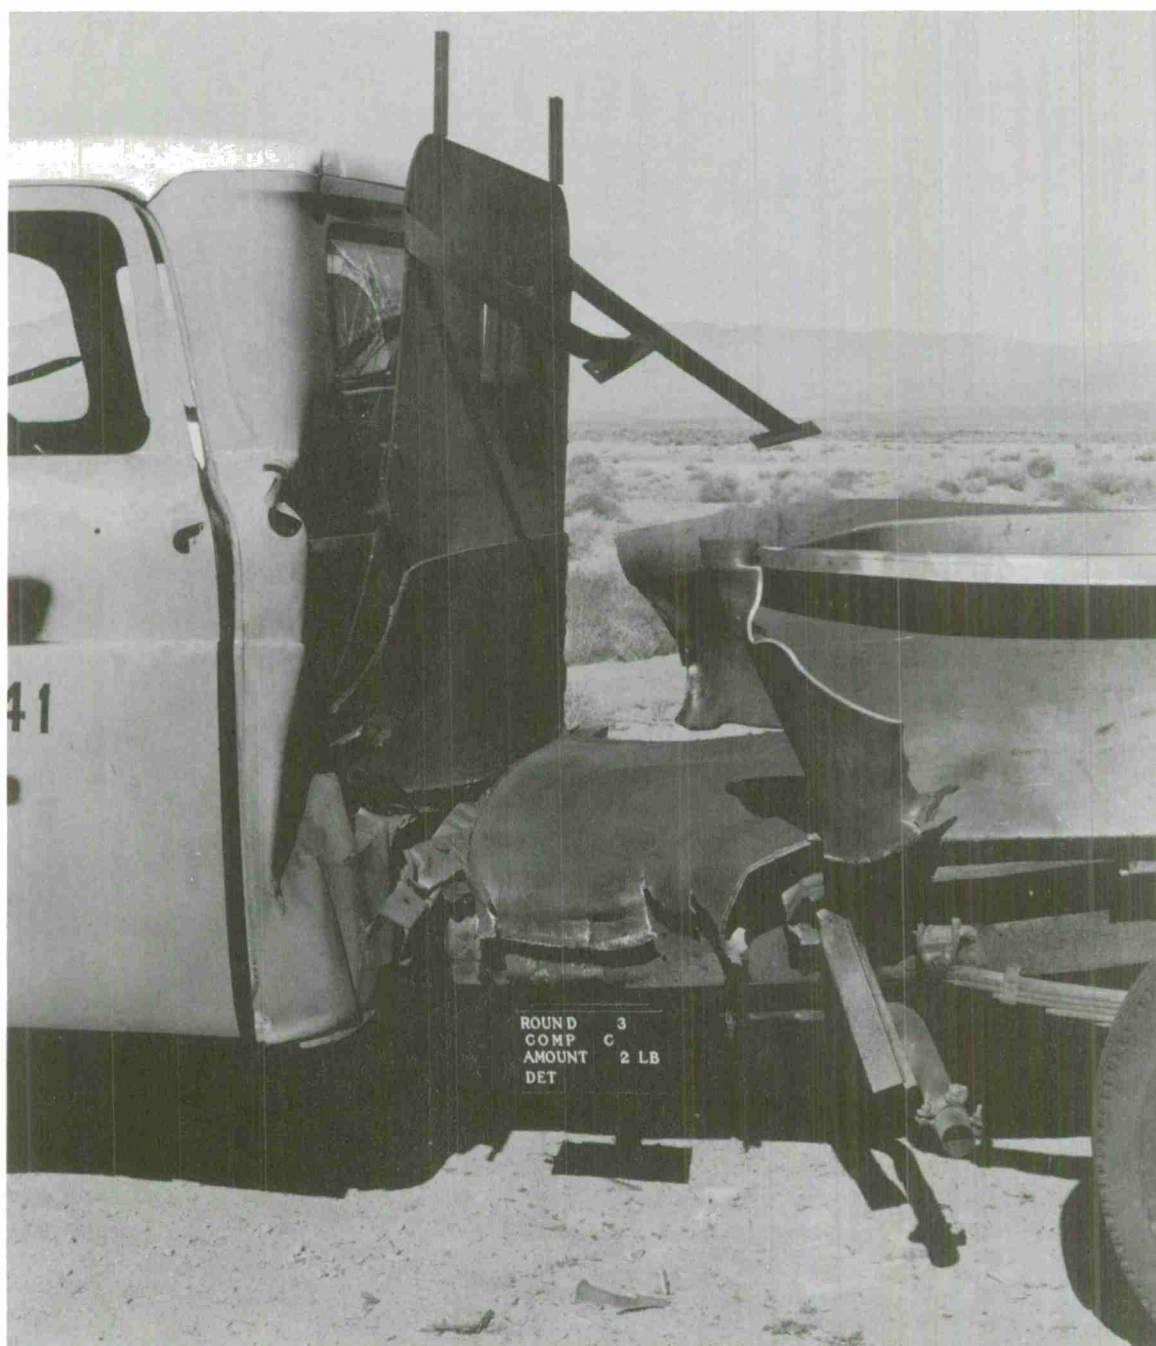
FIG. 11. Closeup of Damage Resulting From Test 3.

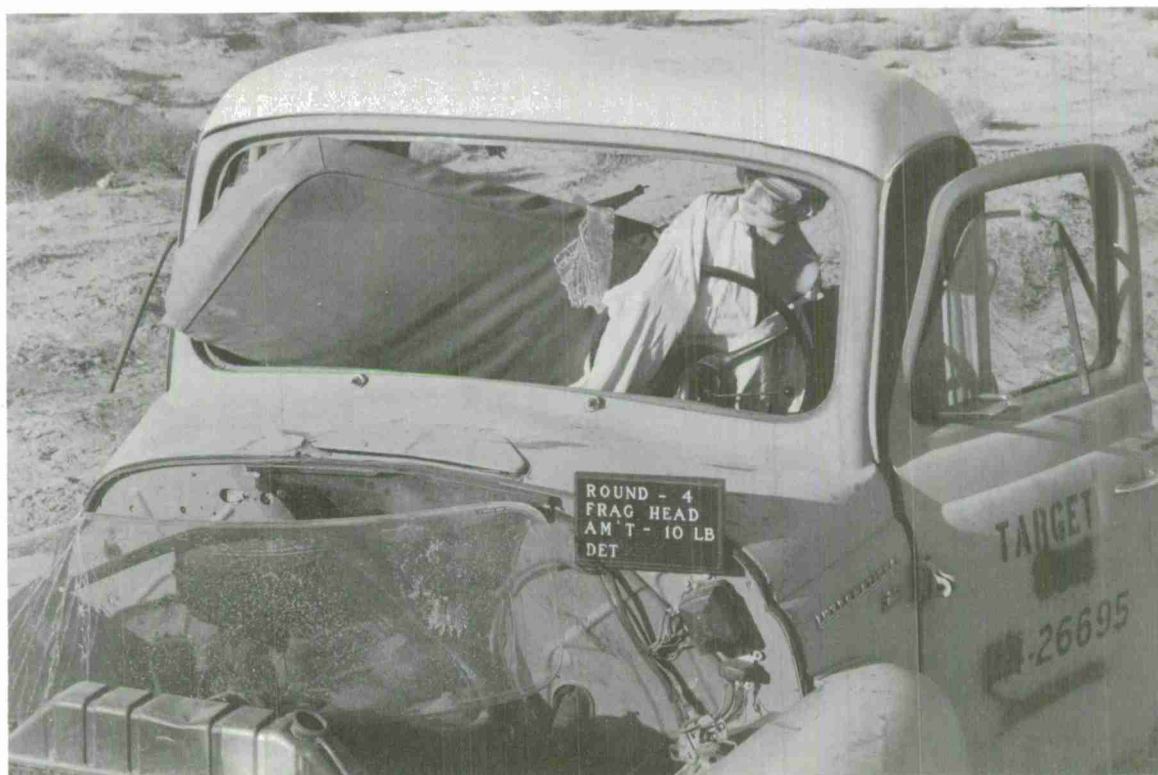
FIG. 15. Cab of Truck After Test 4.

By the extent of the damage resulting from the detonation, there is little doubt that persons in the truck cab would have been fatally injured.

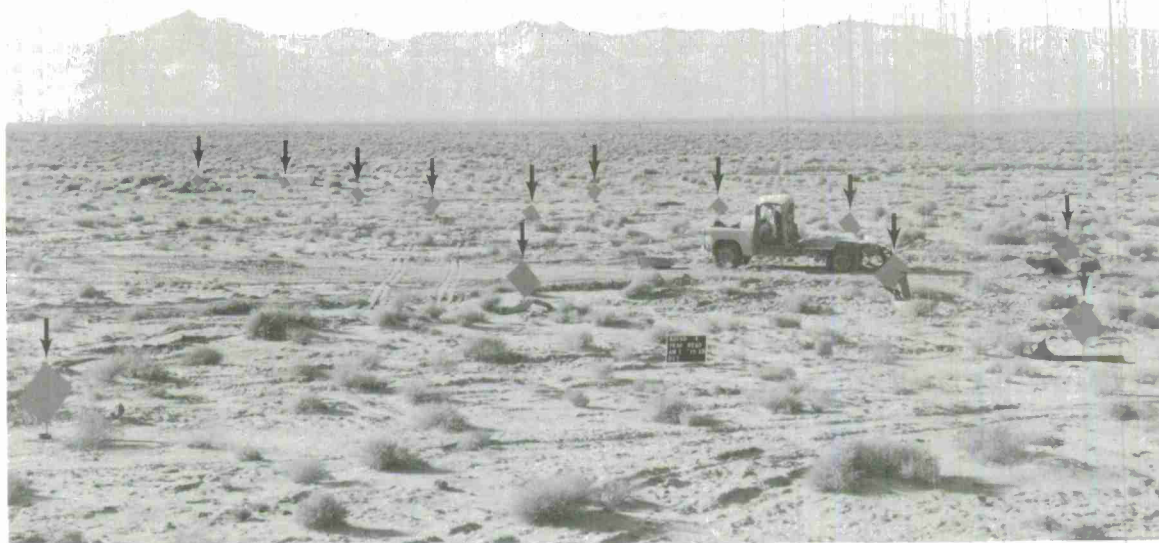
FIG. 16. Dispersion of Truck Fragments (Arrows), Test 4.
