AFRPL-TR-70-43

**LONG-TERM STORABILITY
OF
PROPELLANT TANKAGE AND COMPONENTS
INTERIM REPORT #1**

R. B. MEARS, 1st LIEUTENANT, USAF

INTERIM REPORT #1

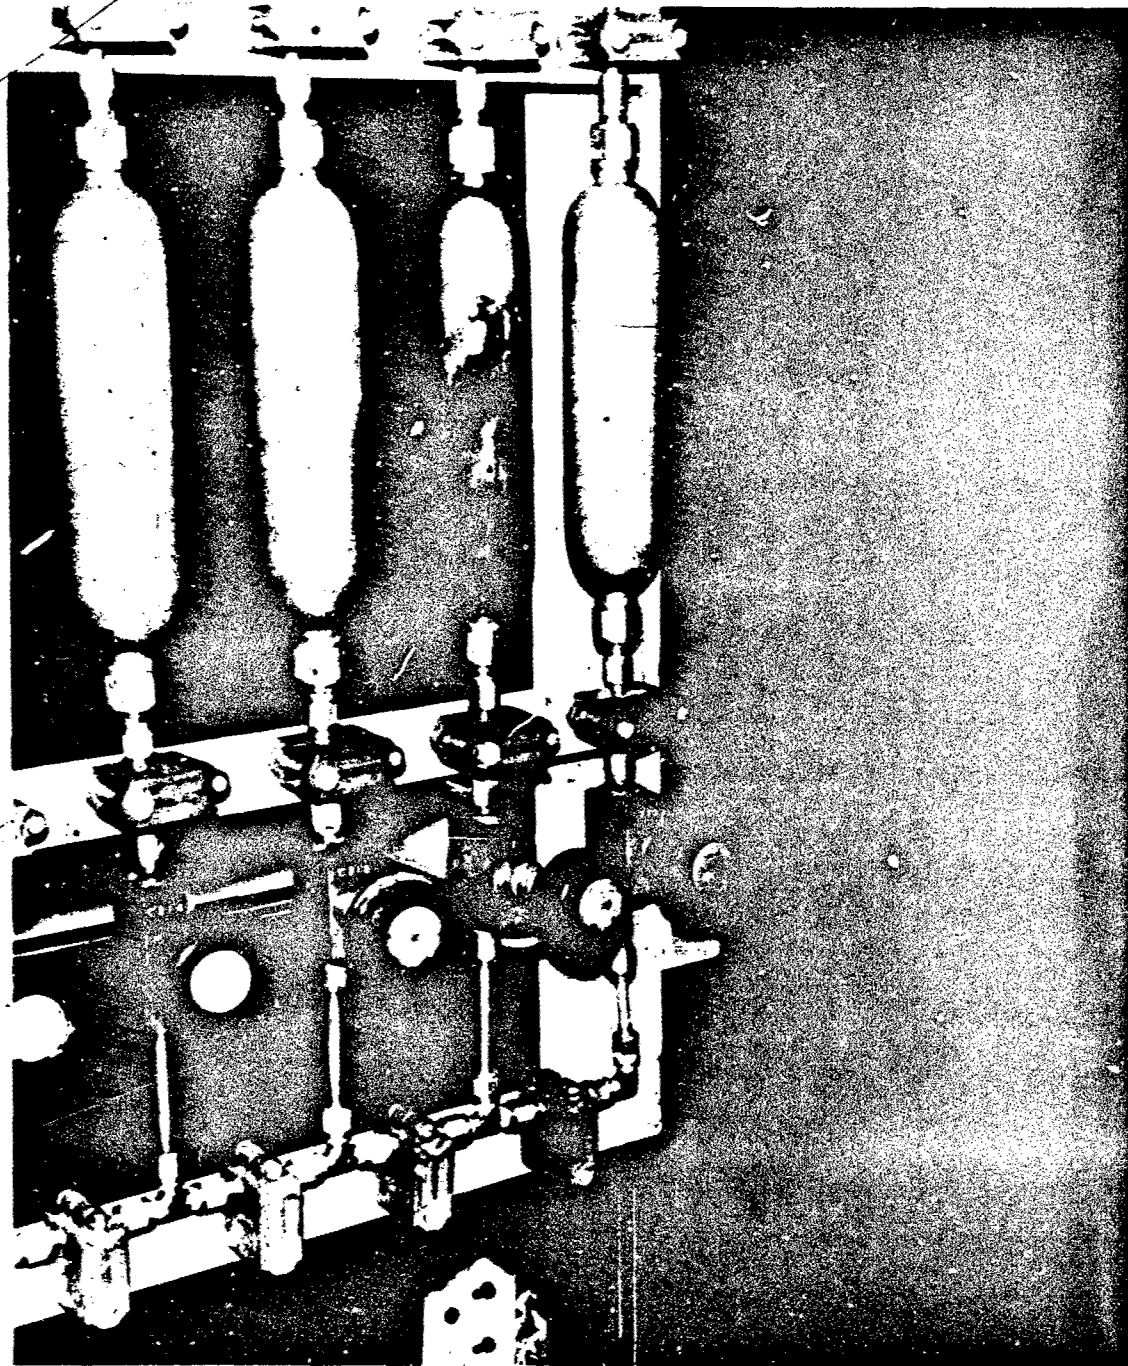
On 14 August 1969 twelve Phase II integrated systems were loaded with ClF_5 . Approximately two weeks later the environment in the oxidizer storage facility was maintained at 85°F and 85 percent relative humidity. During the afternoon of Friday, 12 September, the storage facility was inspected and no systems were found to be leaking. On the morning of Sunday, 14 September, the facility was again inspected and a very large concentration of ClF_5 vapors was found in the facility. After a thorough inspection it was determined that at least two tanks were leaking ClF_5 , (one Group I 301 cryogenically stretch-formed AISI 301 stainless steel container, and one Group III integrated system with an AM350 steel tank). (Figures 8 & 9) (Appendix II). Numerous other tanks and systems were detanked because of corrosion damage to their external surfaces. The surfaces were cleaned and the tanks helium leak checked, and all tanks were or will be returned to test, since no leaks were found. The original leak was located in an aluminum tubing weld of a system containing ClF_5 . The large concentration of HF (the product of ClF_5 hydrolysis) vapors resulting from the leaks also damaged the building's conditioning system which has been rebuilt.

Figure 8. ARDE 301 Cylinder With ClF_5 Leak

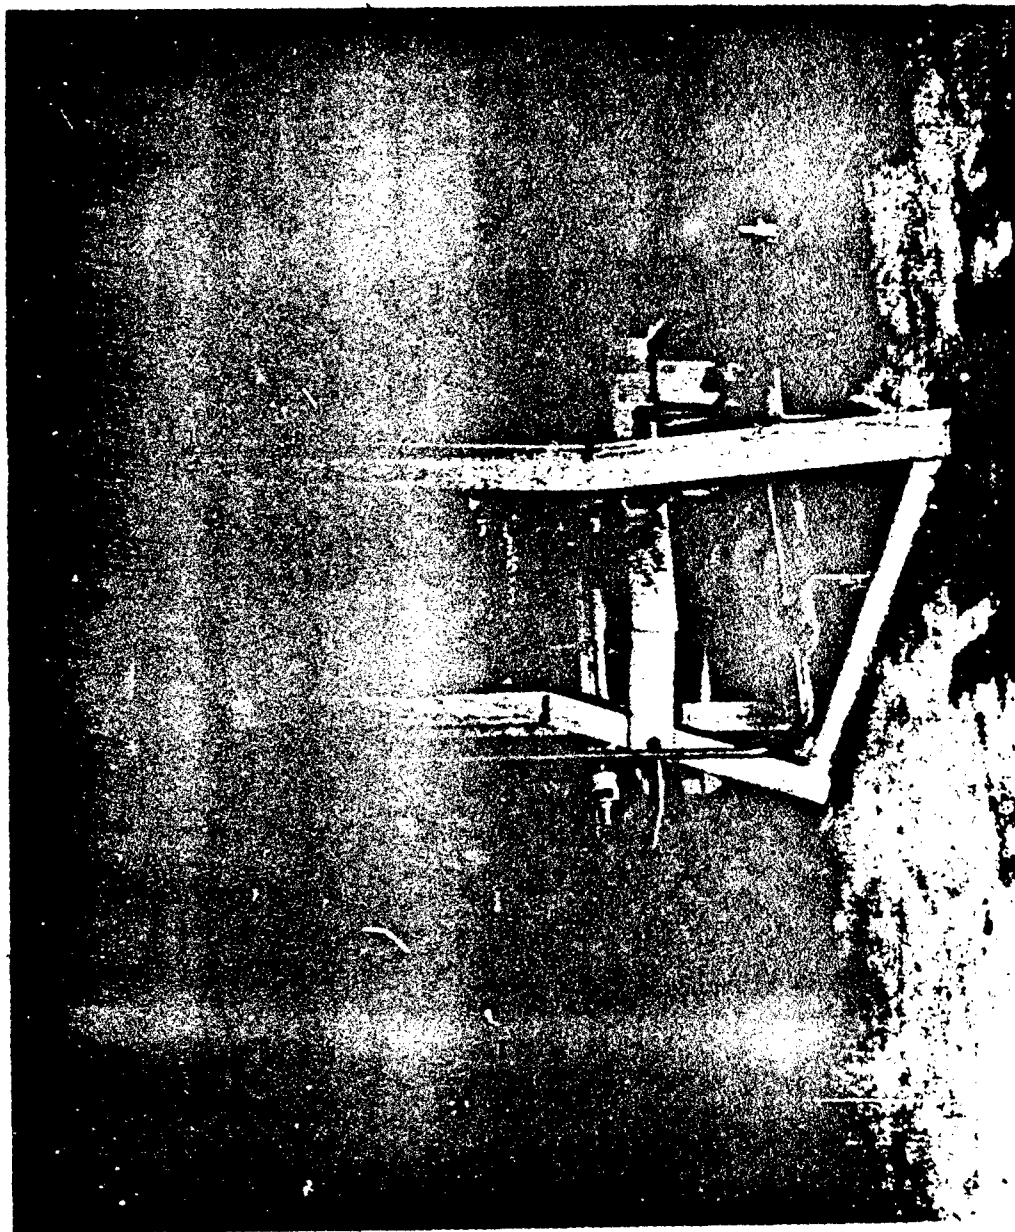
Figure 9. Integrated System With ClF_5 Leak

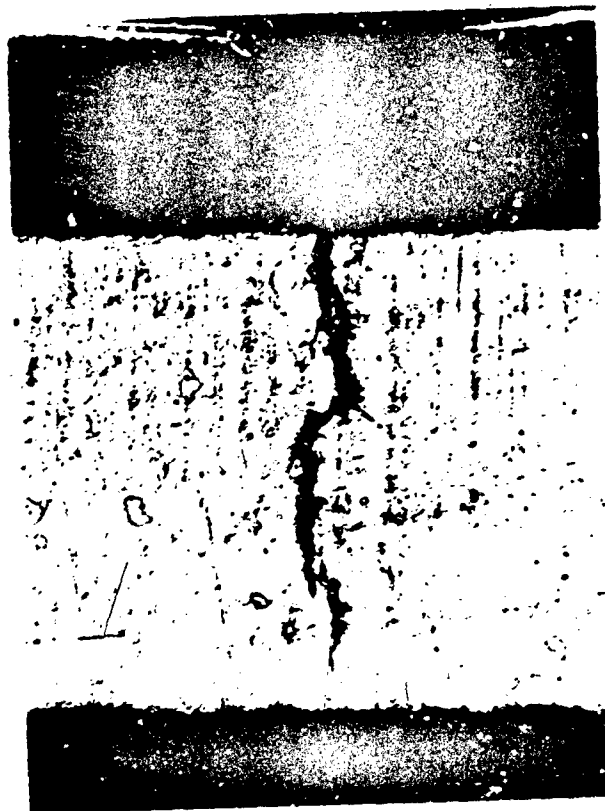
Figure 9. Microsection of Stress-Corrosion Crack
in Top of Tank No. 1 (150X)

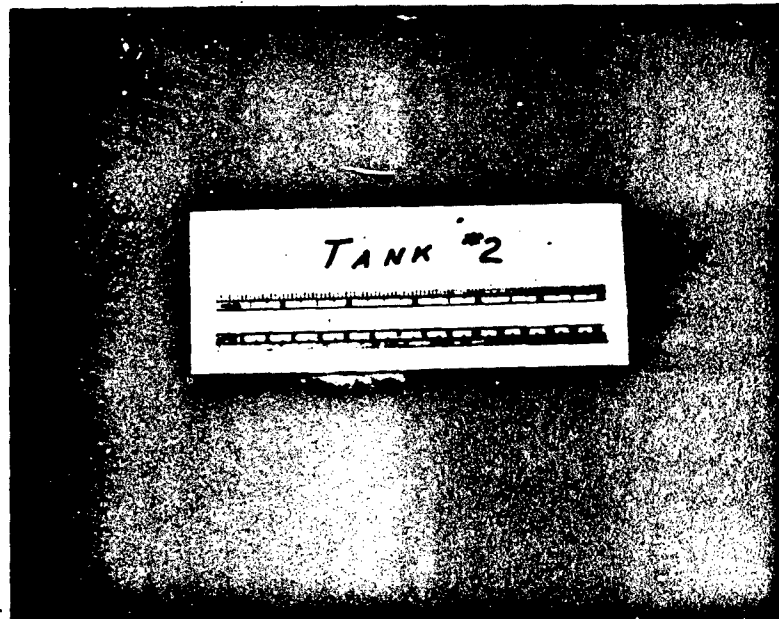
1. The origin of failure of small tank AFRPL S/N 2 was a hot-short crack in the fusion zone (weld bead edge) of a repair weld.
2. Insufficient inert gas coverage, in repair welding the tank, resulted in the formation of stabilized alpha on the surface of the titanium in the weld heat affected zone. This created an embrittled surface and an area of stress concentration.

1. Macroexamination - The tank appeared to be in good condition with the exception of some discolored weld areas and a crack in the fusion zone of a repair weld, Figures 1, 2, 3, and 4.

Figure 2. Closeup of Leak Area in Repair Weld Area

2. All propellant tanks should be welded under conditions which make all repair welds accountable to the cognizant Air Force representative. Repair welds have always presented a problem to all manufacturers.
3. No propellant tanks should be accepted with discoloration showing on welds until it is proven the discoloration formed in a harmless manner, e.g., discoloration can form if the metal, while still above 600°F but less than 1200°F, passes out from under the trailing shield, this would not be harmful. If air contacts the titanium while above 1200°F, embrittlement of the weld can occur.
4. As has been recommended previously, no propellant tanks should be exposed to fumes from leaking vessels while in the humid exposure environment. HNO_3 formed can cause stress and pitting corrosion of the propellant tanks.

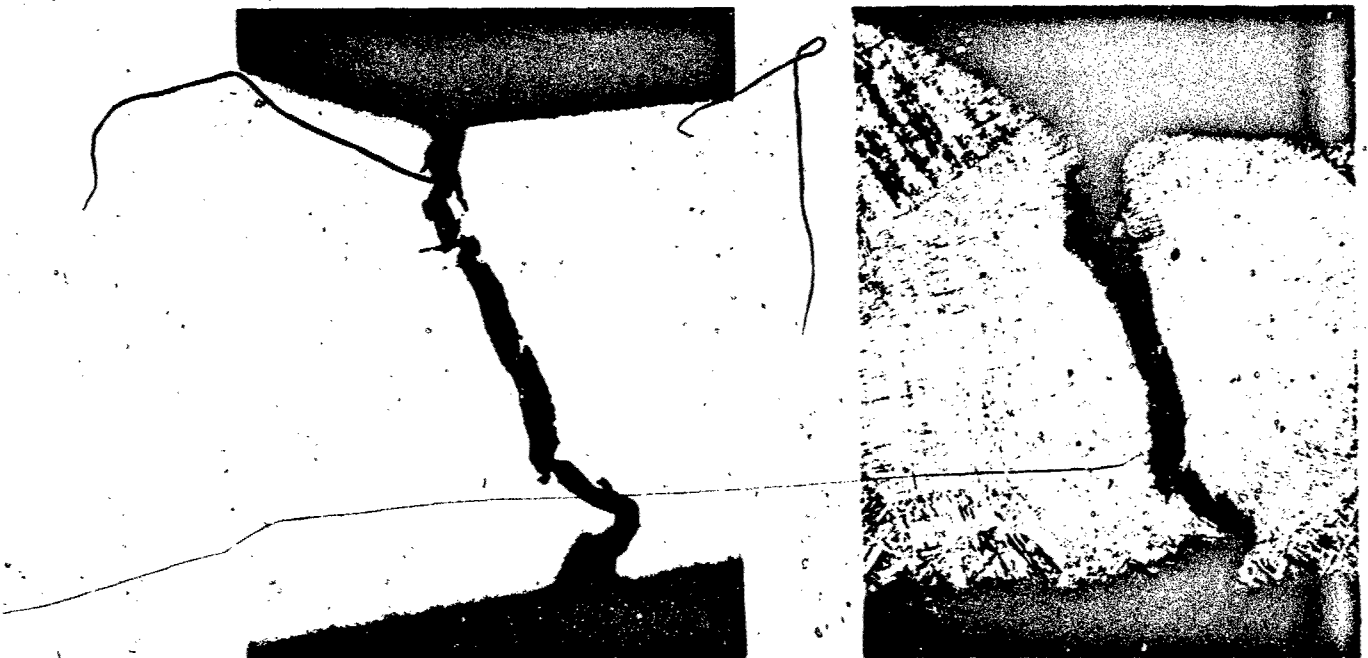
Figure 5. Photomicrographs of Hot-Short Crack in Leak Area
Unetched and Etched (100X)

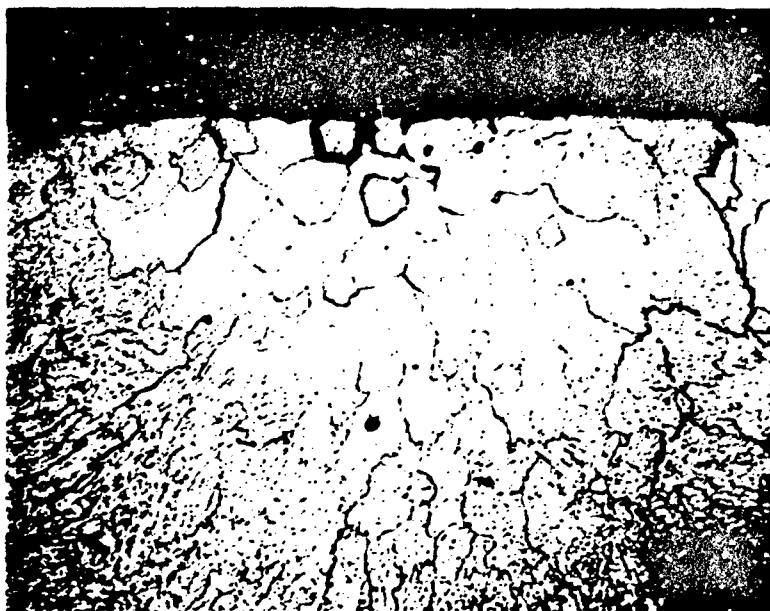
Figure 11. Photomicrograph of Intergranular Corrosion and Stress-Corrosion Cracks on External Surface of Area Shown in Figure 10. (50X)

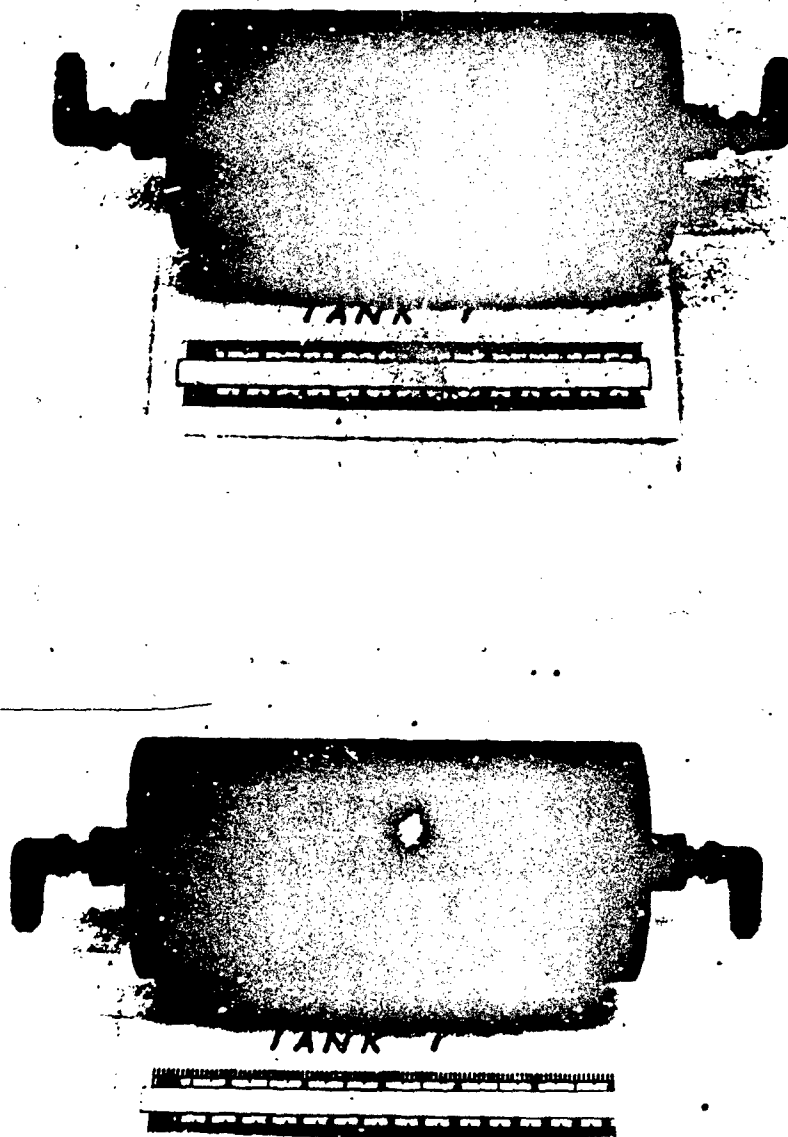
Figure 1. Sideviews of Tank Number 7. 1/2X
Note the Generally Etched Appearance
of the Tank.

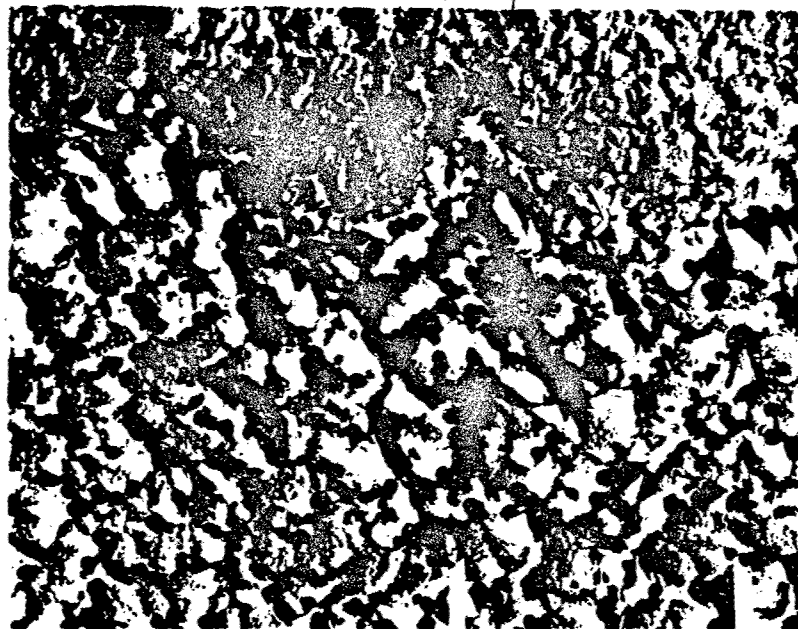
Figure 6. Electron Photomicrograph of Corrosion Failure in Tank No. 10. 7000x

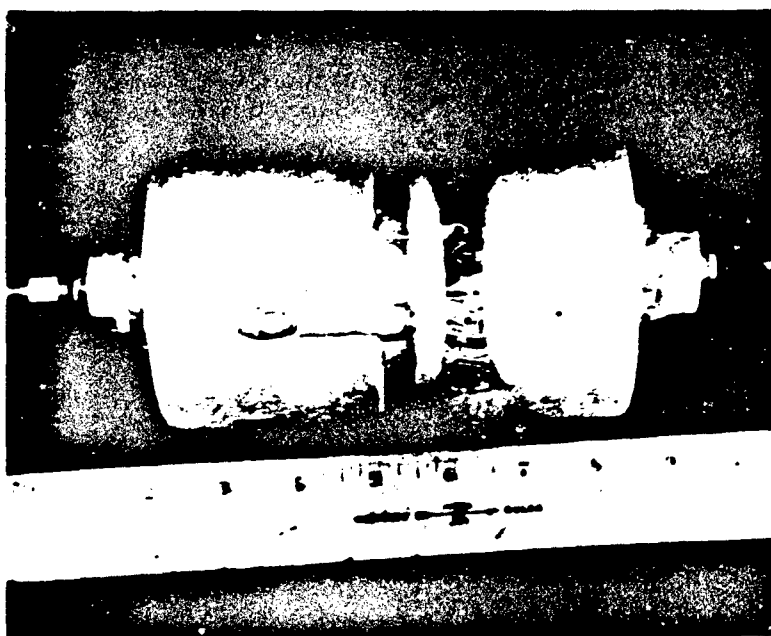
Figure 1. Photomicrograph showing overall sideview of small tank no. 12. Top of tank is shown to the right. 0.6X

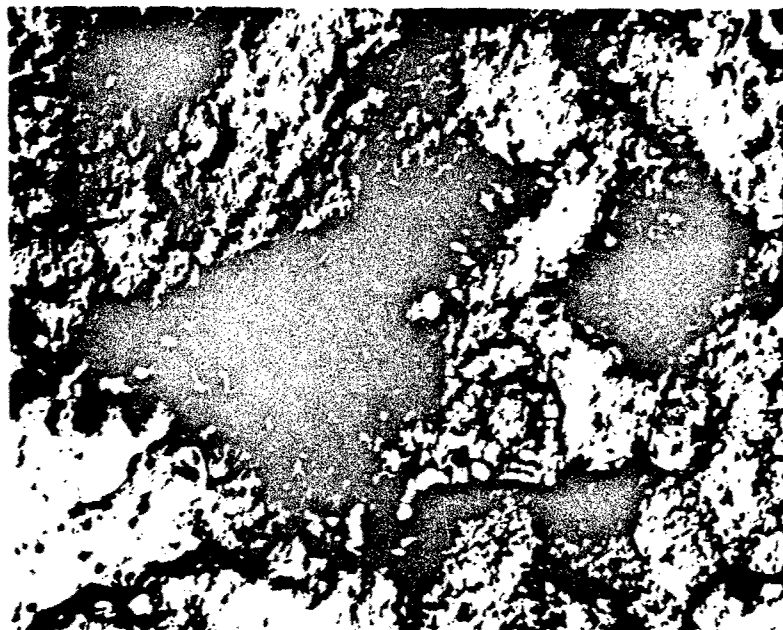
Figure 15. Electron photomicrograph showing representative evidence of intergranular corrosion observed on the surface of the fractures of leak areas 62 x 1 and 32 x 10. 15,000X

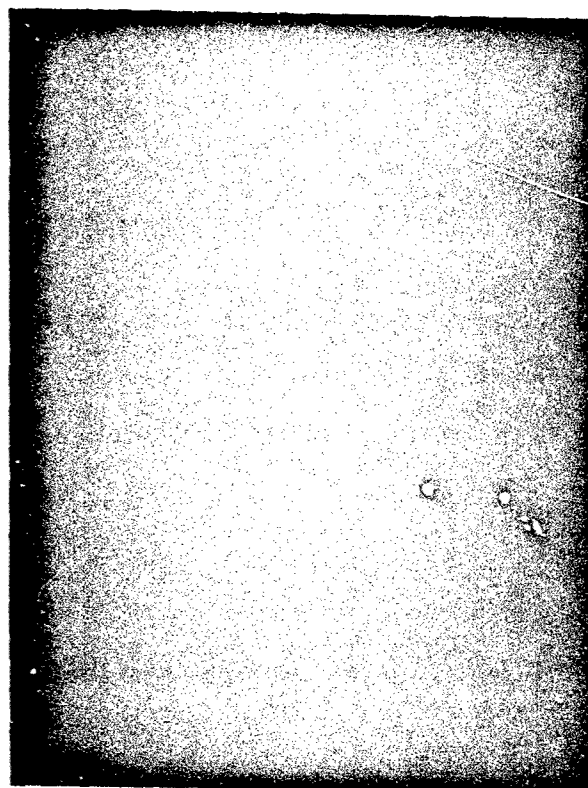
Figure 9. Same crack as in Figure 8.
