SUBJECT: Operational Report - Lessons Learned, Headquarters, 520th
Transportation Battalion, Period Ending 31 October 1970

DEPARTMENT OF THE ARMY
HEADQUARTERS, 520TH TRANSPORTATION BATTALION (AM&S) (GS)
APO 96289

SUBJECT: Operational Report - Lessons Learned 520th Transportation Battalion
(AM&S) (GS) Period Ending 31 October 1970
RCS CSFOR-65 (R2)

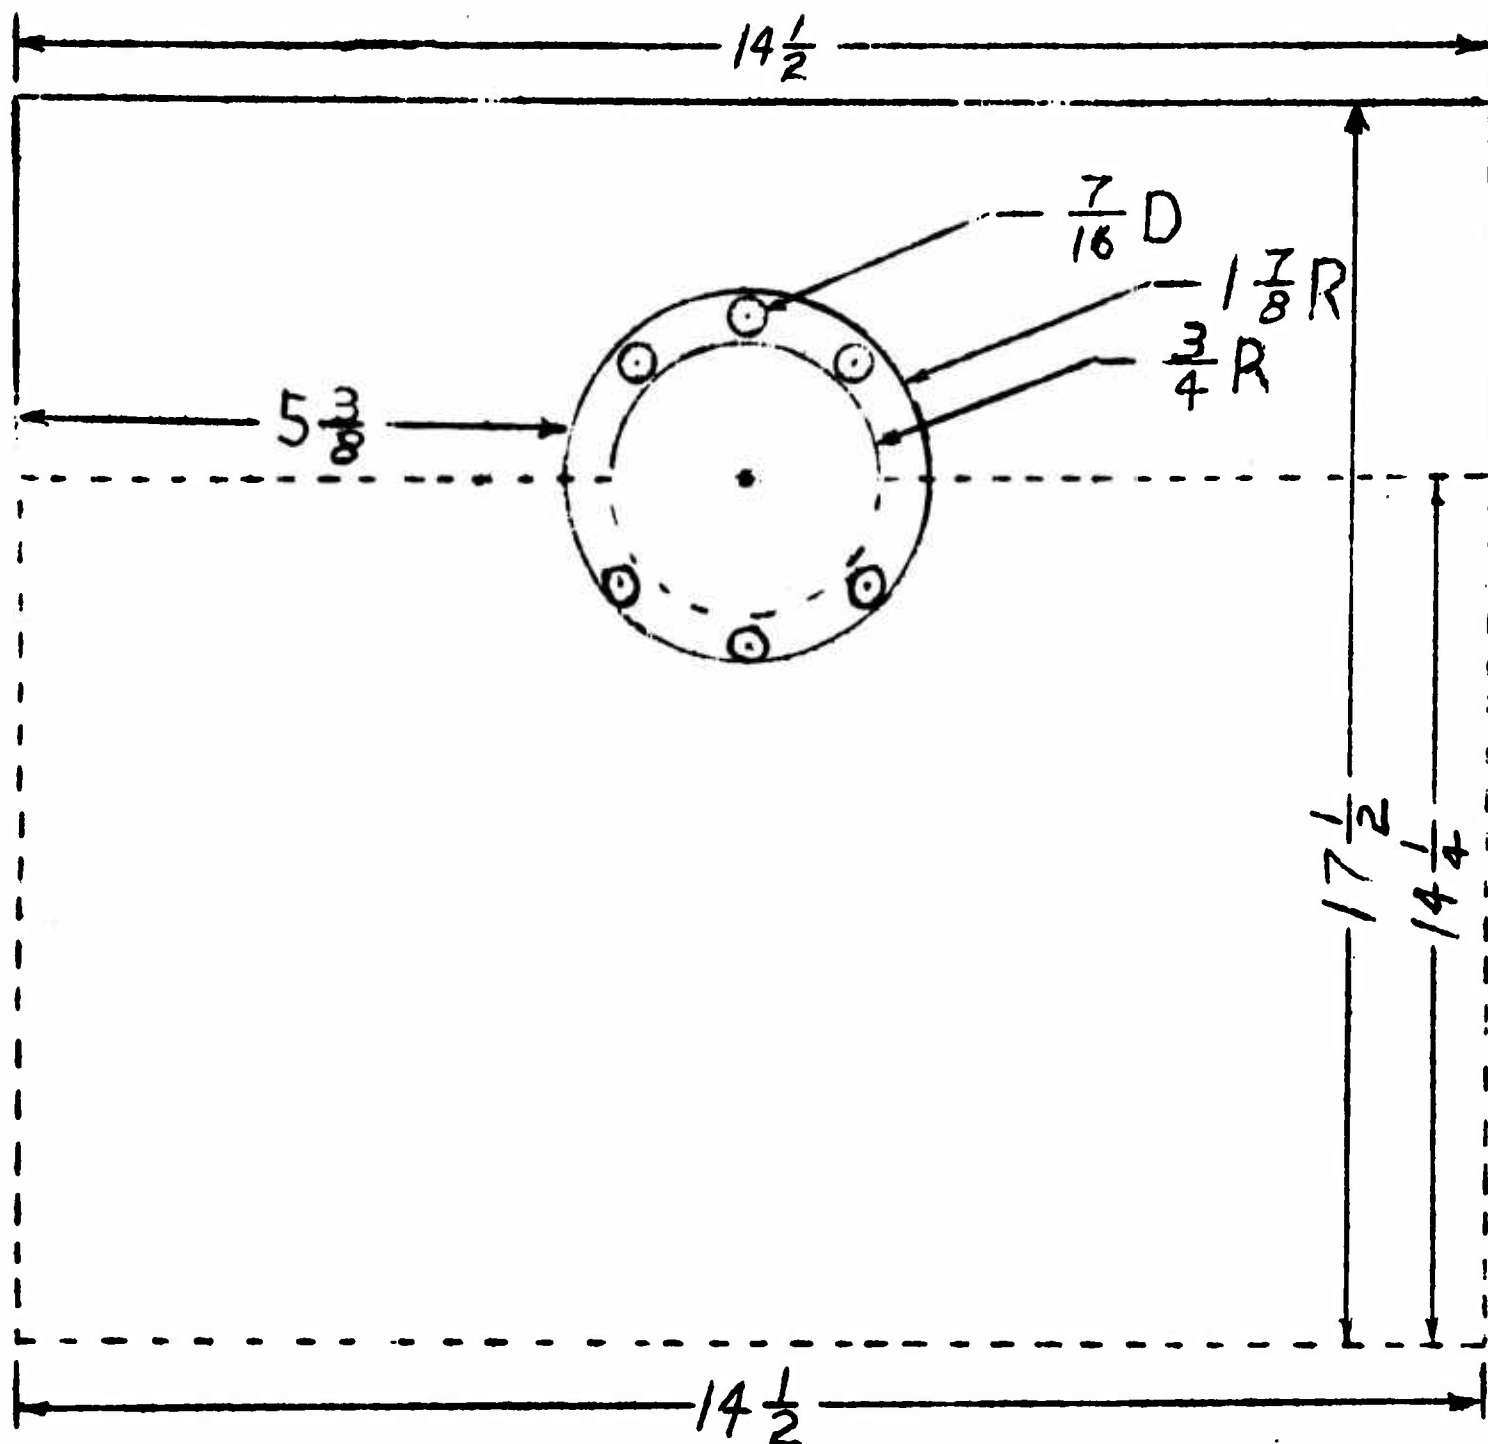
Incl 3

(5) Damage to fuel filler neck panel on the UH-1

(a) Observation: During refueling, both hot and cold, damage has been done to the fuel filler neck panel (P/N 205-030-191-7, FSN 1560-449-6562) and caused contamination to the honeycomb within the panel due to water and fuel entering through the damaged areas.

(b) Evaluation: The primary cause of the damage is the trigger guard on the fuel nozzle hitting the honeycomb material around the fuel filler neck when the nozzle is inserted into the neck all the way. Also, it is caused by accidental bumping and scraping with the nozzle.

(c) Recommendation: An aluminum plate may be installed under the filler opening. Fabricate an aluminum plate large enough to pick up existing rivets on forward and aft and lower panels around the filler neck opening, as depicted in inclosure 2, also shape the plate to the contour of the fuel filler opening to pick up the lower three bolts of the filler opening. Apply proseal 890, between mating surface and seal with bead of proseal around edges.
