**AN  
INVESTIGATION OF INADVERTENT ARMING  
OF  
MK-82 AND M-117 GENERAL PURPOSE  
AND  
MK-82 SNAKEYE BOMBS**

**MUNITIONS CARRIAGE AND HANDLING BRANCH  
BOMBS AND FUZES DIVISION**

**TECHNICAL REPORT AFATL-TR-72-73**

**APRIL 1972**

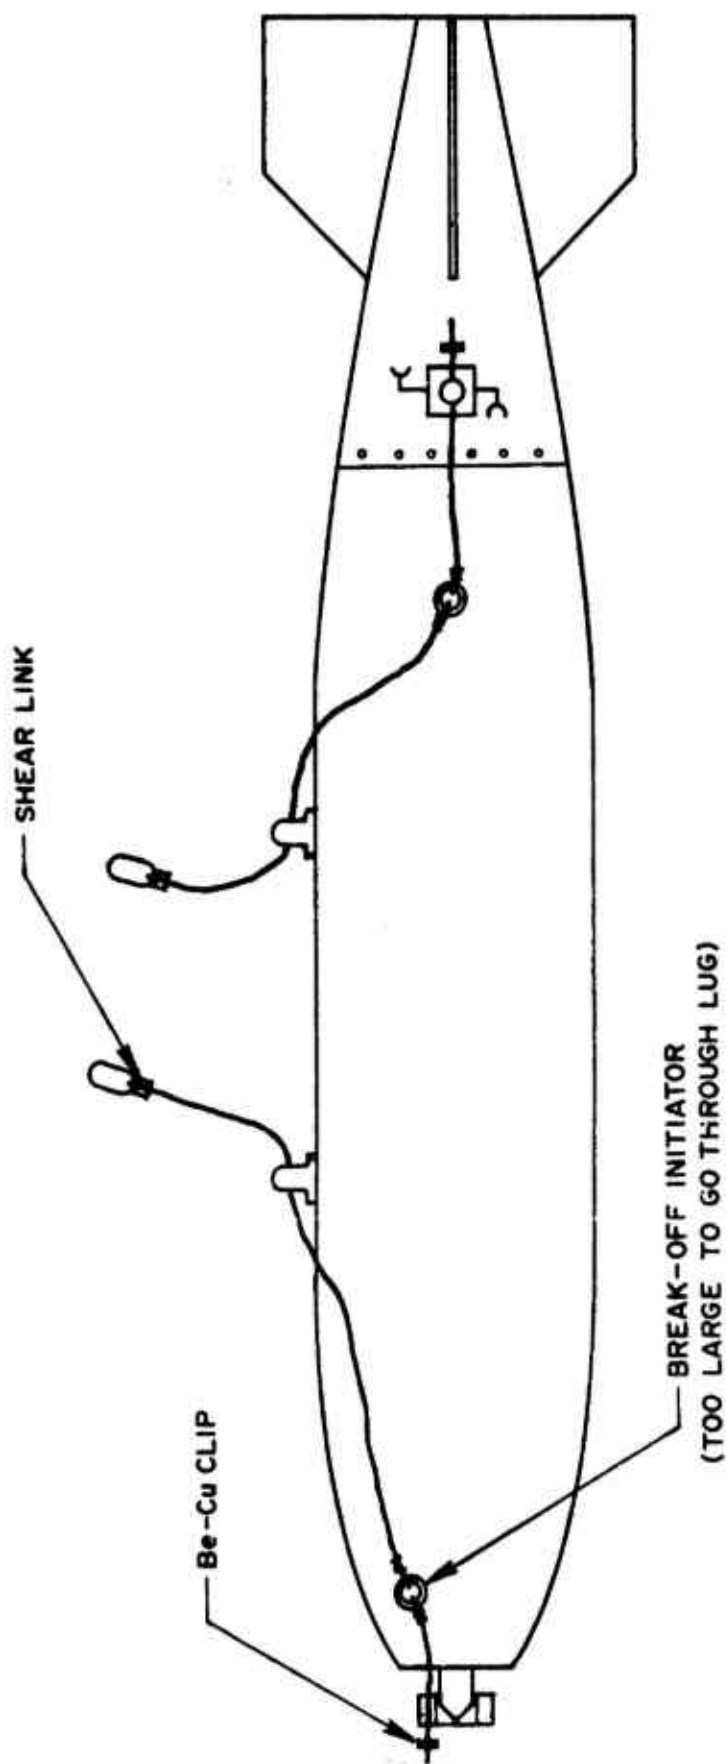
Figure 1. Direct Arming Wire Rigging

Because of the failures which occurred even with the most ideal conditions (small foot and wire on lower side), it was decided that the best solution to the inadvertent arming of GP bombs was direct routing. Direct routing consists of running the arming wire from the nose or tail fuze directly to the nearest solenoid. This solution would eliminate routing the arming wire past the ejector foot where it could hang up, and in addition, would provide a direct 1 to 1 relationship between the tensile force in the arming wire and the force on the solenoid. This relationship would make the force on the clip equivalent to the force on the solenoid so that a 14 pound force (if the solenoid could be assumed to operate reliably as specified) could pull the swivel and link from the solenoid before the clip is stripped from the wire.

The adverse effect of direct routing (the wires remaining on the aircraft) could be eliminated by incorporation of an AFLC/OOAMA proposal (Figure 1). This proposal includes adding a shear link and a break-away initiating component which would hang up on the lug, thus allowing the arming wire to fall away with the bomb.

To validate direct routing as a solution to the GP inadvertent arming problem, 12 bombs were released with the nose fuzing wire attached to the forward arming solenoid. Four bombs were released from the MER/TER center-line station and eight from the shoulder station, and all were successfully released safe as desired.

For the MK-82 and M-117 GP bombs, it would appear that the most feasible solution to the inadvertent arming problem is direct routing. A shear link which will allow the arming wires to separate with the bomb should be fabricated and tested (both in the safe and armed mode) and, if successful, should be used to eliminate banjo rigging. Flight tests should be conducted to insure that any piece added to cause the wire to shear will not be subject to flutter in the slipstream because this could extract the arming wire.
