**SIGAR 16-26 Inspection Report**

Afghan Air Force University: Contract  
Requirements Were Generally Met, but  
Instances of Non-Compliance, Poor  
Workmanship, and Inadequate Maintenance  
Need to Be Addressed

**MARCH  
2016**

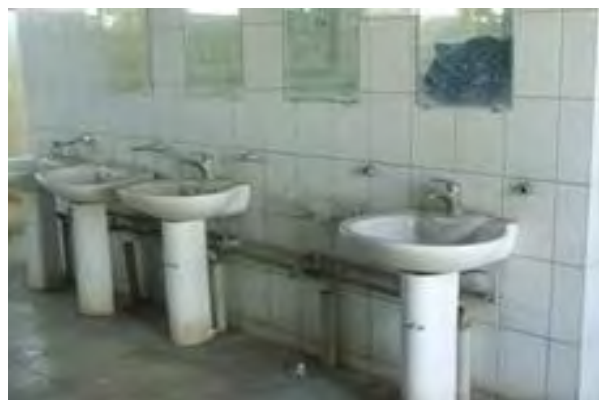
At the time of our March 2015 site visit, we found that the four bathroom buildings transferred to Afghan authorities in April 2014 were not being used. However, according to USACE officials, these four buildings are now being used by Afghan students and staff, despite the fact that a number of sinks and faucets are broken, some light bulbs are burned out, and the water heaters are not functioning.

**Photo 2 - Poorly Maintained Facilities in Bathroom Building 7**
