Demonstration of Antimicrobial Corrosion-Resisting Interior Coating Systems for Military Facilities in Warm, Humid Locations

Final Report on Project F10-AR04

June 2017

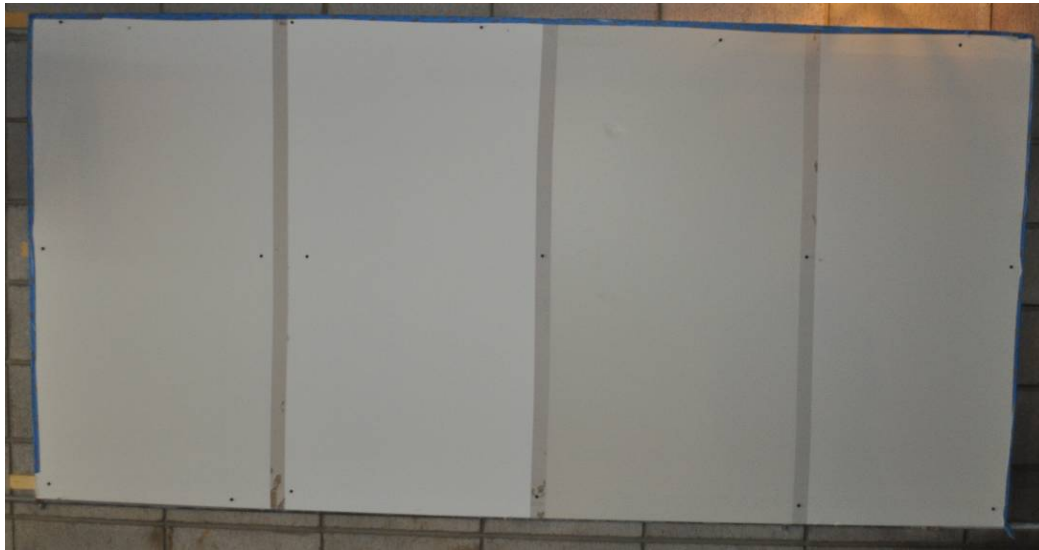
Mechanical room test panels. None of the test panels in the mechanical room showed any signs of mold or mildew in this inspection (Figure 9).

Figure 9. Test panels in the mechanical room after 4 months.

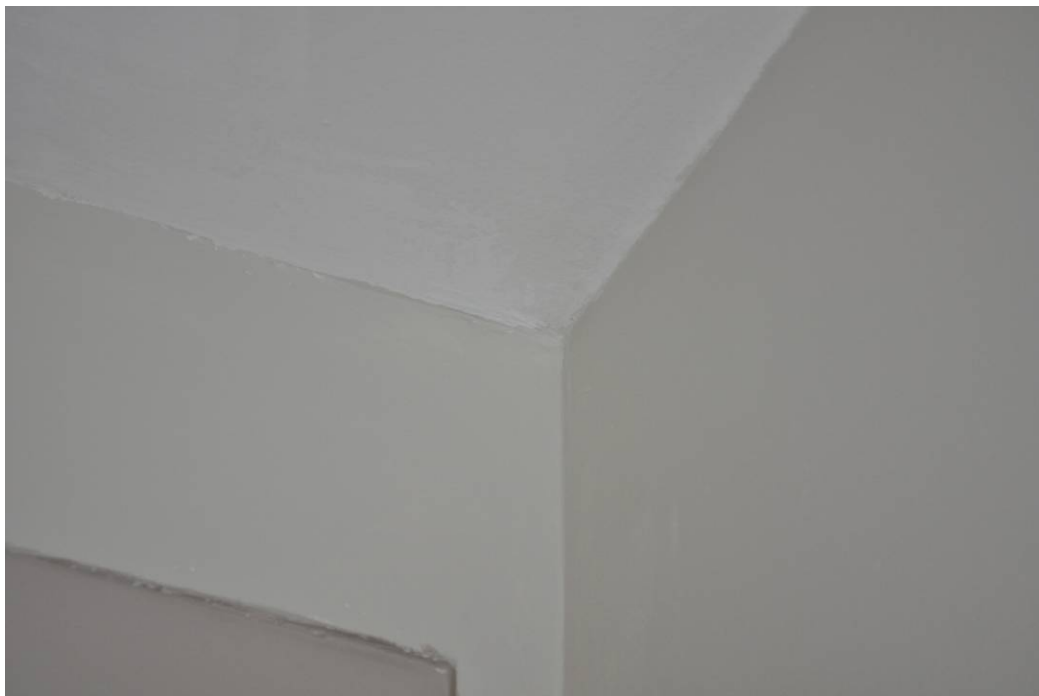
Room 4 – Foster 40-20. Noting the addition of a new HVAC system and repainting of most test surfaces, the inspection found no signs of mold or mildew on the ceiling. The repainted walls also showed no signs of mold or mildew (Figure 10 and Figure 11).

Figure 10. Walls in Room 4 coated with an unknown coating, and ceiling coated with Foster 40-20 after 4 months.

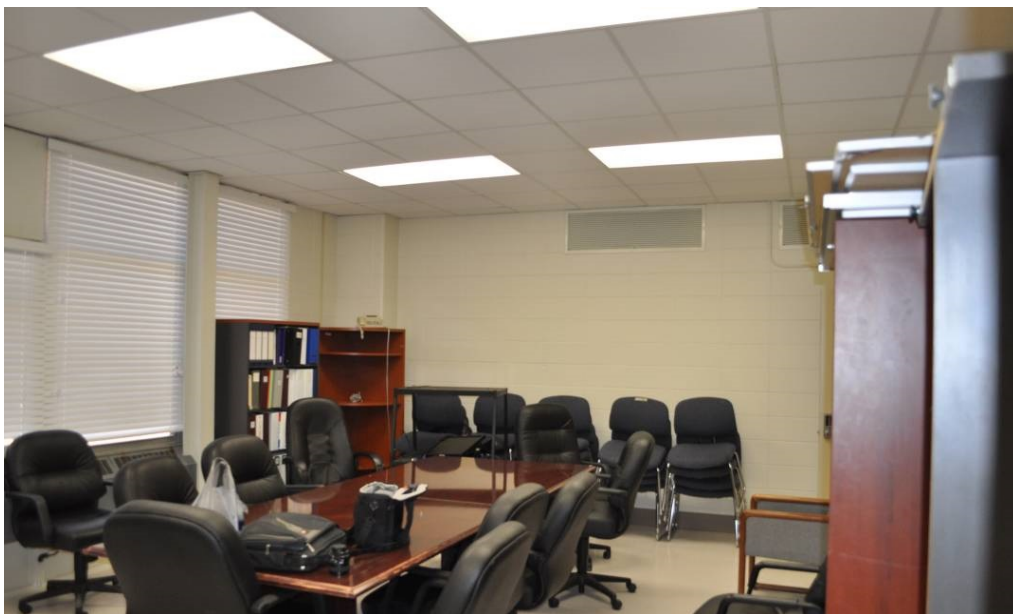
Room 11 – Hirshfield’s Platinum Ceramic. Room 11 showed no signs of mold or mildew other than stains found on the piece of plywood that frames a window air-conditioning unit. The stains appeared to be from exterior water intrusion. This area was specified for close monitoring during the follow-on inspections (Figure 14, Figure 15, and Figure 16).

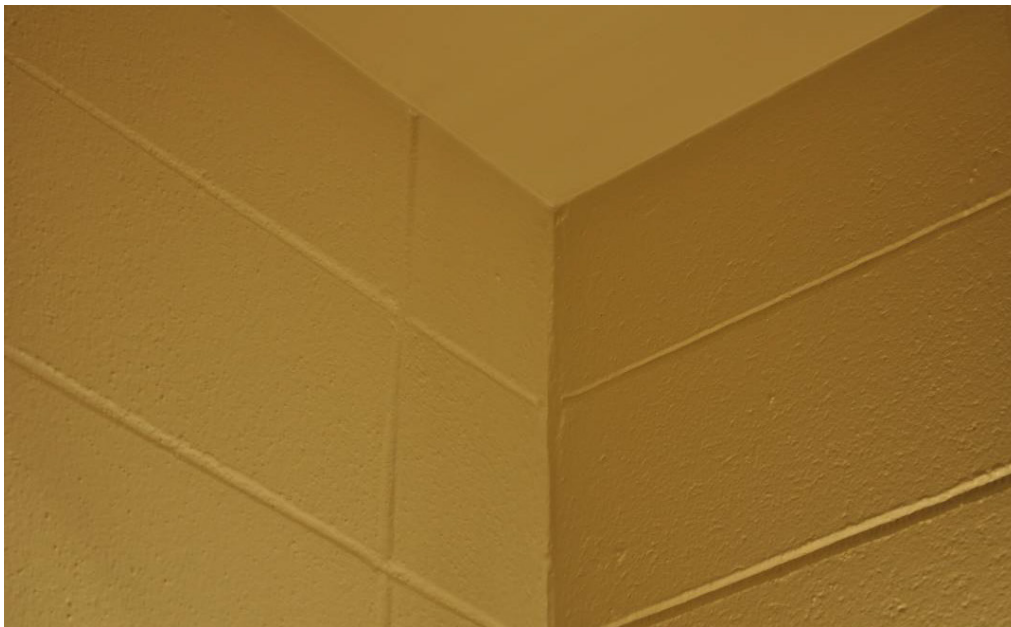
Room 14, adjacent washroom – Sherwin William ProMar 200 (control).
The washroom next to Room 14 showed no signs of mold or mildew. The room was originally coated from floor to ceiling, but tile had been installed

halfway up the side walls, including around the sink and toilet areas, after coating application (Figure 17, Figure 18, and Figure 19).

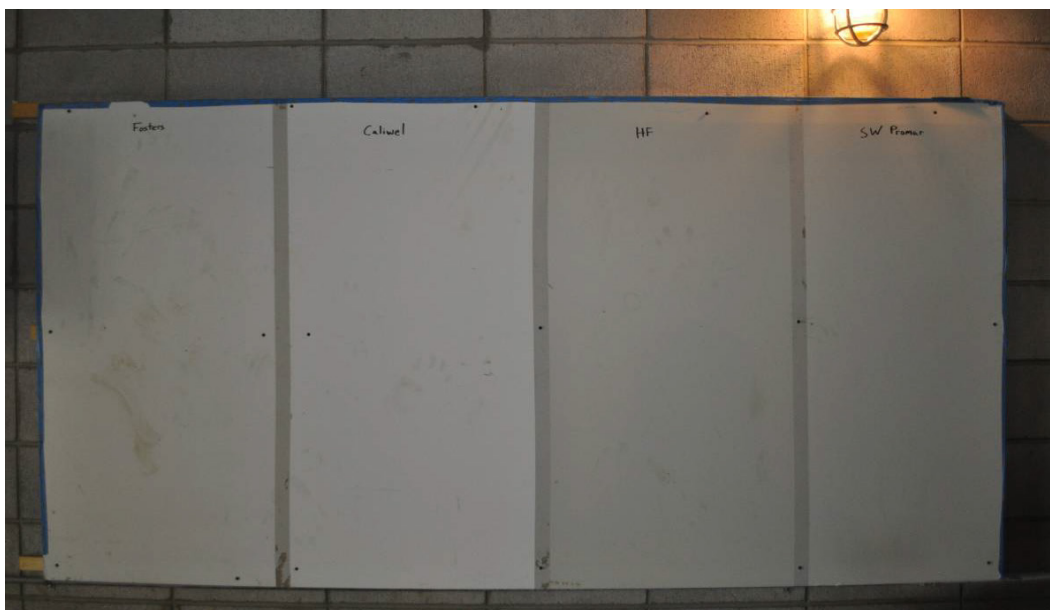
Mechanical room test panels. None of the test panels in the mechanical room showed any signs of mold or mildew (Figure 20). Handprints and residue had been left on the gypsum test panel. The condition inside the room continued to be less humid than previously due to refurbishment of the building.

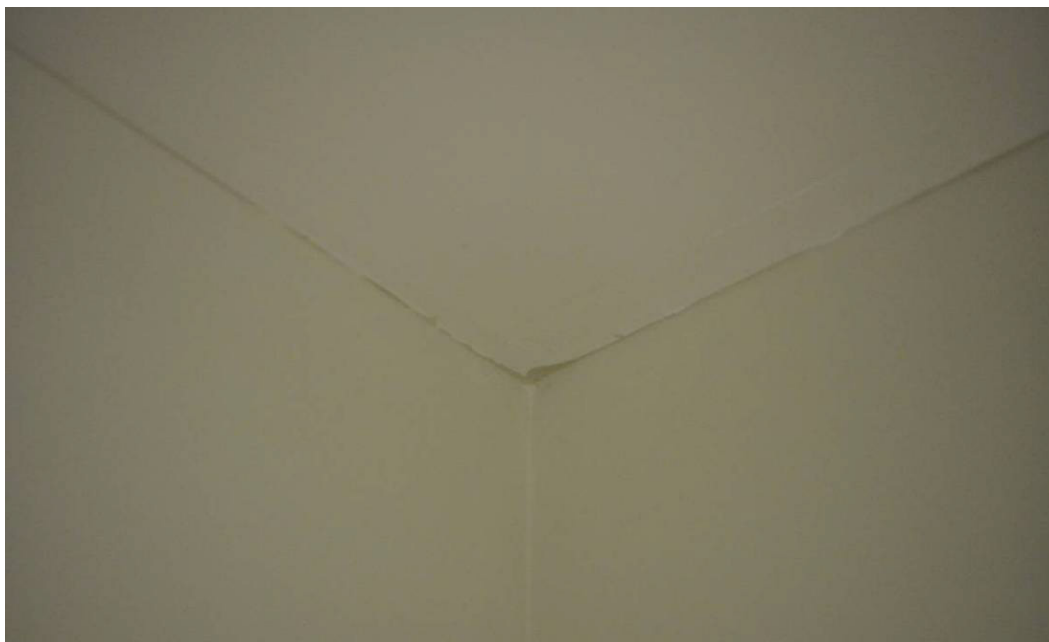
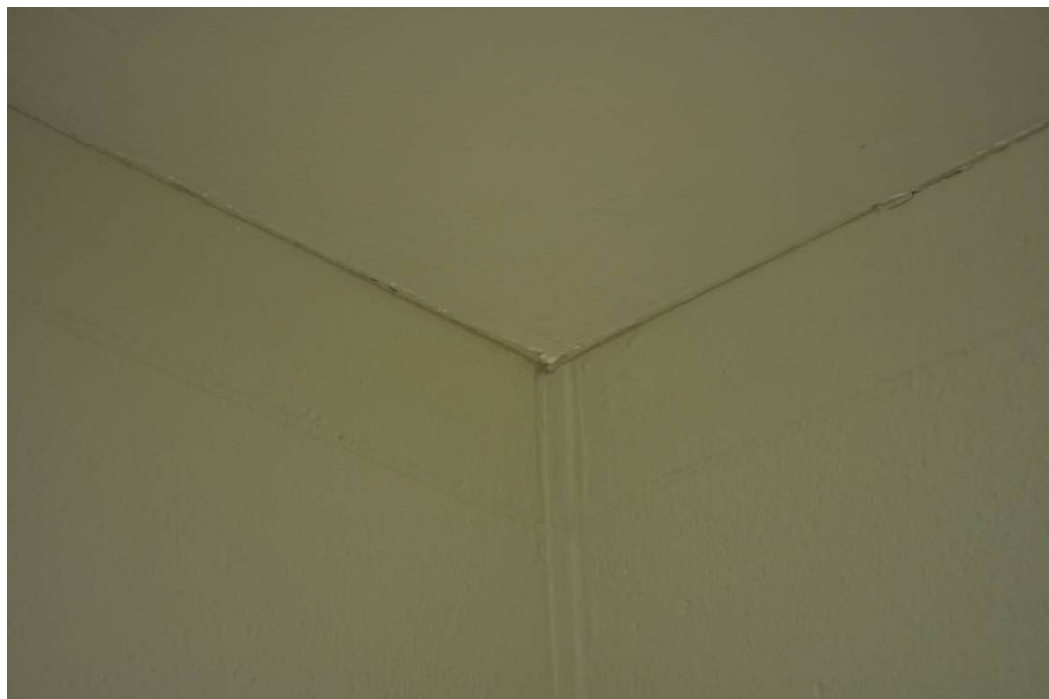
Room 9 – Caliwel with BNA. The demonstration coating on the ceiling showed no signs of mold or mildew (Figure 23). The repainted walls, using an unknown coating, also showed no signs of mold or mildew (Figure 24).

Figure 23. Washroom of Room 9, after 8 months, with an unknown coating on the block walls. Caliwel is still present on the ceiling.

Figure 24. Washroom of Room 9, after 8 months, with unknown coating on the block walls. Caliwel is still present on the ceiling.

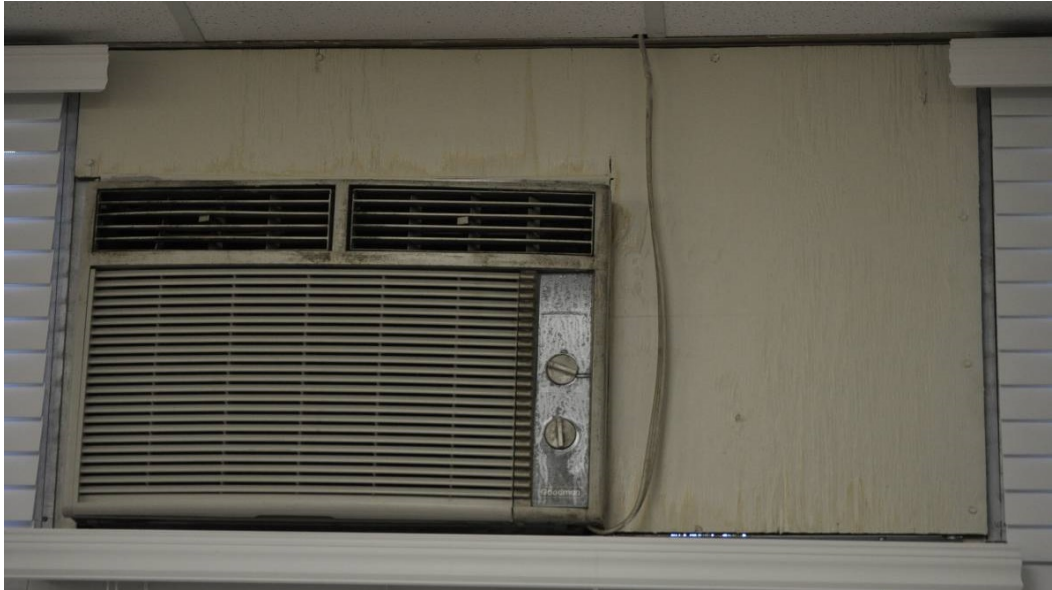
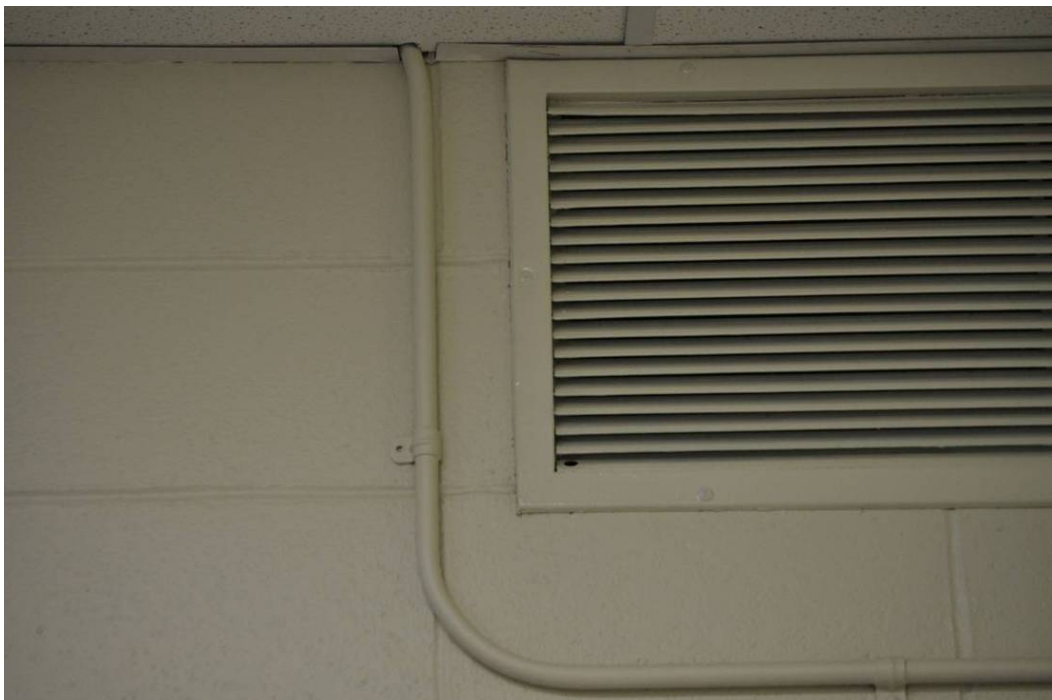
Room 11 – Hirshfield’s Platinum Ceramic. Room 11 showed no signs of mold or mildew other than the stains found on the piece of plywood that surrounds a window air-conditioning unit (Figure 25). The stains appeared to be from exterior water intrusion. There were no additional signs of mold or mildew since the previous inspection (Figure 26 and Figure 27).

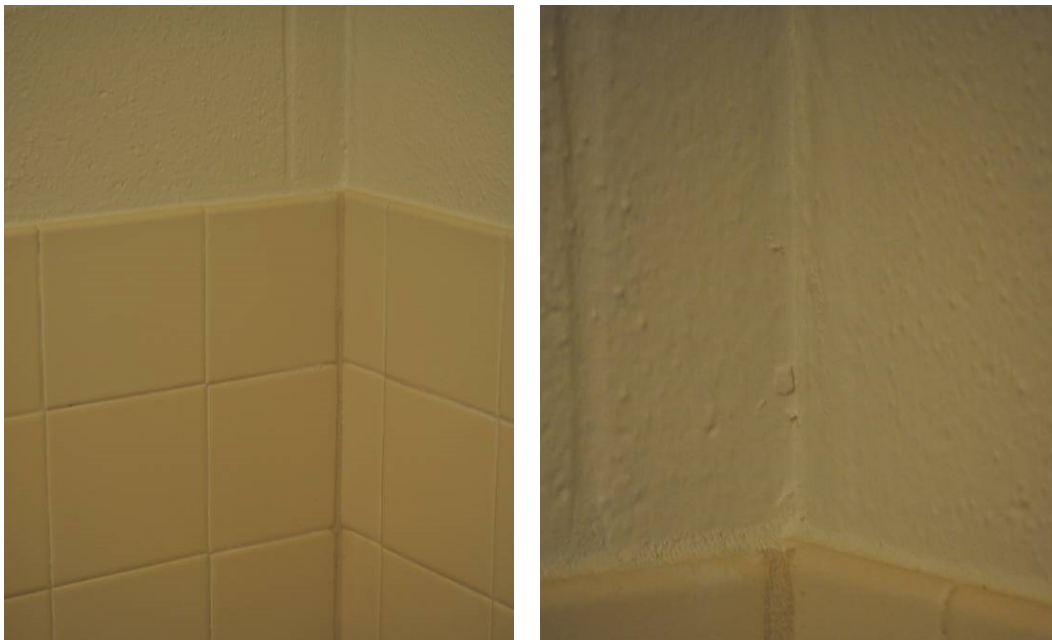
Room 14, adjacent washroom – Sherwin William ProMar 200 (control).
The washroom next to Room 14 showed no signs of mold or mildew (Figure 28, Figure 29, and Figure 30).

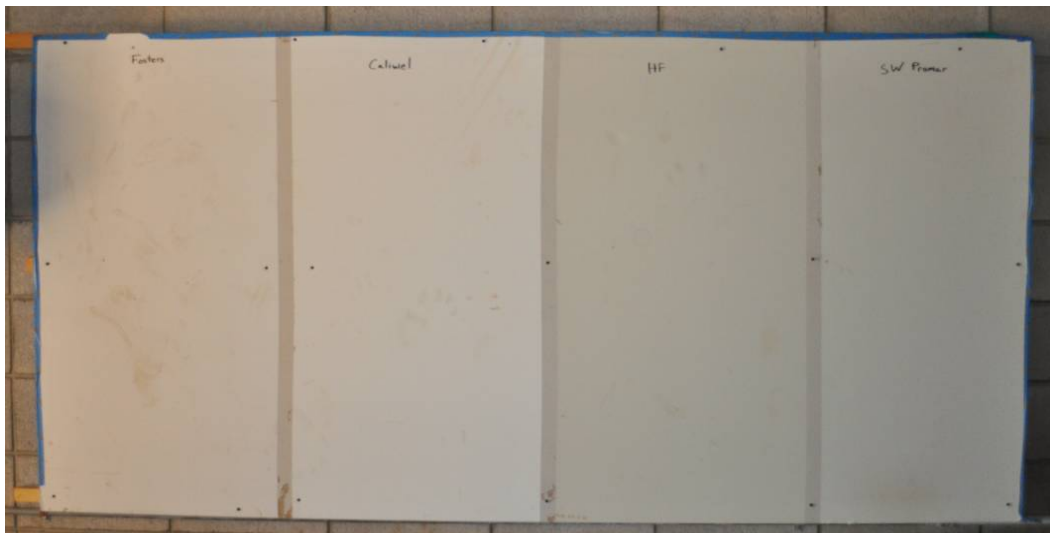
Mechanical room test panels. None of the test panels in the mechanical room showed any signs of mold or mildew (Figure 31). All standing water that was present in the beginning of the test period dried up and did not reoccur. Humidity remained significantly lower than before renovations.

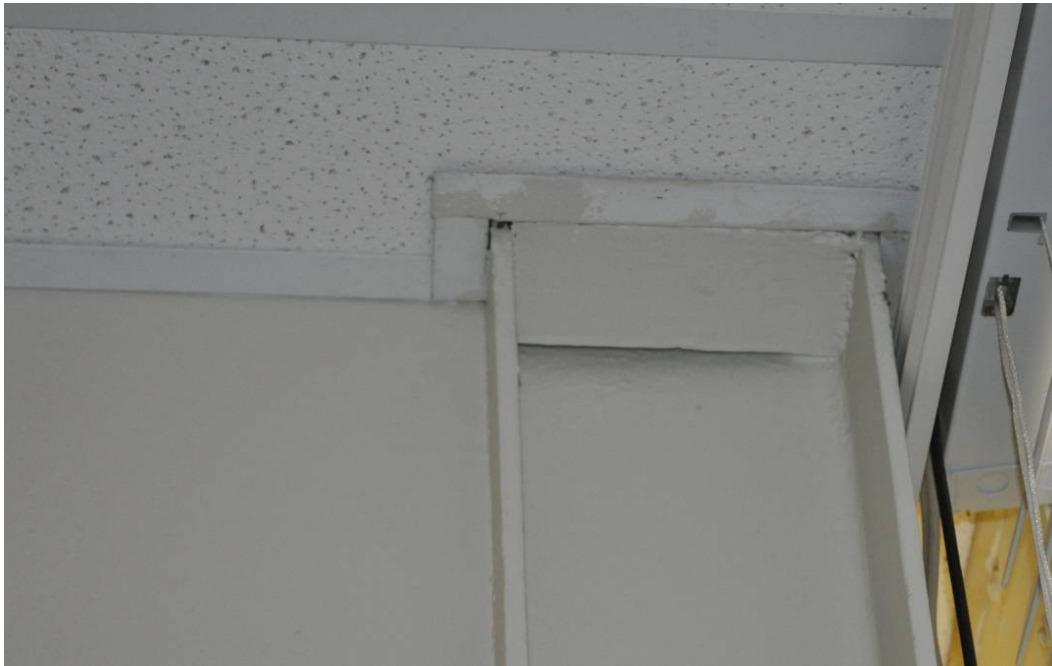
Room 11 – Hirshfield’s Platinum Ceramic. Room 11 showed no signs of mold or mildew other than the stains found on the piece of plywood that surrounds a window air-conditioning unit. The stains appeared to be from exterior water intrusion (Figure 36). Mostly, there appeared to be no additional signs of mold, mildew, or water intrusion from the last inspection (Figure 37). However, an HVAC vent on the interior of the room had begun to show signs of mildew, as shown in Figure 38.

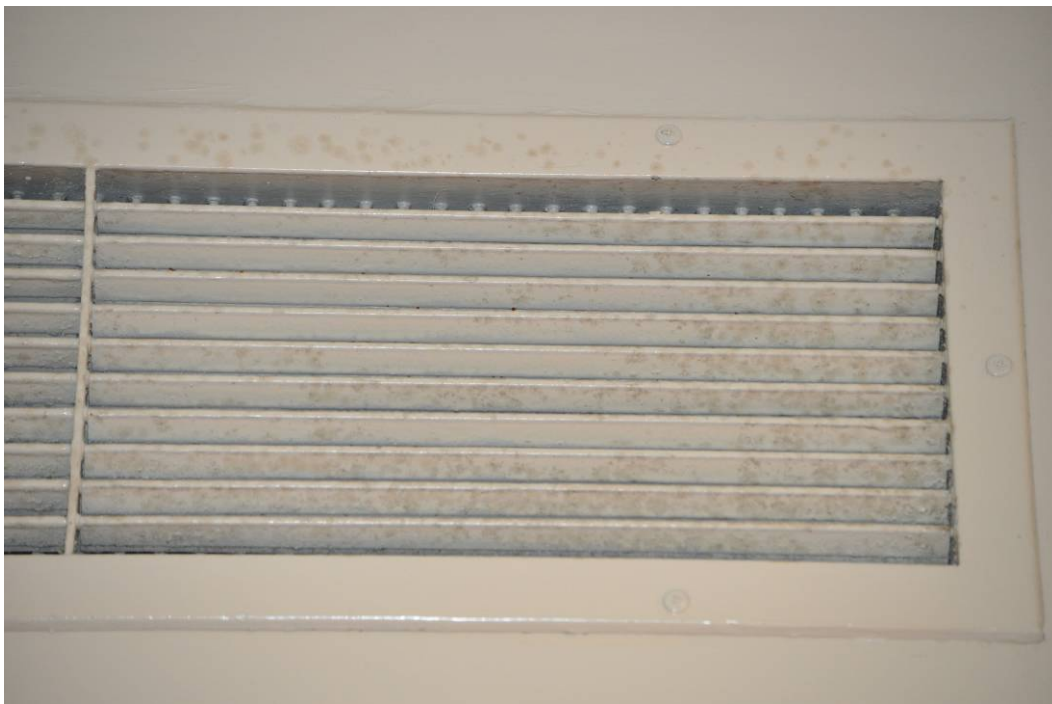
Figure 38. Air vent in Room 11, after 12 months.

Alternative 3. The Hirshfield's coating failed to prevent mildew growth on a metallic ceiling duct after 12 months of testing and therefore, it is not part of this analysis. This observation does not indicate a definite failure to perform, but rather, it is inconclusive because of the loss of experimental control.

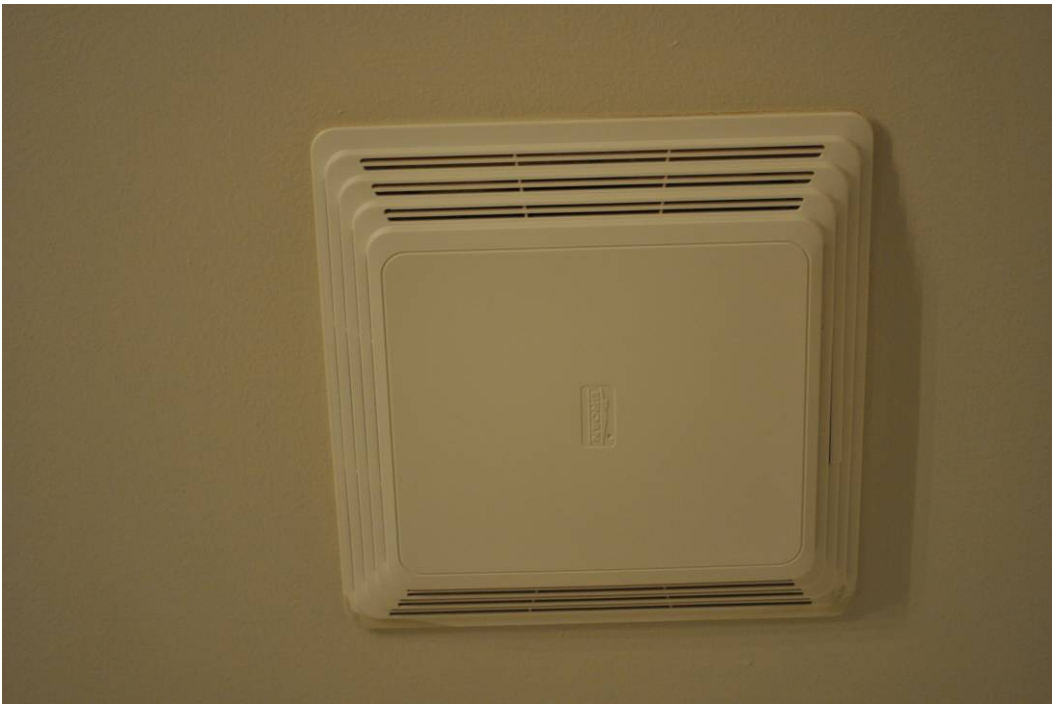
Room 14, adjacent washroom – Sherwin William ProMar 200 (control).
The washroom next to Room 14 shows no signs of mold or mildew (Figure 39, Figure 40, and Figure 41).
