## **Demonstration of an In Situ Pipe-Lining Technology for a Fire Suppression Deluge System at Fort Drum, NY**

Final Report on Project F07-AR17

May 2018

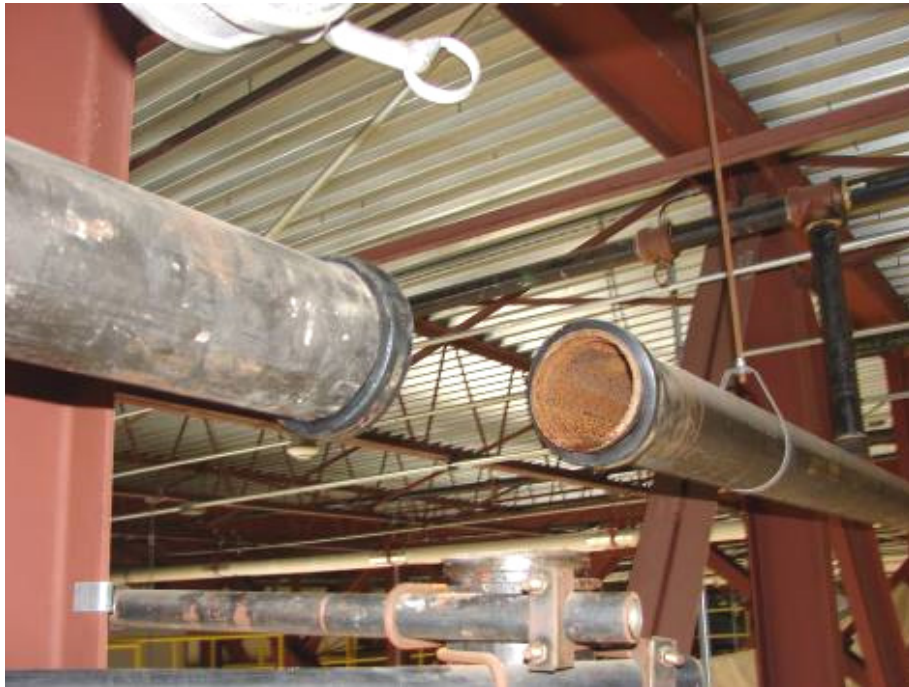
All plumbing within both the AFFF distribution system and the deluge system consisted of black iron pipe (Figure 2), with a combination of threaded fittings and couplers.

Figure 2. Deluge system with tee removed.

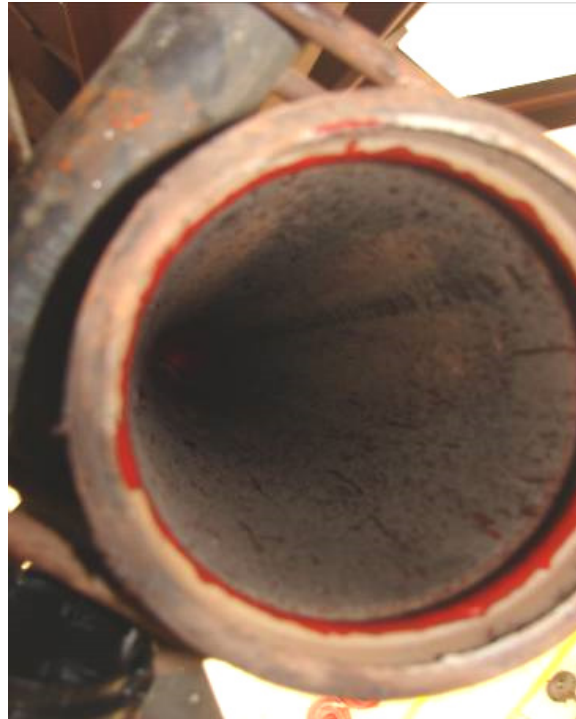
As part of the barrier-coating process, the metallic surface must be clean and free of any corrosion, oil, water, or debris (Figure 5). To achieve this clean surface, an abrading agent (grit) was introduced into the air stream

**Figure 5. Interior of the deluge system's main pipe after sand blasting.**

Per the epoxy lining manufacturer's specifications, a minimum surface-roughness profile of 2 mil was required for proper adhesion and bonding of the epoxy to the pipe. To ensure that the specified profile minimum was met, an impression tape called Press-O-Film<sup>4</sup> was used. Once the impression was taken of the pipe's interior surface, the profile was measured with a micrometer.

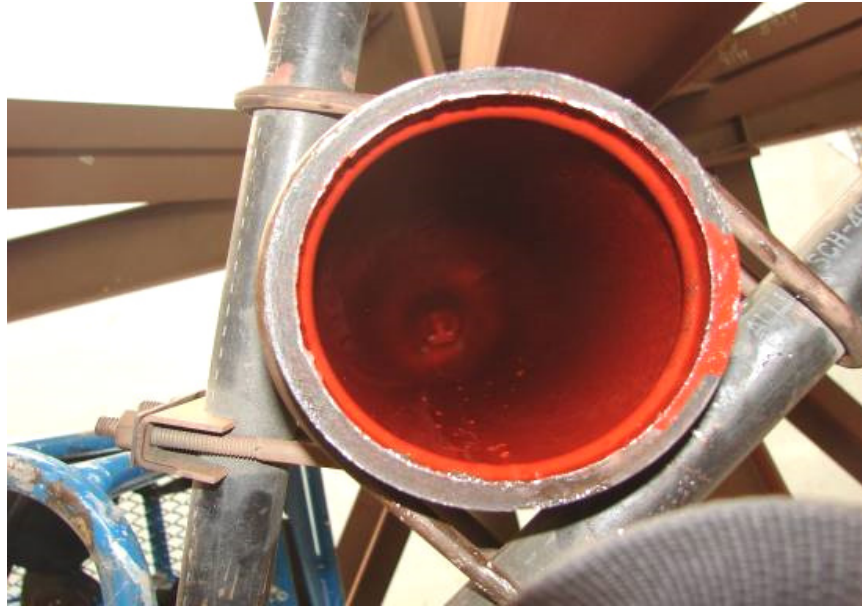
had reached the exit air connection and had thinned to specified thickness. To gage the thickness of the epoxy coating, wet film thickness cards were used. An epoxy-lined pipe is shown in Figure 6.

Figure 6. Inside the deluge system's main pipe after epoxy lining.
