SITE SPECIFIC REPORT SSR-2525-SHR

PIPELINE COATING CONDITION ASSESSMENT AND INSTALLATION ASSESSMENT, SAN NICOLAS ISLAND

November 1999

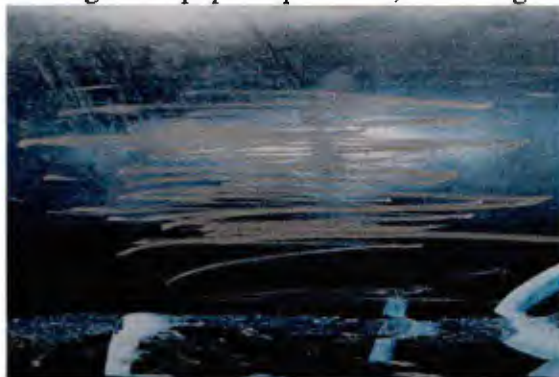
Light rubbing using sand stone on coating: Sandpaper equivalent, 80 grit.

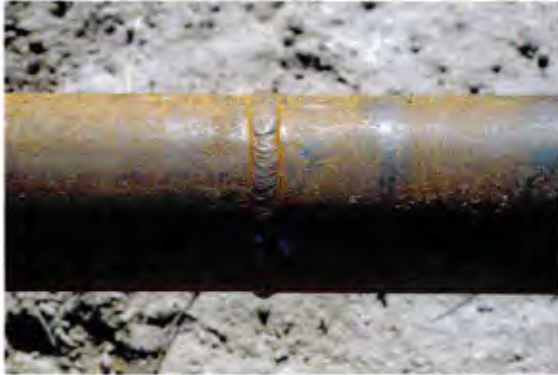
Close-up of pipe weld: Notice flash rusting.

The majority of pipe requiring a field coating contained visually significant quantities of flash rusting. Prior to coating, flash rusting requires complete removal by re-blasting. Flash rusting decreases the adhesion of coatings to steel and results in a reduced coating service life. On San Nicolas Island, flash rusting is good indication that chloride ions have contaminated steel surfaces. If chloride ions are not removed to acceptable concentrations (less than 7 ug/cm² of chloride ion contamination), chloride ions will attract water of a lower chloride ion concentration into contaminated surfaces. The chloride ion effect will not stop until the contaminated steel surface is at equilibrium with surrounding liquids. Prior to the field application of coatings, exposed pipe surfaces should be washed with hot potable water followed by grit blasting to produce a 2 – 4 mil anchor profile. All field applied coatings where the above procedure was not employed may experience reduced performance.

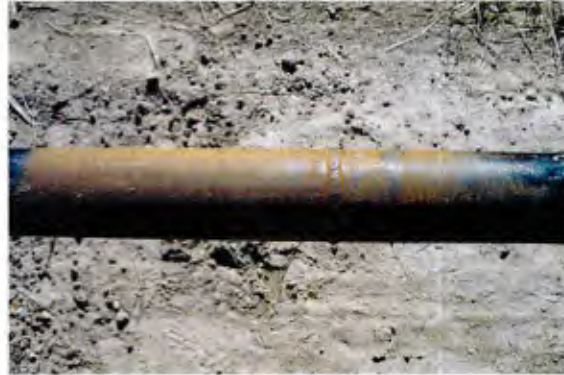
Pipe surface requiring field coating.

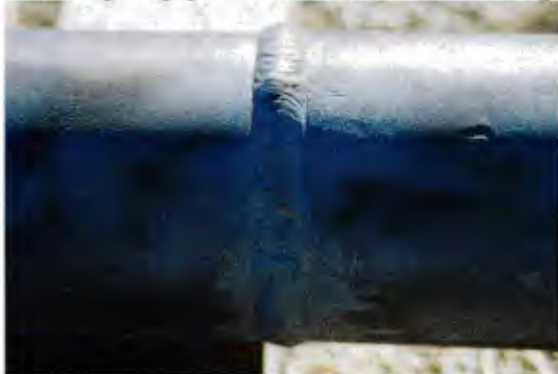
Grit blasted pipe weld.

Field surface preparation consists of a combination of #60 grit blasting, wire wheel abrading, and power grinding. Power grinding and wheel abrading are acceptable techniques for coating removal; however, they are unacceptable when used to prepare steel surfaces for coatings requiring immersion service. Only grit blasting is capable of producing the required angular anchor profile. Furthermore, the contractor's choice of #60 grit appeared to be producing a 1 – 2 mil anchor profile in lieu of the desired 2 – 4 mil anchor profile. Larger grit is required to produce a 2 – 4 mil anchor profile.

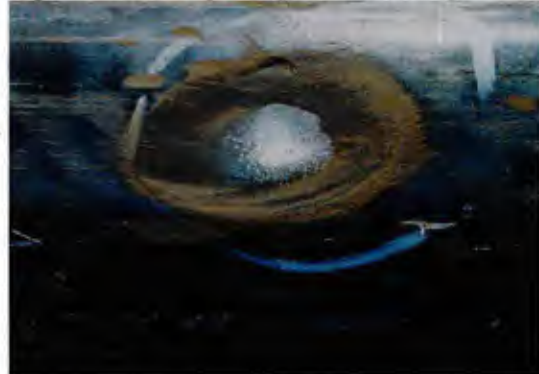
Holiday surface preparation.

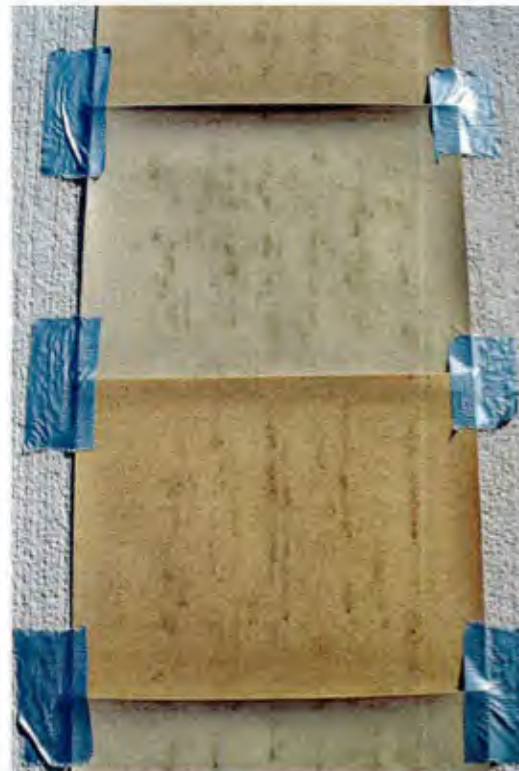
Resulting sandpaper surfaces after nine pulls: Notice black coating deposits

Results: 1) Coating weight loss, 0.76355 g (over a 7.854 in² area), and 2) Coating thickness loss, 5 – 10 mils (0.0194436 – 0.0097218 g/mil, in²).
