## Guided Wave Testing of Trunnion Rods at West Point Dam, Georgia

*by Jason D. Ray, Richard W. Haskins, and James A. Evans*

**PURPOSE:** This Coastal and Hydraulics Engineering Technical Note (CHETN) describes trunnion rod crack detection testing using the portable guided wave test system on a sample of the trunnion rods located at West Point Dam, Georgia, in January 2016. It is also intended to be used as a guide for test efforts at other sites.

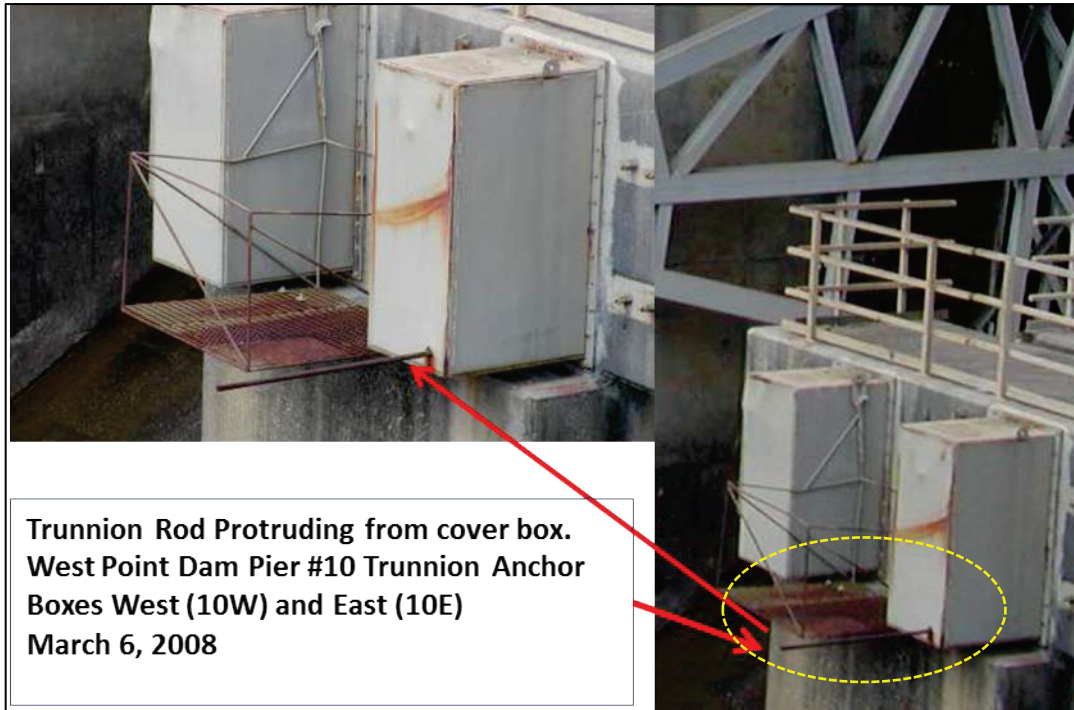
Trunnion rods are now failing at dam sites. Several of these broken rods project through the trunnion anchor cover boxes, as highlighted in Figure 2. The appearance of the cracks in the rods examined indicates that the trunnion rods had been cracked for some time prior to breaking. Stress corrosion cracking may have caused the final loss of the trunnion rod shown in Figure 3. As of 2012, 10 USACE dams contained broken trunnion rods (Table 1).

Figure 2. Trunnion rod protruding from the protective case after breaking.

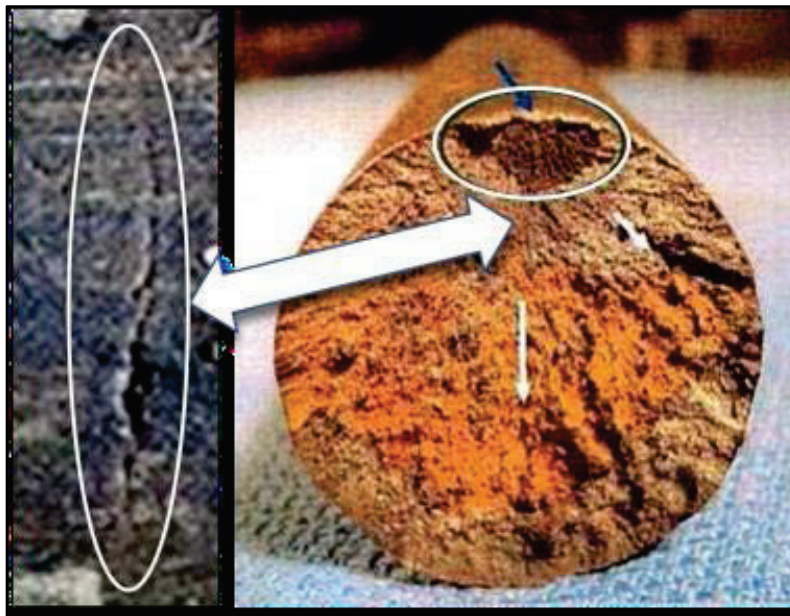
Figure 3. Emerging trunnion rod surface crack (left) and rod completely broken (right).

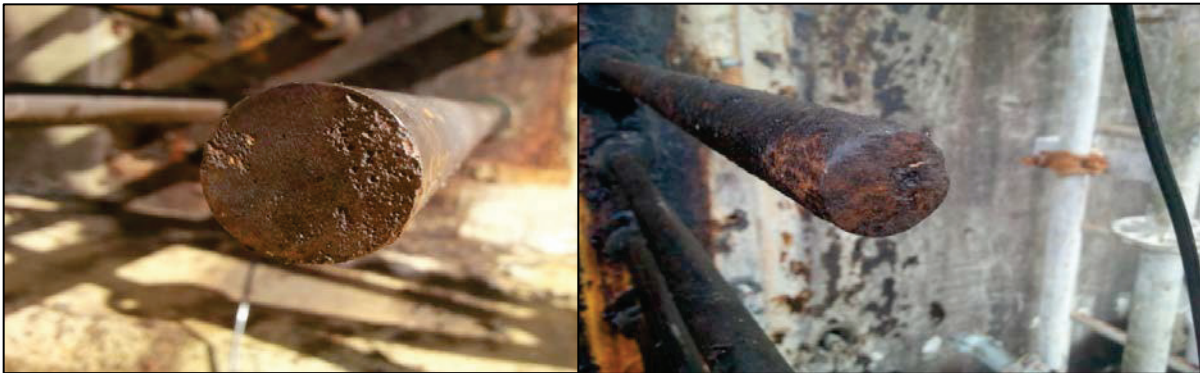
**TEST PLAN:** Safety concerns at this dam dictated that no grinding or unnecessary contact with the rods would be allowed. It was known before testing that the rod ends were, for the most part, in good shape and would not require any work to prepare the surfaces. A few rods exhibited surface anomalies (Figure 4). Other rods were very flat and were quite responsive to the test (Figure 5).

Figure 4. Pitted rod and surface corrosion on rod.

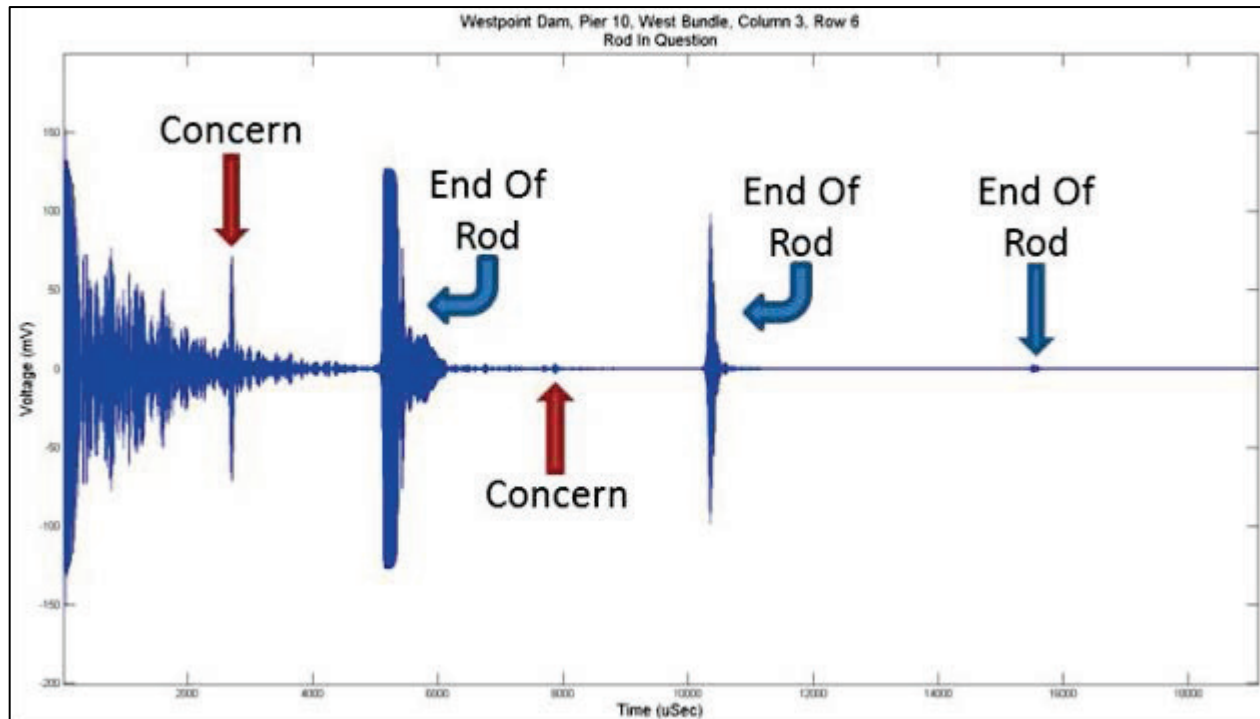
A non-typical response from a rod is shown in Figure 11. Note the return midway between the exciting pulse and the end of rod reflection.

Figure 11. Pier 10, west bundle, column 3, row 6 display, showing areas for concern.

Figure 11 is an annotated display of the data set from a trunnion rod on Pier 10 that displays a possible crack. Although several things could cause the unusual return in these data, the history of this particular pier makes it reasonable to suspect a crack in the rod. Additional analysis of the data set is being conducted to increase the assurance that a defect is present.

**CONCLUSION:** The purpose of this CHETN is twofold: (1) to describe the testing done at West Point Lock and Dam and (2) to provide an overview of the procedure used to test rods at any dam site. Of the rods that were tested at the West Point dam, one displayed a probable defect. This defect is believed to be a crack in the rod.
