Evaluation of Reentry Effects of Delta II Second Stage Propellant Tanks

March 21, 2018

Gary L. Steckel¹ and Paul M. Adams²

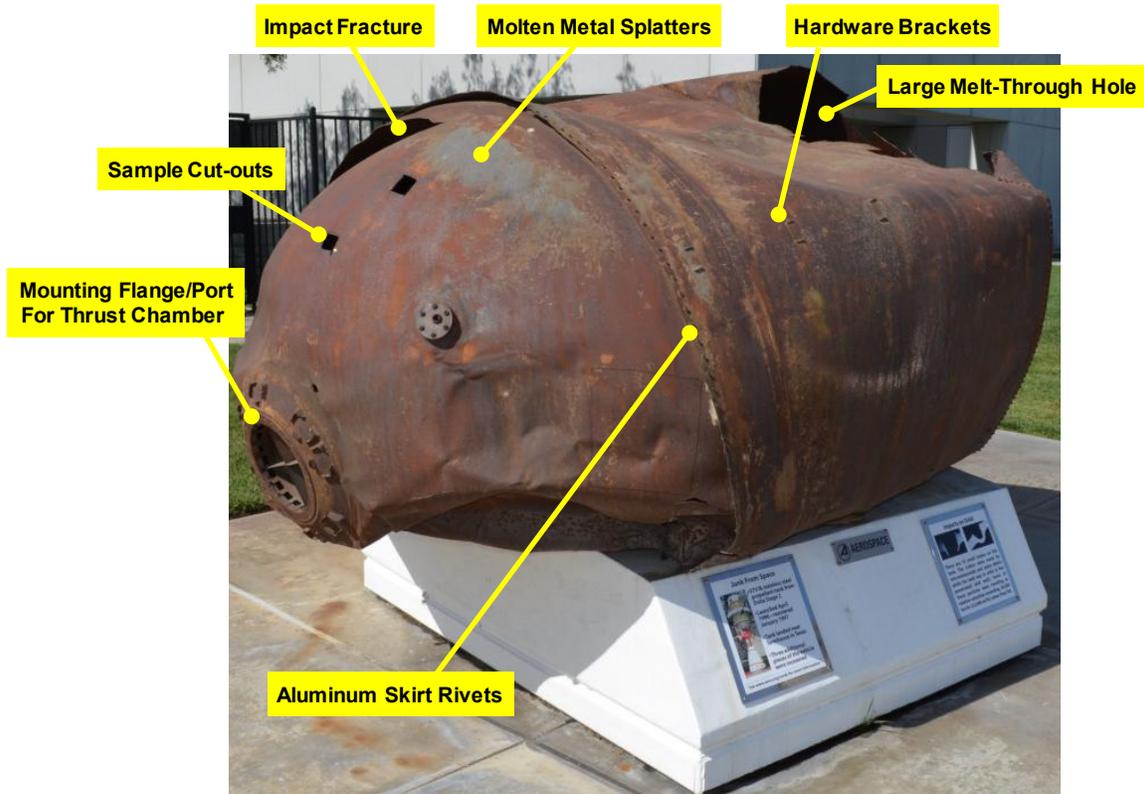
Figure 3. Photograph of Delta II 2nd Stage propellant tank that reentered in 1997 and landed in Texas.

A large hole with an area around 0.5 m^2 was present on the upper side of the forward dome. It was concluded from the presence of resolidified metal around the perimeter of the hole that the stainless steel skin had melted at this localized area during reentry. However, such gross melting of the stainless steel skin, which occurs at approximately 1500°C , was not observed at any other location on the tank. There were, however, splatters of various sizes of resolidified molten metal at several locations on the tank surface. It was determined from SEM/EDS analyses that these splatters were primarily aluminum. It was concluded that aluminum hardware attached to the Stage II tank had melted during reentry and landed on the tank surface. Since aluminum alloys melt at approximately 660°C , it was concluded from these observations that the peak reentry temperature of the tank was at least 660°C , but less than 1500°C .

It is apparent from Figure 3 that the Texas tank has a dark rusty appearance, and it will be shown in section 4.3.1 that the Mongolia tank has a similar appearance. The photographs of the South Africa tank revealed that it has a lighter brown color. The 410 stainless steel alloy has a martensitic structure that is susceptible to atmospheric corrosion. The Texas and Mongolia tanks have been stored outdoors for many years, while the South Africa tank was relocated indoors at SAAO shortly after recovery. Thus, the rusty appearance of the Texas and Mongolia tanks are indicative of their post-reentry storage history.

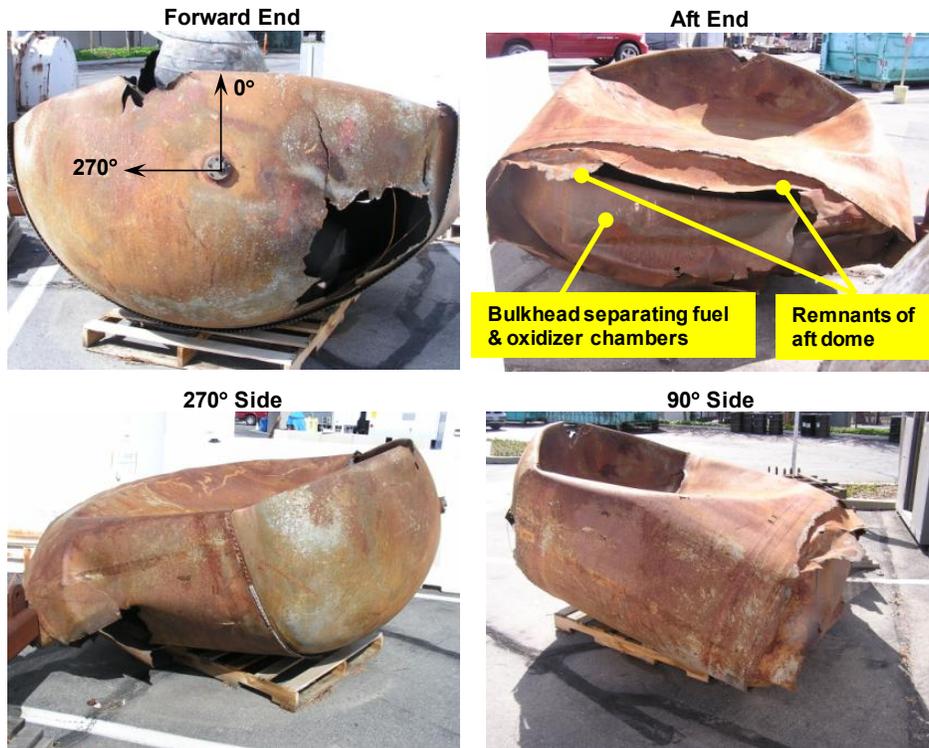
A set of four photographs in Figure 4 show the forward and aft ends and opposing side views of the Mongolia propellant tank. The tank was more grossly deformed than the Texas and South Africa tanks. One side totally collapsed into a concave bowl shape; it is assumed that initial Earth impact was on this side. An arbitrary coordinate system, as shown on the forward end photo, was used to define relative angular positions around the cylindrical tank. The center of the concave side was defined as 0°. Figure 5 shows a second set of four photographs taken with the concave side facing downward. These photos show very little deformation on the upper side of the tank at the forward end, but at the aft end they show flattening into an oval shape. The aft end photos in Figures 4 and 5 show that the aft dome was almost completely missing and the bulkhead that separated the fuel and oxidizer chambers was pushed outward through the remnants of the aft dome. The jagged edge of the dome remnants suggest that the dome fractured circumferentially a short distance behind the welded interface to the cylindrical section. Heating damage was observed around much of the fracture surface, suggesting that the dome probably fractured during breakup of the Stage 2 vehicle in the early stage of reentry. This likely occurred when the thrust chamber and engine were ripped away from the tank. Whereas clean separation between the tank and thrust chamber occurred at the mounting flange for the Texas and South Africa tanks, separation for the Mongolia tank occurred by failure of the stainless steel dome skin. The structural integrity of the tank was greatly diminished by removal of the aft dome. This probably allowed the tank to collapse into a concave shape upon Earth impact.

Figure 4. Photographs of Delta II 2nd Stage propellant tank that reentered in 2009 and landed in Mongolia.

A large melt-through hole was observed on the forward dome, as shown in the forward end photo in Figure 4. The hole was similar in size ($\cong 0.5 \text{ m}^2$) and location to the melt-through hole on the Texas tank. Furthermore, the perimeter of the melt-through hole consisted of resolidified metal, appeared to have aluminum splatters on the external surface, and was curled outward. All observations were consistent with the hole on the Texas tank. A second, smaller melt-through hole is visible in Figure 4, near the center of the forward dome at the rim of the concave deformation. It is not surprising that the melt-through holes for both tanks were on the forward dome. As shown in Figure 1, a large aluminum housing joining the propellant tank to the guidance section is riveted to the forward end of the cylindrical section, while only a short aluminum skirt is riveted to the aft end. Thus, the potential for heavy molten aluminum splatters and aluminum burning is much higher for the forward dome.

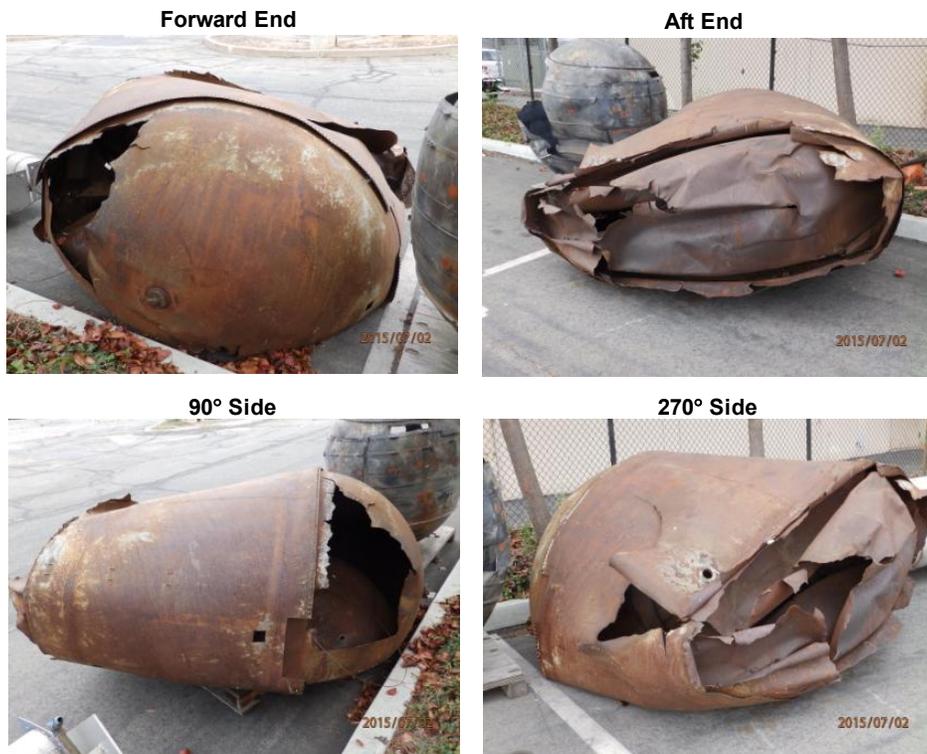
Figure 5. Photographs of Mongolia propellant tank with concave side facing downward.

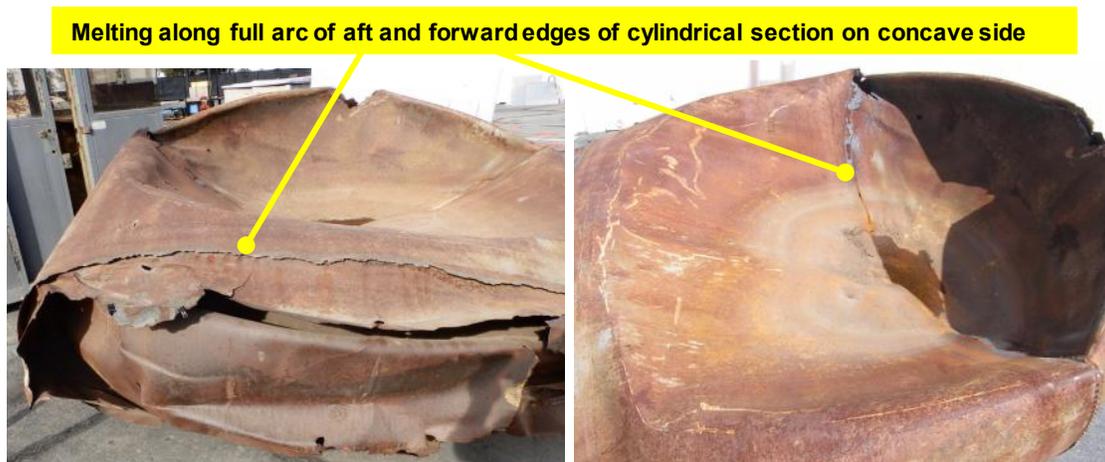
Widespread melting or erosion of the forward and aft ends of the cylindrical section back through the stainless steel rivets occurred on the concave side of the tank (Figure 6). On the other hand, very little melting or erosion of cylinder ends occurred around the opposite side ($\cong 70^\circ\text{--}290^\circ$). Furthermore, as shown in Figure 7, residual aluminum remained under the rivets, along a portion of the forward end of the cylindrical section.

Figure 6. Melting along ends of cylindrical section on concave side of Mongolia tank.

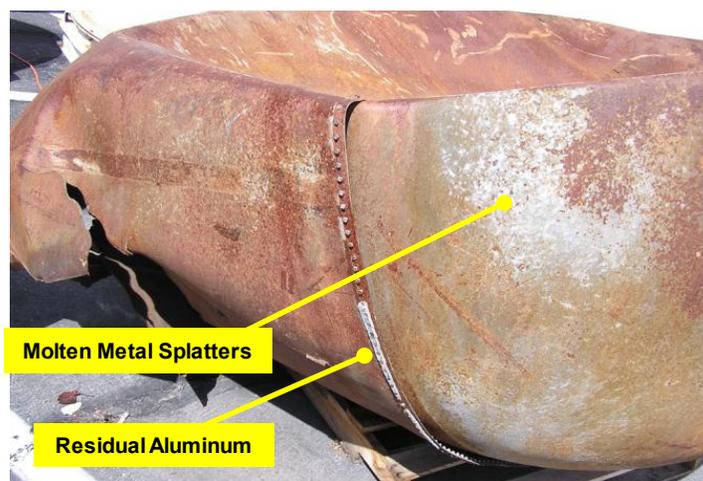
Figure 7. Residual aluminum attached to forward end of cylindrical section and under rivets for Mongolia tank.

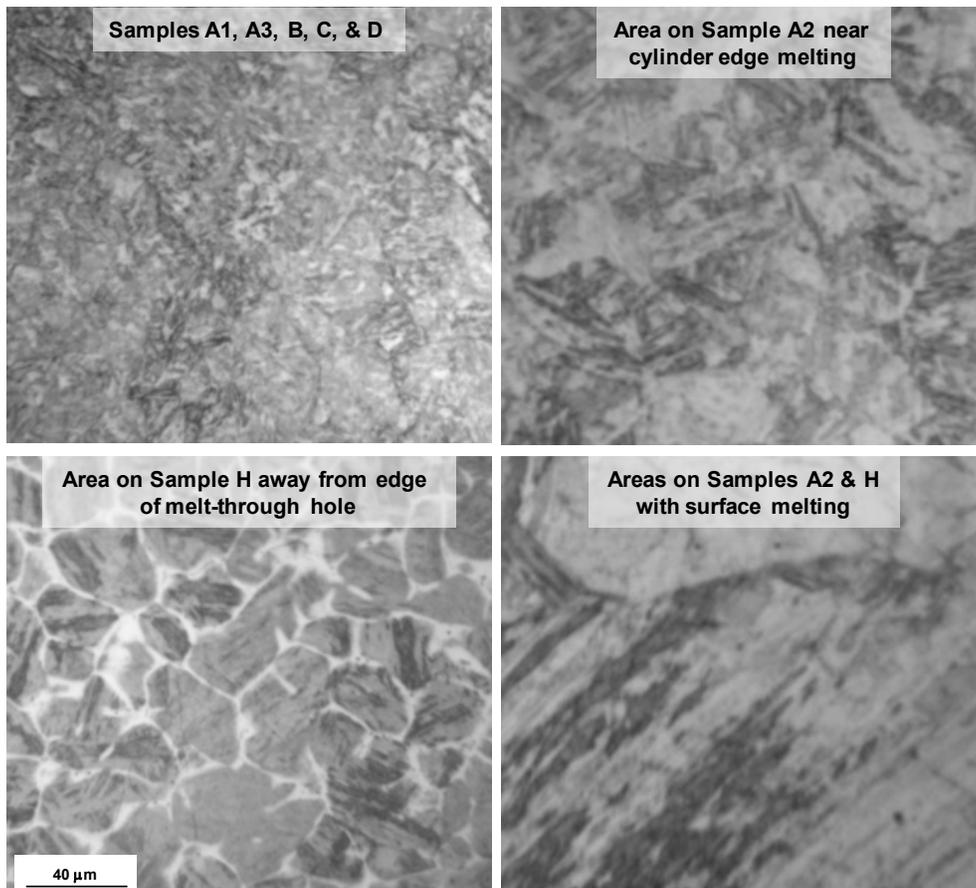
Seven of the eight samples listed in Table 2, excluding Sample J, were cross-sectioned, mounted, polished, and etched for evaluation of post-reentry microstructures by optical microscopy. Figure 8 shows four micrographs that represent the microstructures observed for the samples from the seven different tank locations. The upper left micrograph in Figure 8 is representative of all the areas on the tank that had no melting of the stainless steel during reentry (Sample Nos. A1, A3, B, C, and D). This is the lath martensite structure typical of 410 stainless steel. The orientation of the lathes differs for individual prior austenite grains. It follows that the prior austenite grains had diameters in the range of 20 to 40 μm . The upper right and lower right micrographs show the same microstructure as the upper left, but with larger prior austenite grain sizes. The upper right micrograph is of an area near the cylinder wall edge that melted during reentry, but with no surface melting. The lower right micrograph represents areas with surface melting. Progressively higher peak temperatures at the locations of the upper left to upper right to lower right micrographs caused increasing amounts of austenite grain growth. Prior austenite grain diameters were around 30 to 50 μm for the upper right microstructure, and over 150 μm for the lower right micrograph.

The lower left micrograph shows a unique microstructure observed near the melt-through hole on Sample H. The dark areas are lath martensite, and the white areas are retained austenite at the prior austenite grain boundaries that did not transform during post-reentry cooling. This microstructure clearly shows the prior austenite grain size, similar to that in the upper right micrograph. The cause of the retained austenite was not pursued, but could be due to carbon or chromium depletion at the grain boundaries.

Figure 8. Optical micrographs showing martensitic microstructures at various locations on the Mongolia tank.

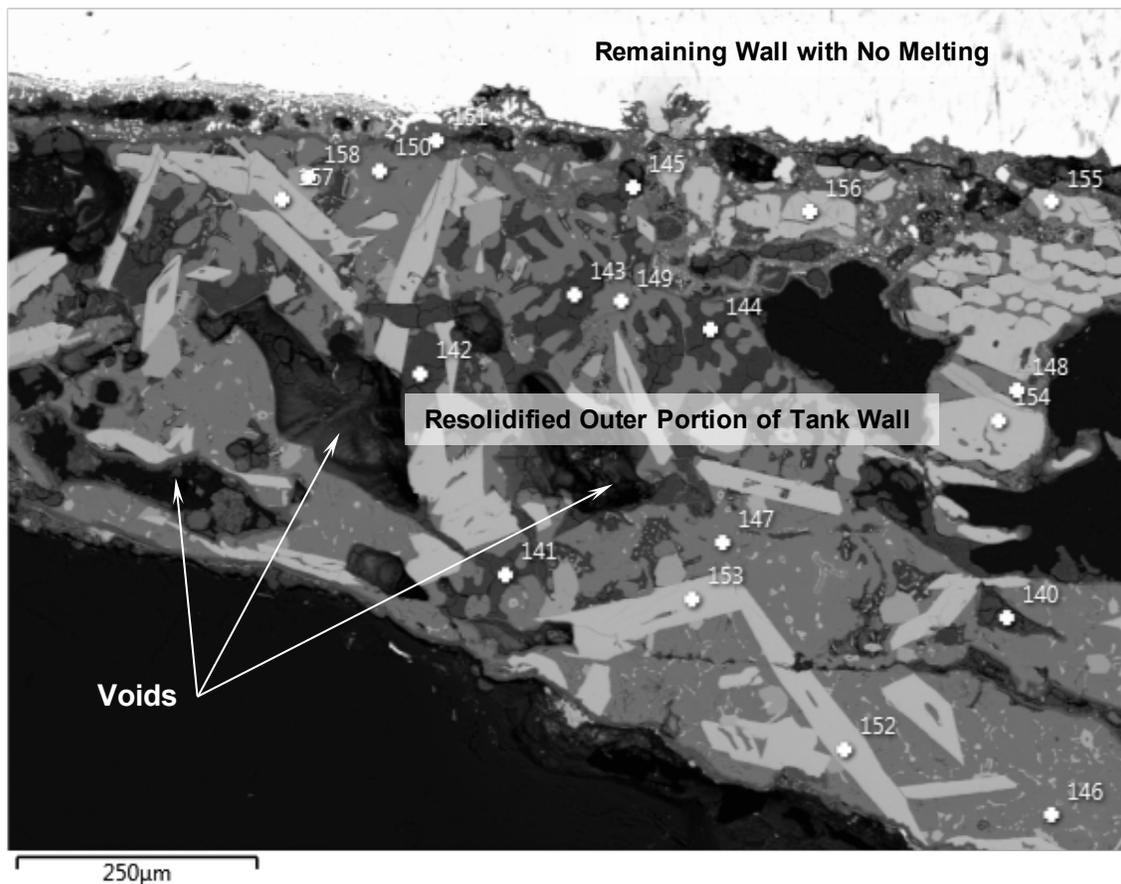
The polished cross-section of Sample H was analyzed in the SEM using EDS to determine the chemical composition of the resolidified metal near the edge of the melt-through hole on the outside and inside surfaces of the tank wall. Figure 9 is a low-angle backscatter electron (LBE) image of an area on the outside surface. The image is centered 3 mm to the left of the edge of the hole.

Figure 9. SEM/LBE image of an area on outer surface of tank cross-section at perimeter of melt-through hole.

In this backscatter electron image, high atomic number constituents appear brighter than lower atomic number constituents. The bright area at the top of the image is an interior region of the stainless steel tank wall that did not melt during reentry. The porous material below the remaining wall is a layer of resolidified metal on the outer surface of the tank wall. It is composed of three different phases, with differing atomic weights yielding three distinct shades of gray in the image. The primary phase is a

neutral gray tone with patches of a dark gray phase having a dendritic appearance and a light gray phase having mostly a platelet morphology. The black areas within the porous resolidified metal are voids. EDS spectra were taken at 19 points within the resolidified metal labeled points 140 – 158. Table 4 shows the tabulated results of the EDS analyses. The primary phase (neutral gray areas, Points 146–150) consisted of essentially elemental aluminum with small amounts of iron, chromium, and silicon from the stainless steel wall and around 3 at.% oxygen. The dark gray phase (Points 140–145 & 151) consisted of fully oxidized aluminum (\cong 37 at.% Al and 61 at.% O). The light gray platelet phase consisted of an alloyed mixture of aluminum and 410 stainless steel consisting of approximately 77 at.% Al, 20 at.% Fe, and small amounts of Cr and Si.

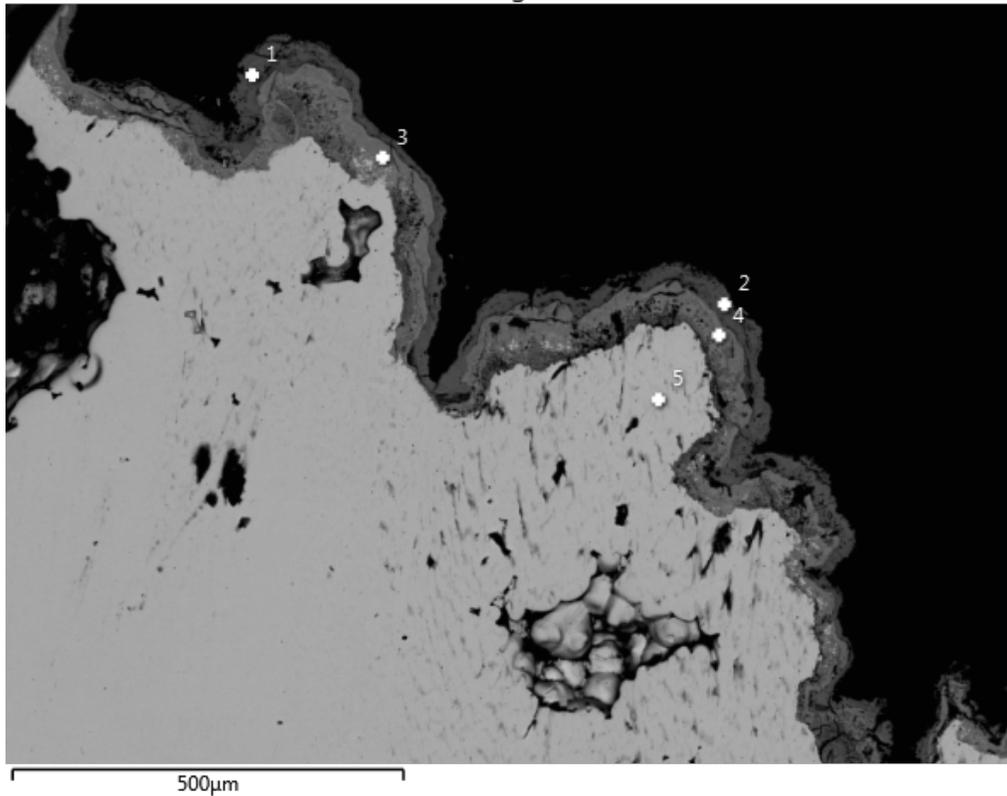
Figure 10 shows an SEM/LABE image of an area on the inside of the tank wall approximately 5 mm from the edge of the melt-through hole. Table 5 presents the results of EDS spectra at Points 1–5. The light gray area represented by Point 5 consists of remaining unmelted stainless steel wall. The gray inner layer of resolidified material (\cong 30–80 μ m thick, Pts. 3 & 4) was highly oxidized with equal amounts of iron and chromium. The darker gray outer layer (\cong 10–40 μ m thick, Pts. 1 & 2) was mostly iron oxide. The inner surface of the tank was not accessible to molten metal splatters, so very little aluminum was present. The

high concentration of Cr in the inner oxide layer can probably be attributed to the fact that Cr_2O_3 has a much lower free energy of formation at the melting temperature of 410 stainless steel than any of the potential iron oxides (FeO , Fe_2O_3 , or Fe_3O_4). Thus, an oxide layer rich in Cr formed first. Once the available Cr was all oxidized, free Fe atoms diffused through the inner oxide layer to react with oxygen to form the outer oxide layer.

Figure 10. SEM/LABE image of an area on inner surface of tank cross-section at perimeter of melt-through hole.

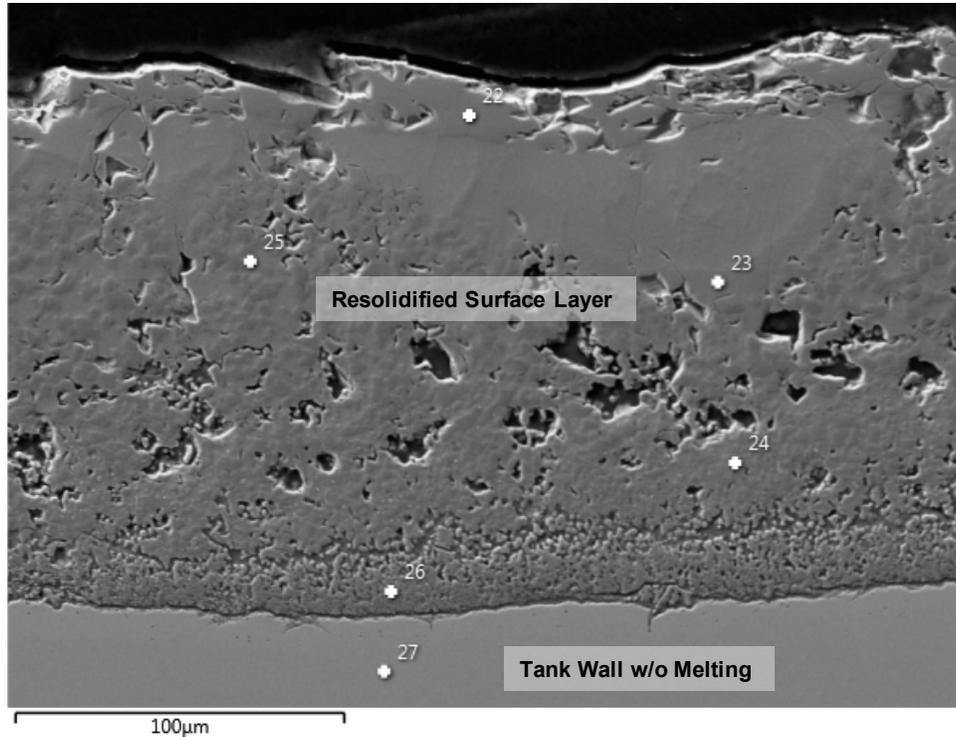
Figure 11 shows an SEM/LABE image of a polished cross-section of Sample A2 from the forward edge of the cylindrical section. The lower area consists of remaining wall thickness that did not melt, and the porous upper area consists of resolidified metal on the outside surface. The results of EDS spectra taken at Points 22–27 are tabulated at the bottom of the figure. The resolidified metal was highly oxidized throughout the thickness, but was mostly iron oxide near the free surface (points 22, 23, & 25), with higher concentrations of chromium present near the remaining tank wall (Points 24 & 26). Although some aluminum was present, the concentrations were low, and there was no evidence of aluminum burning contributing to the tank melting. Similar results were obtained at five other areas on the cross-section. The results were consistent, with the assumption that melting was due to enhanced aerodynamic heating at the exposed cylinder edge.

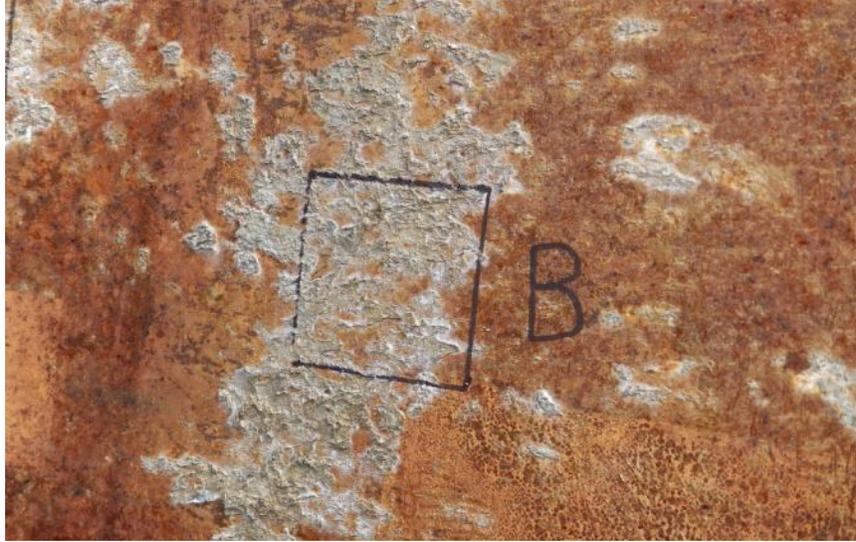
Figure 12. Photograph of Sample B before cutting from region with resolidified metal splatters.

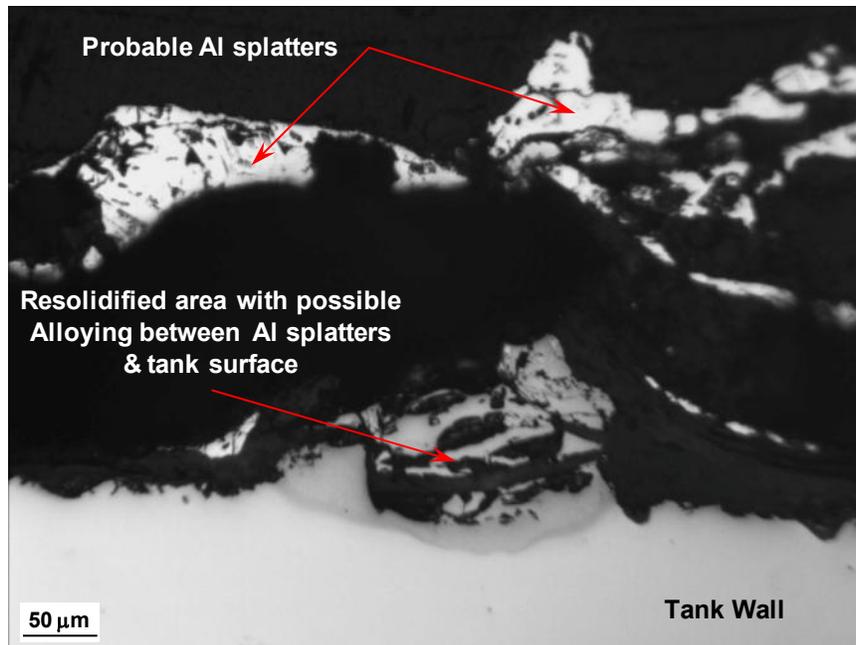
Polished cross-sections of the four samples were examined by optical microscopy to identify areas with possible alloying between the aluminum splatters and stainless steel tank surface. An example of an area selected for analysis is shown in the optical micrograph in Figure 13. This area appeared to have resolidified aluminum splatters on the tank surface and a resolidified area that appeared to be bonded to the tank surface—an indication of alloying between the aluminum and stainless steel. Figure 14 presents a SEM image of the same area, along with EDS elemental maps showing the locations of Al, Fe, and Cr (red, yellow, and green, respectively). The Al map verified the presence of Al splatters on the tank surface. The Fe and Cr maps clearly highlight the stainless steel tank wall. Most importantly, the maps verified the presence of Al, Fe, and Cr within the resolidified material that appeared to have a continuous bond with the tank wall. Thus, the mapping verified alloying between the Al splatters and stainless steel wall, making this a suitable area for more detailed SEM/EDS analyses to determine the peak reentry temperature at this location on the propellant tank.

Figure 13. Optical micrograph of cross-section of Sample B showing possible alloying between Al splatters and tank wall.

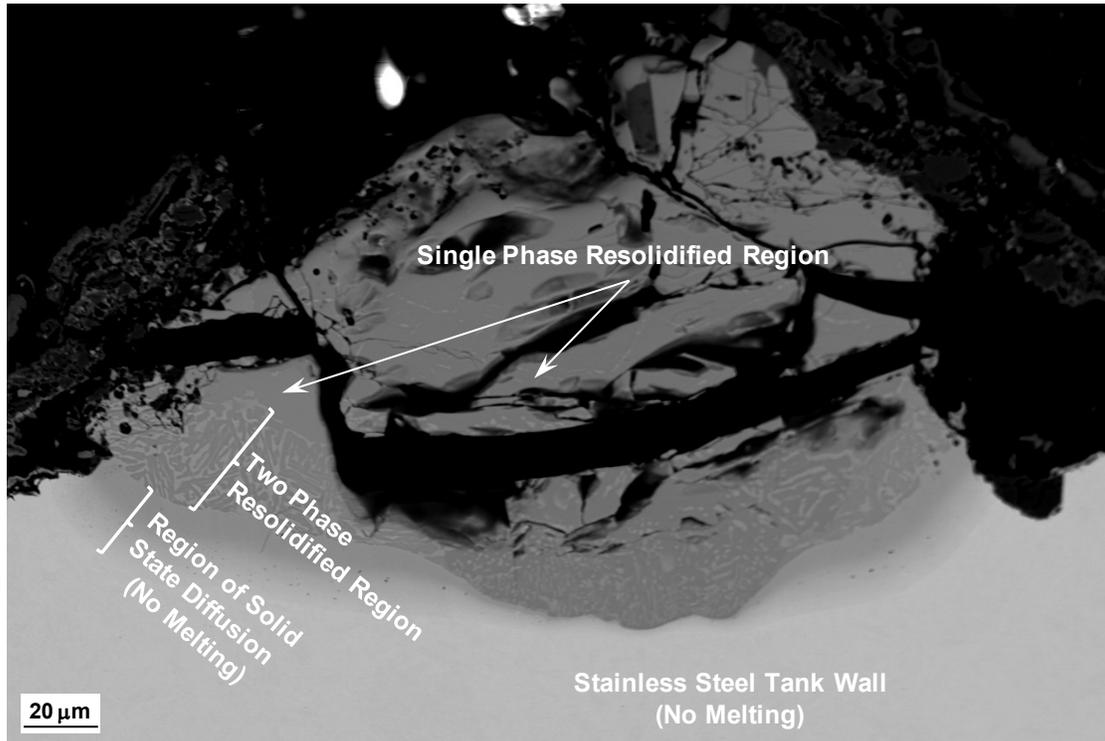
A higher magnification SEM/LABE image of the area of interest in Figure 15 shows that the resolidified material consists of a single-phase region and a two-phase region. Both these areas were fully or partially melted at the peak reentry temperature for this location. A region of solid-state diffusion joins the resolidified material to tank wall. The diffusion zone is highlighted by increasing LABE image brightness across the zone from the two-phase region (low atomic mass) to the tank wall (higher atomic mass). The diffusion zone and remaining tank wall did not undergo any melting during reentry.

Figure 15. SEM/LABE image of polished cross-section showing region with alloying between Al splatters and tank wall.

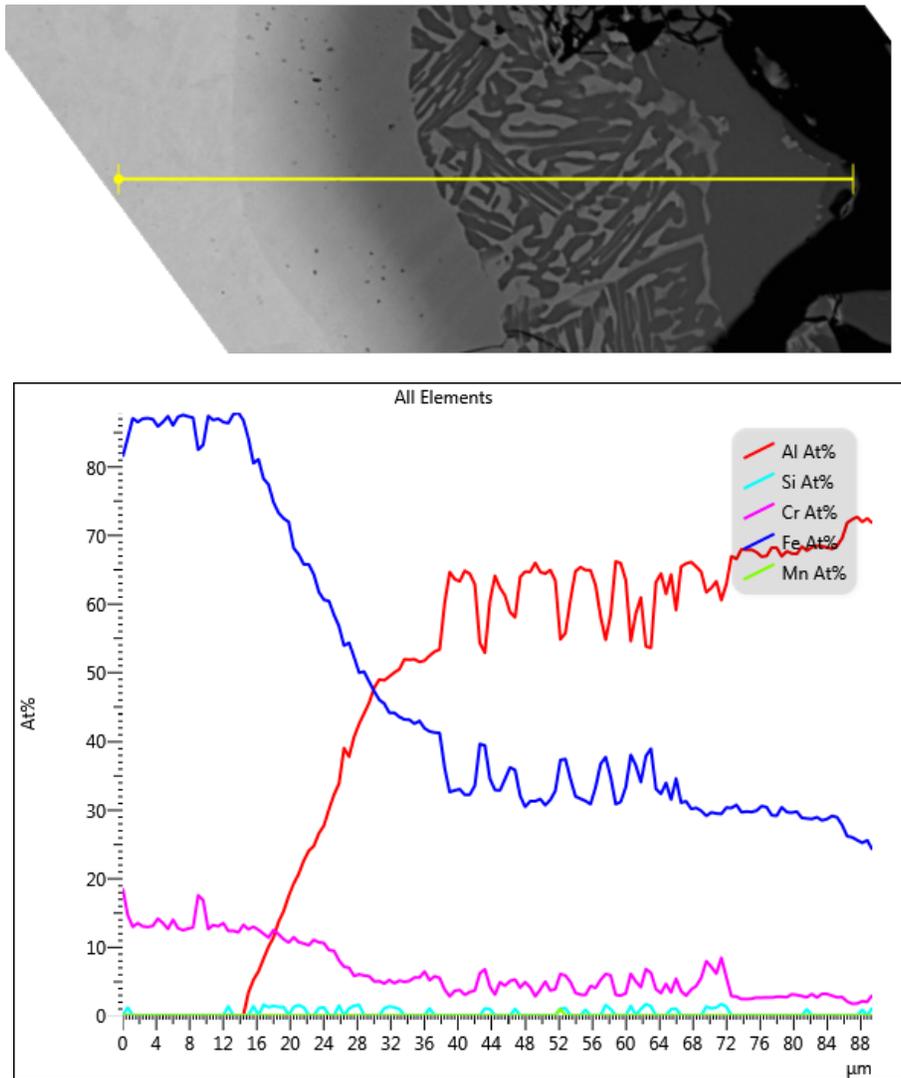
An EDS elemental line scan was made across the diffusion zone, the two-phase resolidified region, and into the single-phase resolidified regions (Figure 15), as shown in Figure 18. The line scan included the elements Al, Si, Cr, Fe, and Mn, but the only elements of interest for our analysis are Al and Fe + Cr. The line scan was initiated within the unalloyed region of the 410 stainless steel, with the typical Fe and Cr compositions of 87 and 13 at. %, respectively. At 13 μm along the scan, the beginning of the diffusion zone was reached, as indicated by slight darkening of LBE image. The Fe and Cr content continually decreased across the diffusion zone while the aluminum content increased. At the end of the diffusion zone just before reaching the two phase resolidified region, the Al content was 53 at. %. This is the maximum Al content for the portion of the tank thickness that did not melt. From the phase diagram (Figure 17), an alloy with 53 at. % Al melts at the peritectic temperature of 1215°C. Thus, the peak reentry temperature at this location on the tank did not exceed 1215°C.

Figure 18. SEM/EDS elemental line across region with alloying between stainless steel tank and aluminum splatters.

As the line scan proceeded across the two-phase region, the Al content varied between approximately 67 and 54 at. %, the respective compositions of the dark and light phases. At approximately 72 μm , the scan entered the single-phase resolidified region, and the Al content stabilized at approximately 67 at. %. A

large area EDS scan of the two-phase resolidified region gave an Al content of 61 at. %, the weighted average for the two phases. From the phase diagram, at temperatures below 1092°C, an alloy with 61 at. % Al (as indicated by the red line) has a microstructure consisting of α_2 with an Al content of approximately 55 at. % (light phase in Figure 18) and ξ with an Al content around 66 at. % (dark phase). For 61 at. % Al, melting initiates at 1075°C. Thus, the peak reentry temperature at this location on the tank was at least 1075°C, but did not exceed 1215°C.

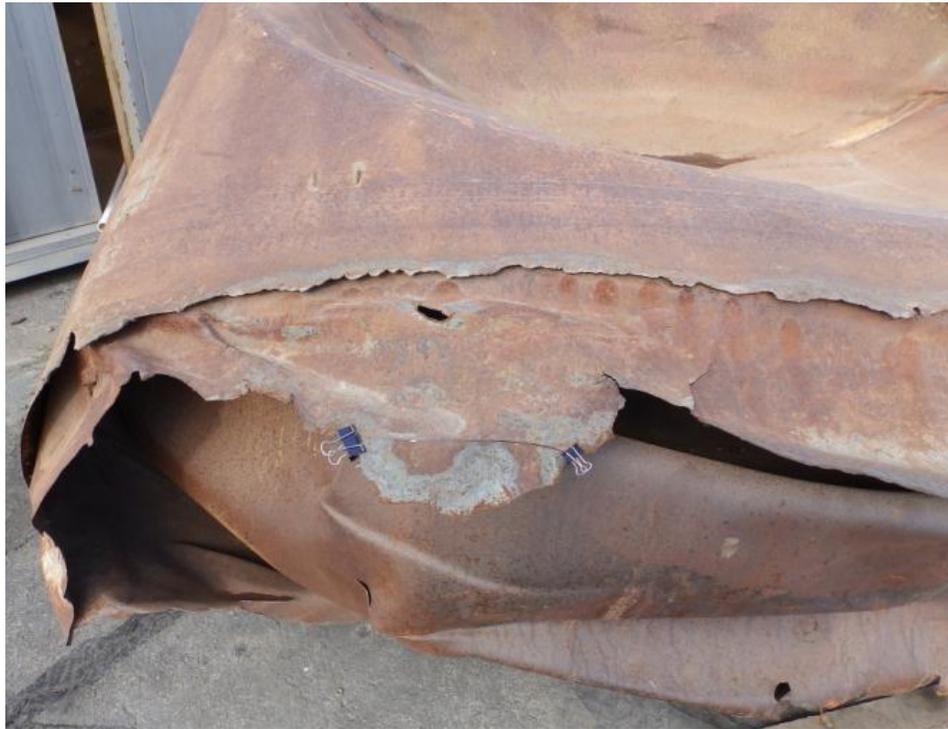
Sample A1, shown in Figure 19, was cut from the aft dome of the propellant tank along the path where the dome fractured during breakup. It was originally cut from the tank for evaluation because the light gray pattern on the outside surface suggested that a thick layer of molten aluminum had splattered along the fracture path during reentry. However, once the sample was removed, it was discovered that a matching gray pattern was also present on the inside surface (Figure 20). SEM/EDS spectra were taken on the surfaces of the gray area as well as the reddish area. No aluminum was detected on the gray area, and

both surface areas were predominantly iron and oxygen. The reddish iron oxide was representative of most of the tank surface, resulting from atmospheric corrosion due to outdoor storage following reentry.

Figure 19. Photograph of Sample A1 secured to aft dome by binder clips after removal from Mongolia tank.

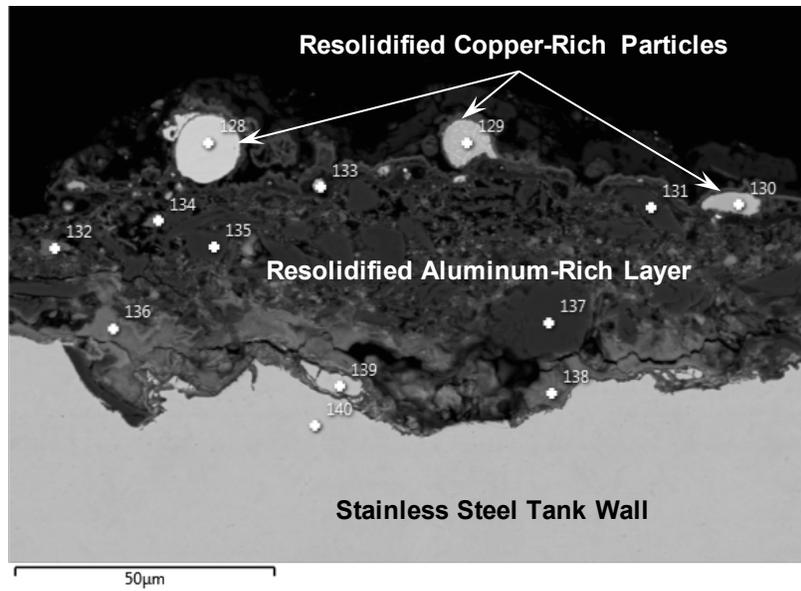
Molten metal splatters on the Mongolia tank were primarily aluminum, with small concentrations of common aluminum alloying elements such as magnesium and silicon. Copper was also detected by SEM/EDS at several locations. Figure 23 is a LAME image of a typical area with Cu-rich particles on the cross section of Sample A3. The particle on the left was 70 at. % Cu and 25 % Al and the other two particles were 45 at. % Cu + 40 % Al + 10 % Fe. All the splatters observed with high copper concentrations also had significant aluminum concentrations. However, we were primarily looking at cross-sections of areas with obvious aluminum splatters. Thus, it is quite possible that copper splatters were present at other locations in the absence of any aluminum. For the samples that were analyzed, Cu-rich particles were usually on the surface of the resolidified aluminum splatters, but were occasionally imbedded in the Al-rich layer. The Cu-rich particles were usually similar in size (10–20 μm across) to those in Figure 23, but often had a more irregular cross-section than did the round particles in the figure. The copper probably originated from electrical wiring attached to propellant tank that melted and splattered onto the tank surface.

Figure 23. LBE image of Cu-rich particles on top of aluminum splatters on Sample A3.
