UNITED STATES ARMY AVIATION BOARD
Fort Rucker, Alabama

REPORT OF TEST

PROJECT NO. AVN 1162

EVALUATION OF RYANAV IV DOPPLER NAVIGATION
SYSTEM

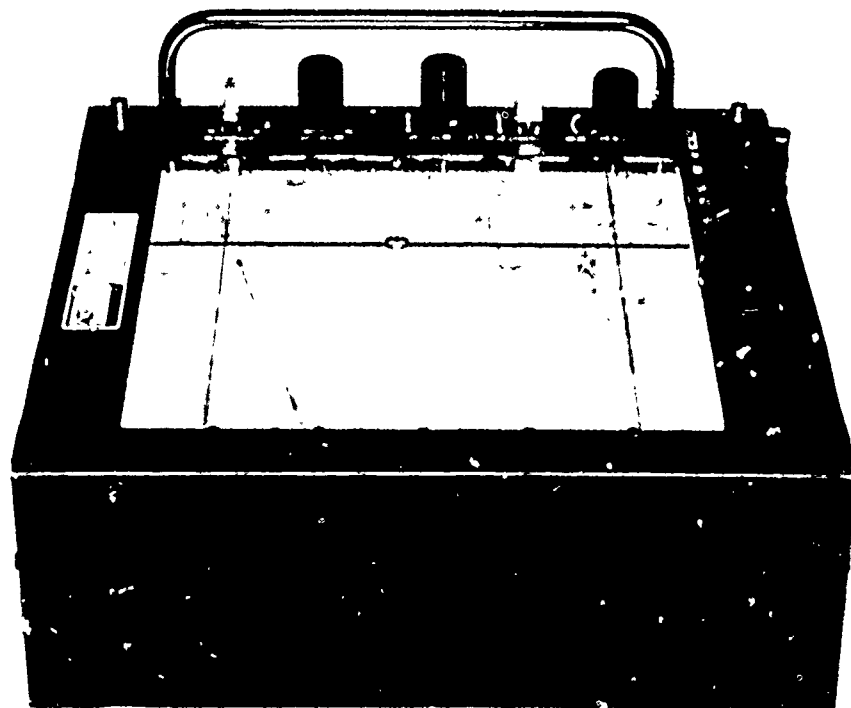
Figure 3. AFC plotting board

(2) The plotting board (see figure 3) had limited application in this configuration. Templates used in the plotting board covered 40-nautical-mile square areas for charts of 1/500,000 and 80-nautical-mile square for charts of 1/1,000,000. At an average airspeed of 140 knots on a generally straight-line mission, it was necessary to change templates every 17 minutes for the 1/500,000 charts and every 34 minutes for the 1/1,000,000 charts.

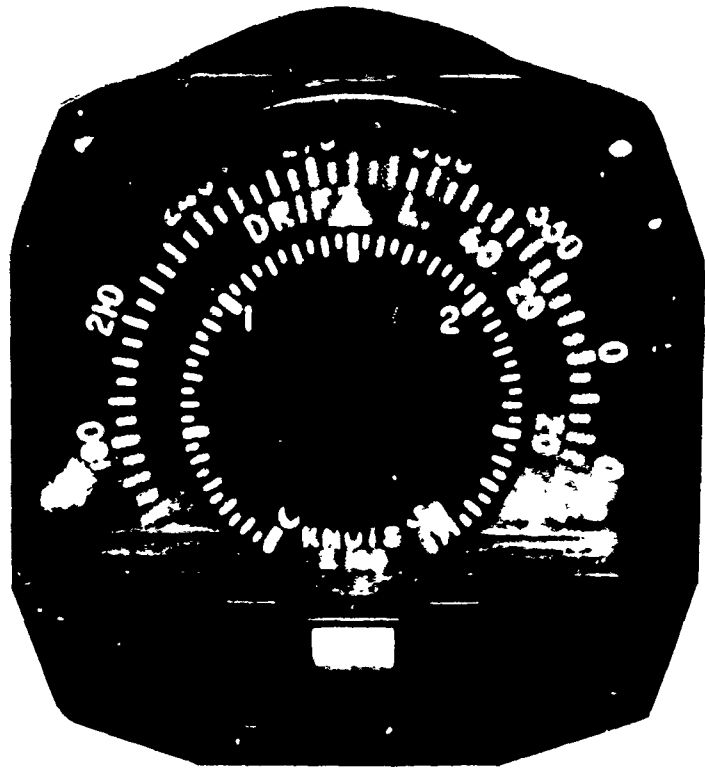
Figure 5.
Groundspeed/
drift-angle,
windspeed/wind-
direction indicator

(1) The groundspeed/drift-angle, windspeed/wind-direction indicator (figure 5) was difficult to read and differed from normal instrument presentation in that:

(a) One index served for both wind direction and drift angle, but used two sets of numbers for read-out. The wind direction was shown on a compass card with the numbers on the outside of the card; the drift angle was shown as "Left" or "Right" with the numbers nearer the center of the instruments.

(b) When switching from groundspeed/drift-angle to windspeed/wind-direction, the "knots x 100" pointer oscillated wildly for 5 to 10 seconds before stabilizing.

(c) The outside compass card of the instrument accepted and displayed instantaneous Doppler information without

damping, thus jerking and jumping at intervals of from one to five seconds in increments of five to fifteen degrees. The groundspeed and windspeed pointer varied constantly but in much smoother and smaller increments.

2. Presentation of the groundspeed/drift-angle, windspeed/wind-direction indicator is too complicated and information was displayed erratically and with oscillations.	Redesign indicator with damping incorporated taking into consideration engineering factors with regard to readability and simplicity of the instrument face.

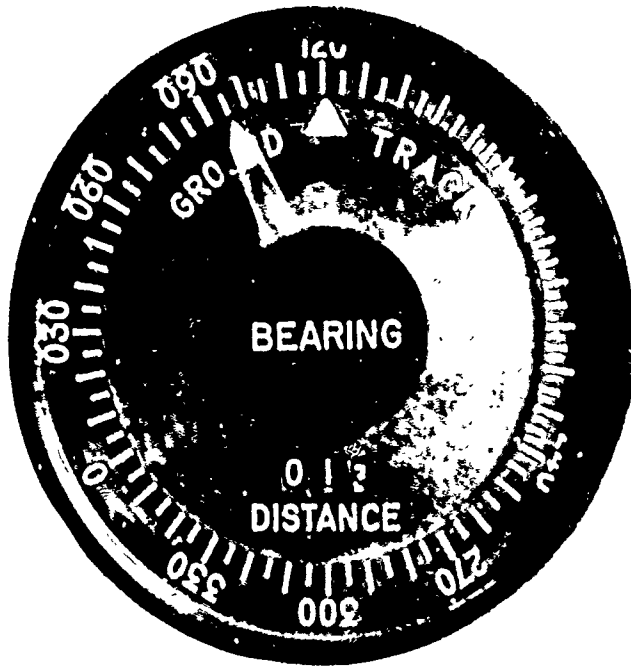
Figure 6. Original configuration of the bearing-to, ground track, and range indicator

(2) At the beginning of the test, the ground-track, bearing-to, and range indicator displayed ground track on a compass card that had the heading numbers on the outside of the card and the degree increments on the inside (figure 6). This was later reversed (figure 7), enabling easier interpretation. The numbers on the digital range read-out were too small for normal operation and were hidden by the center of the instrument when viewed at an angle from above.

3. Bearing-to, ground-track, and range indicator has numbers in the digital range read-out which are too small for normal operation and are hidden by the center of the instrument when viewed at an angle from above.	Redesign the digital readout so that the digits are large enough for normal operation, and relocate the read-out so that it is readily readable from all normal observing angles.	The manufacturer has partially corrected this by enlarging the digits. However, the digital read-out has not been relocated.

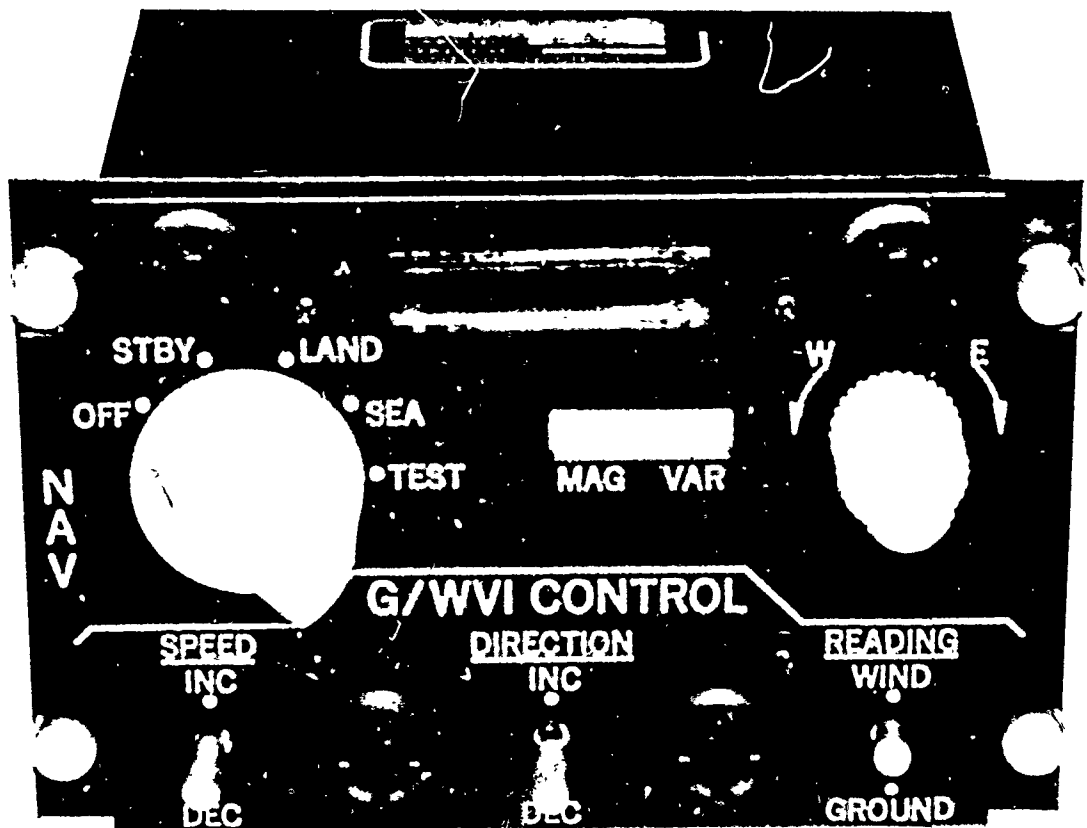
Figure 8. The G/WVI control

(1) The G/WVI control (figure 8) was easy to operate in that the switches and control knobs were readily available and lettering was easily readable. The two switches controlling wind speed and direction and the switch controlling the wind/ground reading seemed fragile. At one time one of the switches was bent, but still usable. No failures occurred during the evaluation.

<u>SHORTCOMINGS</u>	<u>SUGGESTED CORRECTIVE ACTION</u>	<u>REMARKS</u>
The three toggle switches on the G/WVI control are too fragile.	Install more rugged switches.
