Technical Note N-1450

EXPERIMENTAL POLYURETHANE FOAM ROOFING SYSTEMS

August 1976

CIVIL ENGINEERING LABORATORY  
Naval Construction Battalion Center  
Port Hueneme, California 93043

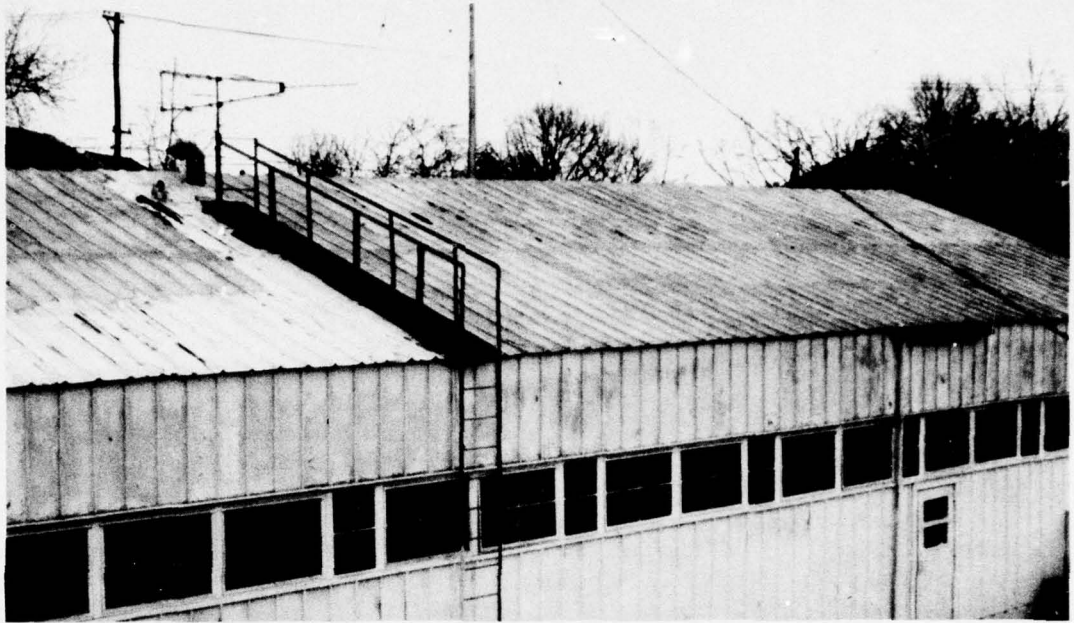
Figure 1. North Building Showing Accumulation of Old Coatings, Before Reroofing

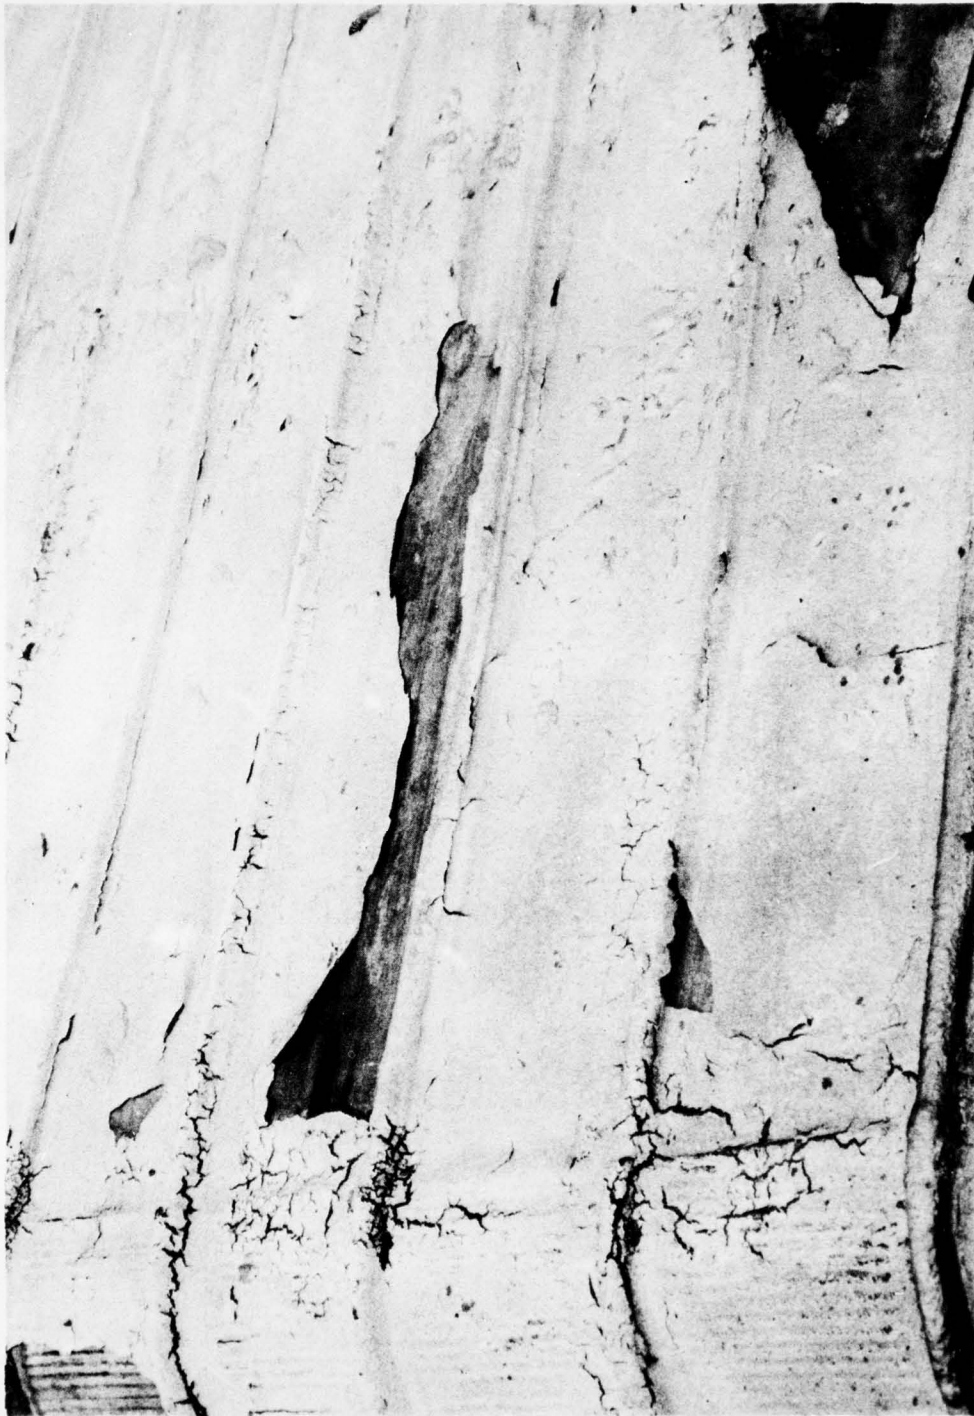
Figure 4. Roof Ridge Showing Cracked and Flaked Coatings, Before Reroofing

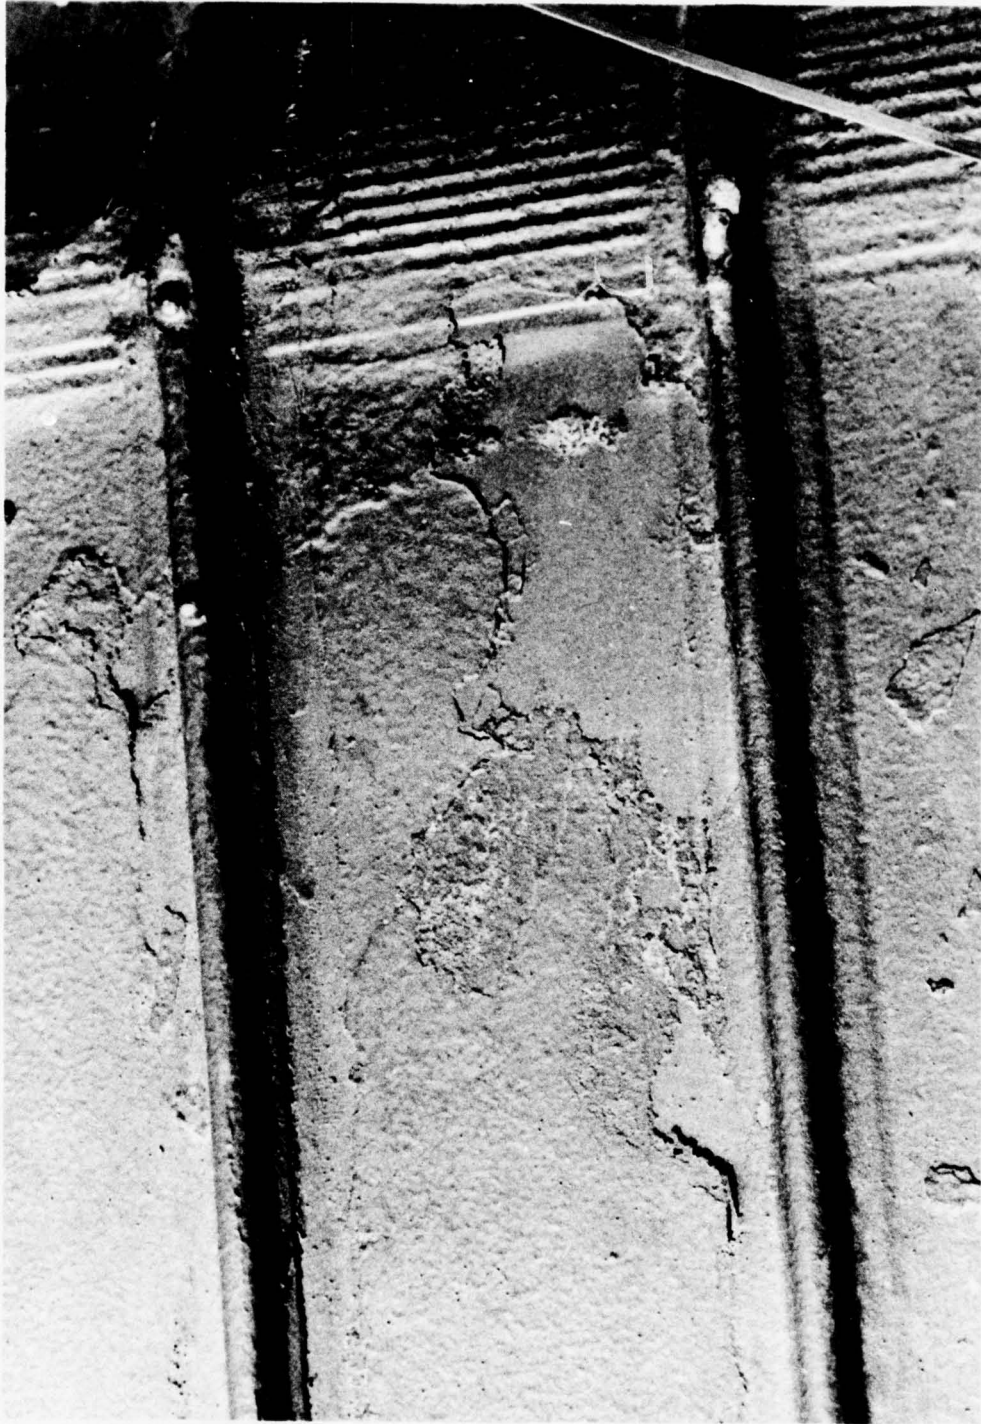
Figure 7. Loose Coating Caused By Asphalt Primer Solvent

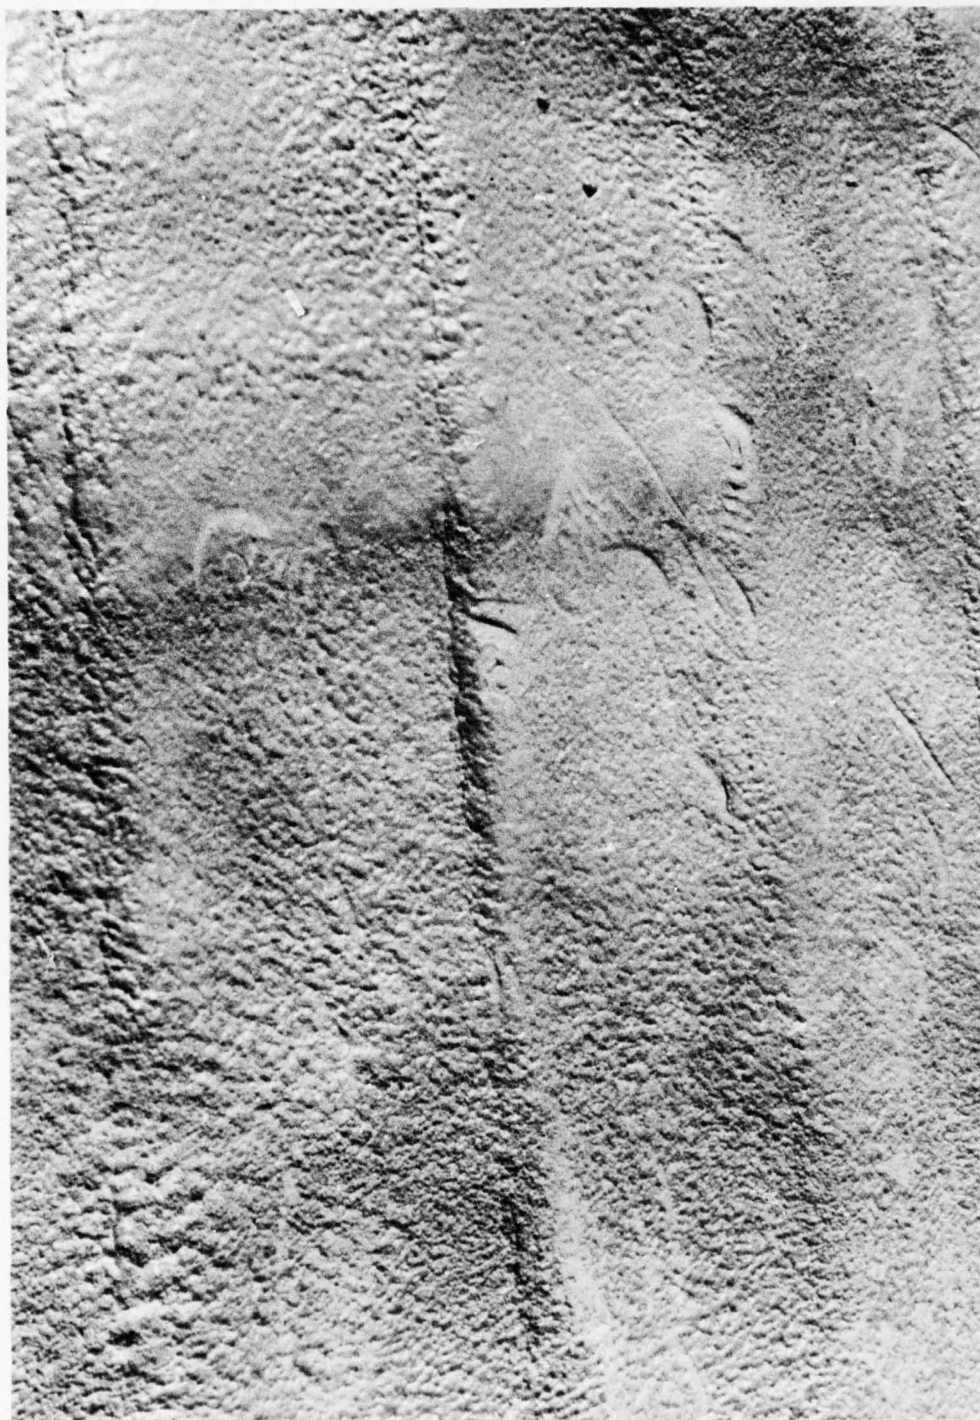
is shown in Figure 10. Note in Figure 11 footprint indentations in the foam surface made by foam applicators wearing basketball-type shoes.

Figure 11. Close-up of Typical Foam Surface

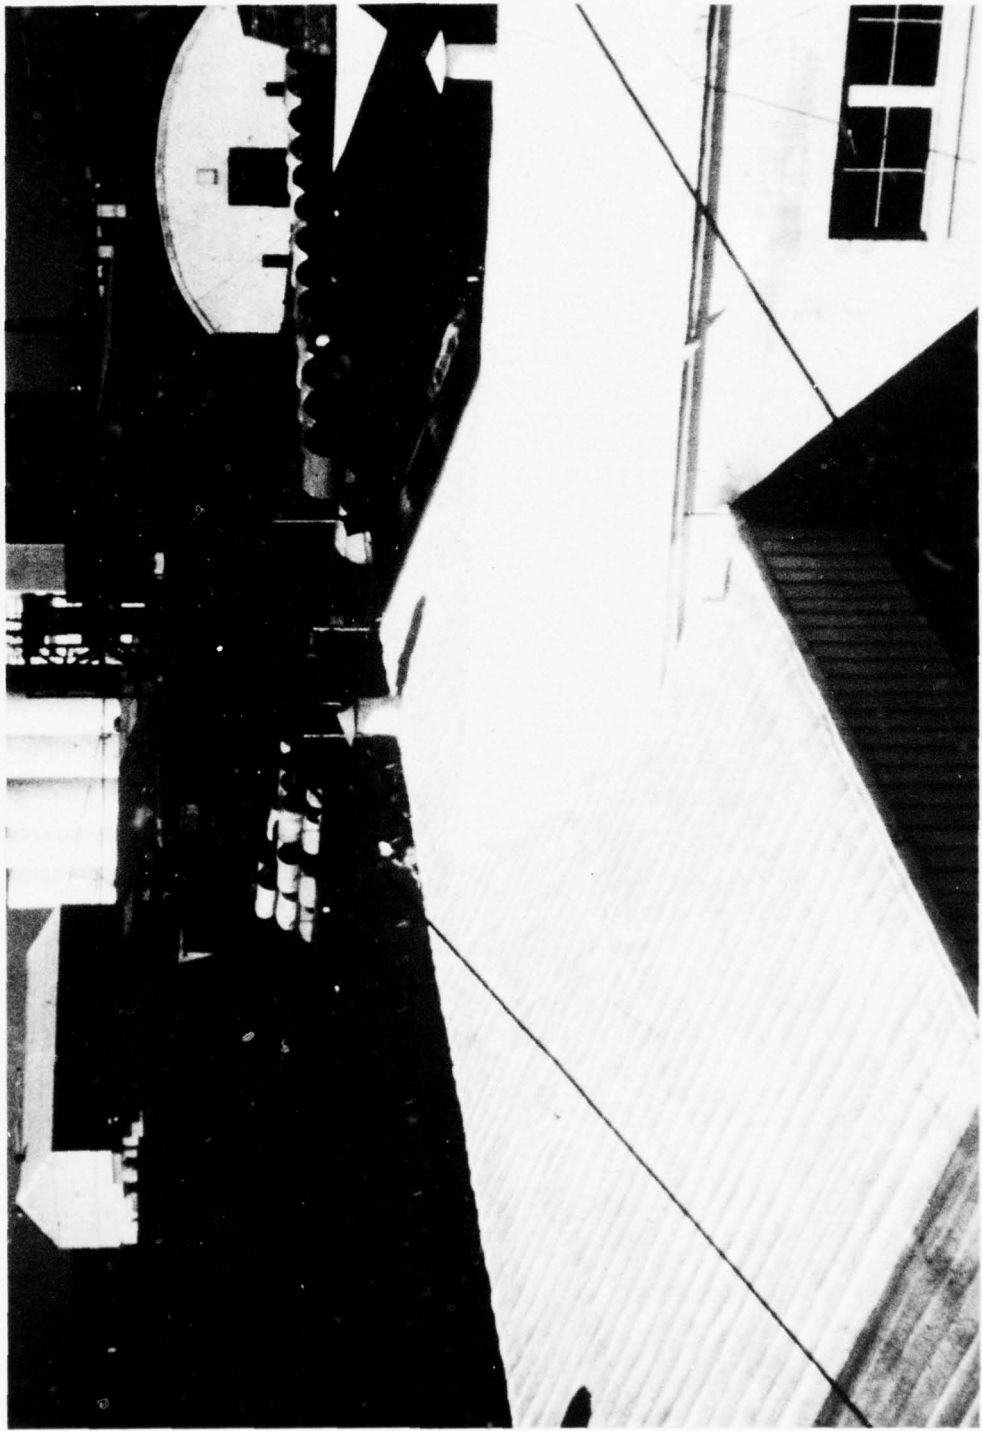
Figure 22. East Side of Junction of Boiler House and South Building

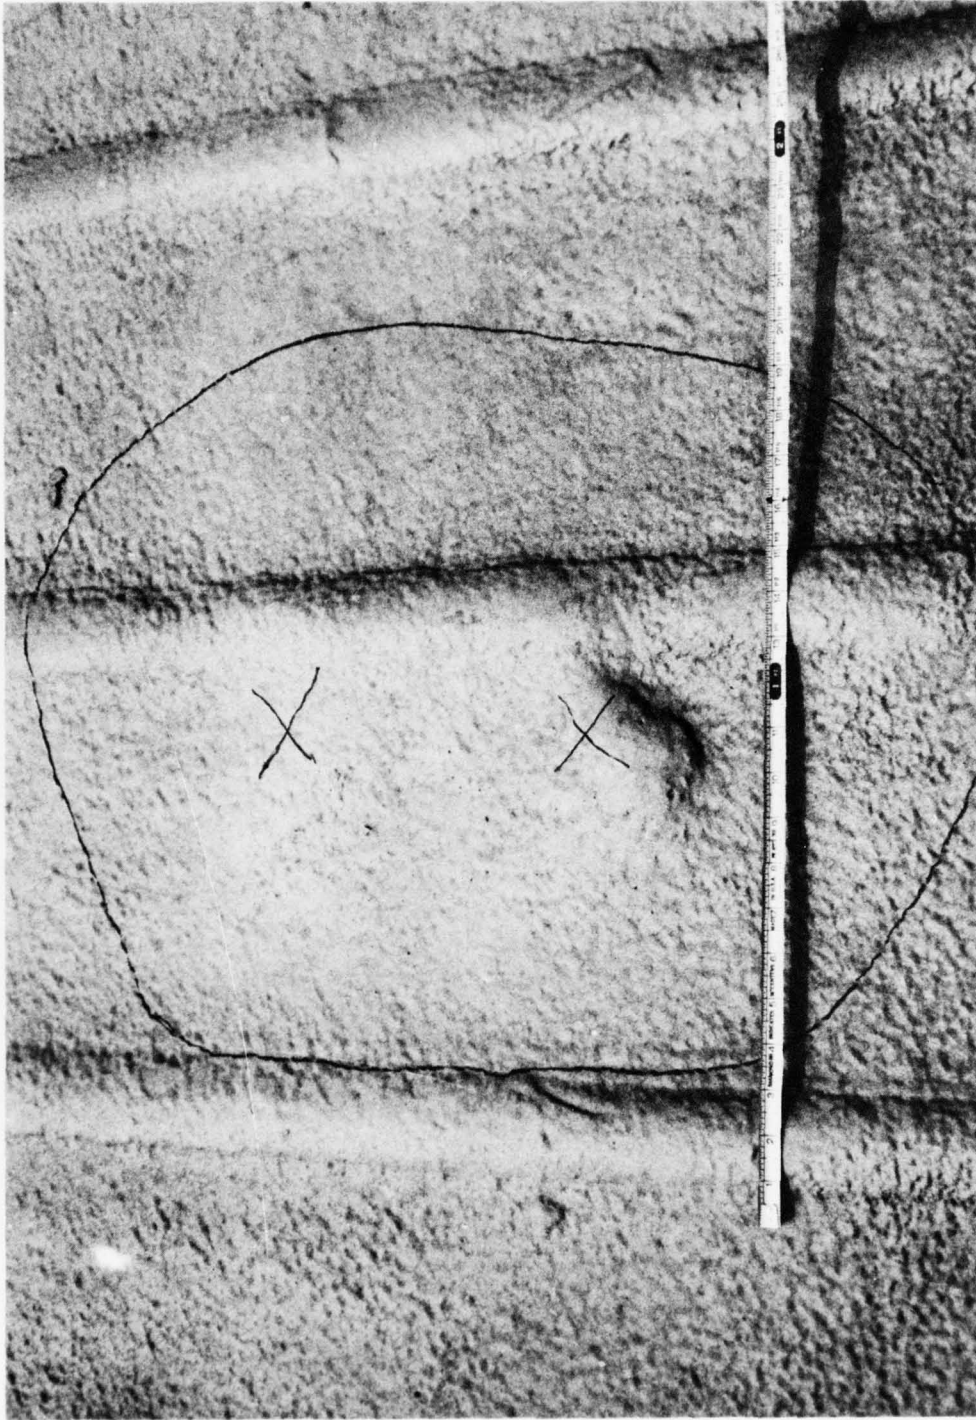
Figure 23. Soft, Spongy Area on North Side of System 1 (Without Granules) After 9 Months Weathering

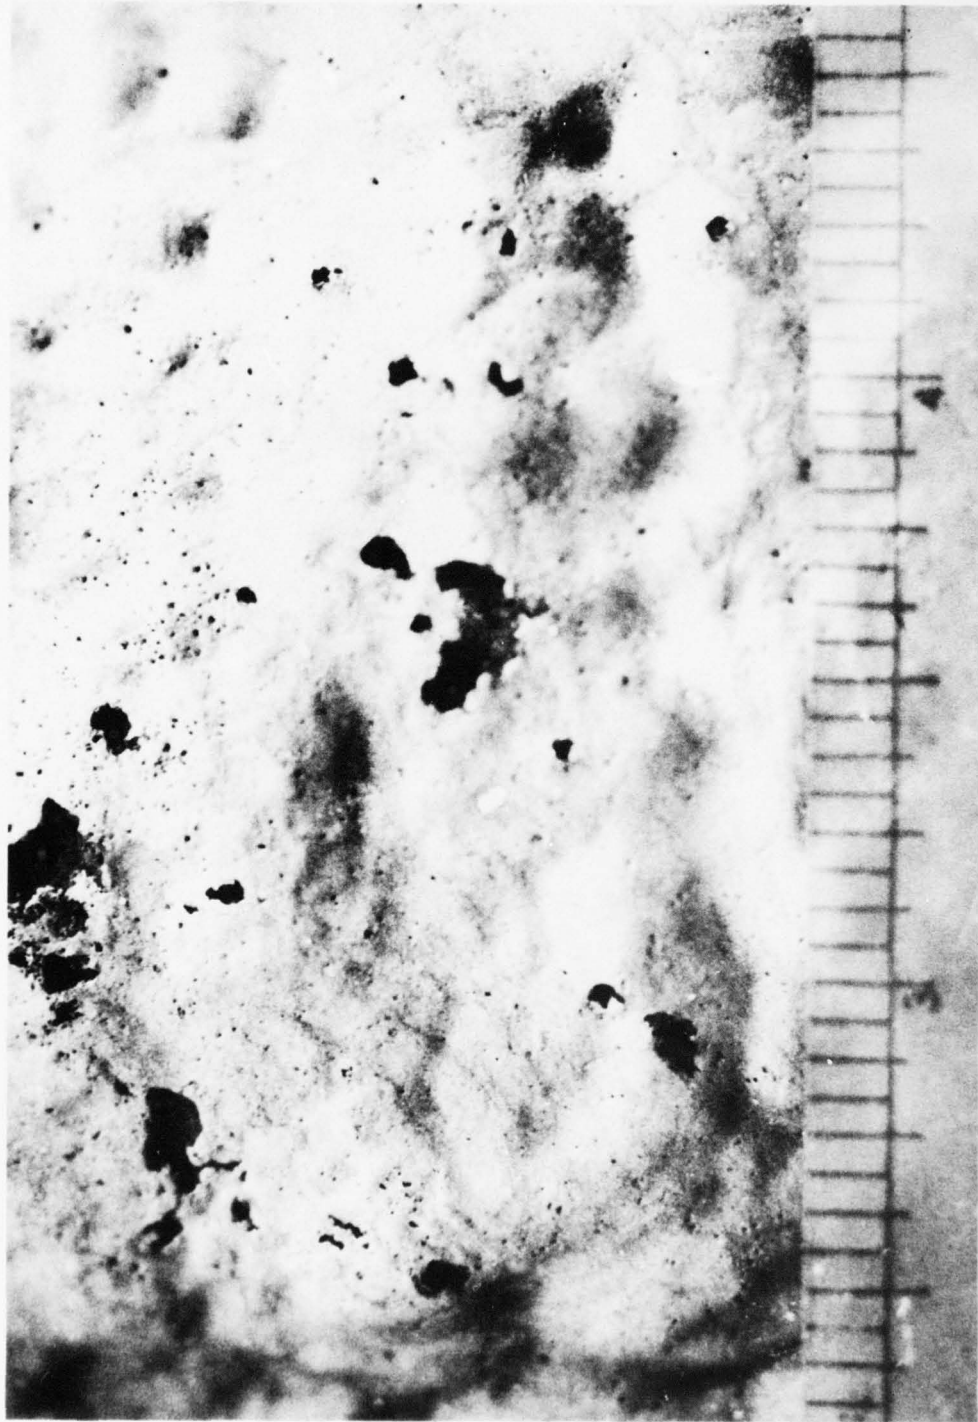
Figure 24. Deteriorating Catalyzed Silicone Rubber Coating Over Replaced Foam 12 Months After Application

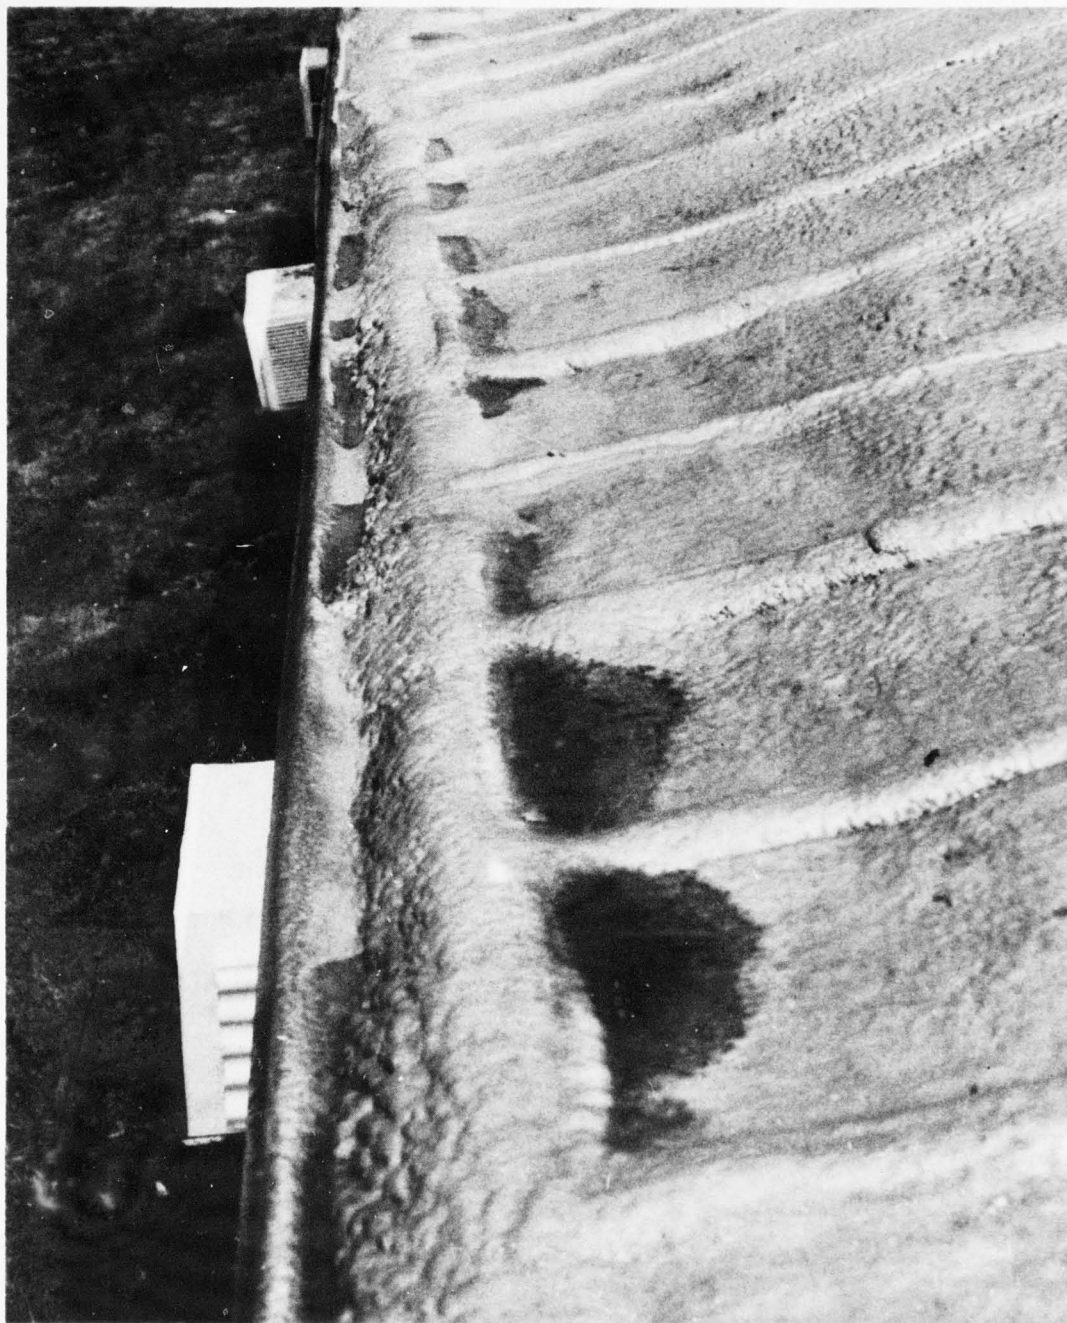
Figure 25. Ponded Water Along Gravel Stop in the System 1 Section

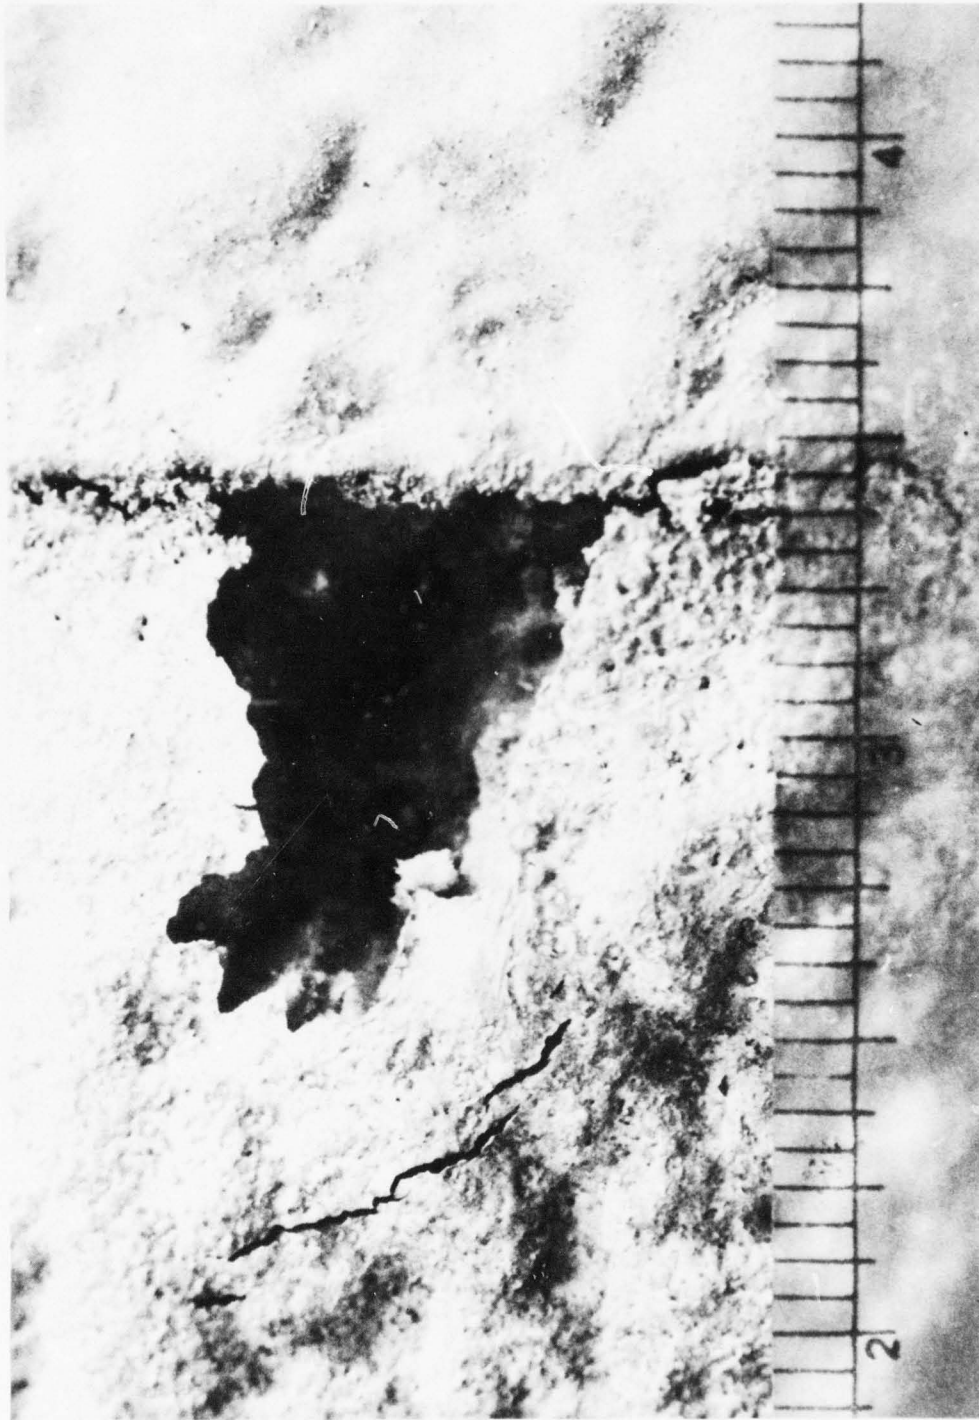
Figure 26. Close-up of Small Area Showing Bird Pecking in System 1 Section After 22 Months of Weathering

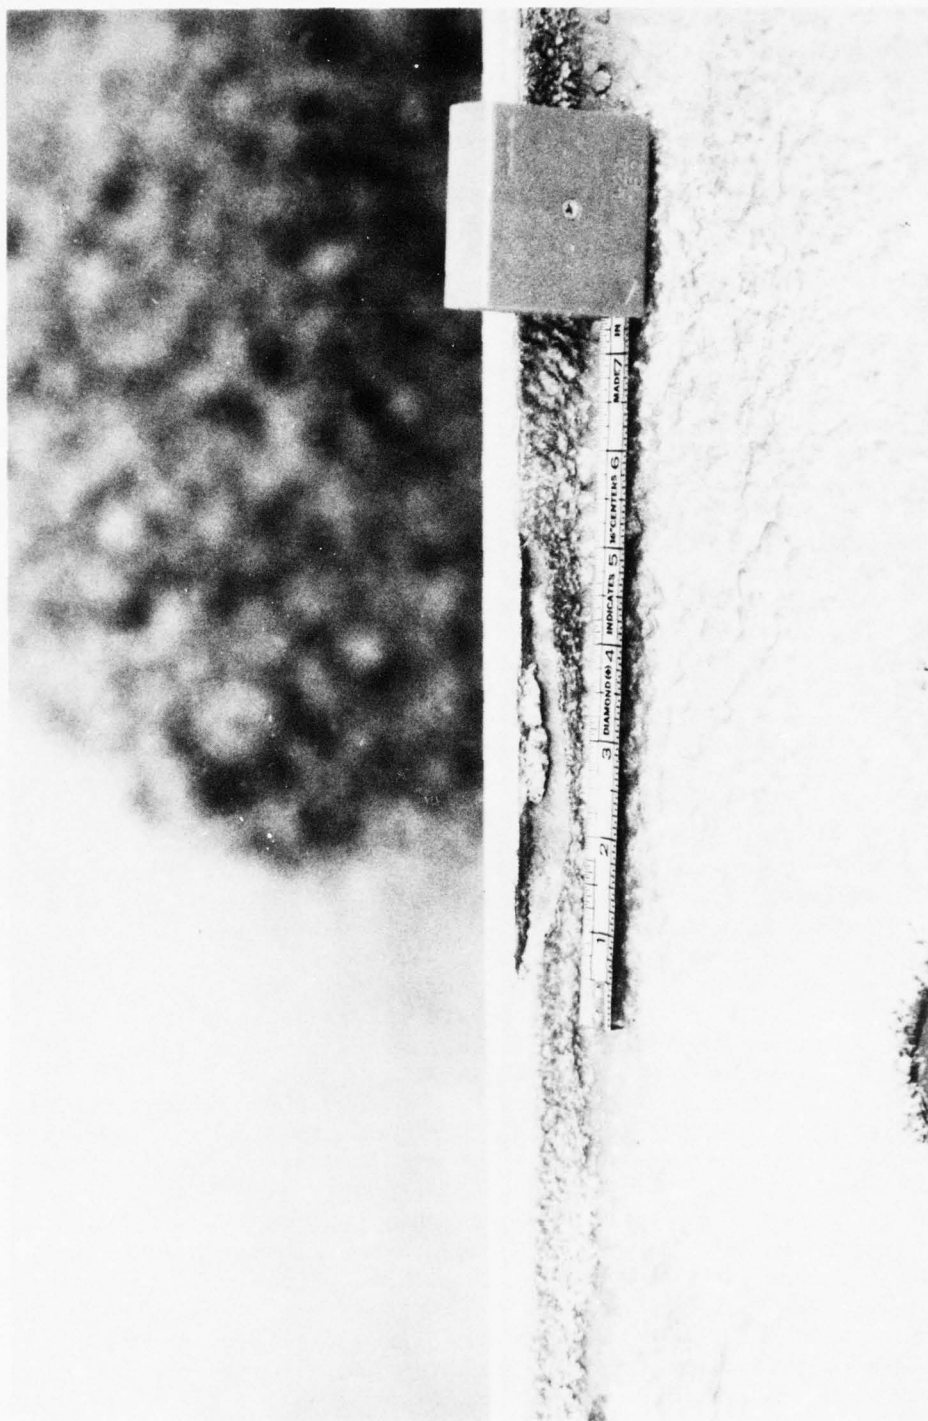
Figure 27. Damaged Areas in System 2 Section Caused by Sliding Snow and Ice

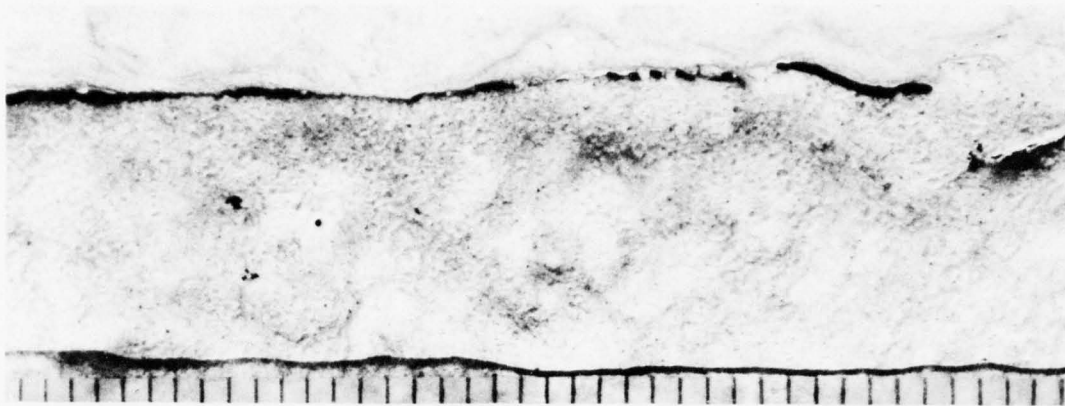
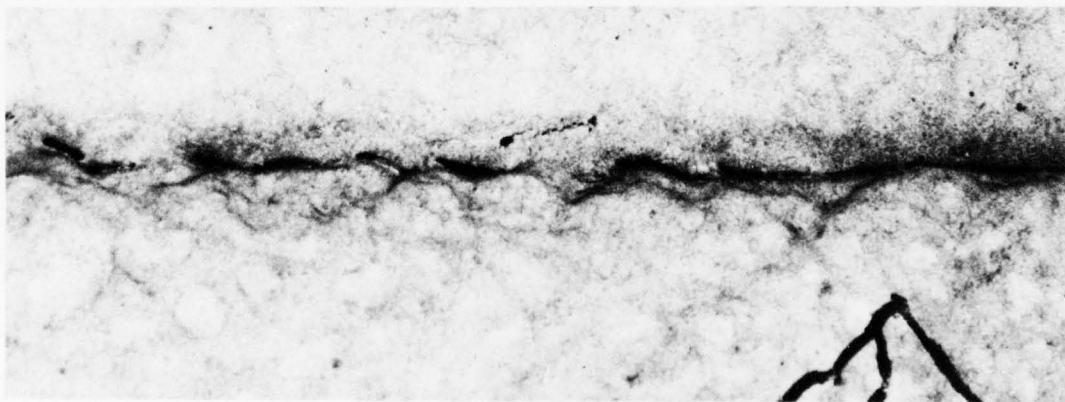
Figure 28. Cracking of Moisture-Curing Silicone Rubber Coating in a Depression Along a Rib; Note Cracking Has Not Progressed.

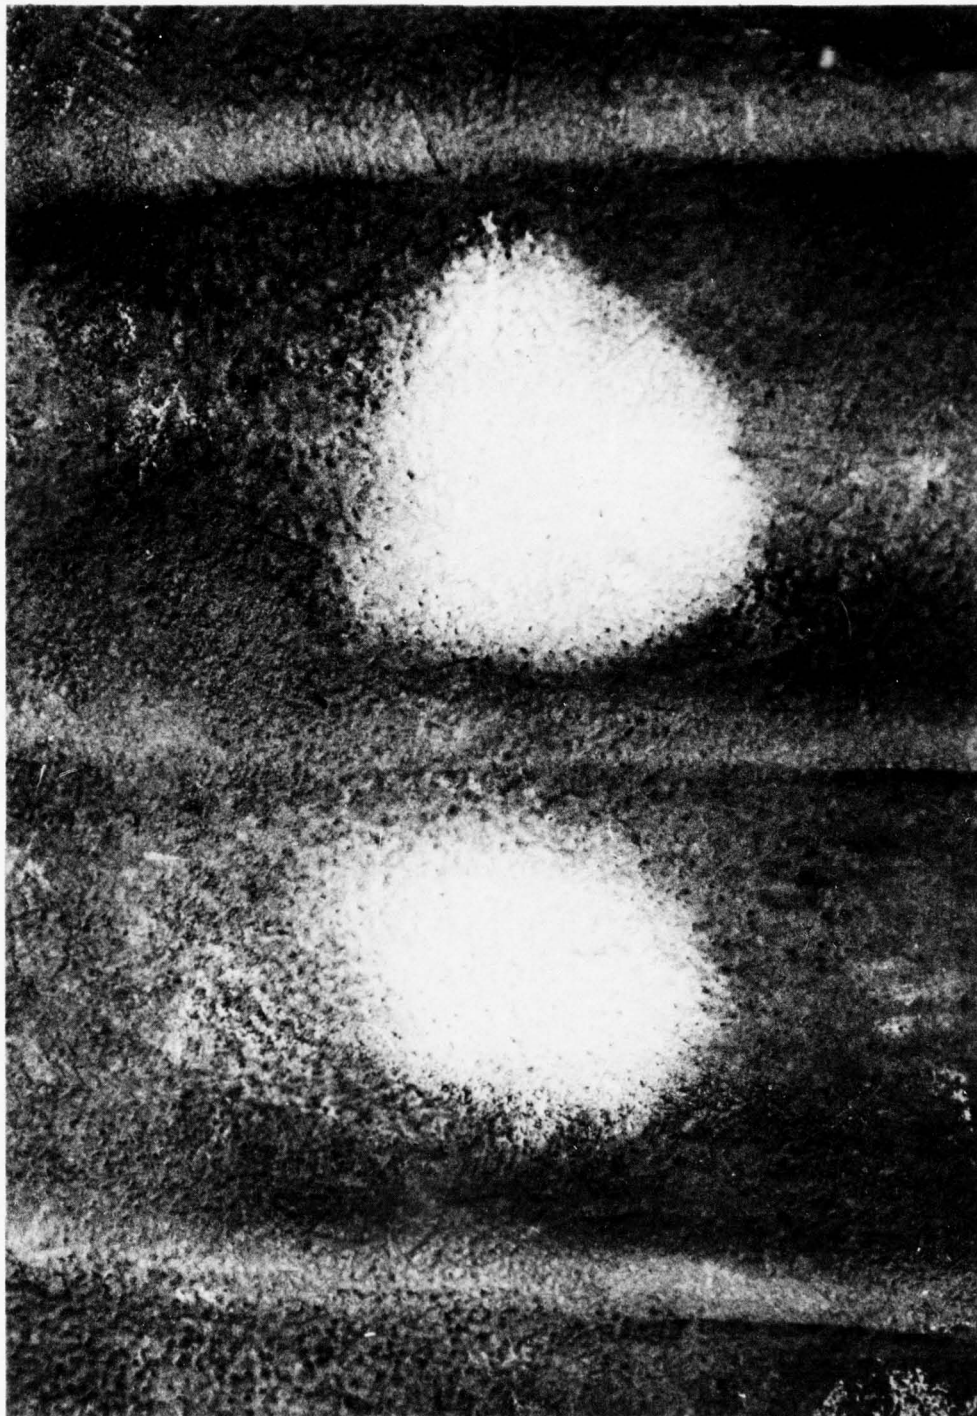
Figure 29. Two Cleaned Spots in System 2 Coating That Show Extent of Dirt Retention  
by Moisture-Curing Silicone Rubber Coating

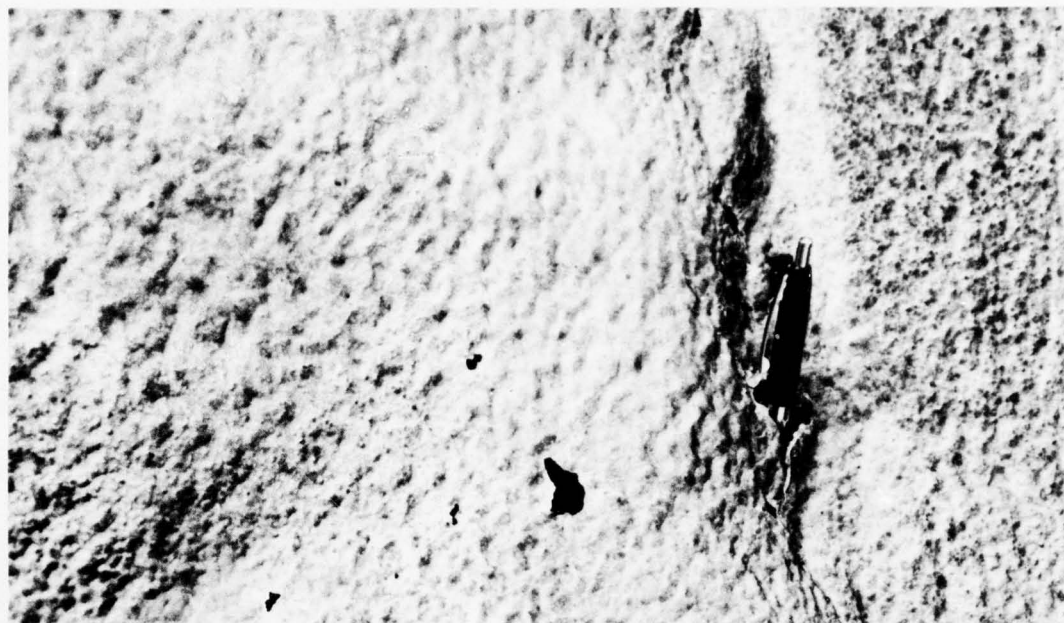
(a) Small Holes in Coating (Note Pen Protruding From Coating).

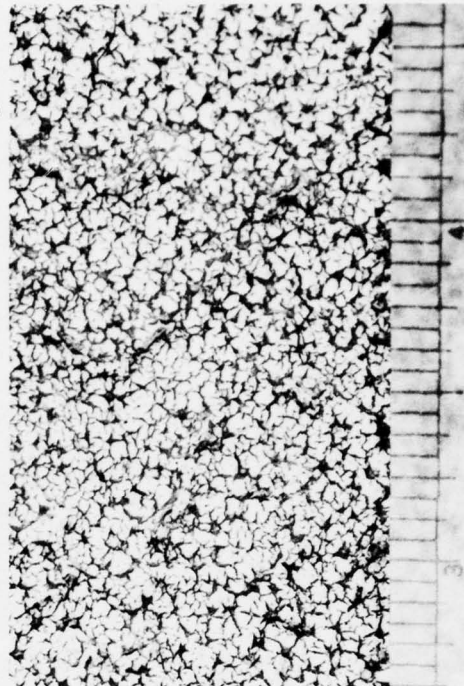
(b) After 9 Months of Weathering

Figure 31. Progressive Degradation of Catalyzed Butyl-Hypalon (System 3)

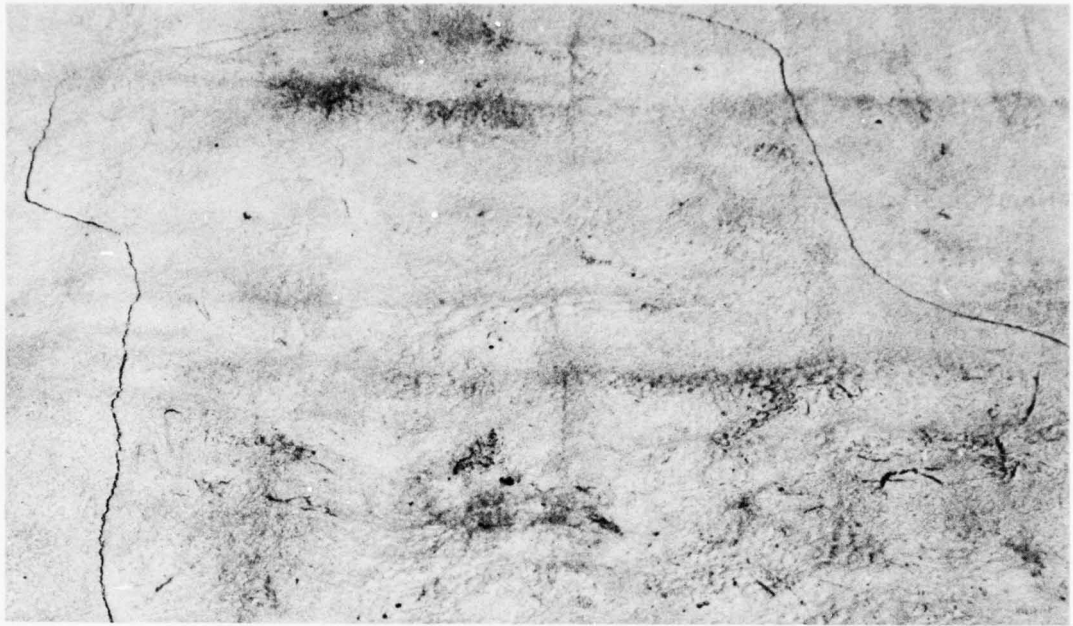
This system also had the largest areas in the experimental roof systems with poor quality foam. These are shown in Figure 32 and Figure 33. Figure 32 shows an area of about 10 square feet of spongy foam, while Figure 33 shows a relatively small area with blistered foam just below the area of spongy foam. In the latter case, the top lift of the foam had blistered from the lift underneath. These areas are believed to have been caused by improper proportioning of components of the foam during application. These areas have also been satisfactorily repaired by the contractor, and their repair is described in a following section.

Figure 32. Area of Spongy Foam on North Side of System 3 Section After 9 Months of Weathering

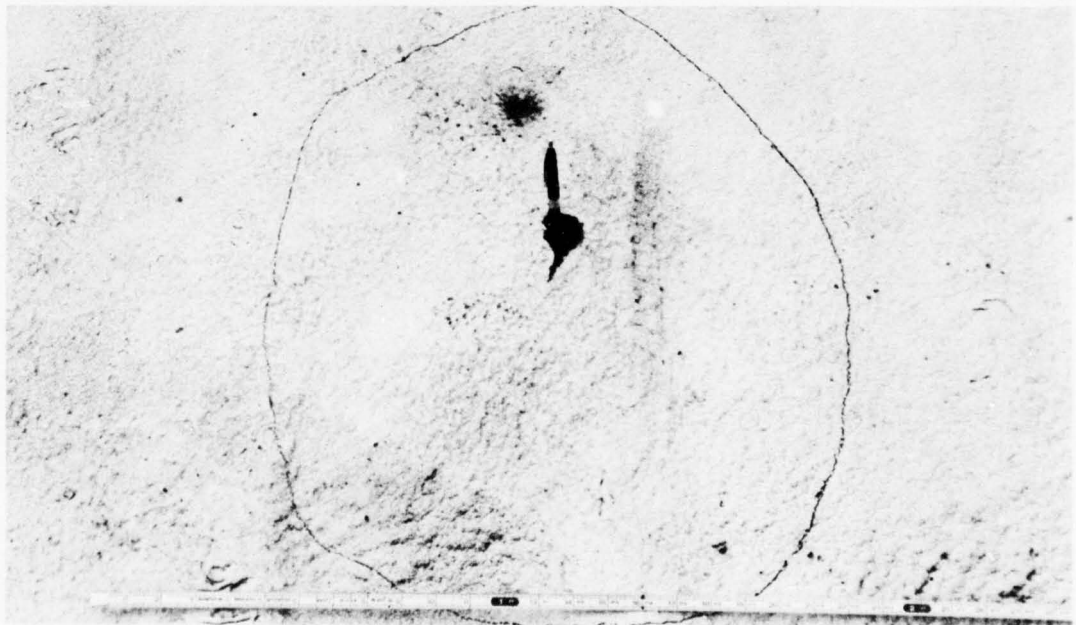
Figure 33. Area of Blistered Foam on North Side of System 3 Section After 9 Months of Weathering

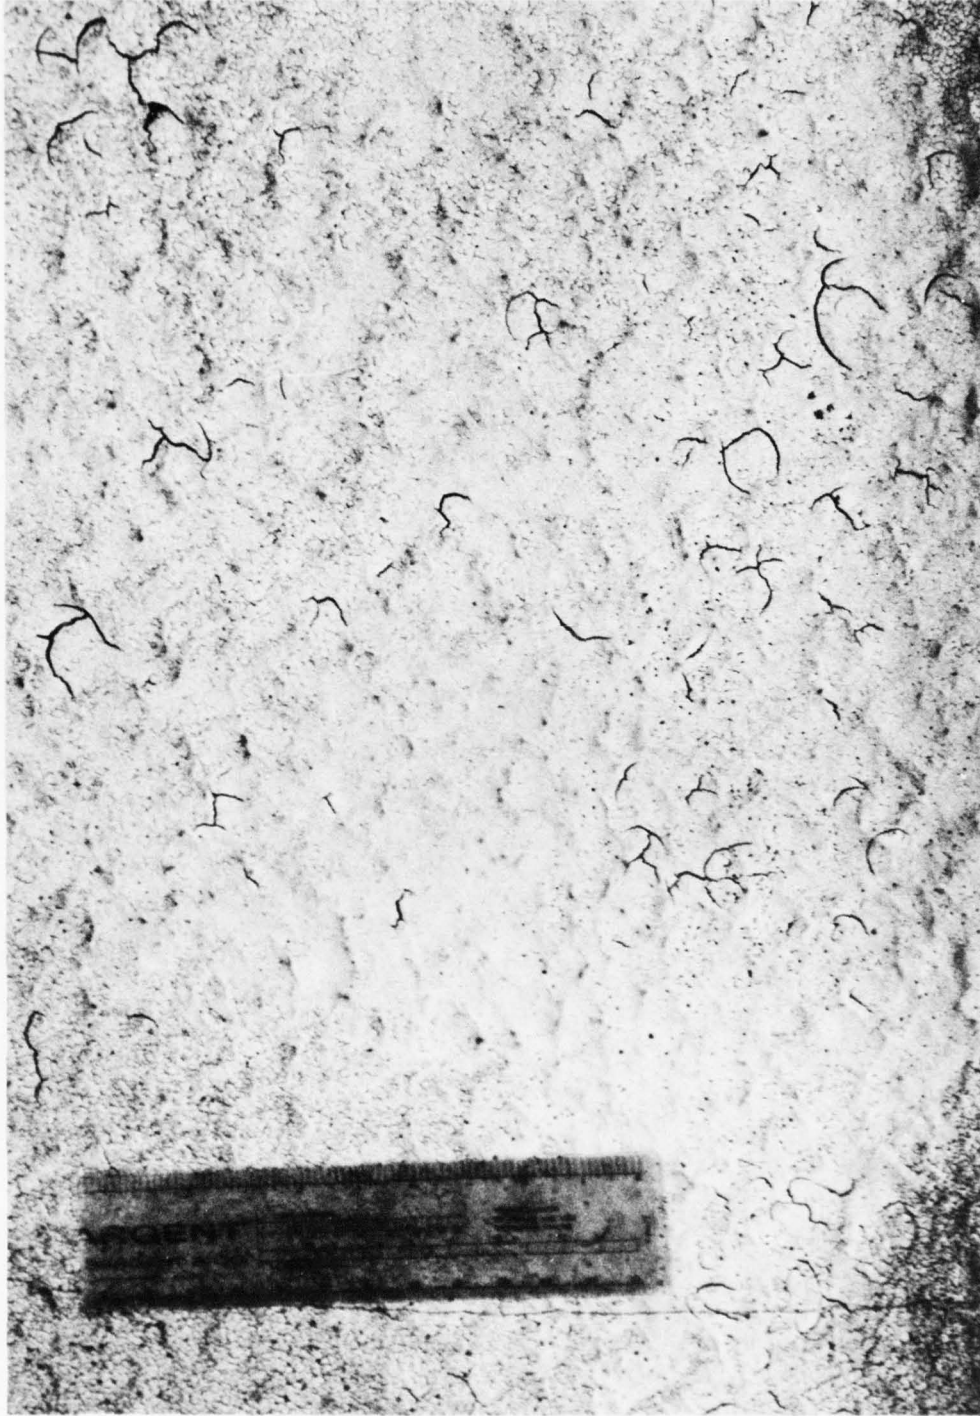
Just before the 22-month inspection, the Clifton area had a severe hailstorm. The hailstones were unofficially described as being as large as golf balls. Interestingly enough, damage was limited to the South Building, Systems 3, 4, and 5; there was no evidence of hailstone damage to the silicone coatings, Systems 1 and 2. Damage in the System 3 section was almost as great as the damage in the System 4 section. Hailstone damage generally results in semicircular to circular breaks in the coating (Figure 35).

Figure 35. Hail Damage in System 3 Section

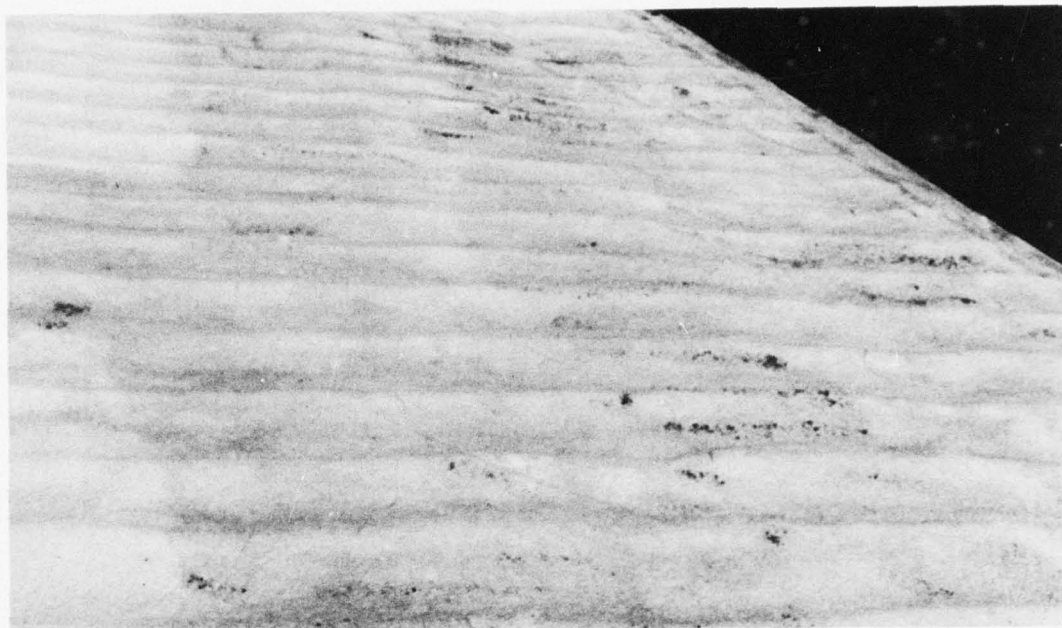
Figure 36. Area of Hypalon Mastic (System 4) Showing Greatest Erosion Damage After 22 Months of Weathering

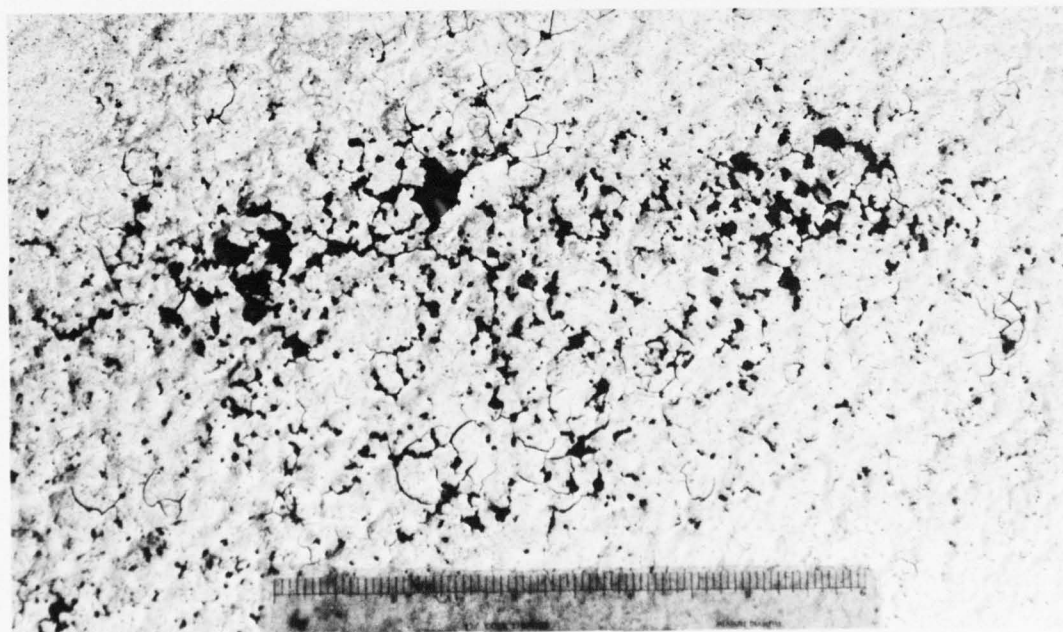
Figure 37. Close-up of Badly Eroded Portion of Hypalon Mastic, (System 4) After 22 Months of Weathering

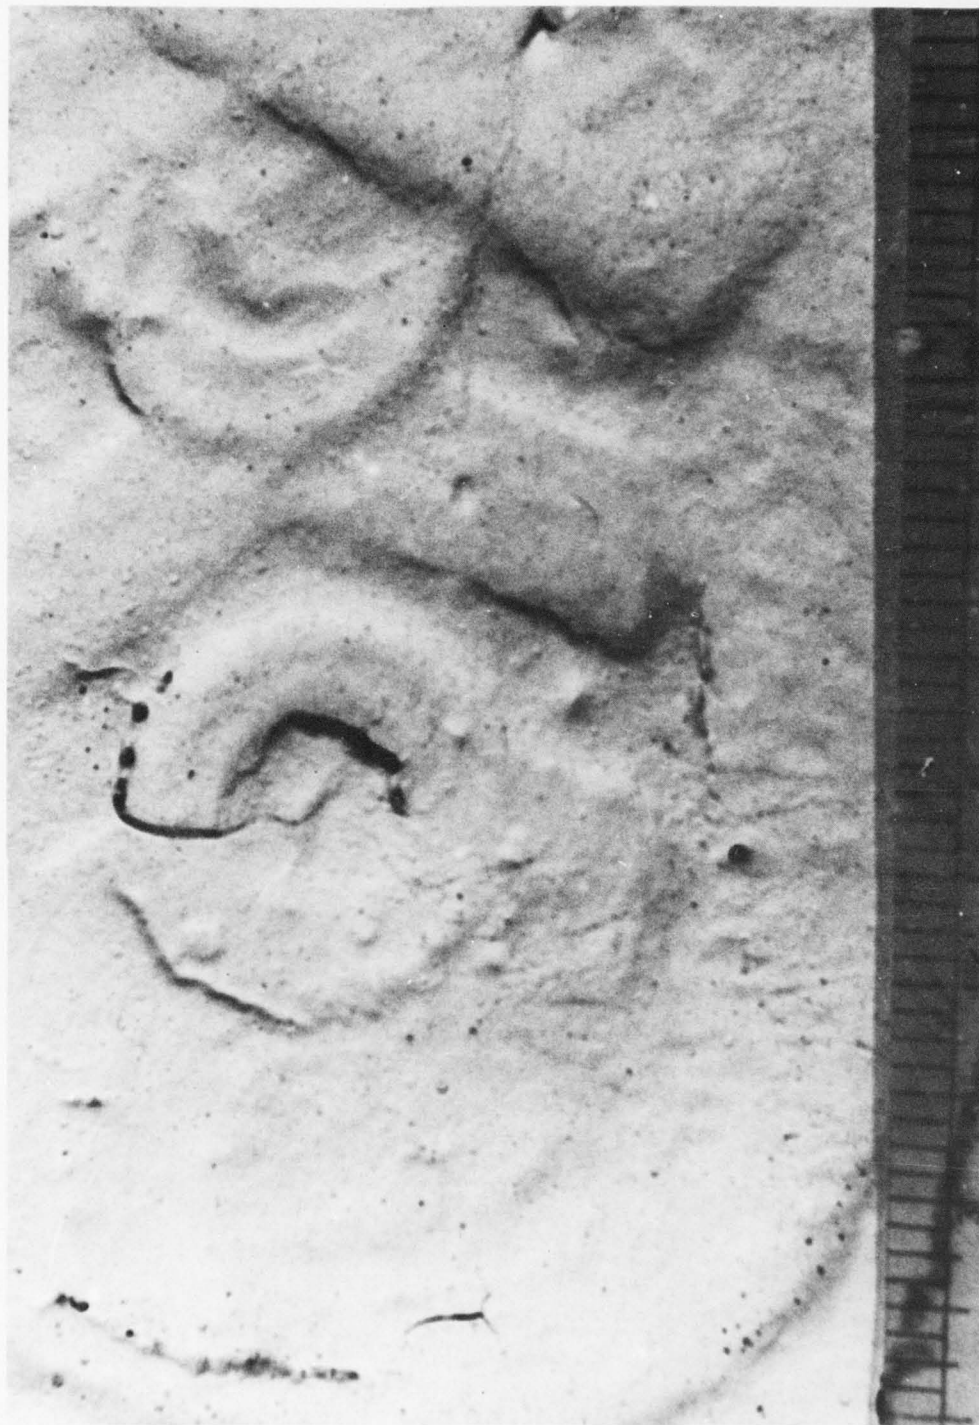
Figure 38. Cracking of Hypalon Mastic (System 4) in Heelprint After 22 Months of Weathering
