Technical Note N-1450

EXPERIMENTAL POLYURETHANE FOAM ROOFING SYSTEMS

August 1976

CIVIL ENGINEERING LABORATORY  
Naval Construction Battalion Center  
Port Hueneme, California 93043

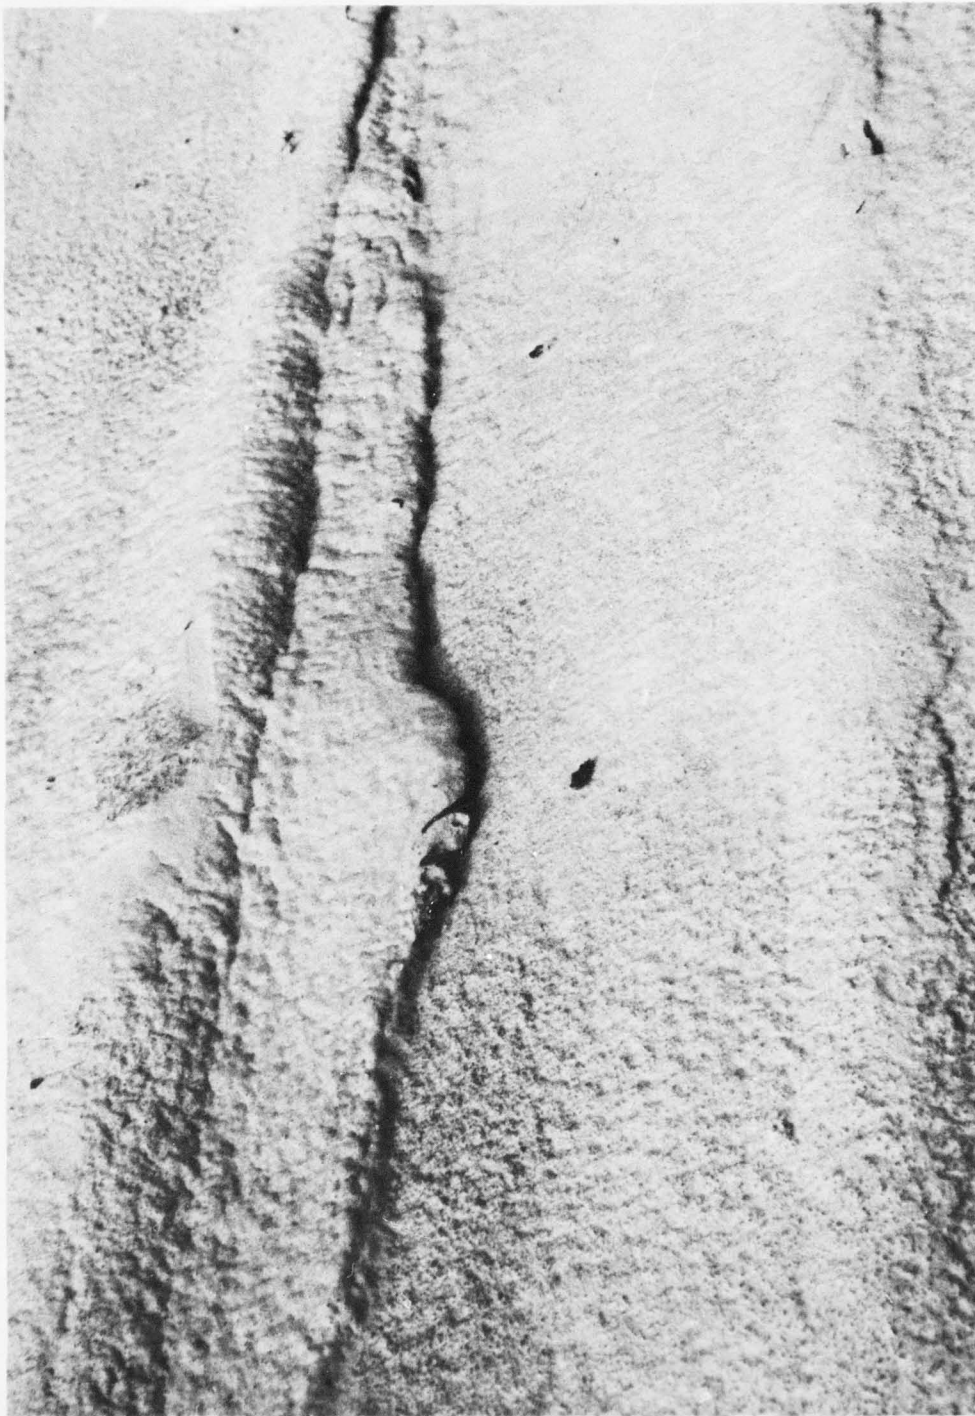
Figure 39. Poorly Constructed Overlap Joint Between System 3 Section and System 4 Section

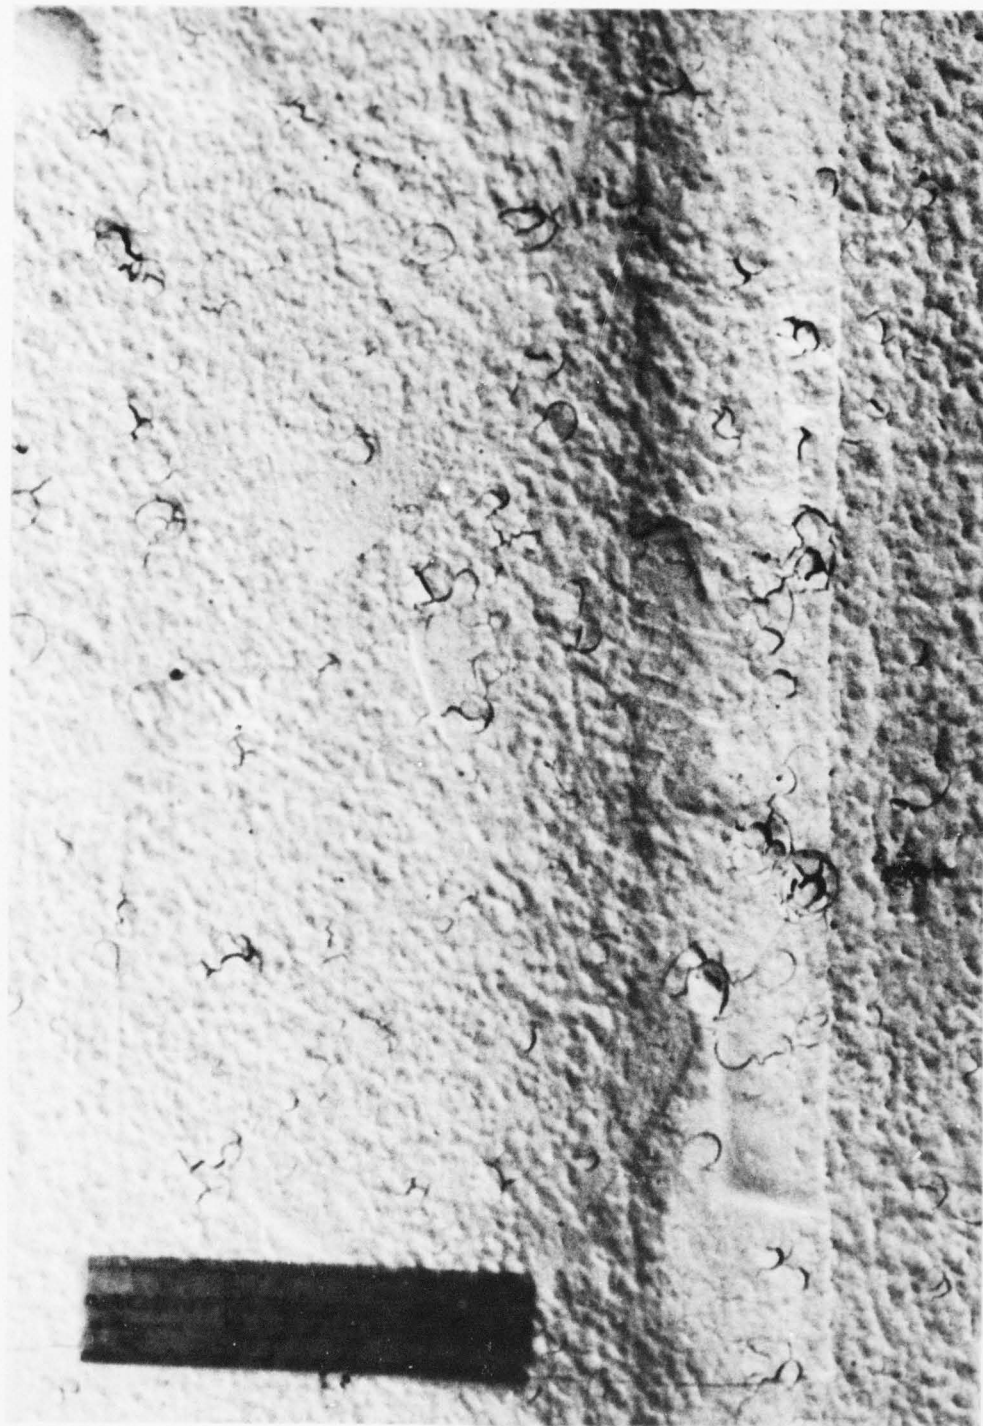
Until the hailstorm mentioned above, this coating system was considered to be performing very well. Damage by hailstones was less on this than on either of the other two systems that were affected. Typical damage is shown in Figure 40. Prior to this storm, weathering of this system consisted of very light flaking in scattered areas of the roof and pinholes in the coatings (Figure 41). These pinholes are characteristic of high-solvent butyl coatings, although in this case, the pinholes have not led to early failure of the system.

Figure 40. Hailstone Damage to Catalyzed Butyl-Hypalon (System 5) After 22 Months of Weathering

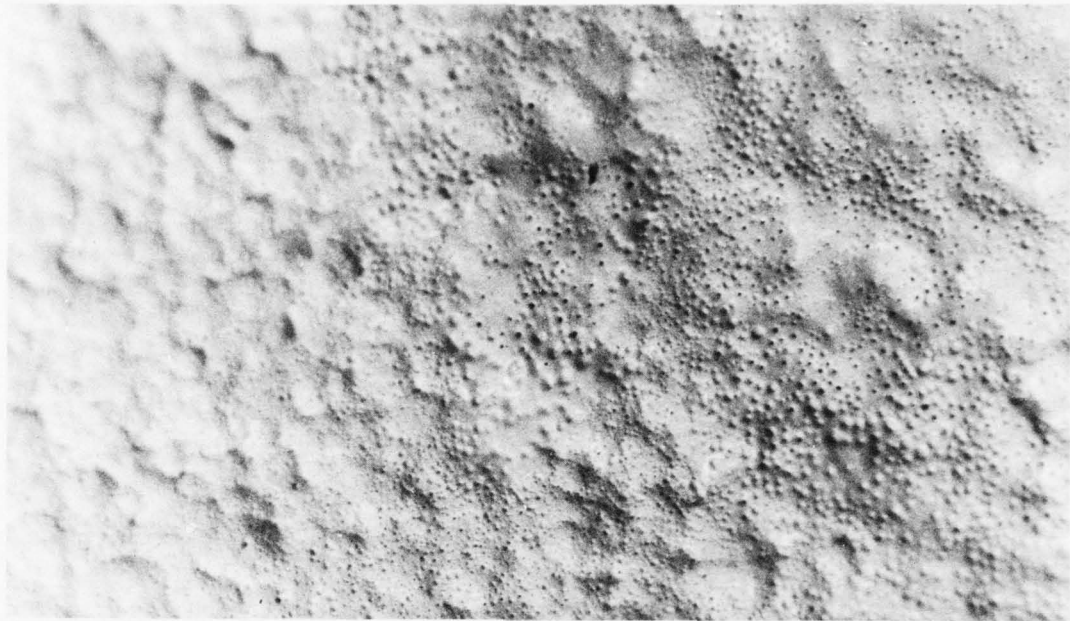
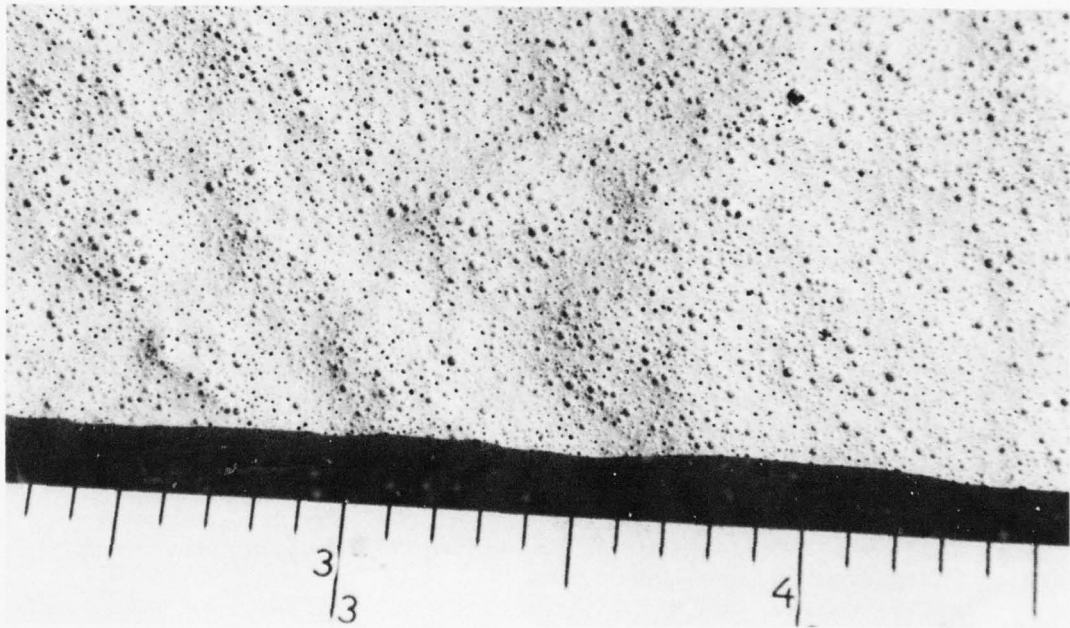
Figure 41. Pinholes in Catalyzed Butyl-Hypalon (System 5)

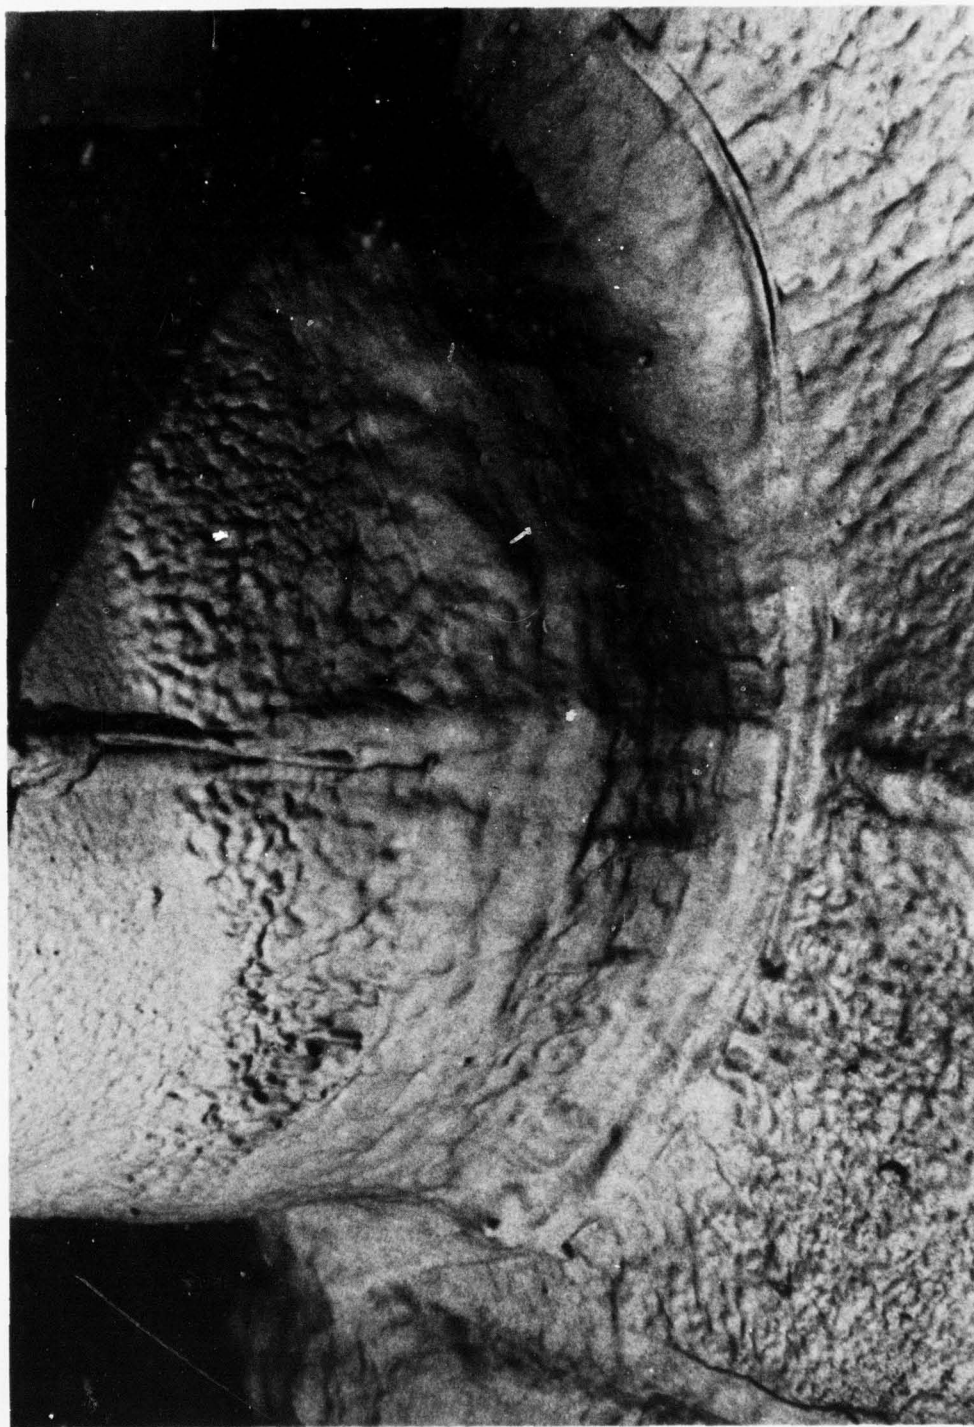
Figure 42. Fabric-reinforced Vent Flashing in System 2 Section, Performing Well After 18 Months of Weathering
