DETERMINATION OF THE AIRWORTHINESS OF ZPG-3W COTTON D-621  
AND THE ZPG-2 DACRON GDC-5 AIRSHIP ENVELOPES

Eleanor Th. Vadala  
Air Vehicle Technology Department  
NAVAL AIR DEVELOPMENT CENTER  
Warminster, Pennsylvania 18974

31 JANUARY 1977

FINAL REPORT

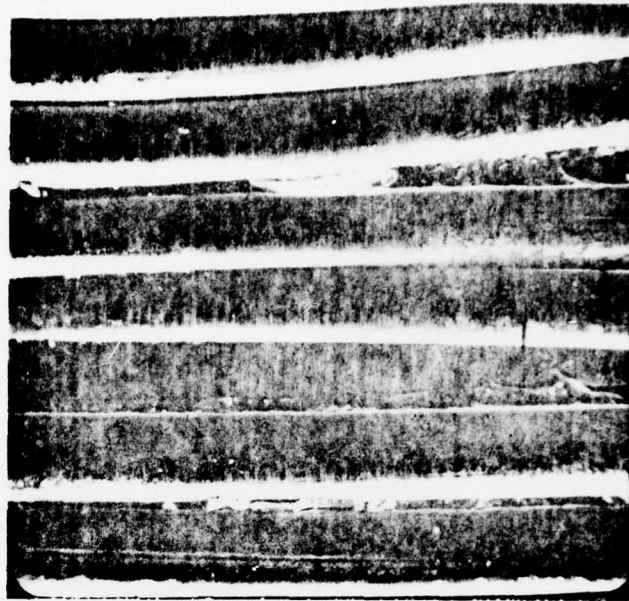
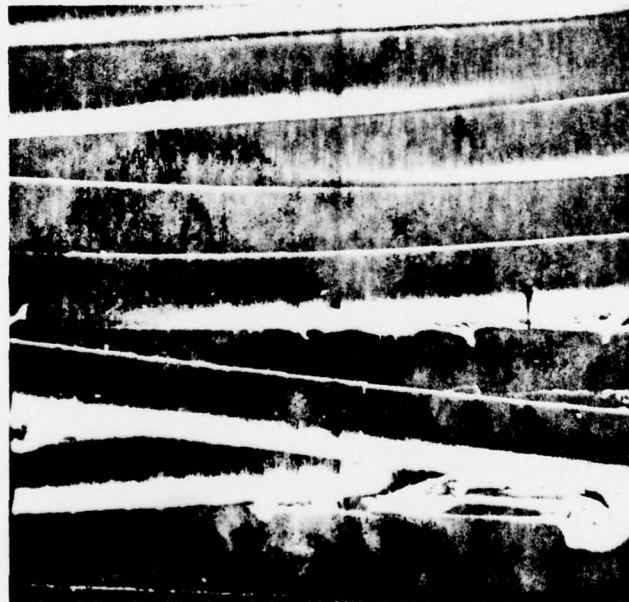
Figure 2. Photomicrographs of Specimens from the ZPG-2  
Dacron Envelope GDC-5, (552X)

An electron microscopy examination was made by the Range Measurement Laboratory. The photomicrographs, Figure 2, show that the neoprene pulled off the polyester monofilaments of the better ply adhesion test specimens with difficulty, leaving pull marks (irregular mottled spots). These pulled marks are raised deformations caused by tension. No such pull marks appear on the monofilaments of test specimens with low ply adhesion.

The Range Measurement Laboratory, reference (h), hypothesized that the poor adhesion was caused by hydrolytic deterioration of the surface of the polyester yarns monofilaments. The electron photomicrographs do not verify that the weak adhesion of the neoprene interply is the result of such hydrolytic decomposition. The photomicrographs, however, do show that the neoprene pulled off the areas of good ply adhesion with difficulty leaving "pull marks" evidenced by the irregular mottled spots. Tension between the plies probably caused these deformations. In contrast, the specimens with poor ply adhesion did not show any "pull marks" but the surface of the polyester monofilaments were smooth.

Specimen from Sample Disc with Good Ply Adhesion

Specimen from Samples Disc with Low Ply Adhesion

It was recommended by the inspection team that the areas of the ZPG-2 Dacron envelope GDC-5 exhibiting low ply adhesion be reinforced or replaced. The exact method of repair should be determined prior to actual commitment to use. The loading conditions and stresses should not exceed design values.
