**CRITICAL DESIGN REVIEW  
UH-1N HELICOPTER RESCUE HOIST**

TECHNICAL REPORT ASD-TR-73-25

JULY 1973

AERONAUTICAL SYSTEMS DIVISION  
AIR FORCE SYSTEMS COMMAND  
WRIGHT-PATTERSON AIR FORCE BASE, OHIO

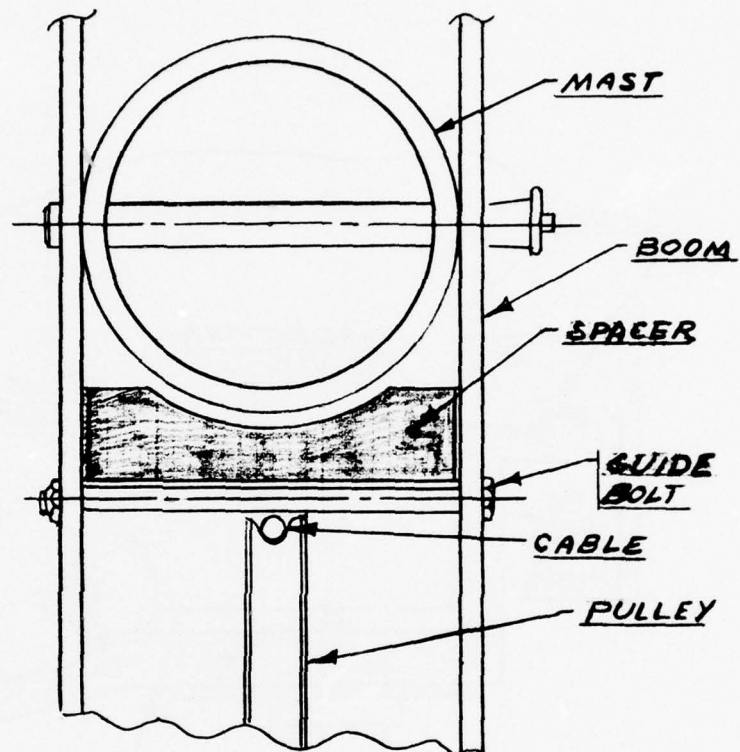
FIGURE 5

(2) Pulley - Although smaller than recommended by cable manufacturers for optimum cable life, the inboard boom pulley (Fig 1, item 28) is considered adequate in structure and cable interface. The adequacy is, however, dependent on cable replacement within prescribed intervals. With regard to installing a new cable on the hoist, there is a configuration in this area that has led to a misreeved and subsequently failed cable. The cable guide bolt (Fig 1, item 34) is located so that cable can be reeved over the bolt rather than properly between the bolt and pulley. The potential for misreeving could be greatly reduced by incorporating a spacer to block out the area between the bolt and the mast. The area in question and spacer configuration are schematically depicted in Fig 5.

SPACER TO PREVENT MISREEVING

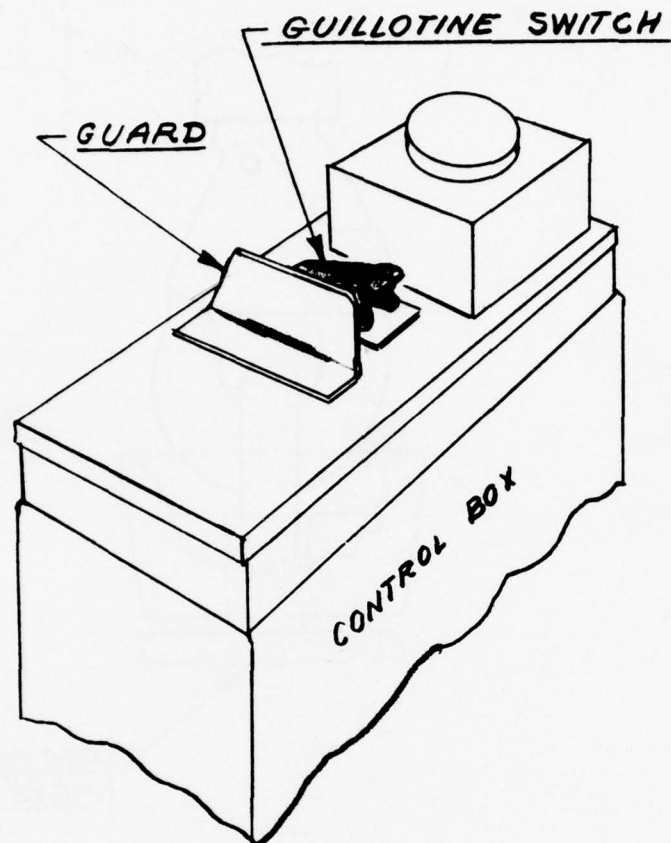
FIGURE 8

(4) Guillotine - The guillotine assembly proper (Fig 1, item 4) is considered adequate. There is, however, a potential problem in its activating switch located on the electric control box. The existing switch and safety cover actuate in the same direction of rotation. This means that a single motion, single direction, manual manipulation could expose and activate the switch. Such a configuration in the present location is susceptible to inadvertent actuation. Incorporating a switch guard (Fig 8) would greatly reduce this hazard.

GUILLLOTINE SWITCH GUARD

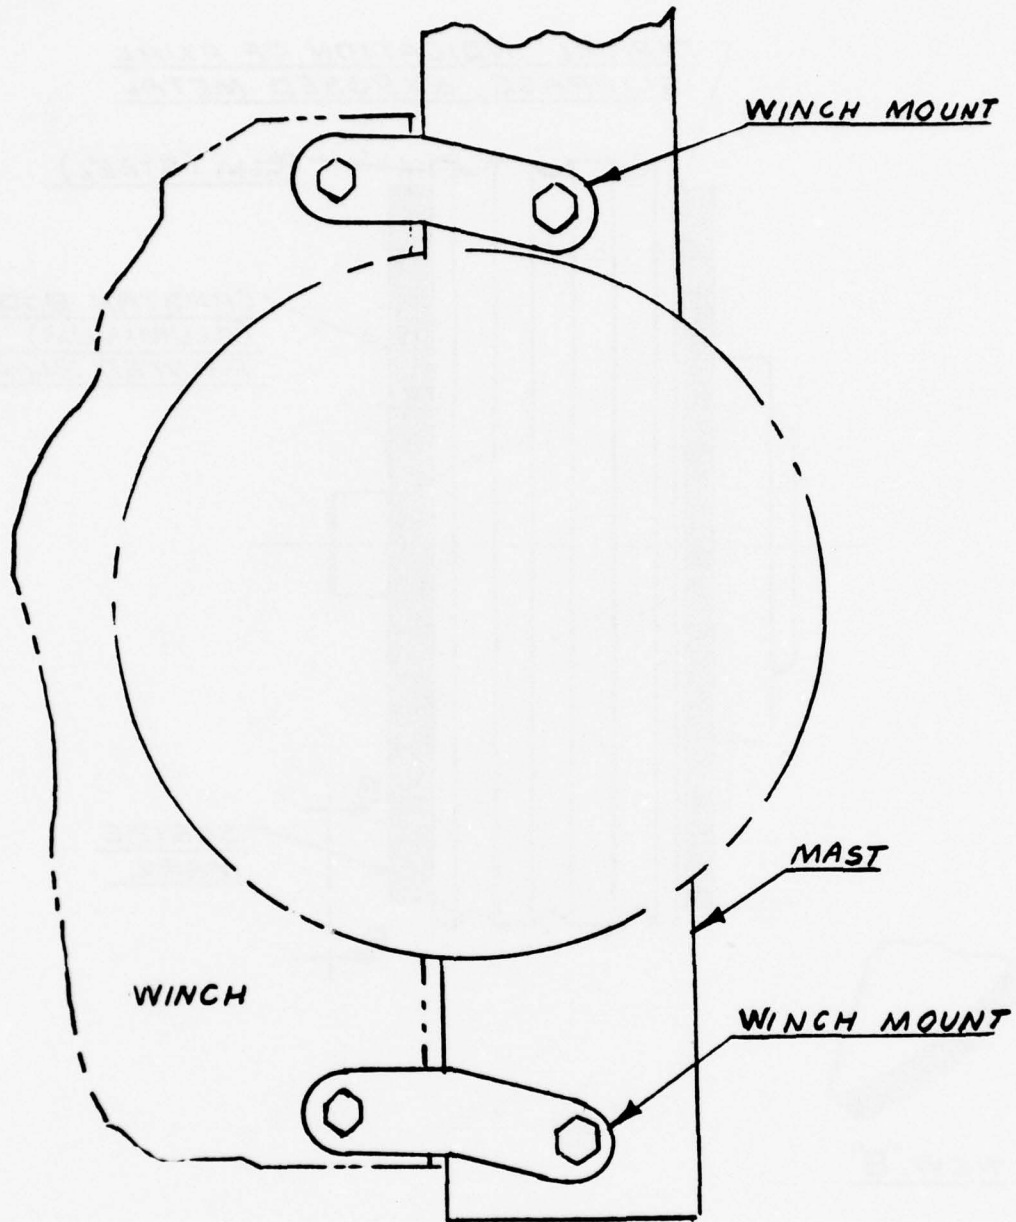
FIGURE 9

b. Winch Mounting - The winch manufacturer considers it a distinct possibility that secondary capstan fatigue failure may be caused by excessive displacement of one winch mount (Fig 9) with respect to the other, and that mast deflection would cause this displacement. With this in view, it is recommended that the contractor investigate the feasibility of incorporating a single "strong back" mount to reduce displacement.

EXISTING WINCH MOUNT  
CONFIGURATION

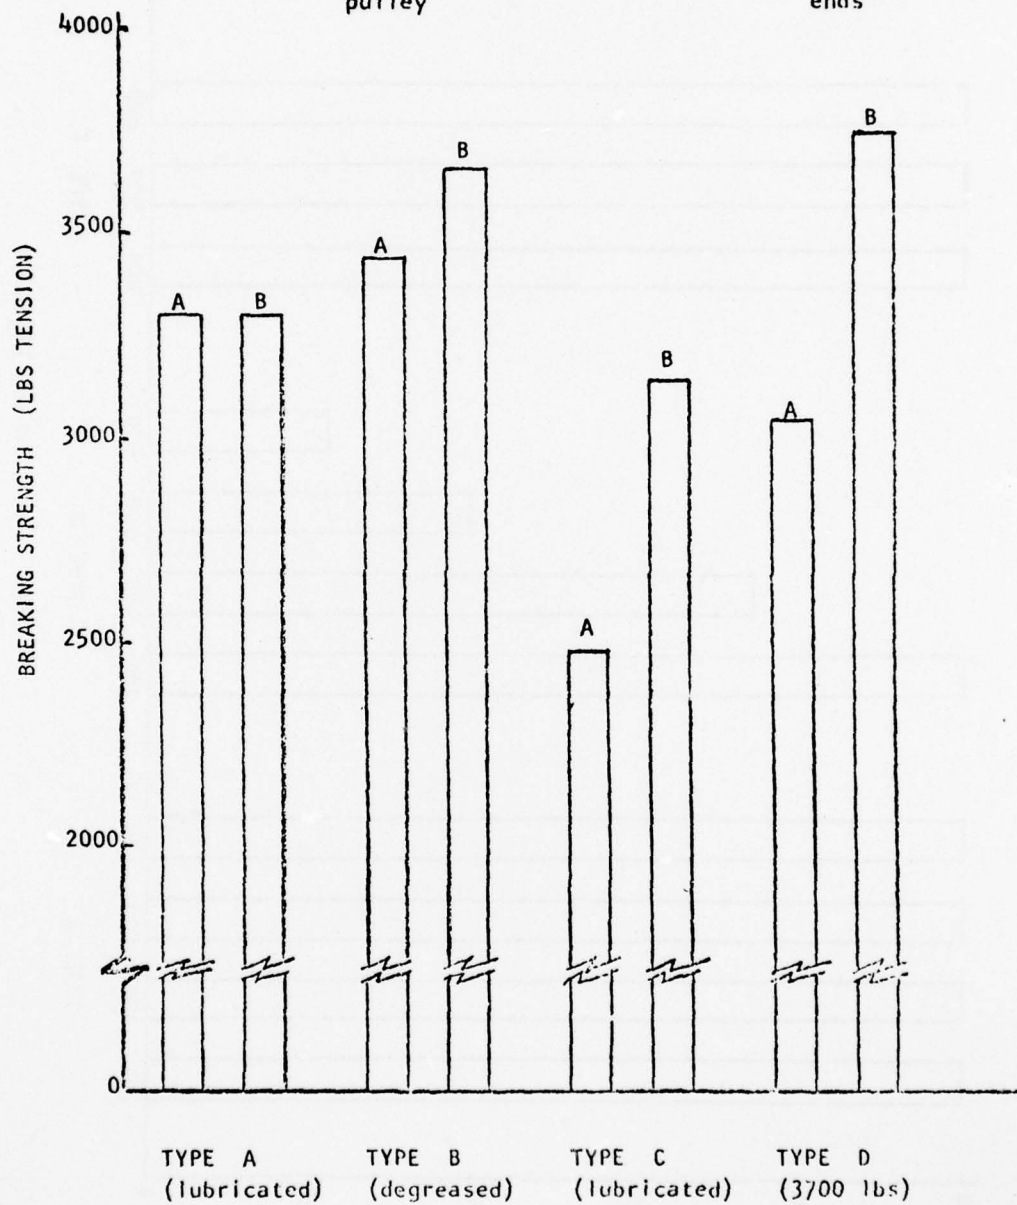
Figure 4 COMPARISON OF CABLE BREAKING TECHNIQUES

e. The method of breaking cables as presently contained in MIL-W-83140 is not representative of true cable strength in the UH-1N hoist applications. Our testing used a free end set-up which showed a decrease in cable strength of approximately 10-25 percent in some cases, which is considered significant. This phenomenon is characteristic of non-rotating or spin resistant cable due to its construction in that a certain amount of torque is developed when the cable is under a tensile load. If one end of the cable is free to rotate, a torque unbalance occurs which tends to tighten the inner strand lay and unwrap the outer lay strands. If the unbalance is significant, the result is a large decrease in ultimate breaking strength. The degree of torque unbalance generated varies directly with tensile load and appears to be primarily dependent on the ability of the contractor to obtain a uniform and stable torque-balanced cable construction during manufacturing. Consequently, since each contractor uses a unique set of wire sizes, wire material, strand lays, and rope lays, somewhat different characteristics are obtained, depending on the source of the cable. Figure 4 readily shows these differences.
