# INFRARED THERMOGRAPHY OF BUILDINGS

## Qualitative Analysis of Window Infiltration Loss

Federal Office Building, Burlington, Vt.

September 1977

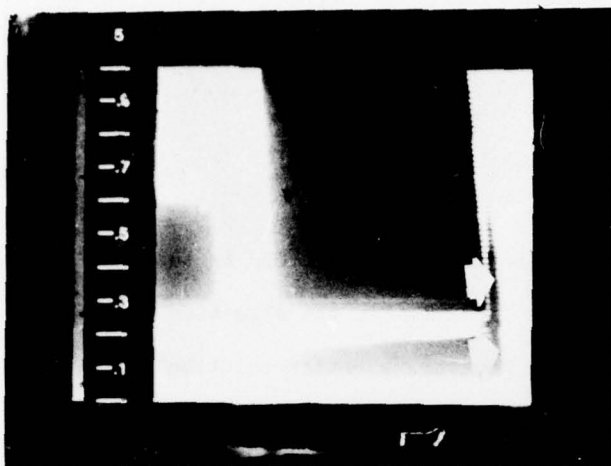
Figures 1 and 2 show thermograms of two north-facing windows in Room 621 taken from inside the building. The infiltration (arrows) seen around these windows is typical of the condition observed at all of the randomly selected windows during the thermographic inspection of this building. Note that in Figure 2 the infiltration is more extensive than in Figure 1. The horizontal black line between the two arrows in Figure 2 shows cold

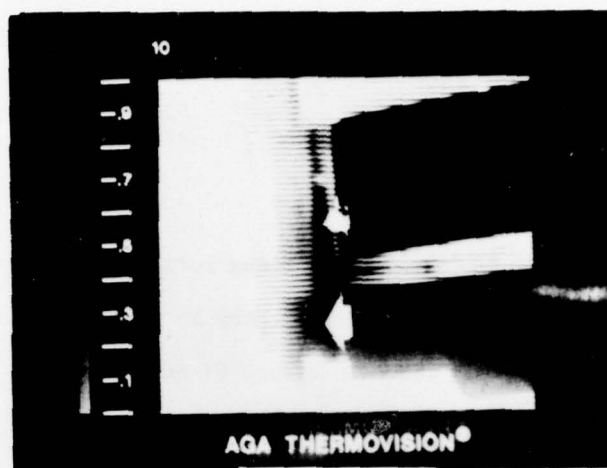
Figure 2.

air leaking through the seal at the top of the opening window. Generally speaking, the air leakage at this location was not as severe as it was around the framing space of these windows. Figure 3 is a photograph of three windows in Room 621.

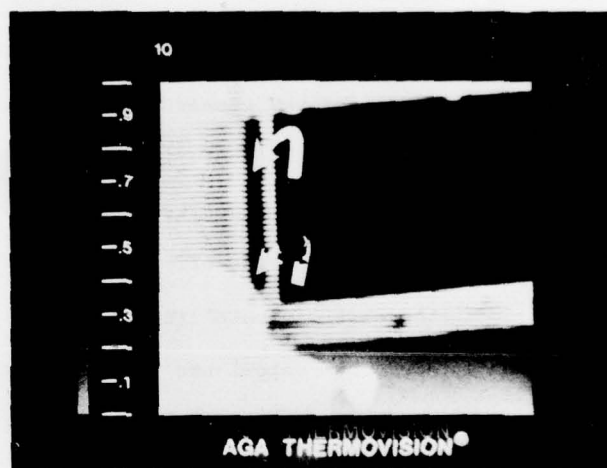
Figure 4.

Figure 4 is a thermogram of the top left part of another projected window in Room 621. Note that air leakage at the window opening is minimal compared with leakage through the window framing space. Also, note in the three thermograms shown in Figures 1, 2 and 4, and in all subsequent ones, that the aluminum frames do not constitute a source of heat loss quite as severe as the infiltration losses.

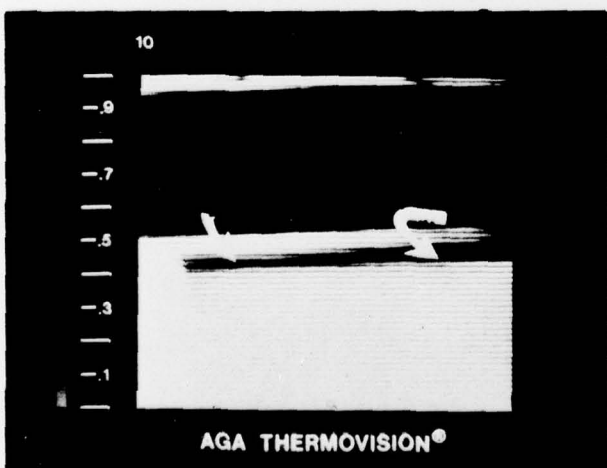
Figure 5.

Figure 5 is a thermogram of cold air leakage under the frame of the opening sash of a window in Room 621. This leakage is probably due to a deficiency of caulking, whereas in the previous three thermograms (Figs. 1, 2 and 4) lack of insulation in the framing space results in excess heat loss.

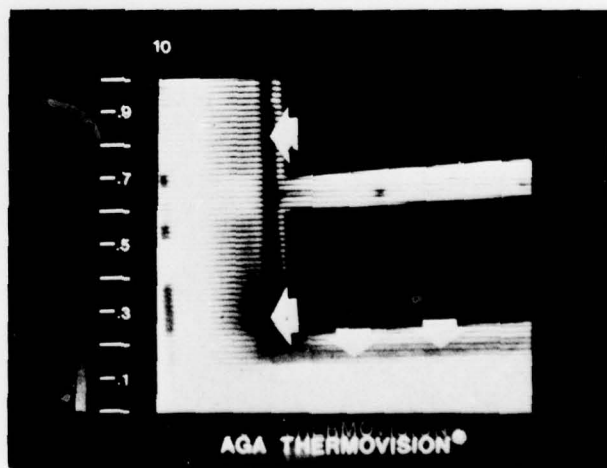
Figure 6.

Figure 6 is a thermogram showing the comparative difference between the heat loss through the framing space (horizontal arrows) and the heat loss under the frame of the opening window (vertical arrows). In this situation, there is more heat loss through the framing space than under the window frame.

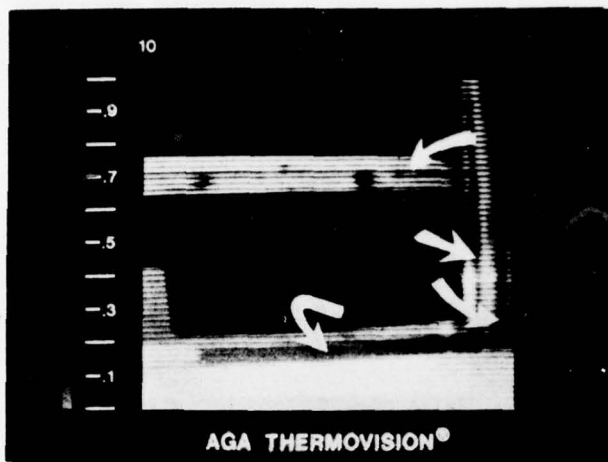
Figure 7.

All of the previous thermograms were taken of windows adjacent to opaque wall sections. Figure 7 is a thermogram of a window which is bounded on each side by another window. The top arrow points to cold air

leaking around the seal at the top of the opening window. The lower right two arrows identify cold air leaking around the mullion between this window and an adjacent one. The arrow at the lower middle identifies a location of greater leakage under the frame of this window than at the other two locations mentioned above.

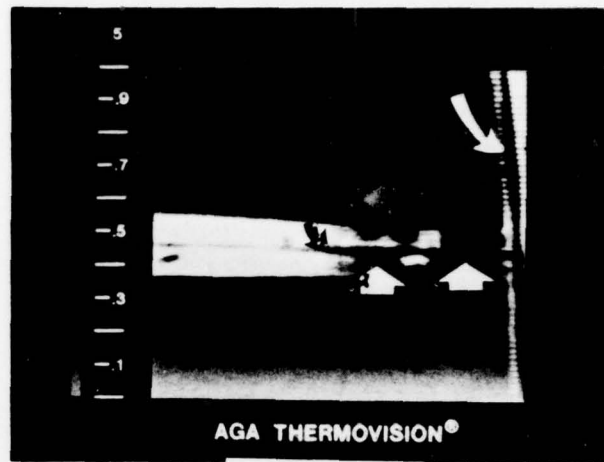
Figure 8.

Figure 8 is a thermogram of a window showing heat loss due to infiltration around the mullion (top arrow) and around the glass-aluminum frame interface (bottom arrows). The heat loss at the latter location could be due to a poor glazing seal. However, it is difficult to determine from the thermogram which pane of glass is not glazed properly. The black arrow identifies excess air leakage around the top seal of the opening window.

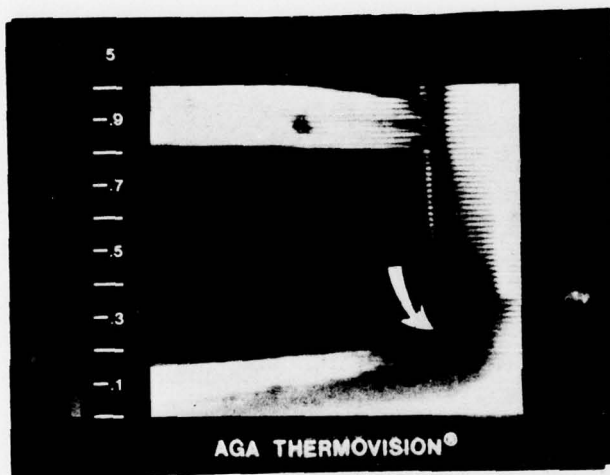
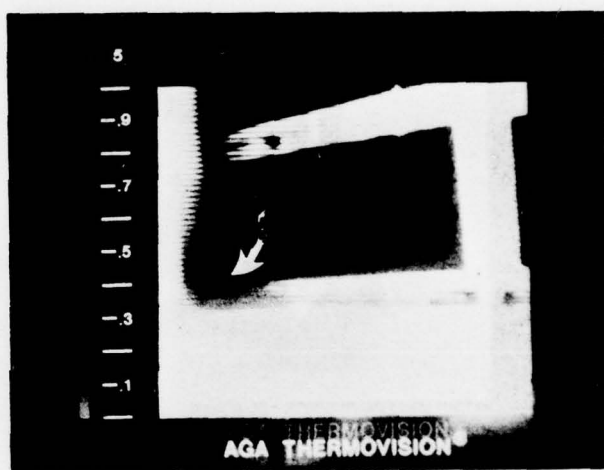
Figures 9 and 10 are thermograms of two north-facing opening windows in Room 629. The arrows identify excess air leakage entering the room through the interface of the glass and aluminum frame. As in the case of Figure 8, the heat loss around these windows could be due to an inadequate glazing seal. Figure 11 is a thermogram of the lower left corner of another window in Room 629 having a situation similar to those in Figures 9 and 10.

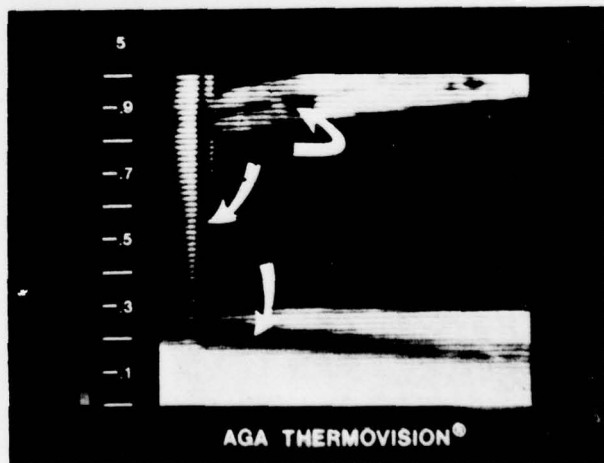
Figure 12.

Figure 12 is a thermogram of an opening window on the northeast corner of Room 631. The top arrow identifies heat loss at the top opening crack, the middle arrow locates air leakage around the mullion, and the lower arrow shows air leakage under the aluminum frame.

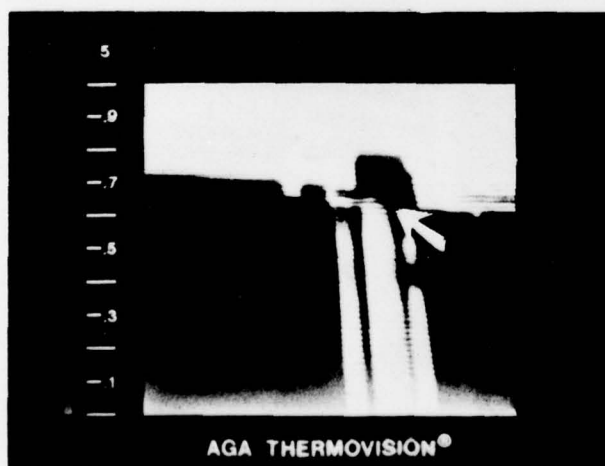
Figures 16 and 17 are thermograms of mullions of north-facing stationary windows in Room 234. The excess heat is probably being lost at the glass/aluminum frame interface in a manner similar to the situation in Figures 8-10.

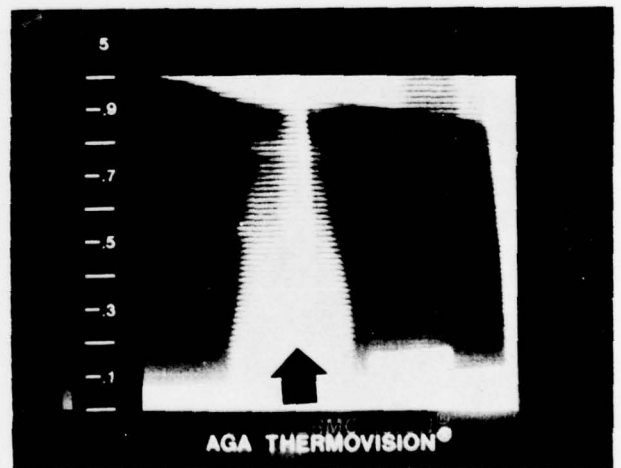
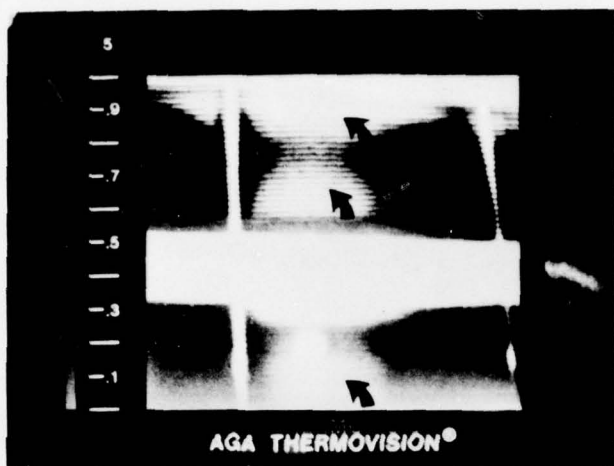
Figures 23 and 24 are thermograms of the lower sections of the east-facing stationary single-pane windows in the Post Office lobby. Arrows identify a plume of heat rising from the convectors directly under these windows. Figure 25 is a thermogram of the top section of one of these windows. The arrows locate the warm spots on the glass due to the heat rising from the convectors. Figure 26 is a photograph of these windows.

The discussion relating to the windows considered the retrofit options for all of the projected windows which opened. However, referring to Figures 23, 24, 25 and 27, we see that significant heat losses are occurring through the stationary windows in the Post Office lobby. To effect a significant reduction in heat loss, two possible corrective actions can be taken: 1) reduce glass area according to our previous recommendations or 2) retain the same glass area but install double- or triple-glazed windows. In either case, we also recommend that 1) aluminum reflectors be placed behind the convectors to deflect the heat back into the lobby, 2) heavy lined drapes be used during all non-occupancy hours, and 3) the temperature in the lobby (and in the whole building) be maintained at 68°F during occupancy hours, and reduced to 65°F at night.

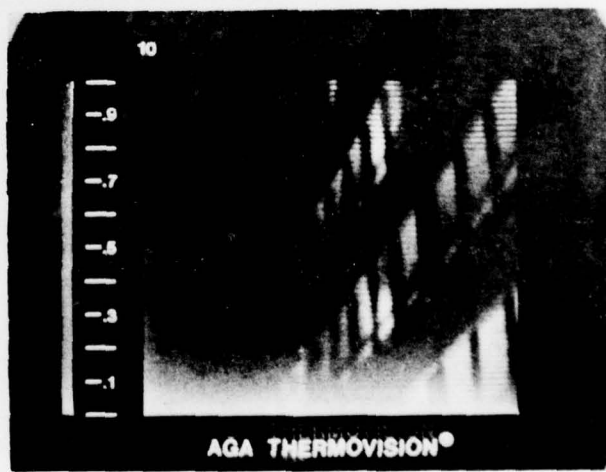
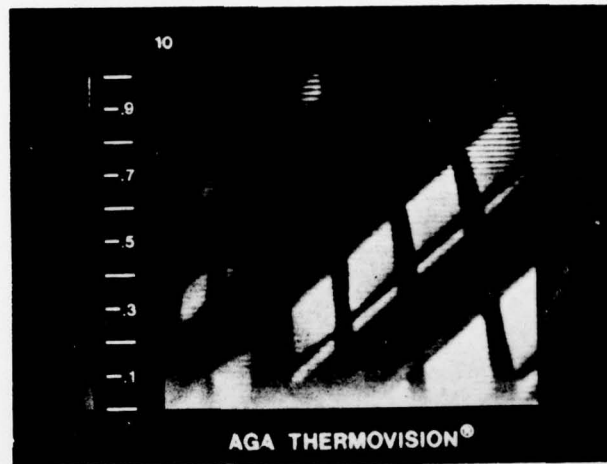
The remaining three thermograms (Figures 29-31) show the heat loss from east-facing windows. The windows having "bright" thermal patterns either have warmer interior temperatures than the ones that do not, or in some cases, the "dark" windows have a higher thermal efficiency due to the presence of drapes.
