Special Report, 77-39

6  
TEMPORARY PROTECTION OF  
WINTERTIME BUILDING CONSTRUCTION

Fairbanks, Alaska, 1976-77.

CORPS OF ENGINEERS, U.S. ARMY  
COLD REGIONS RESEARCH AND ENGINEERING LABORATORY  
HANOVER, NEW HAMPSHIRE

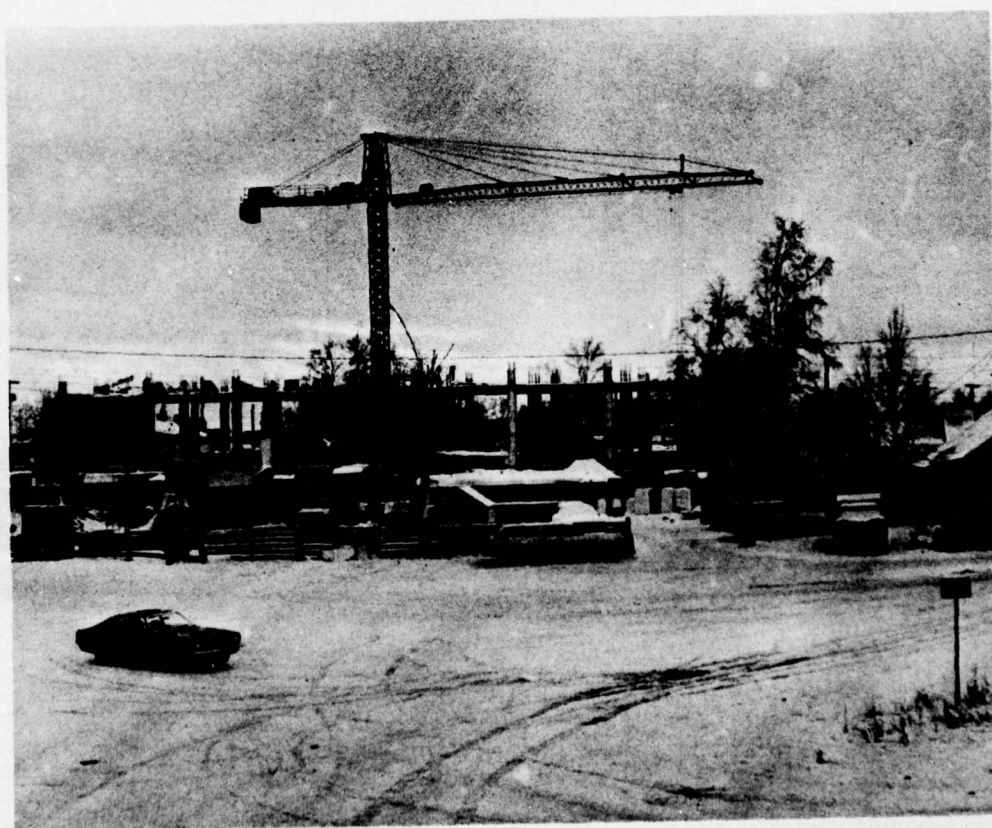
This project, owned by Fairbanks Real Estate Development Corporation and Bering Straits Development Corporation, was not active during the 1976-77 winter. Figure 5 shows this project, with its tower crane standing idle; the idleness was due not to winter conditions, but, instead, to financial difficulties. Contractors on this project, located at 1st Avenue and Hall Street, include O.L.Q. and Sons, and Life Systems Corporation.

5. Fairbanks Plaza Hotel, activities suspended -- not by winter, but by lack of funds. November 28, 1976. +32°F.

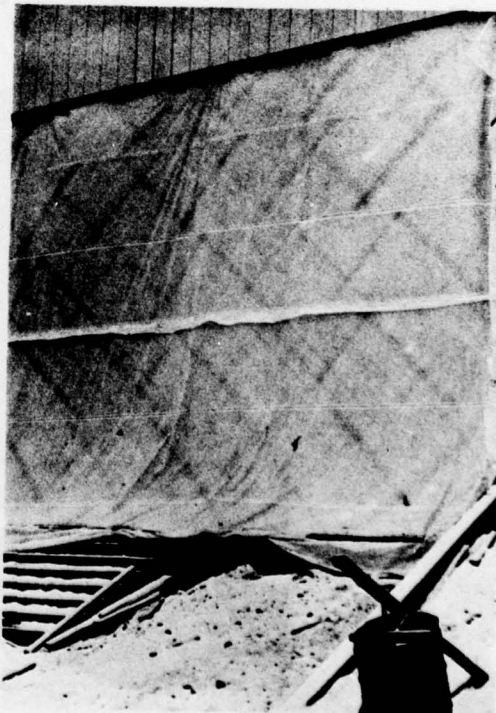
22. Federal Building project. Polyethylene cover on northeast corner. November 28, 1976. +32°F.

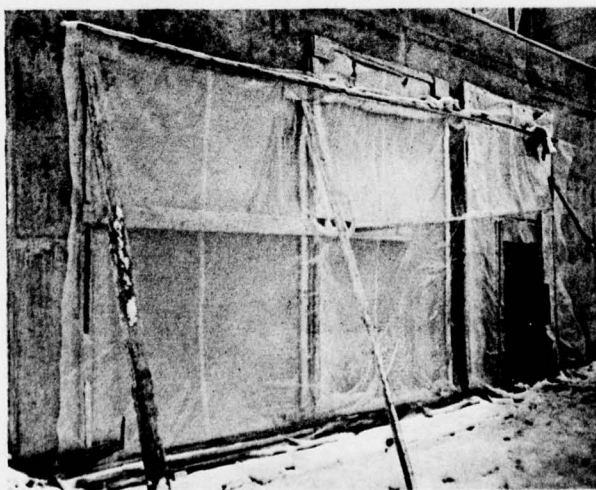
24. Reinforced polyethylene sheathing providing temporary enclosure for garage door at Federal Building project. November 24, 1976. +12°F.
