**ROUND VALLEY NORTH DAM**

**ROUND VALLEY DYKE**

**PHASE I INSPECTION REPORT**

**NATIONAL DAM SAFETY PROGRAM**

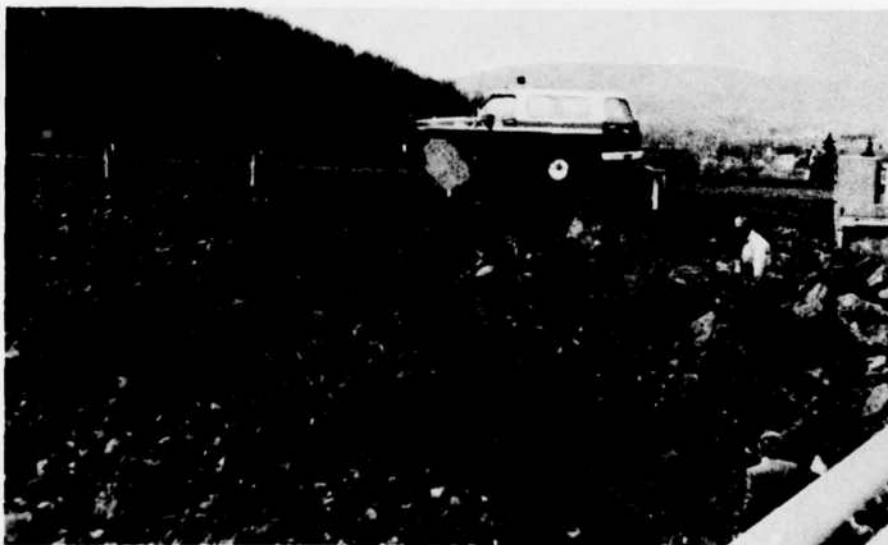
b. North Dam - The riprap on the upstream face of the dam is a poorly graded mix of large angular rocks (2 to 4 feet in diameter) and small rocks (6 inches or less in diameter). There is little uniformity in the distribution and placement of the rocks. The upper portion of the embankment appears to differ from the design drawings. The drawings indicate a 3:1 slope for the upstream face with no benches. The visible portion of the upstream face appeared to have a steeper slope (about 2:1) and a 10 to 15-foot bench just below the water surface. Some driftwood was noted within 2 to 3 feet of the top of the dam. On the east side of the embankment is an area of about 25 square feet that is free of riprap.

The riprap on the upstream slopes is poorly graded and inadequate to provide the necessary protection against wave erosion. The rock appears to have been susceptible to stress release or frost-wedging against fracture planes. According to Mr. Chase, considerable deterioration of the rock has occurred since its placement at the time of construction. Subsequent wave action has left portions of the embankment unprotected. The vertical cracks along the crest of the North Dam could be simply a sign of temperature change or could indicate a more serious condition relating to lateral movement.

| VISUAL EXAMINATION OF | OBSERVATIONS | REMARKS OR RECOMMENDATIONS |
|---|---|---|
| RIPRAP FAILURES | <p><u>NORTH DAM AND DIKE</u><br/>Gradation of the riprap is poor. Large angular stone (2 to 4 feet in diameter) is mixed with small stone and gravel (6 inches or less), with very little intermediate sized stone. The stone sizes are segregated in some areas.</p> | <p>The rip rap should be graded more evenly, and sizes added as necessary.</p> |

POOR GRADATION OF RIP RAP ON NORTH DAM  
EMBANKMENT

c. Within one year from the date of approval of this report, the upstream slope protection should be repaired to provide a suitable well graded riprap layer.
