PASSAIC RIVER BASIN

DUNDEE LAKE DAM

PHASE I INSPECTION REPORT  
NATIONAL DAM SAFETY PROGRAM

JUNE 1978

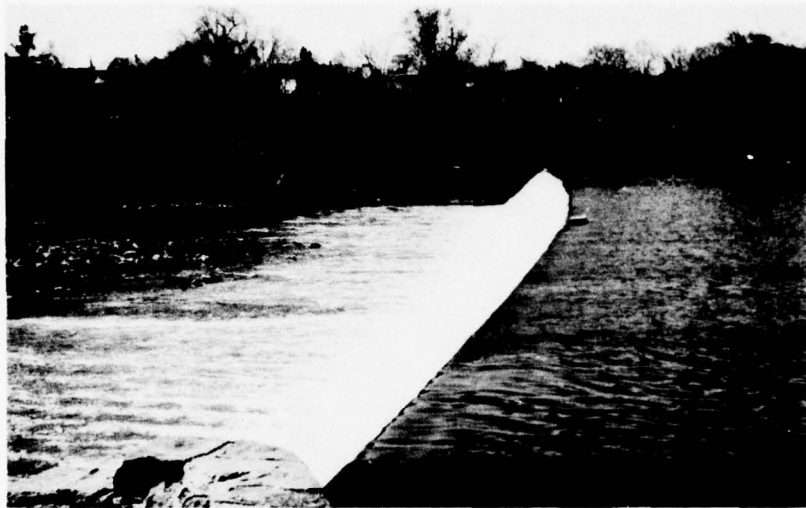
Photo 1 - General view from left bank toward right  
abutment and canal intake on right bank

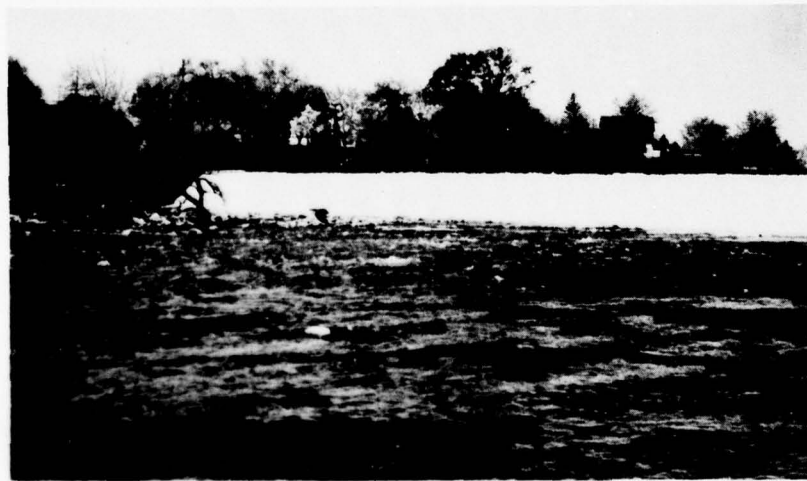
Photo 2 - View from downstream left bank looking  
toward right abutment

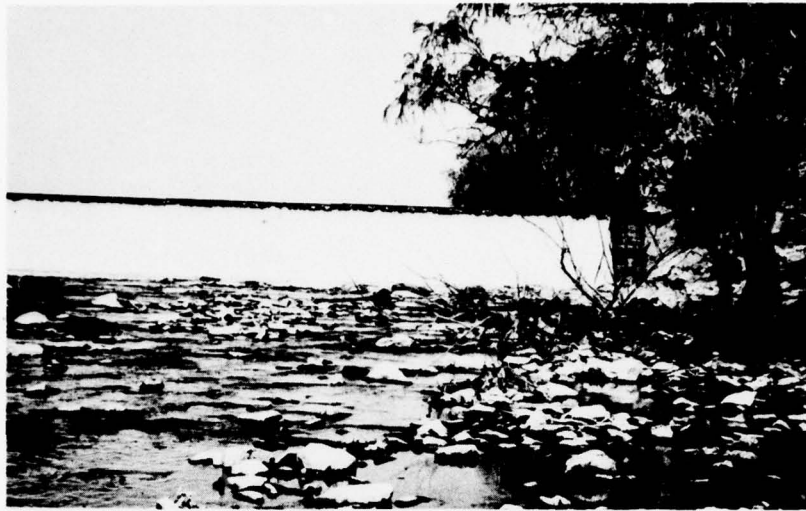
Photo 3 - View from downstream left bank at left abutment

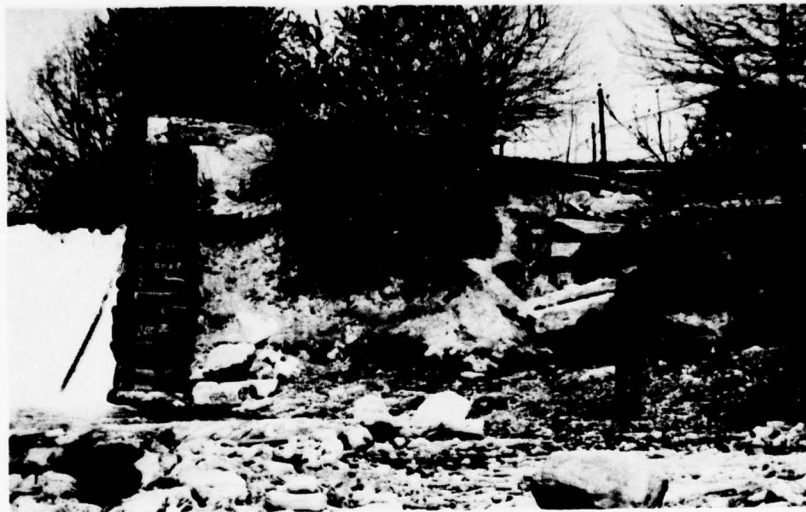
Seepage was observed in two areas, 3 to 5 feet in length, above the toe of the left abutment, approximately 12 to 15 feet from the spillway wingwall. The seepage was estimated to be about 1 gpm at the time of the inspection, and the source is believed to be the reservoir.

Photo 4 - Close-up view of left abutment; seepage is coming out at a point half way between the figure and the spillway training wall

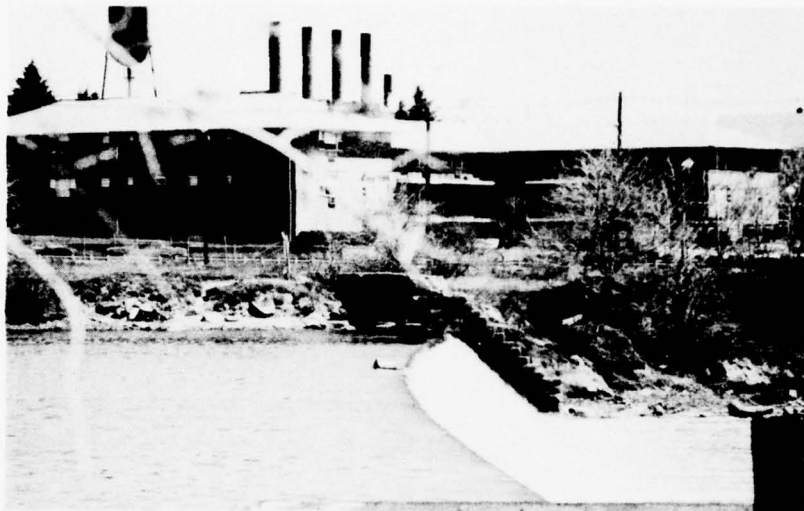
Photo 5 - View of left abutment and left spillway training wall from right abutment

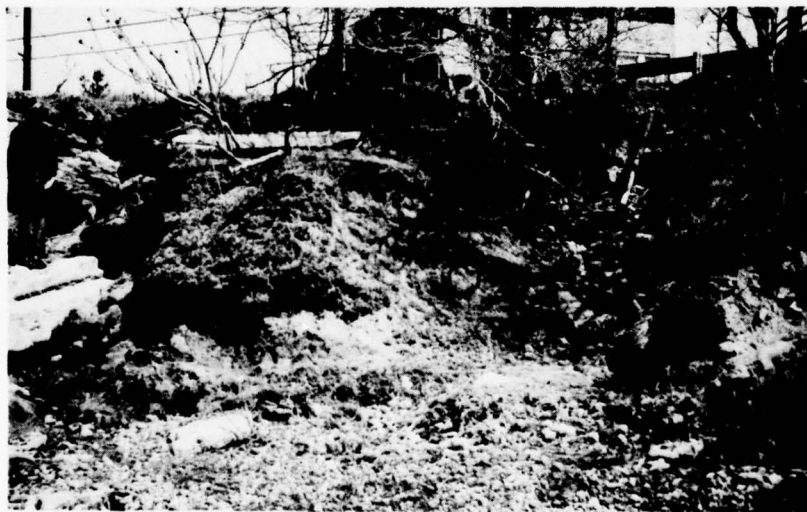
There was no evidence of structural cracking. The left abutment has been partially destroyed or vandalized at the top courses of masonry. The downstream area of the left abutment is severely eroded by drainage

Photo 6 - Close-up view of left abutment area downstream of dam showing stream bank erosion caused by local street drainage overflow

- (1) Regrade the area downstream of the left abutment and protect against erosion and slope instability.
- (2) Make provisions to control surface runoff from River Drive, Garfield.
- (3) Repoint eroded joints in masonry on left and right abutments.
- (4) The riverward canal embankment should be cleared of uncontrolled brush growth and replaced with suitable ground cover.
- (5) Upgrade Operation and Maintenance procedures by issuing an O & M Manual.
- (6) Install head and tailwater gages.

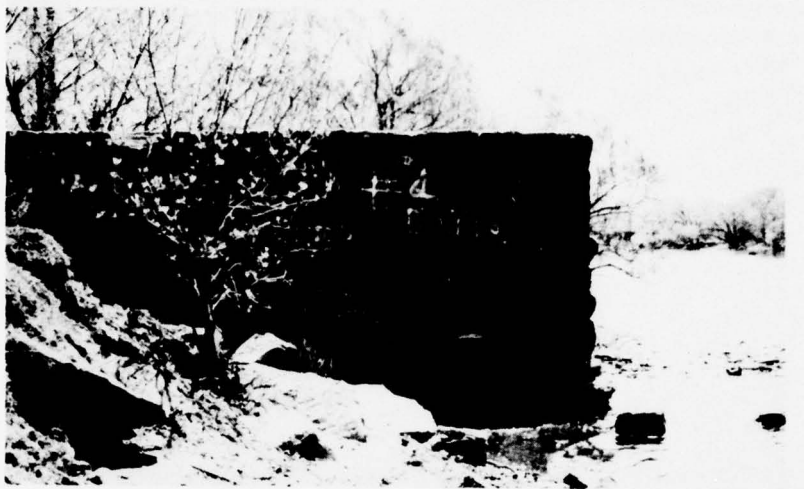
Photo 7 - View of left abutment from upstream side of dam

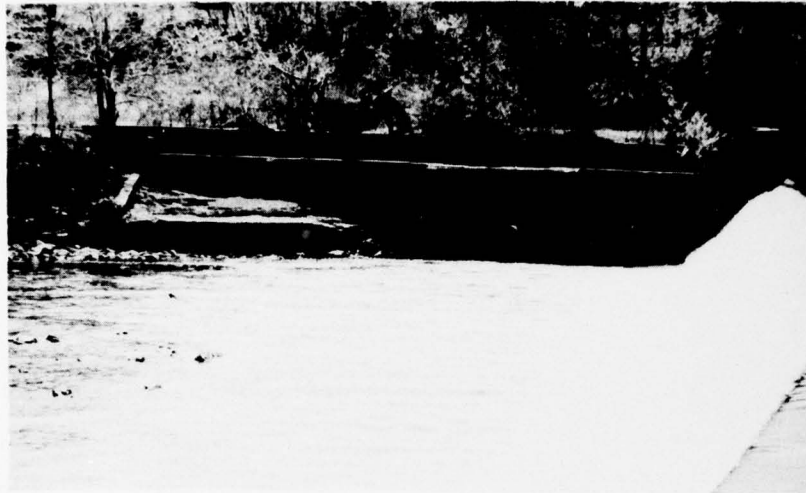
Photo 9 - River wall of Dundee Canal intake; the wall has been lowered to act as a water level control weir for the Dundee canal at high flow rates of the Passaic River; wall is leaking at places through masonry joints

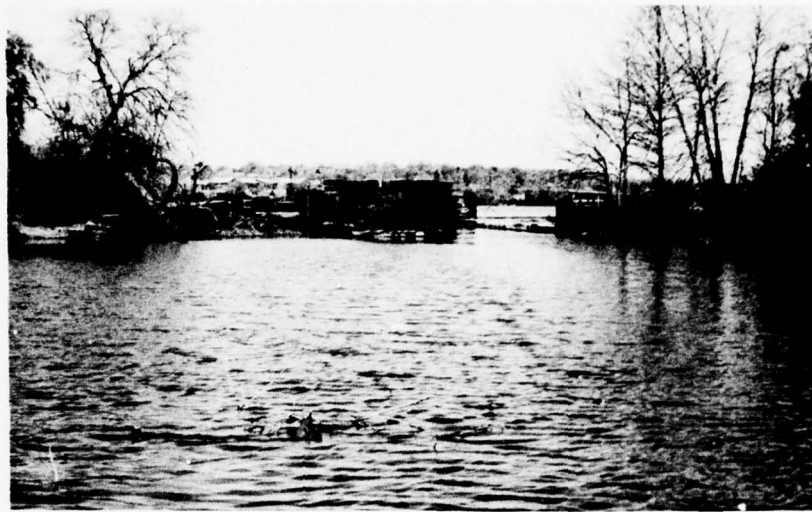
Photo 11 - General view of Dundee Canal intake from right canal bank looking upstream

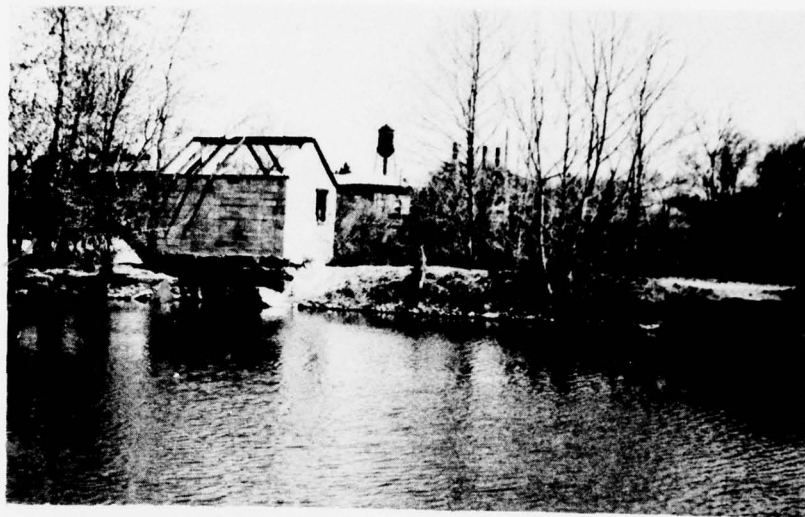
Photo 13 - View of gate house looking across Dundee Canal toward left abutment
