CHARLOTTEBURG DAM

PHASE I INSPECTION REPORT NATIONAL DAM SAFETY PROGRAM

NJ00316

JUNE 1978

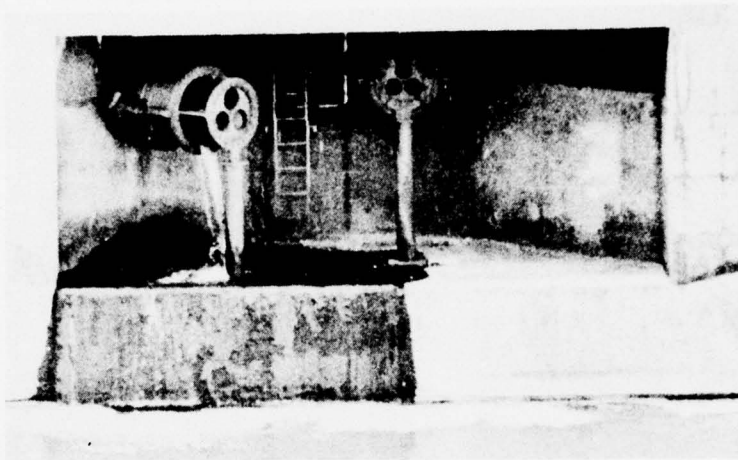
The outlet hollow cone valve for the 48-inch by-pass line located on the left side of the stilling basin had a crack in the operating mechanism housing. As a result, if lubricating oil were placed in the drip feed reservoir, it would run out through the housing. The leak in the housing should be repaired so that proper lubrication can be provided for the operating mechanism.

Photo 7 - Left stilling basin wall showing recess for 30-inch diameter hollow cone valve from 48-inch diameter by-pass line (left) and 24-inch diameter hollow cone valve for draining of 54-inch diameter raw water line (right)

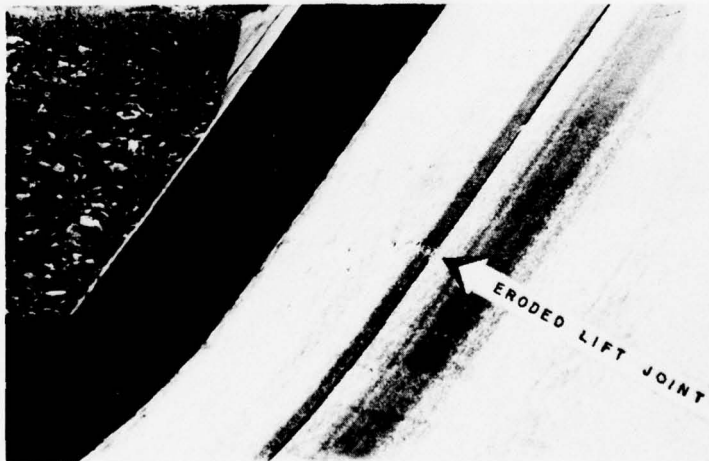
Photo 10 - Spillway looking toward right abutment
showing poor lift joint in monolith 9

- (2) Repair lift joint in overflow monolith No. 9 at elevation 685 to 690 \pm .
- (3) Dewater stilling basin and inspect floor, chute blocks and end sill for erosion of concrete surfaces. Repairs, if required, should be initiated in calendar year 1979.

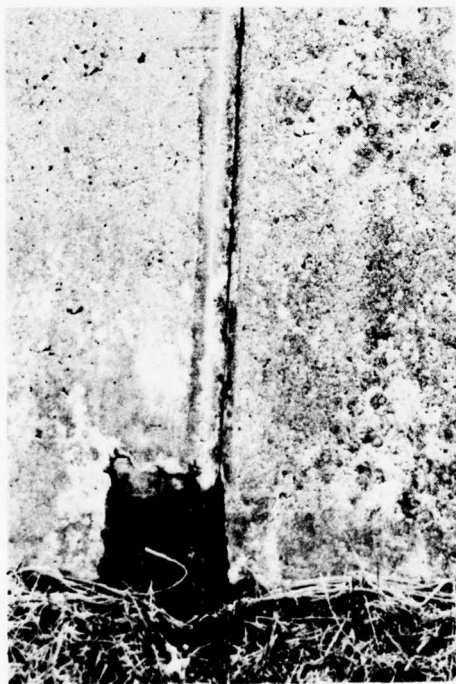
Photo 12 - River Wall - Leaking
vertical monolith joint
at base of monolith

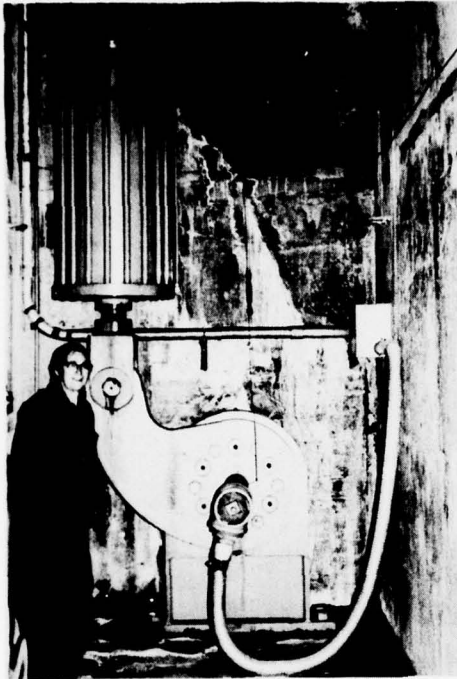
Prior to this inspection, the hydraulic cylinder on the east end of the bascule gate had developed a small leak at the piston rod seal. Operation of the gate was not affected, and the leak eventually stopped. The local operator stated that Allis Chalmers, the original manufacturer of the gate, was scheduled to replace the piston rod seal during July 1978 (when the reservoir level is down below the concrete crest).

Photo 13 - Spillway bascule gate
actuating cylinder on
left abutment

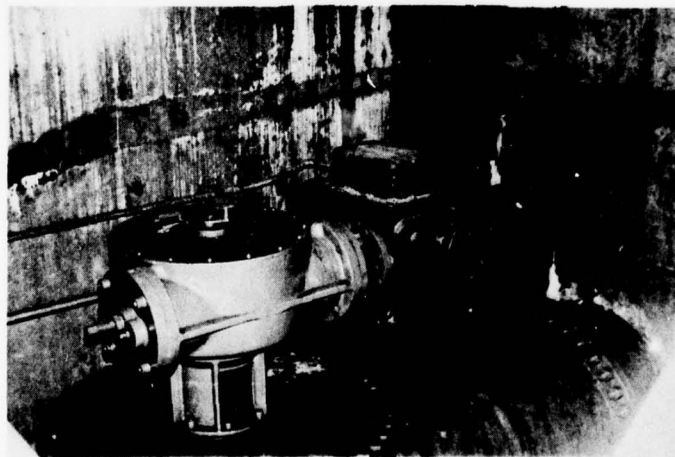
Photo 14 - Valve shaft and 30-inch diameter cone valve
on right side 48-inch diameter pass of raw
water line; looking upstream
