PASSAIC RIVER BASIN  
RAMAPO RIVER, BERGEN COUNTY  
NEW JERSEY

# LAKE VREELAND

## PHASE I INSPECTION REPORT NATIONAL DAM SAFETY PROGRAM

JULY 1978

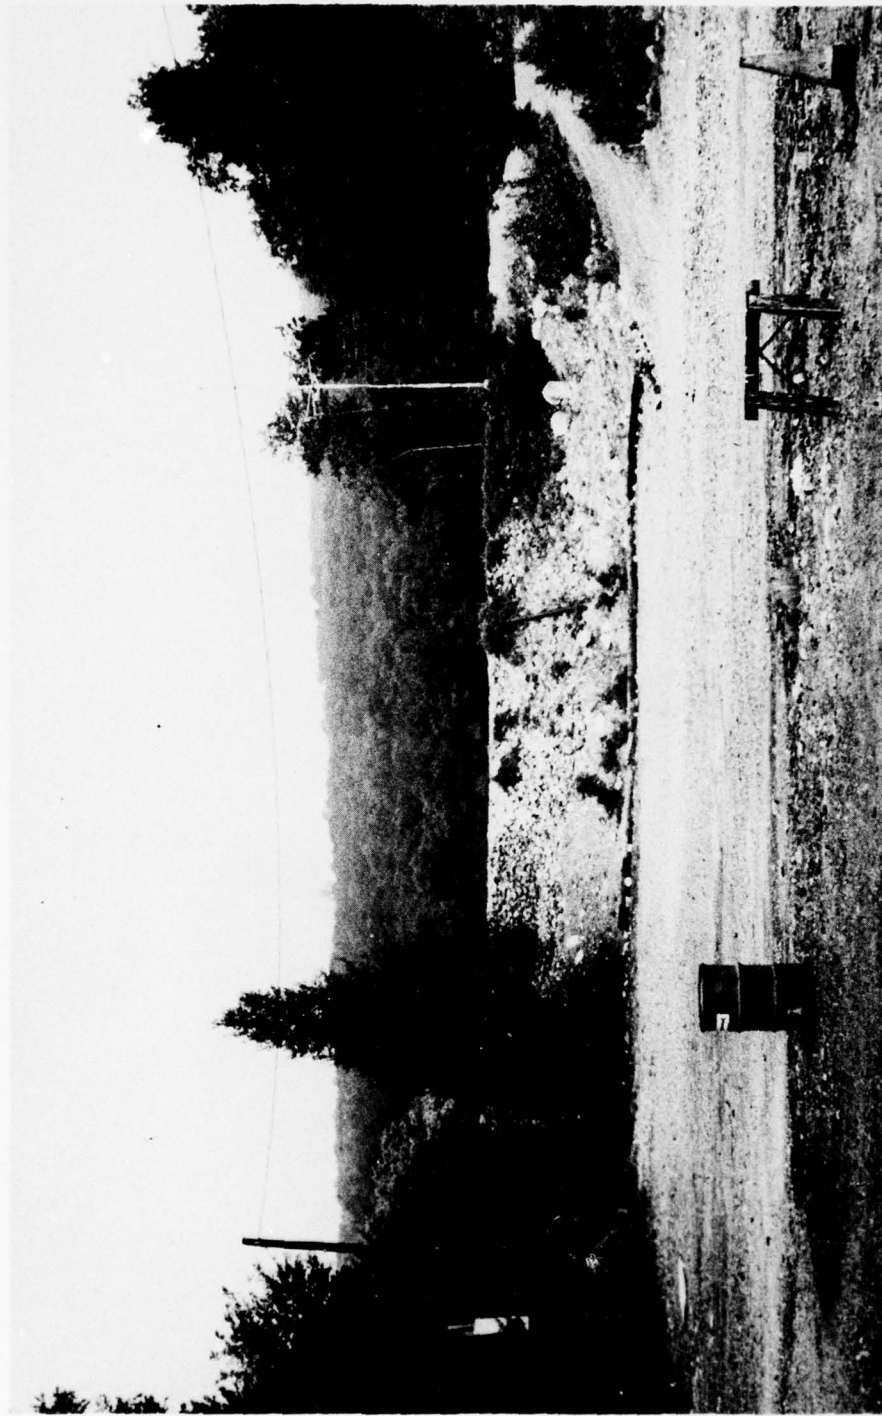
OVERVIEW - LAKE VREELAND DAM

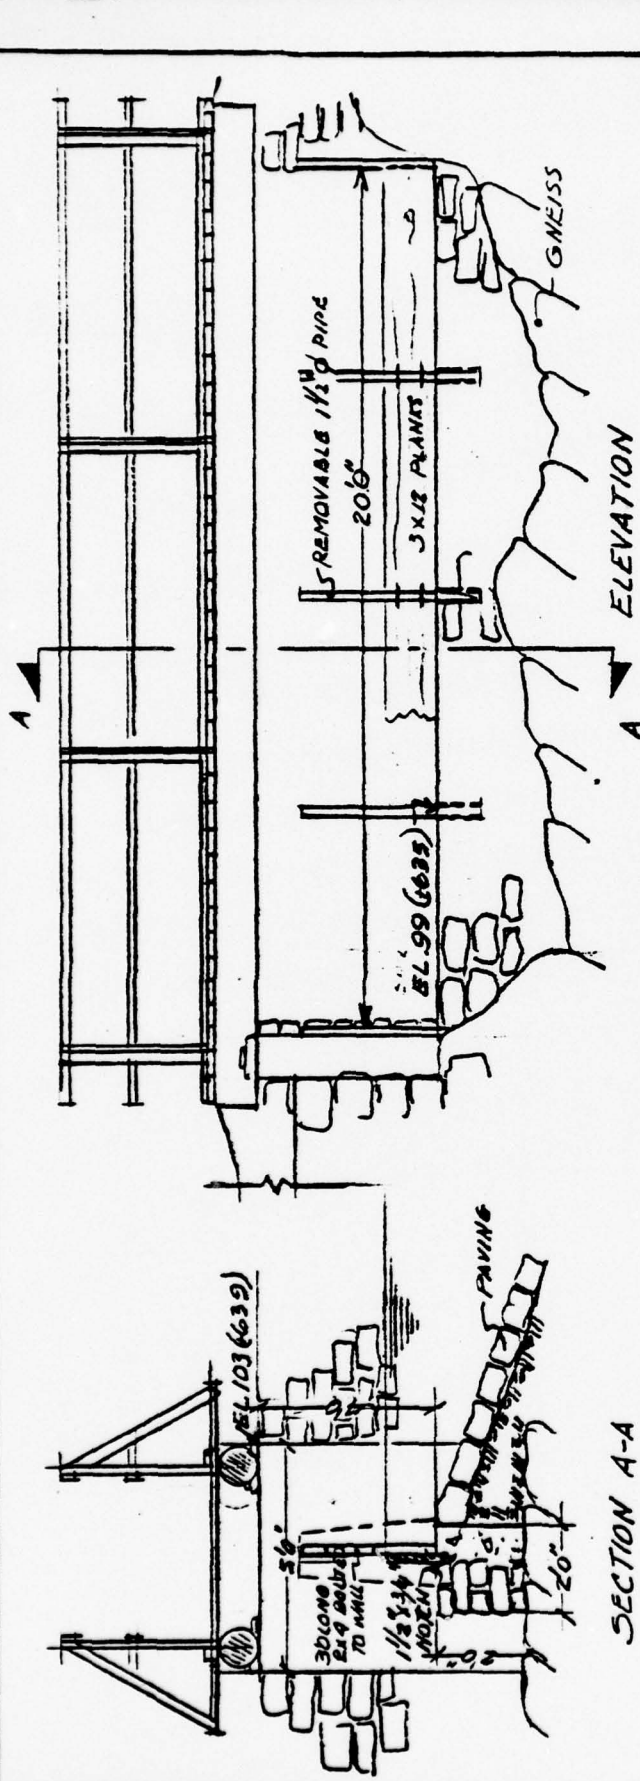
SPILLWAY DETAILS  
SCALE 1 INCH = 2 FEET  
SOURCE: DNB 52141

ITEM	REMARKS
SPILLWAY PLAN	Present spillway does not conform to 1917 construction drawing
SECTIONS	(See Figures 3 and 4)
DETAILS	
OPERATING EQUIPMENT PLANS & DETAILS	Not Available Not Available
MONITORING SYSTEMS	None
MODIFICATIONS	None
HIGH POOL RECORDS	None
POST CONSTRUCTION ENGINEERING STUDIES AND REPORTS	Letter dated 5/17/56 by Norman Wittwer - Describes inadequacy of spillway, not large enough to pass flood of 8/19/55 without overtopping. Recommended raising crest of dam 1 foot or not more than 5.0 feet above spillway crest.
PRIOR ACCIDENTS OR FAILURE OF DAM DESCRIPTION REPORTS	None
MAINTENANCE OPERATION RECORDS	None

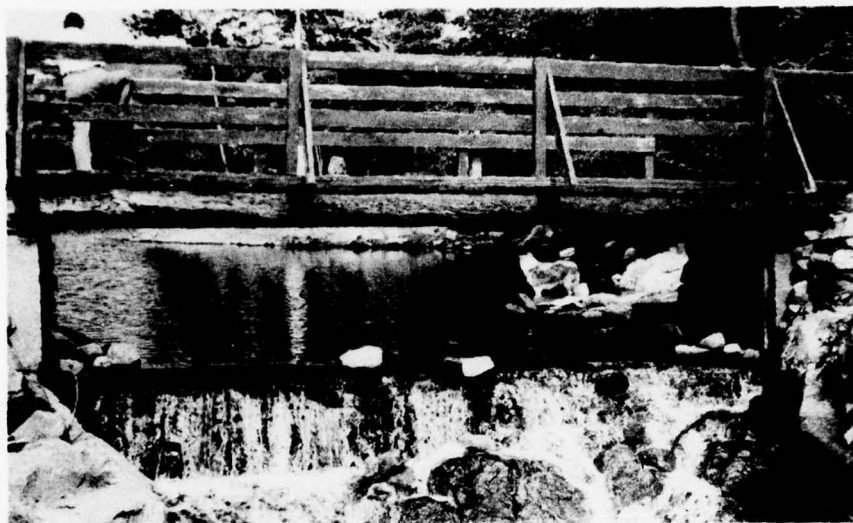
3.1.2 Appurtenant Structures: Concrete surfaces of the spillway wall show some aggregate but do not appear to be detracting from the overall stability of the structure. The wooden bridge and handrail over the spillway were in good condition. The right spillway abutment is of concrete and in good condition (see Appendix H). The left spillway abutment is of fieldstone and needs some touching up with mortar.

SPILLWAY

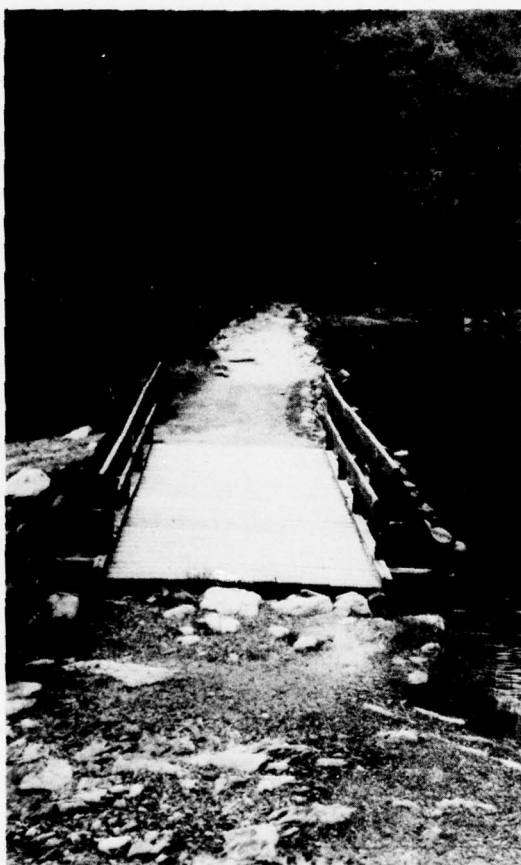
DAM CREST AND BRIDGE OVER SPILLWAY

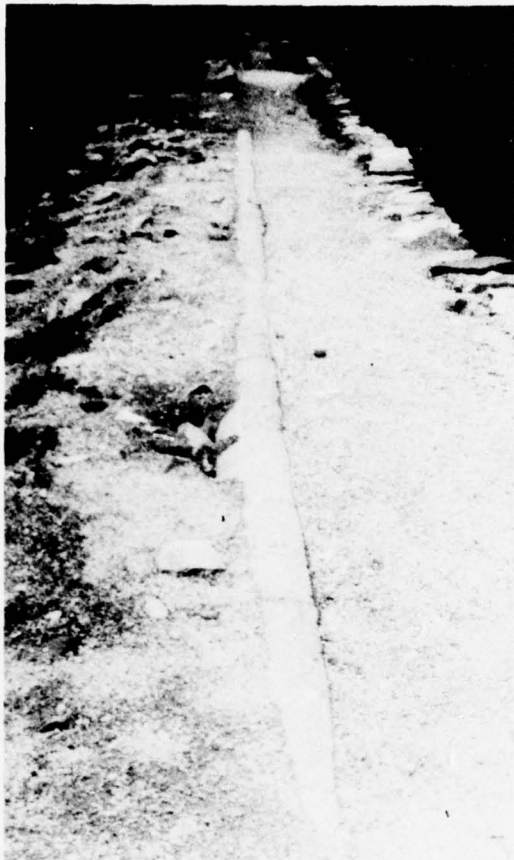
The riprap is stacked vertically and the corewall is exposed over 50 percent of its length. The tilt of a portion of the corewall as evidenced at the crest cast doubts with respect to the integrity of the concrete corewall. The foundation of the concrete corewall may have experienced excessive differential settlement if the wall is founded partially on blue clay and bedrock.

EXPOSED CONCRETE CORE

d. Engineering investigations and studies should be made of the condition of the tilted concrete corewall as well as determination of the properties of the embankment as it pertains to the structure's stability. These investigations and studies should be completed within six months from the date of approval of this report. Any remedial measures found necessary as a result of these investigations and studies should be initiated within calendar year 1979.

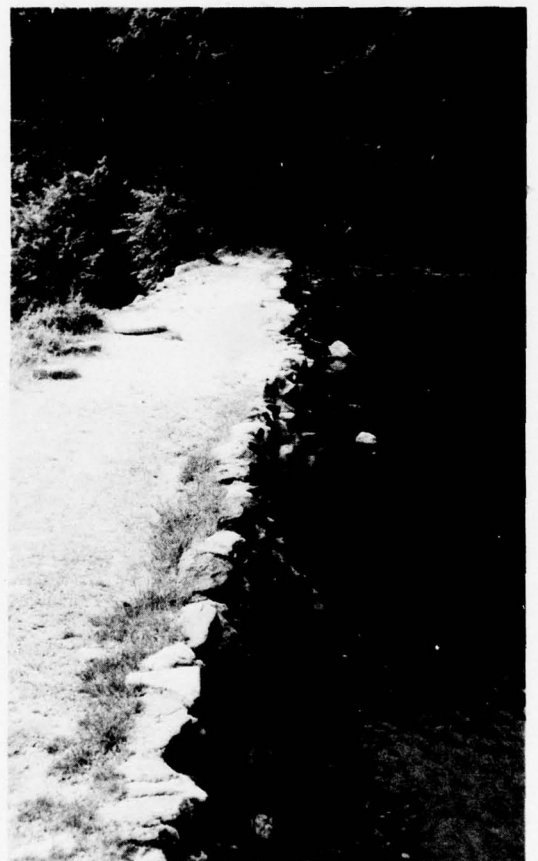
VISUAL EXAMINATION OF	OBSERVATIONS	REMARKS OR RECOMMENDATIONS
RIPRAP FAILURES	Three feet of riprap visible, stacked vertically resting on gently sloping shelf of soil (±3.5 feet wide) on wet side.	The upstream slope was constructed to 2 horizontal: 1 vertical and the entire slope was protected with paving 9 inches thick.
CORE WALL	Visible in two locations, about 25-foot sections. The section nearest the right abutment shows a 10°± angle with the vertical, and the top of the wall section is not level, but slopes towards the downstream side.	Possibility exists that the core wall has cracked, and that water is seeping through said crack with resultant piping etc.
JUNCTION OF EMBANKMENT AND ABUTMENT, SPILLWAY AND DAM	No distress or seepage noted	
ANY NOTICEABLE SEEPAGE	<ol style="list-style-type: none"> <li>1 Minor seepage located at the foot of the slope about 70 feet downhill from the toe of the slope.</li> <li>2 A series of springs flowing at estimated 15-20 gpm is visible in the middle of the parking area, and 220 feet below the toe of the dam.</li> </ol>	The Boy Scout Camp Ranger did not remember if this spring was flowing during deepening of lake in 1976. Lake was drained at the time.

VIEW OF UPSTREAM RIPRAP  
AND VERTICAL DAM FACE

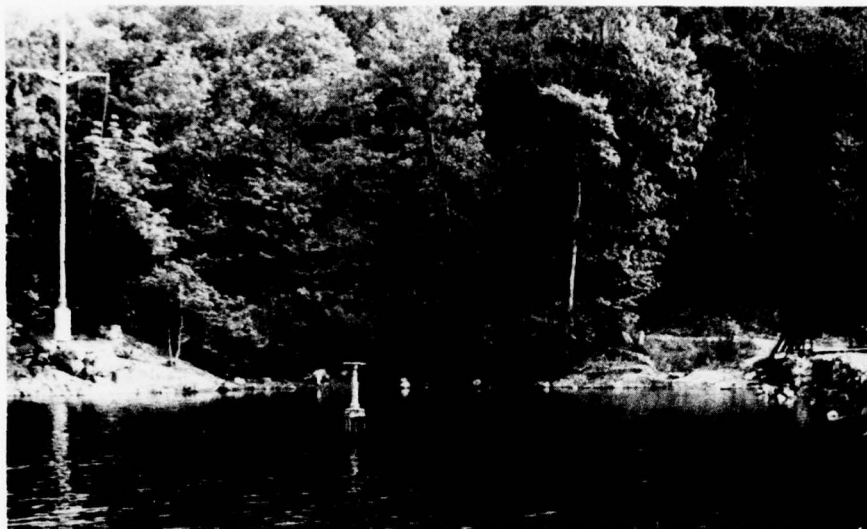
VIEW OF LEFT ABUTMENT  
NOTICE PEDESTAL FOR BOTTOM RELEASE GATE

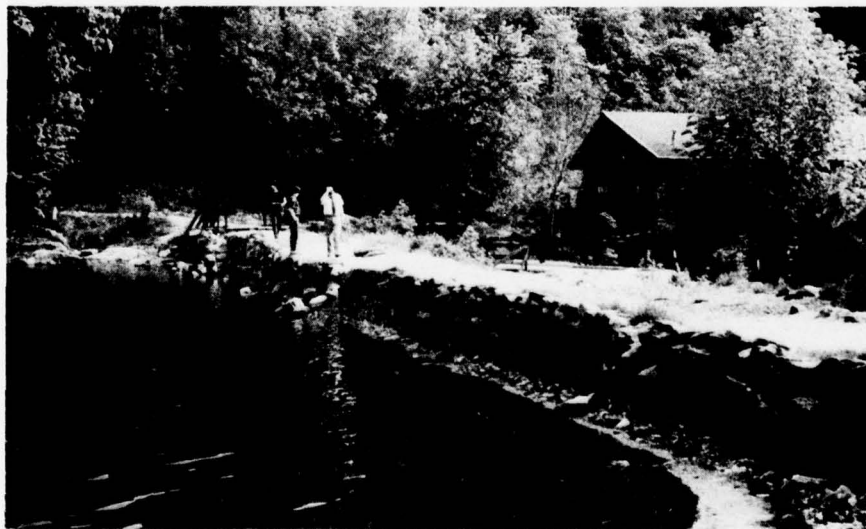
UPSTREAM VIEW OF DAM

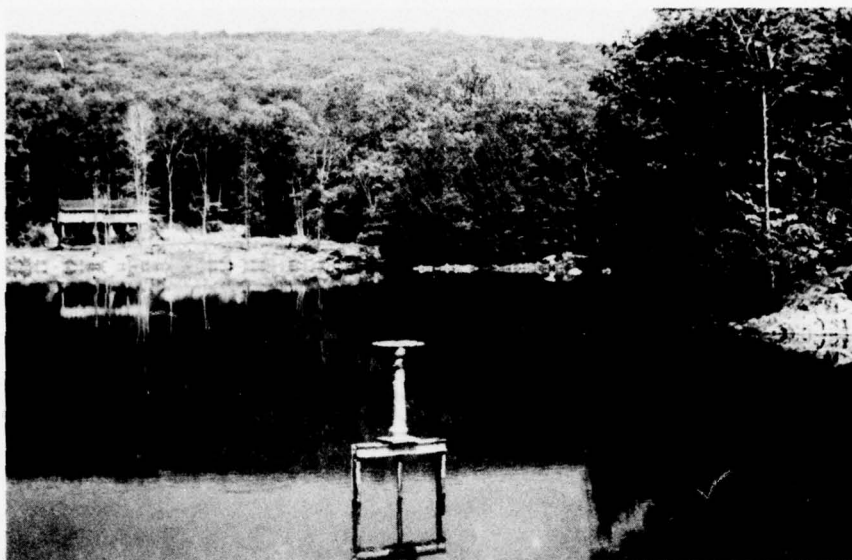
VIEW OF RESERVOIR

NOTE: THERE IS NO BRIDGE TO CONTROL GATE

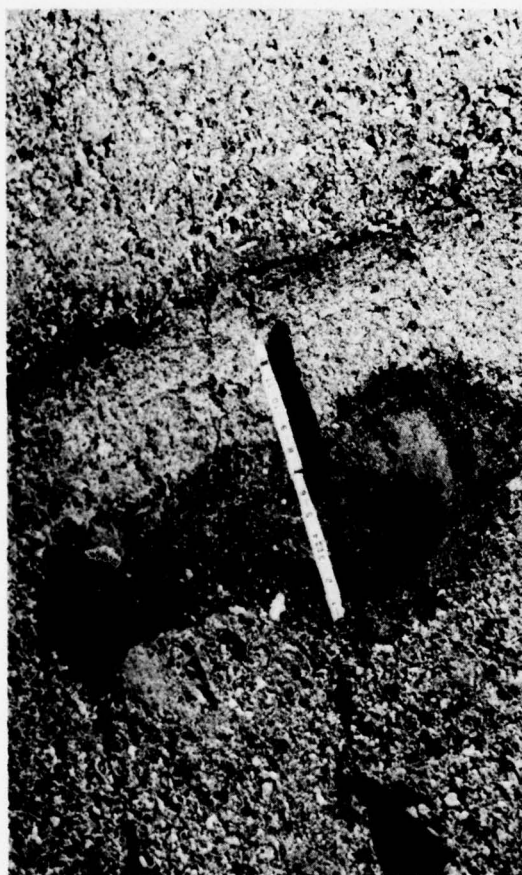
3.1.1 Dam: Some sink holes as large as 9 inches in diameter were observed along the top of the dam. These sink holes were present chiefly along the downstream side of the concrete corewall and the upstream edge of the crest. A section of the exposed corewall on the south side was tilted about 10 degrees toward the downstream. The ground surface at the crest and the top of the corewall were not uniform, which may indicate the results of differential settlements. The downstream embankment varied considerably in slope, material composition and gradation, and method of construction. The material exposed along the downstream slopes is composed chiefly of silty sand, gravel, and boulders. The junction of the embankment and abutment did not show any seepage at the time of inspection. Seepage was not observed along the embankment slopes and toes. There is a small wet ditch located along the toe of the right valley wall at the distance of about 20 feet downstream from the toe of the embankment. A group of intermittent springs with estimated flow of 15-20 gpm at the time of inspection has developed 220 feet downstream from the toe of the embankment at the center of the access roadway. Small amounts of leakage reported (see letter Page E-4, Appendix E) coming out of downstream toe along the concrete culvert pipe at the time of initial reservoir filling, was not discovered at this time of inspection. At a subsequent site visit by the inspection team on June 27, 1978, neither springs nor wet spots were visible.

SINKHOLE ON DAM CREST

f. Sinkholes in dam's downstream crest should be filled with an imperious, stable material within two months from the date of approval of this report.
