# LAKE VALHALLA DAM

## PHASE I INSPECTION REPORT NATIONAL DAM SAFETY PROGRAM

NJ 00330

JULY 1978

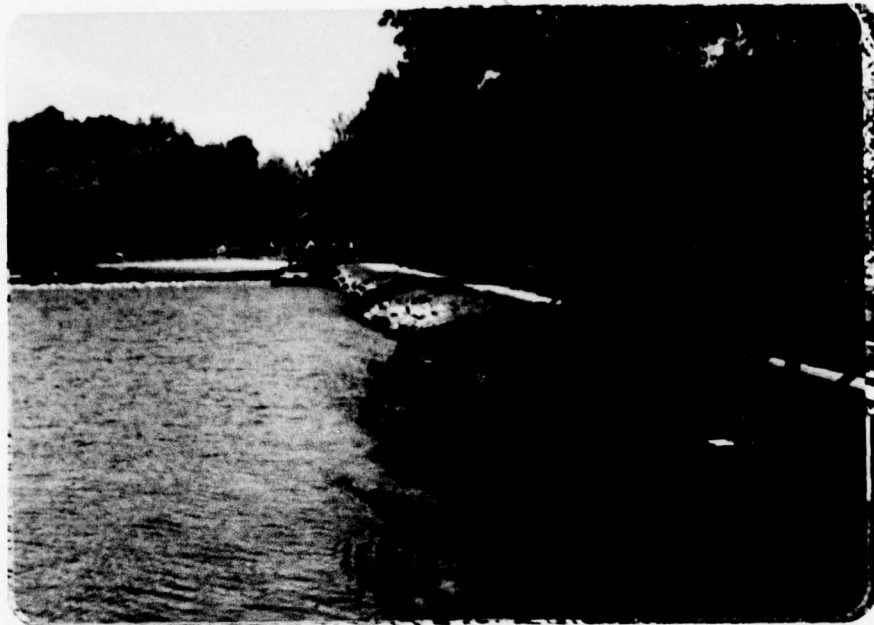
Left embankment and spillway  
looking east

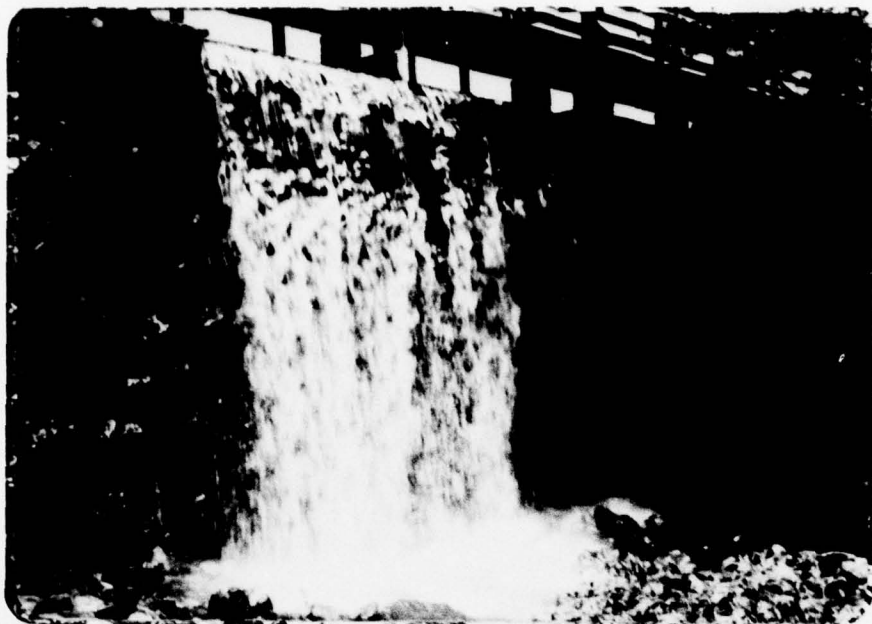
Free Fall Spillway  
Looking Upstream

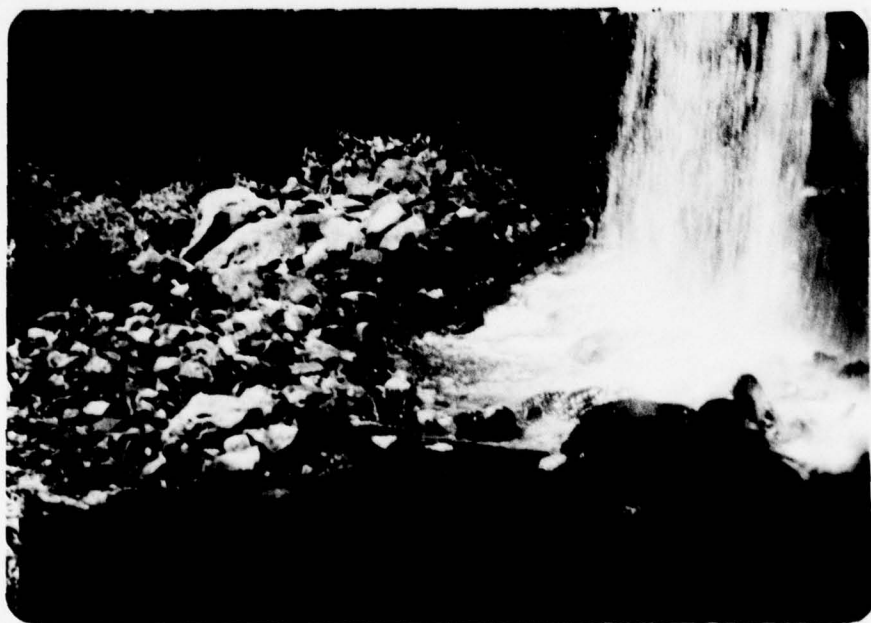
Rocks at bottom of Spillway
