PASSAIC RIVER BASIN  
WANAQUE RIVER, PASSAIC COUNTY  
NEW JERSEY

**GREEN SWAMP NO.4 DAM**  
**PHASE I INSPECTION REPORT**  
**NATIONAL DAM SAFETY PROGRAM**

NJ 00212

AUGUST 1978

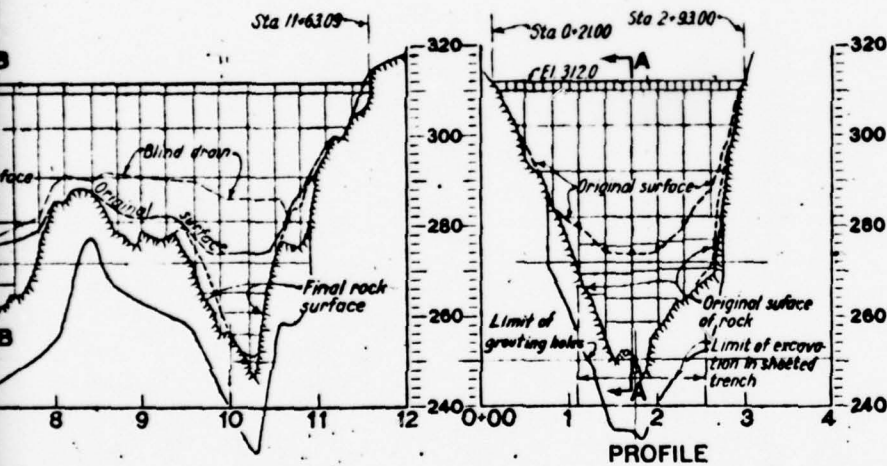
RECORD DRAWING  
SHEET 45 SHEETS IN SET 61

According to the record drawing (sheet 45 in a set of 61) the five 8-inch lateral drains which drain the water from inside the dam should exit above grade. These drains are not visible; presumably they are buried under the granular material along the toe of the dam. A high water level was noted in this material.

Record drawing sheet 45 in a set of 61 indicates that the deepest part of the foundation excavation extends down to 27 feet below original ground giving the dam a maximum height of 67 feet. Competent ledge rock at this depth had been overlain by a boulder zone (Reference 2, page 164). Grouting was performed through 626 linear feet of drill hole using a total of 623 gallons of grout consisting of 47 bags of cement (Record drawing sheet 48 in a set of 61).

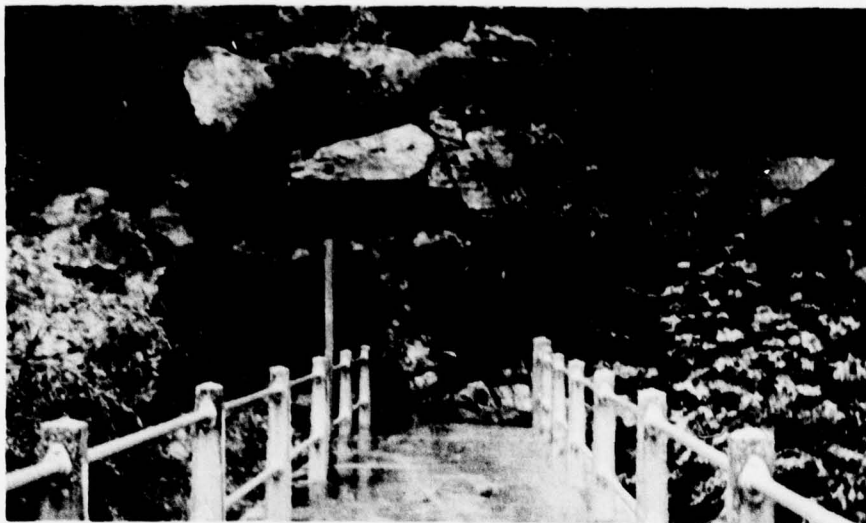
LEFT ABUTMENT

The contact between the abutment and the dam seems to be in good condition. The steep left abutment rock slope appears to be stable.
